**Otter Creek Watershed Tributaries
Phase I Stream Geomorphic Assessment
Furnace Brook, Roaring Brook and Baker Brook
January 2009**

Kiln Brook in Chittenden, Vermont - Tributary to Furnace Brook

Otter Creek Watershed Tributaries Furnace Brook, Roaring Brook and Baker Brook Phase I Stream Geomorphic Assessment

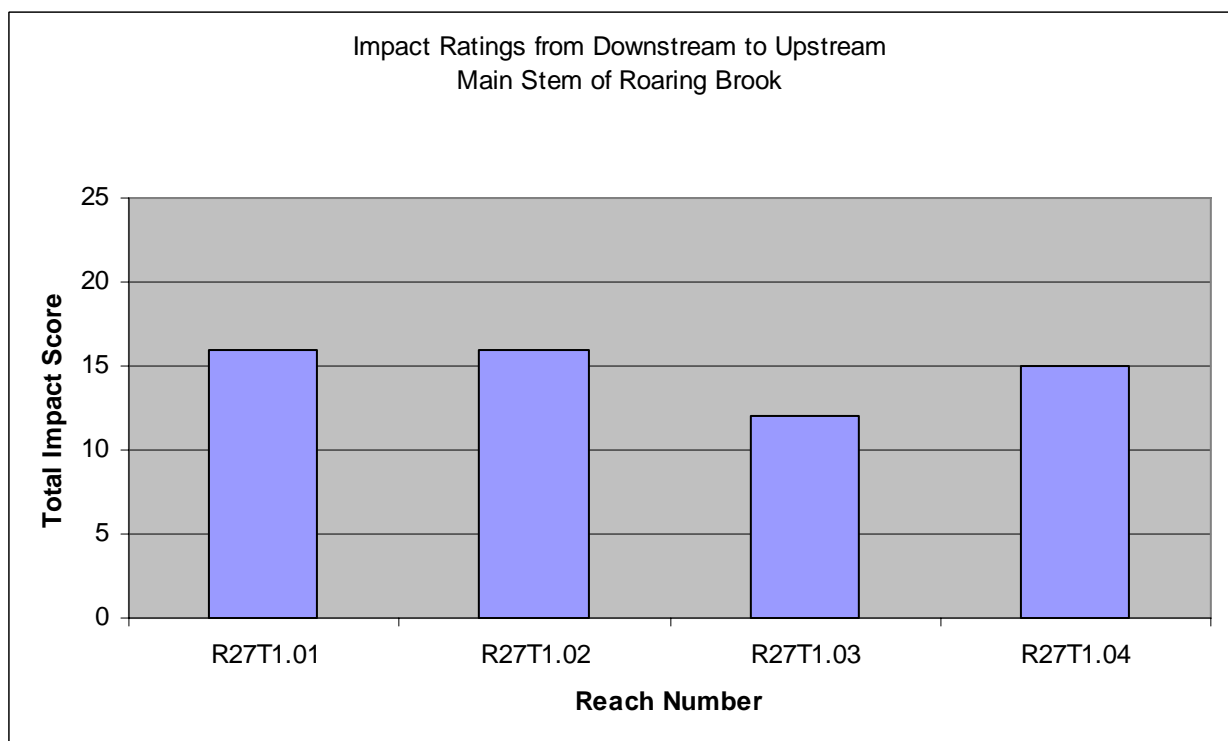
Figure 19: Impact Ratings (out of 32) from downstream to upstream on the main stem of Roaring Brook

The total impact scores (out of 32 possible) for the Phase I assessment for the main stem of Roaring Brook are summarized below in Figure 19. Reaches R27T1.01 and R27T1.02 had the highest total impact rating of 16, while reach R27T1.03 had the lowest total impact rating of 12.

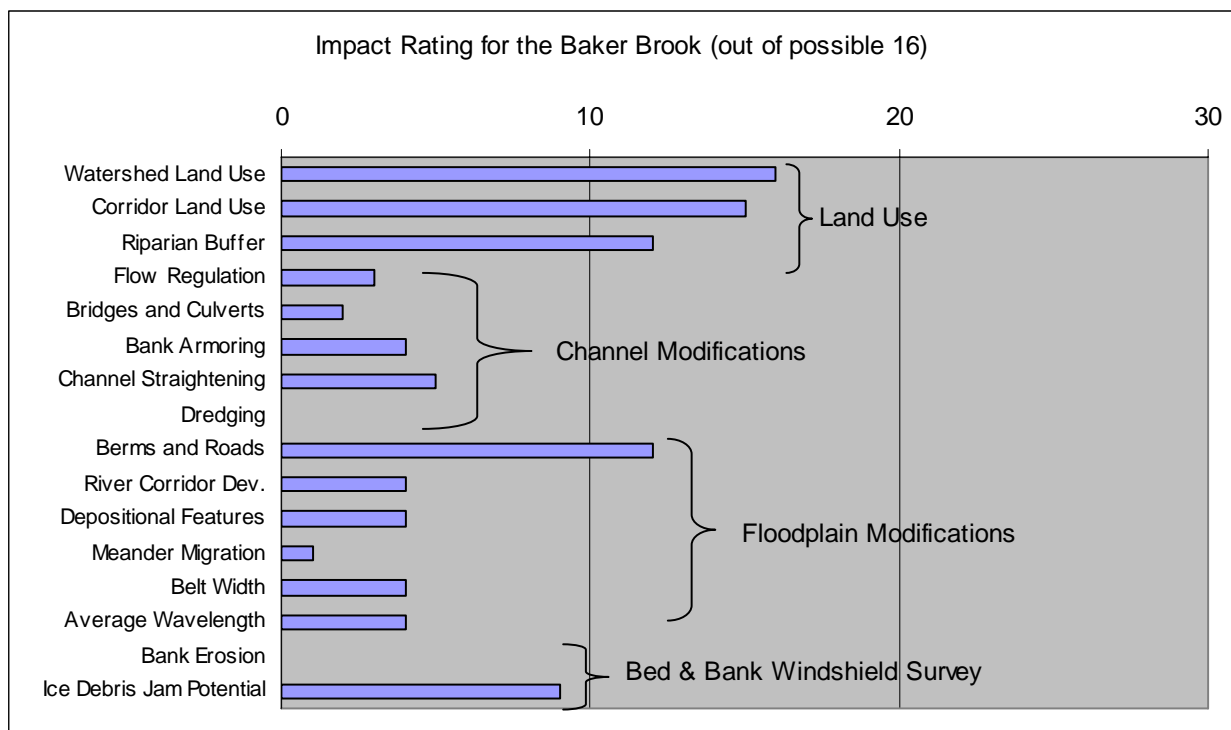
Figure 21: Impact Rating for Baker Brook Watershed by Parameter and Category

Baker Brook Watershed: For the Baker Brook Watershed, the maximum score for each parameter is 16 (8 reaches times impact score of 2). The watershed and corridor land use resulted in the highest impact ratings (Figure 21). The parameters riparian buffer, berms and roads, and ice/debris jam potential also resulted in high scores.
