**WELLS RIVER WATERSHED  
RIVER CORRIDOR MANAGEMENT PLAN**

**WELLS RIVER WATERSHED OF THE CONNECTICUT  
RIVER BASIN**

**ORANGE AND CALEDONIA COUNTIES, VT**

May 27, 2009

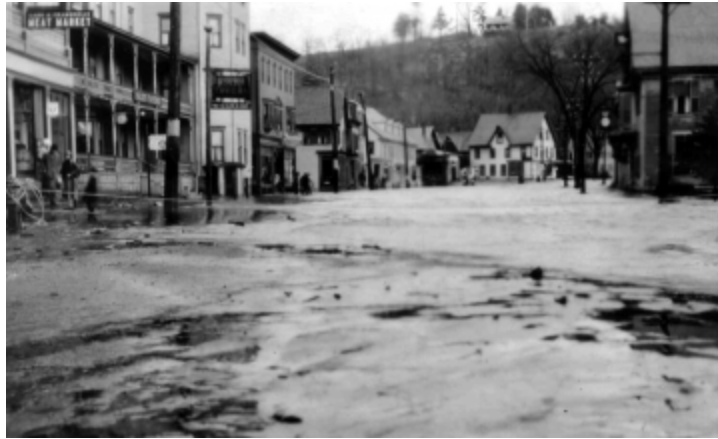
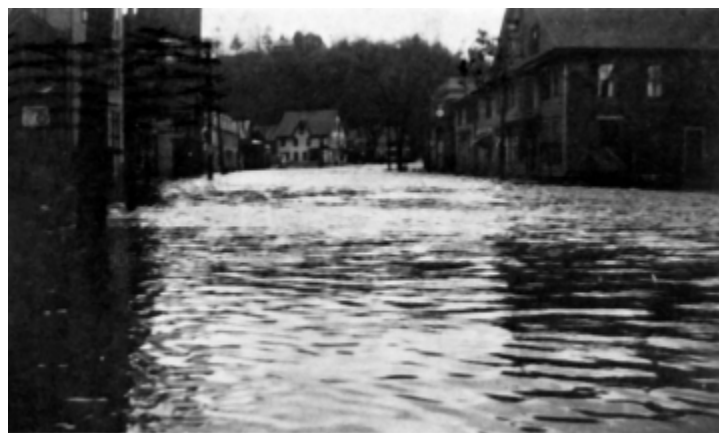
**Figure 3. Pictures of Wells River village valley during floods during the late 1800s (top) and in 1927 (middle). Views of distant hills behind Wells River village in the late 1800s show signs of extensive forest clearing (bottom).**

As Wells River village is located on a flood plain (alluvial fan) at the mouth of the Wells River, flooding has inevitably also been part of its history. Major flooding in the village has been recorded for: the late 1800s (Figure 3), 1927, and 1973.

Although there is common acknowledgement of significant flood events in the Wells River basin (Fig. 3 in this report shows photos of Wells River village during two different flooding events), scientific documentation of impact levels throughout a watershed can be harder to obtain. Streamflow statistics and basin characteristics estimated for the entire watershed area, available from the USGS stream statistics interactive-map internet site mentioned above, are found in the Report below, and in Figure 7. Stream peak flow characteristics can help in flood history comparison with other watersheds. Basin characteristics and stream peak flow statistics for the Wells River drainage basin are summarized in Figure 10.

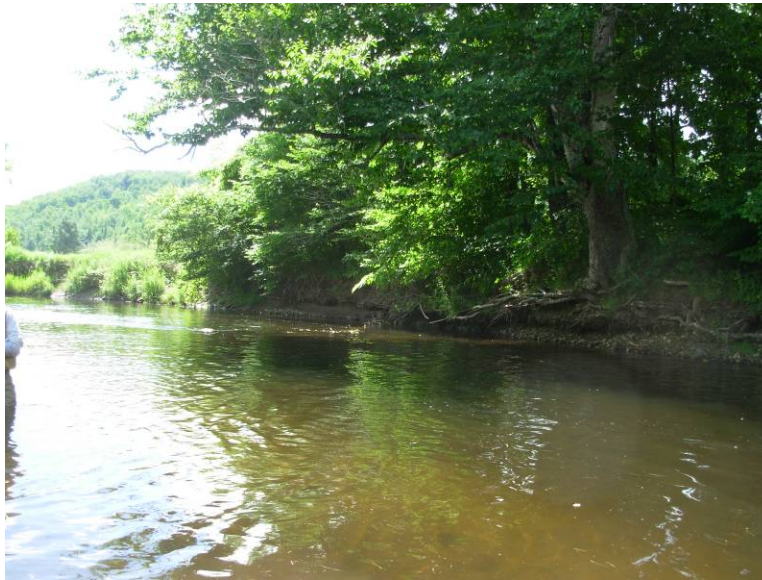
**Figure 19: Bank contrast in M09, showing an intact bank in a forested area next to an eroding bank in an agricultural area.**

Bed materials were coarse in seven of the 12 segments assessed on the Wells River mainstem, and one of the two segments assessed on the unnamed tributary to M04. Stretches of coarse bed material tend to alternate with stretches of fine bed materials. This can be explained by the presence of bedrock grade controls in the upper part of the project area; where sands naturally drop out upstream of a slope-modifying barrier. Upper bank materials are often more easily eroded in flood flows than the bed and lower banks. Sands dominated the upper banks in all but M01 (which has a man-made bank), M04A, M08A, and M04S3.01D. Bank erosion was noted fairly extensively in areas where riparian buffers lack significant vegetation and banks are not armored. Small mass failures were found in a few reaches that have steep valley walls and where the stream channel pushed up against the valley wall. Figure 18 illustrates the importance of a forested buffer to bank stability.

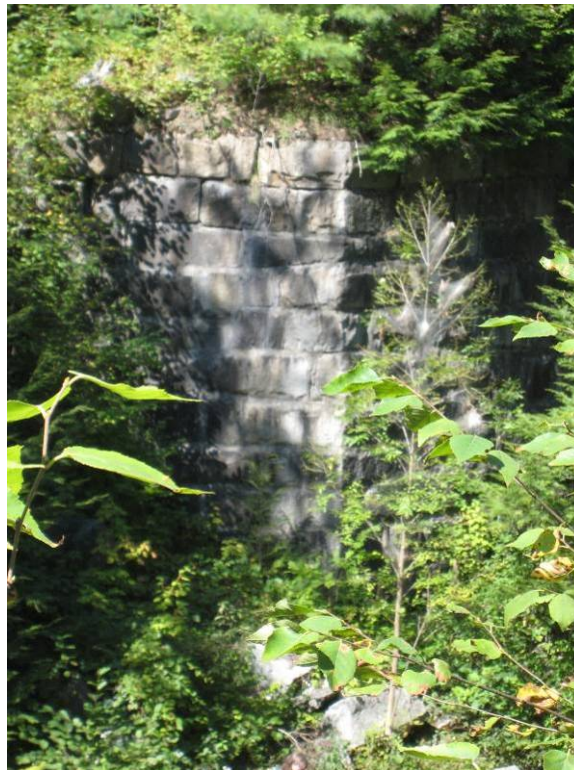
**Figure 28: Wells River mainstem, Reach M04, old railroad bridge abutment.**

Historic (1924) topo shows the old railroad line starting out on the north side of the stream and crossing over to the south side, approximately 850 feet upstream. The old abutments are still visible (Figure 29), and the old bed is visible at the east end between Route 302 and the river. At the west end of this segment, the old railroad bed looks to have been incorporated into Route 302.

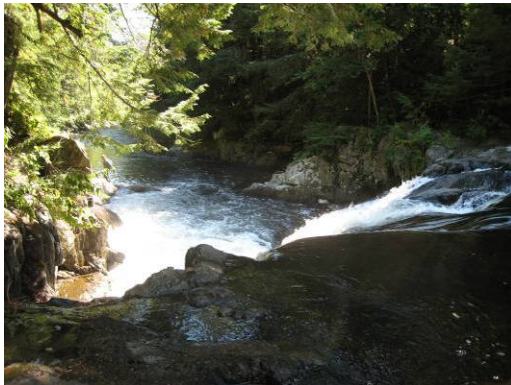
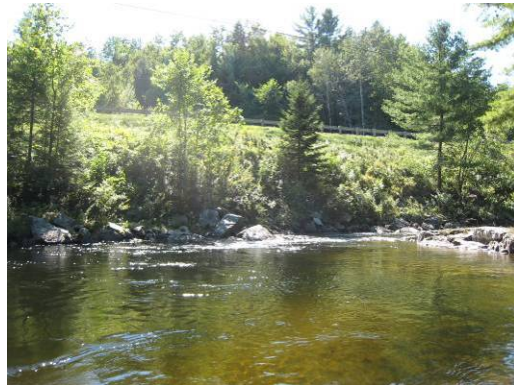
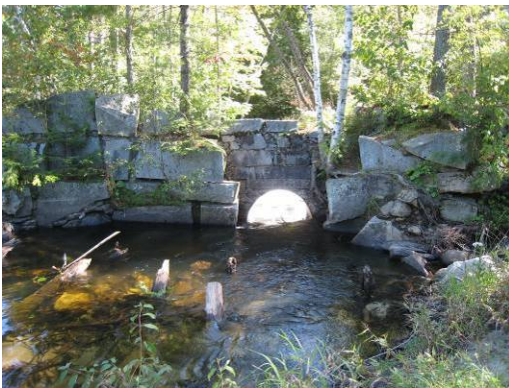
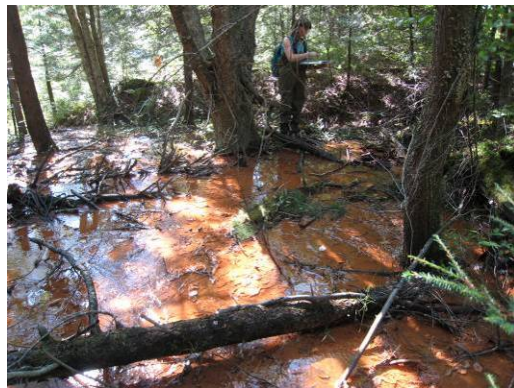
**Figure 30: Reach M04 Segment A has numerous grade control features, some of which are large (upper left), a fair amount of road encroachment and armoring (upper right), a historic dam site (lower left), and some potentially problematic leachate (lower right).**

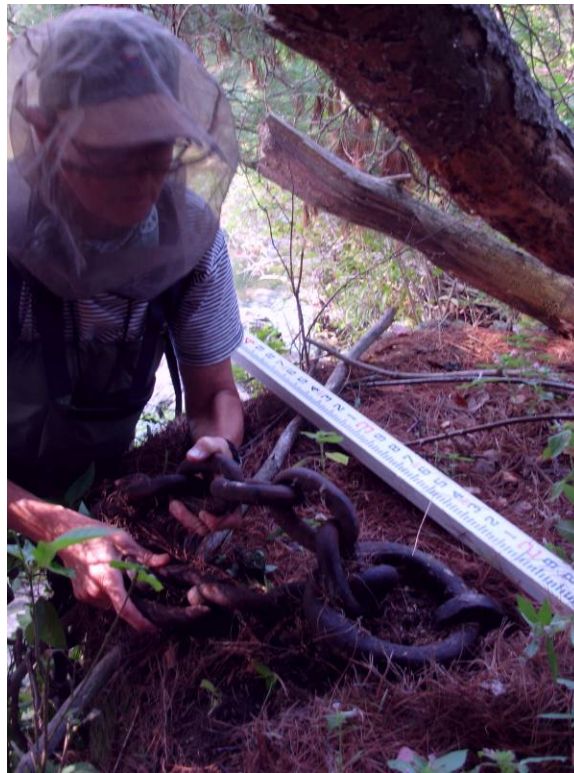
**Figure 31: Reach M04 Segment B has embedded iron features, such as this chain, that indicate historic activities that might be related to log storage before loading onto rail cars.**

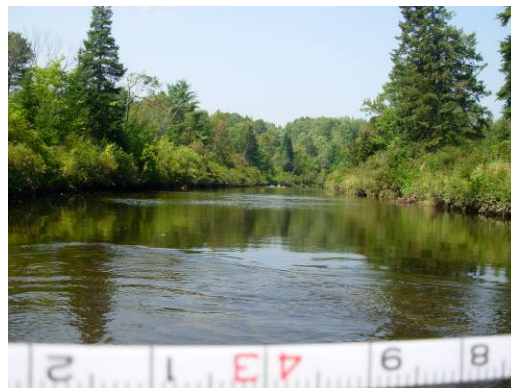
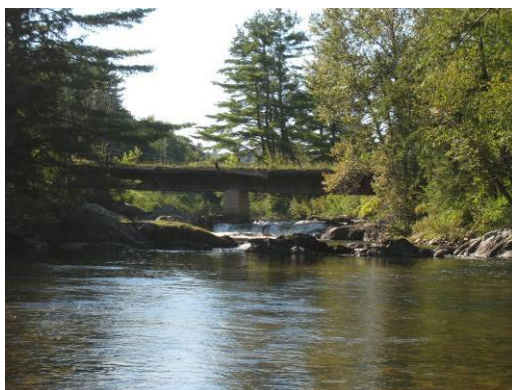
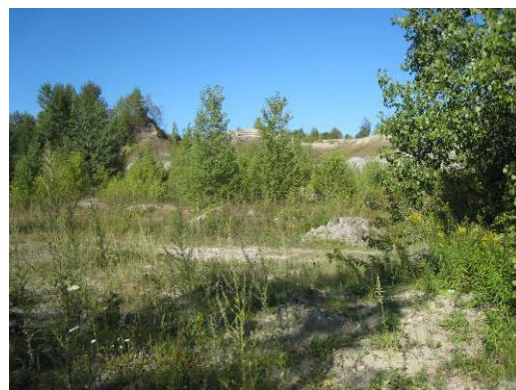
**Figure 32:** Reach M04 Segment B is characterized by having fairly low gradient (top), except where there are bedrock grade controls, such as that found under the now-defunct gravel pit bridge (bottom left). The gravel pit (bottom right) stretches along the entire left bank of this segment, but is no longer actively being used

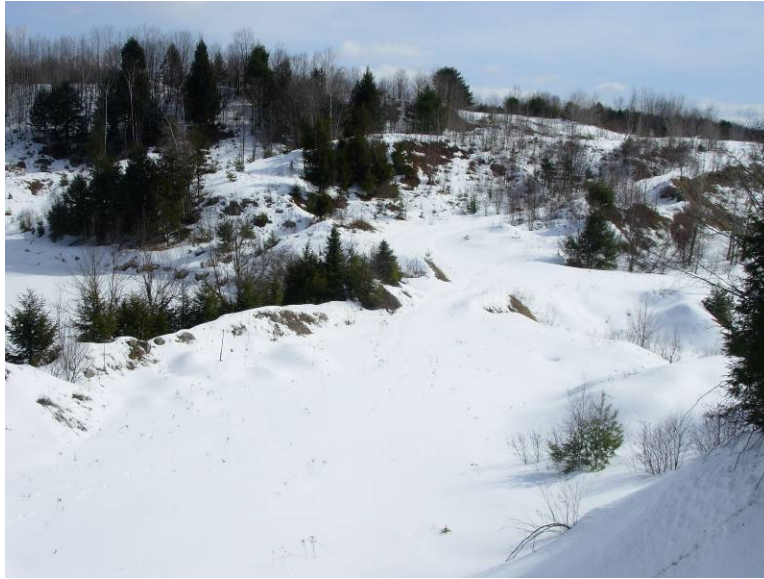
**Figure 35: Reach M05: Potential historic route of the stream at the site of the upstream-most meander could have had the stream going straight (left to right) through this area that is now elevated road bed.**

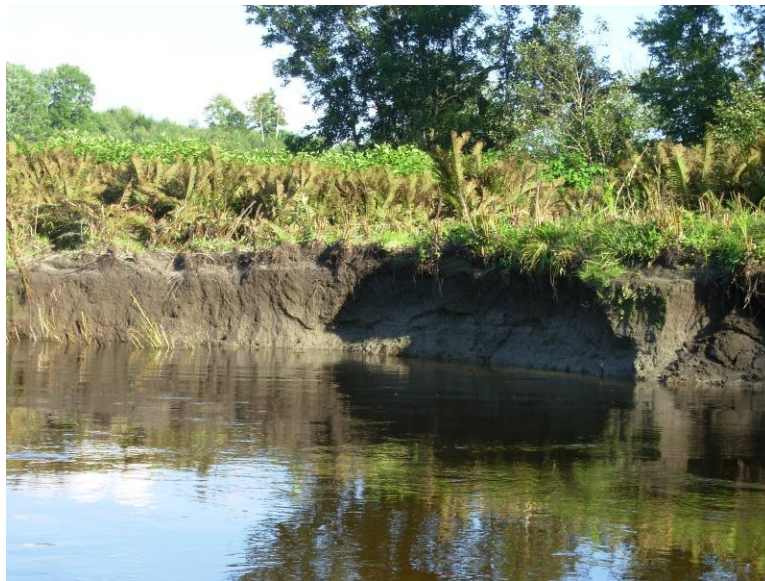
Figure 37: Reach M06 Segment A is characterized by having fine grained substrates and a large amount of bank erosion

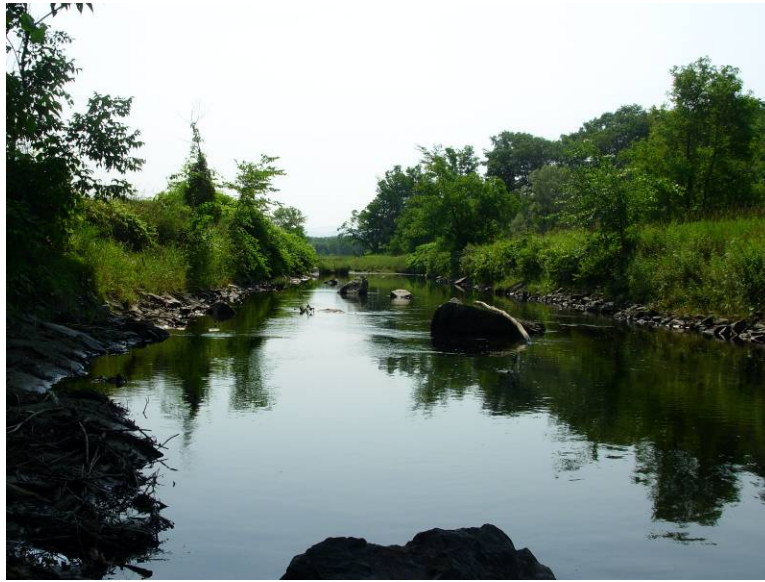
**Figure 39: Reach M06, Segment A has been channelized and straightened under Interstate 91.**

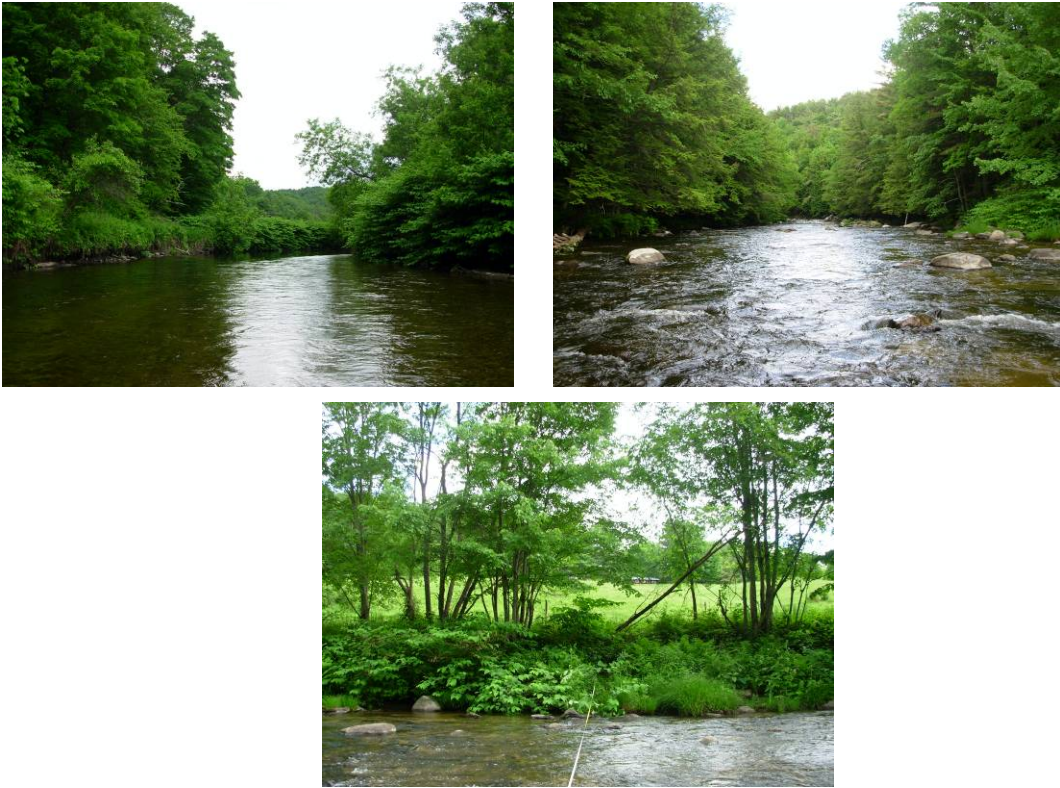
**Figure 41: Reach M07 has a gentle slope and gravel substrate in Segment A (top left) that shifts to a steep grade and coarser substrate upstream in Segment B (top right). Segment B has undergone a stream type departure, but entrenchment is not extreme (bottom).**

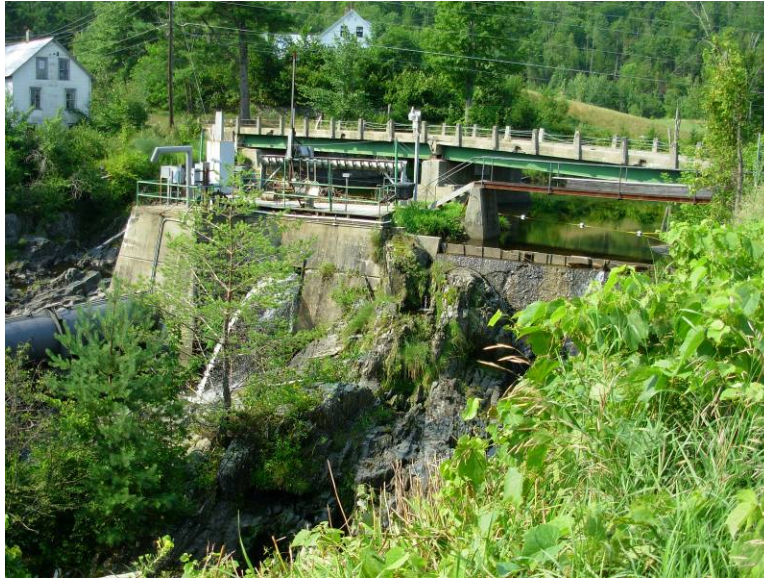
**Figure 42: Reach M08, Segment C has a hydroelectric dam (above) and impoundment located at the top of the segment. It was not included in the Phase 2 assessment process.**

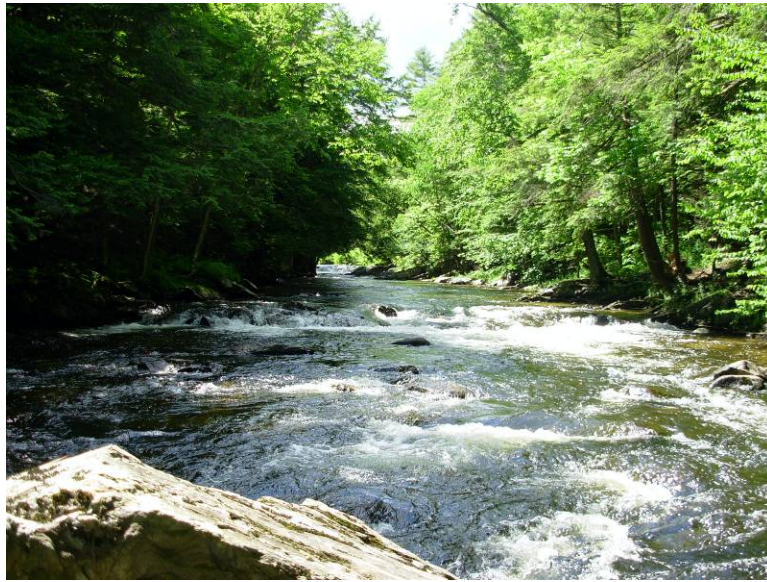
**Figure 44: Reach M08 Segment A is characterized by bedrock in the bed and banks, and a forested buffer.**

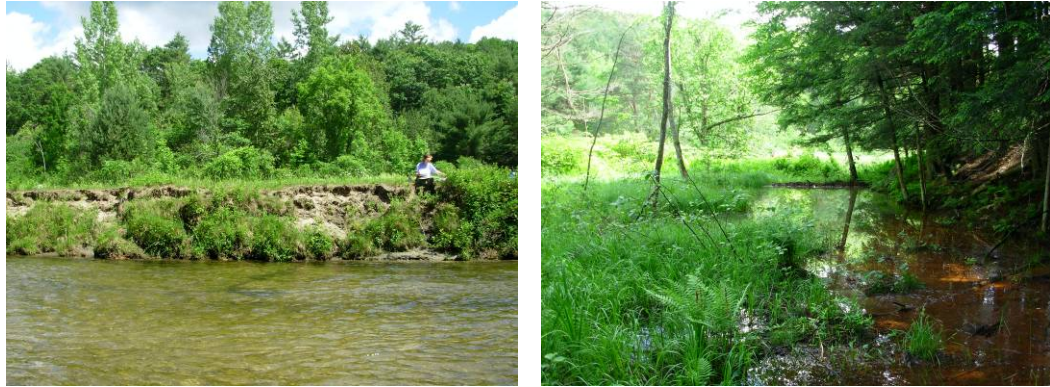
**Figure 45: Reach M08 Segment B is characterized by having a broader valley with agricultural uses in the left bank valley. Lack of buffer is causing bank erosion (left). A historic landfill high up on the right valley is delivering leachate downslope to the river (right).**

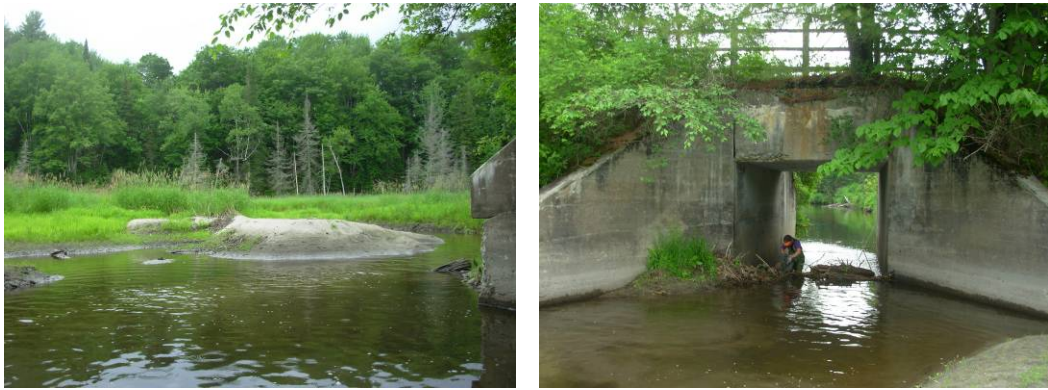
**Figure 48: Tributary Reach MO4S1.01 Segment A is characterized by a Very Broad valley with historic (and some current) beaver use (left). The bridge for the railroad bed trail at the mouth of the tributary constitutes a significant constriction (right).**
