**Town of Richmond Phase I
Stream Geomorphic Assessment Report**

September 27, 2007

Chittenden County Regional Planning Commission
South Burlington, Vermont

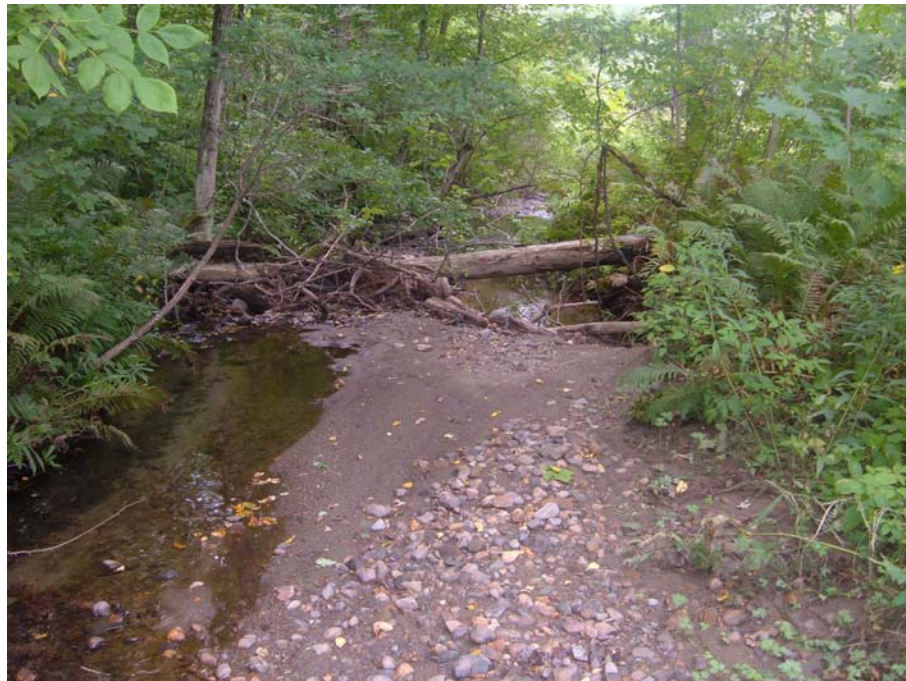
- **R8.S1.03:** This mainstem reach is found to the east of Governor Peck Road upstream of an area of historic beaver activity. The reach is characterized by a moderate-gradient, gravel-bottomed channel with C-type geometry. This reach has received a high impact rating due to the observed changes in planform (28% of the reach has been straightened), and the road encroachment which has led to a reduced floodplain and corridor. Some depositional features were observed during the field visit (Figure 1), indicating the potential for future lateral adjustments.

Figure 1. Depositional feature in reach R8.S1.03

- **Governor Peck Road Tributary:** Seven reaches are recommended for further Phase 2 assessment in this watershed:
 - **Reaches R8.S1.01 to R8.S1.03 (high priority)** should be investigated in further detail to determine the impacts of historic straightening and a lack of vegetative buffer, and to evaluate the potential for stream corridor protection given the encroachment of agricultural, commercial, and residential land uses. This effort would also involve landowner outreach to assess the social constraints to stream restoration.

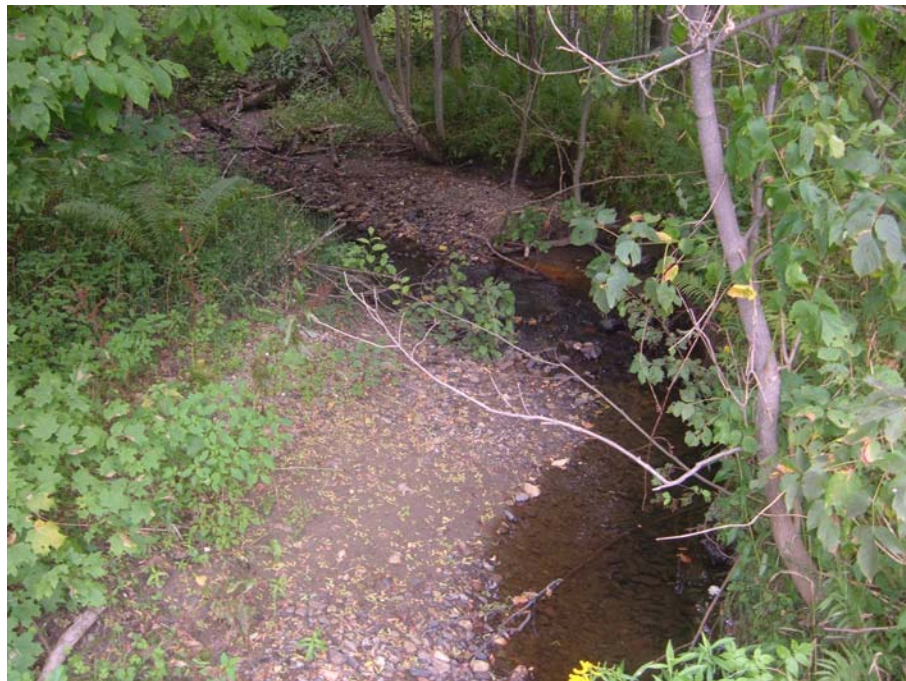
- **R8.S1.05:** This mainstem reach is found along Governor Peck Road from the confluence with the subtributary upstream to where the channel bends to the east away from the road. The reach is characterized by a moderate-gradient, gravel-bottomed channel with C-type geometry. This reach has received a high impact rating due to the encroachments, stormwater

discharges, and undersized culverts associated with Governor Peck Road. Two culvert crossings appear to be inadequately sized, resulting in aggradation of sediment above the structure and scour below. One roadside drainage along Governor Peck Road enters main channel in upper reach and delivers significant amounts sediment to the downstream section. Numerous depositional features were observed during the field visit (Figure 2), indicating the potential for future lateral adjustments. Despite these impacts, numerous brook trout were observed in the reach in plunge pools (at the culvert outfalls) during August, indicating that reach provides important cold water refugia for trout in late summer.

Figure 2. Depositional features in reach R8.S1.05

- **Reach R8.S1.05 (high priority)** contains two culvert beneath Governor Peck Road which appear to be undersized. The culverts should be assessed to determine whether they are a priority for the replacement by the Town of Richmond. In addition, one problematic stormwater discharge was noted (previously described), and multiple depositional features were noted throughout the reach.
