**Crosby Brook Phase 1  
Stream Geomorphic Assessment Report**

October 31, 2007

Windham County Natural Resources Conservation District  
Brattleboro, Vermont

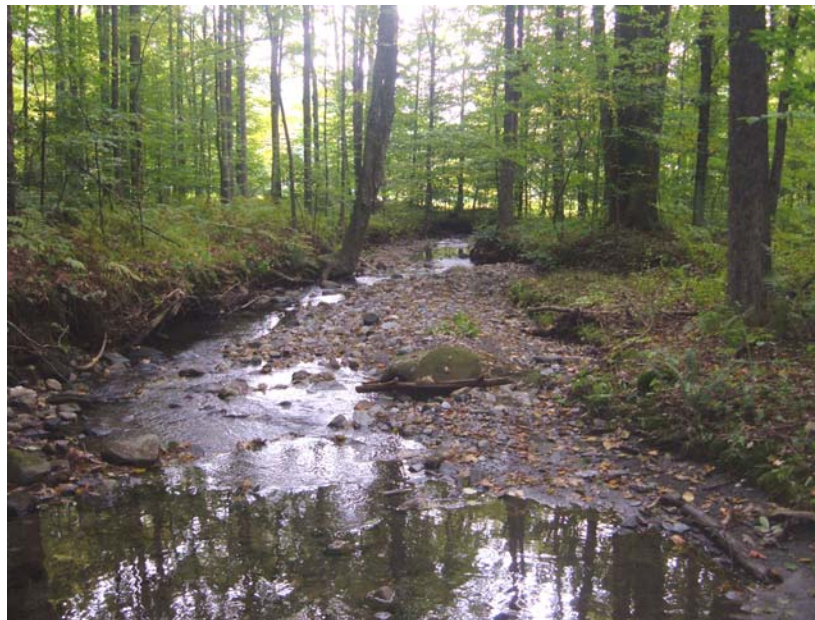
Figure 2. Depositional feature and widening in M06 below Middle Road.

- **M06:** This Mainstem reach is found along Middle Road upstream of the Norse Hollow Road crossing. The reach is characterized by a moderate-gradient, cobble-bottomed channel with B-type reference geometry. This reach has received a moderately-high impact rating due to the road encroachment which has led to a reduced floodplain and corridor. Some depositional features were observed during the field visit (Figure 2), indicating the potential for future lateral adjustments.

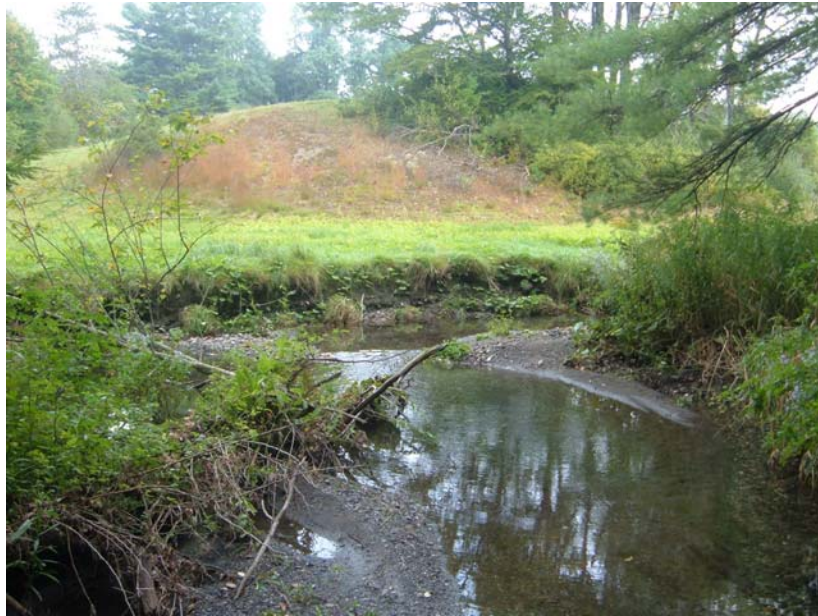
Figure 3. Bank erosion in lower M05.

- **M05:** This Mainstem reach is found within an unconfined alluvial valley east of Middle Road. The location of the present-day channel within the wide valley indicates that much of the reach was historically straightened for agriculture purposes. The reach is characterized by a low-gradient, gravel-bottomed channel with E-type reference geometry. A high degree of lateral adjustment and bank erosion was noted during the windshield survey in the lower reach (Figure 3).

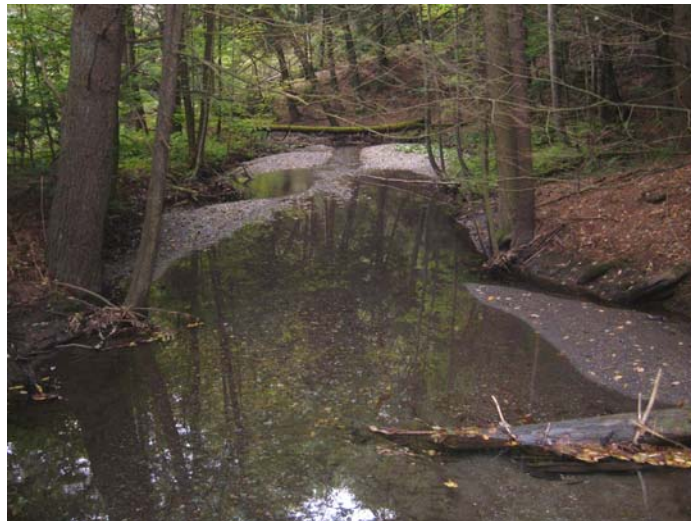
- **M04:** This Mainstem reach is found along Route 5 from the Middle Road crossing down to the Ryan Road crossing. The reach is characterized by a moderate-gradient, gravel-bottomed channel with C-type reference geometry. This reach has received a high impact rating due to the road encroachments and channel straightening along Route 5. Numerous depositional features were observed during the field visit below the Middle Road crossing (Figure 4), indicating the potential for future lateral adjustments.

Figure 4. Depositional features in upper reach M04.

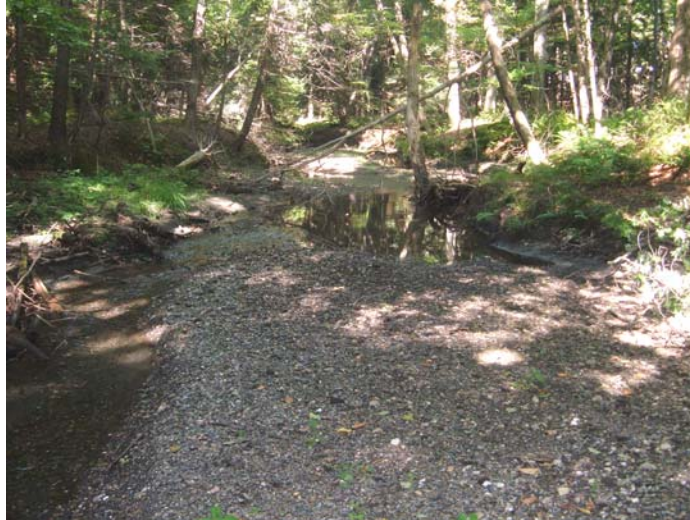
- **M03:** This Mainstem reach is found to the west of Route 5 and I-91 from the Ryan Road crossing down to the confluence with the subtributary (T2). The reach is characterized by a moderate-gradient, gravel-bottomed channel with C-type reference geometry. This reach has received a high impact rating due to the depositional features observed during the field visit (Figure 5), and the highly altered meander geometry. These observations indicate that the reach is recovering from historic

straightening when the surrounding land was used for agriculture. In addition, the aggradation observed in the lower reach has been exacerbated by the supply of fine sediment from the deep gully entering from the east along I-91.

Figure 5. Depositional features and widening in lower reach M03.

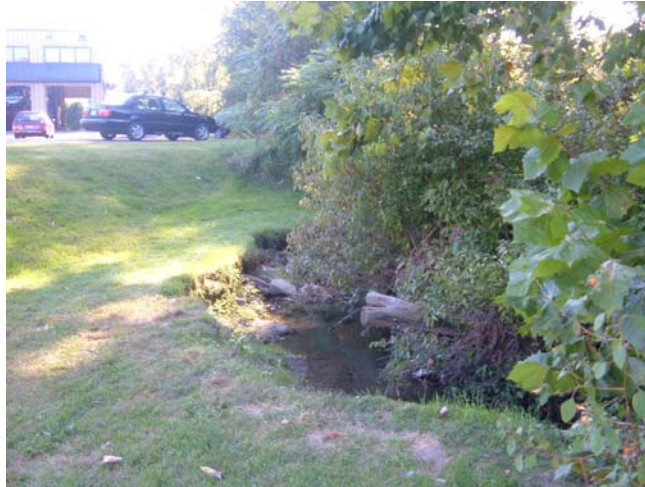
- **M02:** This Mainstem reach is found from the confluence with the subtributary (T2) down to the confluence with the South Branch (T1). M02 has had severe historic impacts to the planform (73% of the channel has been straightened) resulting from the construction of I-91 and from commercial development along the Route 5 corridor. In addition, a section of the reach behind the Quality Inn on Route 5 lacks a vegetative buffer greater than 25 feet, causing bank erosion (Figure 6) and likely elevating the surface water temperature during the summer months due to lack of canopy cover.

Figure 6. Bank erosion and lack of woody vegetative buffer in M02.

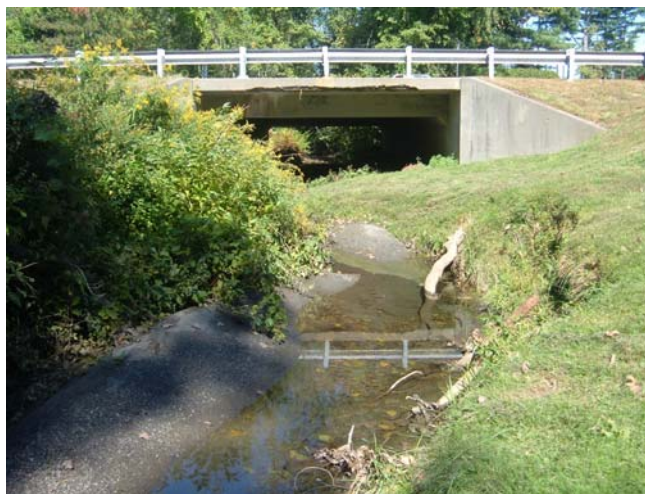
- **M01:** This reach is found from the confluence with the South Branch down to the outlet to the Connecticut River. This reach has had significant direct impacts to the channel boundary conditions (channel straightening in 84% of reach), and the changes in planform and abundant depositional features indicate that it has a high potential to undergo lateral migration (Figure 7). The adjacent commercial and industrial land use is causing significant fine sediment delivery to the channel, and the lack of buffer vegetation is likely elevating the surface water temperature during the summer months due to lack of canopy cover.

Figure 7. Depositional features below the I-91 Exit 3 box culvert.

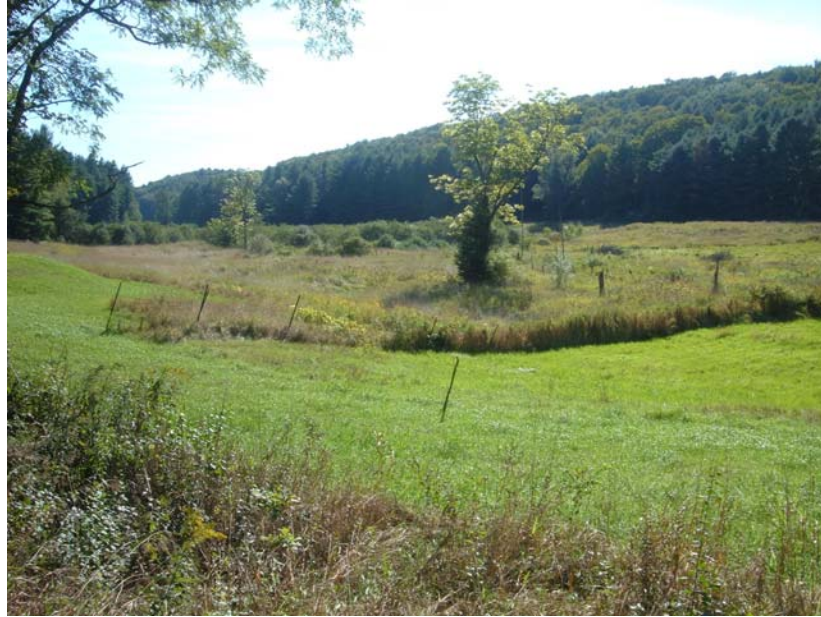
Reach T1.03 is found in a wide alluvial valley to the west of Kipling Road (Figure 8). Under reference conditions we would expect to see a low-gradient, sand-bottomed channel with E-type channel geometry. Agricultural land use has significantly impacted the channel form and buffer conditions in this reach, resulting in a channel with a simplified planform due to straightening (over 90%

of channel length has been straightened). This reach has been identified as having a high impact rating and a high priority for further assessment.

Figure 8. Wide alluvial valley associated with Reach T1.03

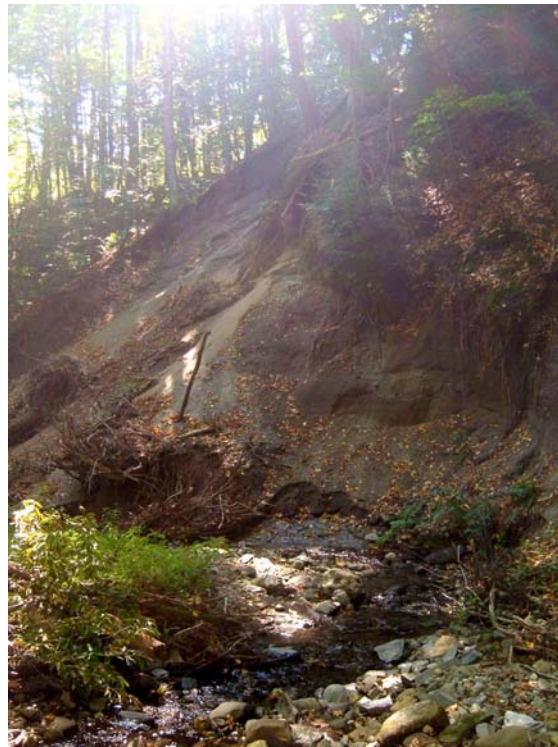
- **T1.02:** This reach is found from the reach break with T1.03 down to a change in valley slope and confinement near Crescent Drive. T1.02 has a diversity of channel forms due to changes in channel slope and confinement, and impacts associated with the encroachment of Black Mountain Road on the floodplain. In the upper and lower parts of the reach, we would expect to find C-type channel geometry given the unconfined valley setting. However downstream of the Dickinson Road crossing and along Black Mountain Road we would expect to find A and B-type channel geometry in a confined valley setting. Numerous mass failures are located along the right bank throughout the reach, including

one 40 foot landslide in the lower reach (Figure 9). A moderate degree of channel incision was observed downstream of the landslide which is likely contributing to the slope instability. Detailed channel geometry measurements will be collected during the Phase 2 analysis to better characterize the adjustments and channel evolution stage in this area.

Figure 9. Large landslide in lower T1.02

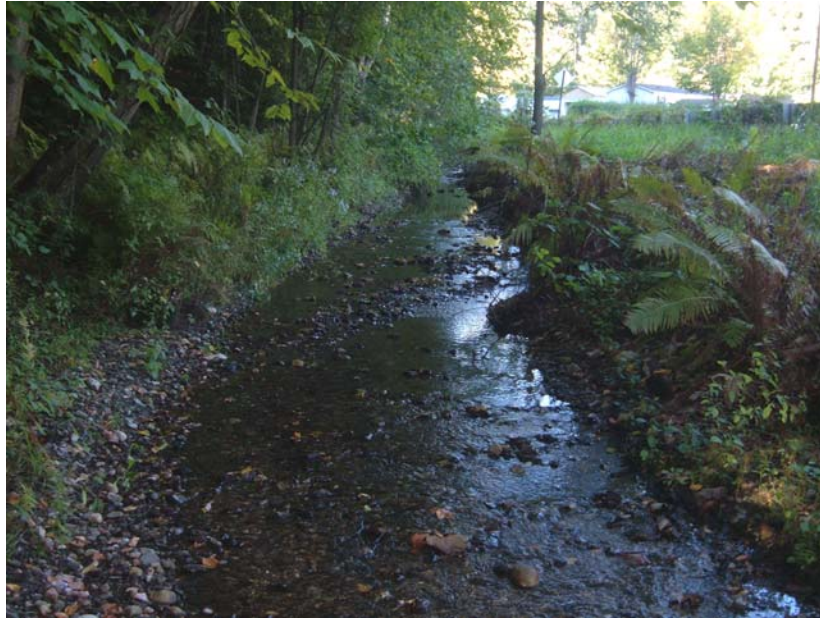
- **T1.01:** This reach is found from a change in valley slope near Crescent Road down to the confluence with the Mainstem. Direct impacts to the channel boundary conditions have occurred in this reach (channel straightening in 53% of reach), and sedimentation of sand and fine gravel was noted during the field visit. The encroachment of Black Mountain Road along the channel in the upper reach has resulted in a simplified channel planform and plane bed morphology (Figure 10). Detailed channel geometry measurements will be collected during the Phase 2 analysis to determine the departure of sediment transport processes from reference conditions.

Figure 10. Plane bedform and road encroachment in upper T1.01

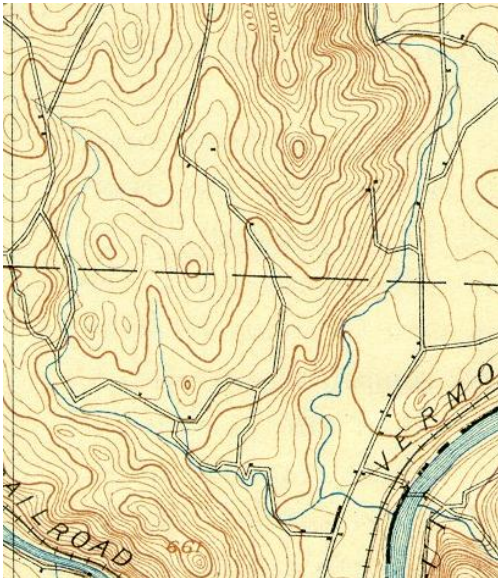
Looks like the entire lower section was moved at some point

1893 topo map from UNH

Unless this topo is wrong (and the 1935 that shows the same location, in 1954 it is in the current location) I would say the entire lower section was straightened. Something to look out for when you are in the field.
