# **Ompompanoosuc Watershed Phase I Geomorphic Assessment**

Orange and Windsor Counties, Vermont

**April 16, 2009**

**Prepared by: Bear Creek Environmental, LLC**

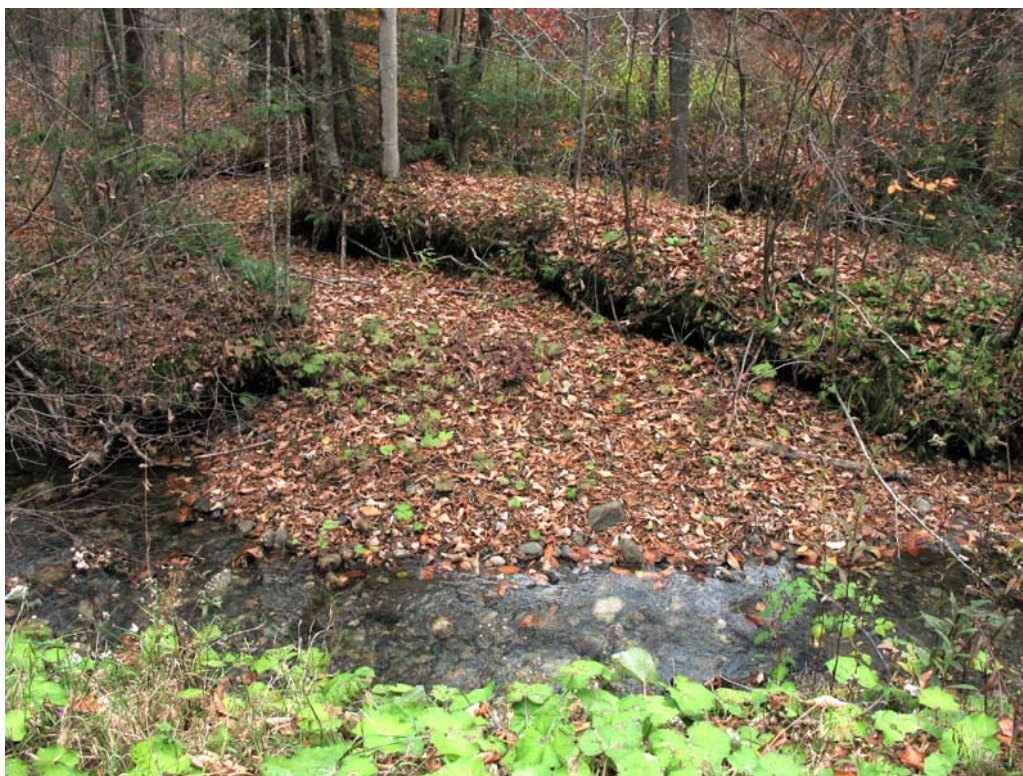
**Figure 7. Channel Avulsion on R18T3.07 (Tributary Three to Ompompanoosuc River)**

Nine reaches in this watershed received an impact rating of high (frequent occurrences) due to evidence of frequent channel migration, avulsion, and neck cutoffs (Figure 7). These reaches are located on the West Branch of the Ompompanoosuc, the main stem of the Ompompanoosuc, Middle Brook, and Blood Brook. On the main stem Ompompanoosuc, high impact reaches are upstream of the confluence with the West Branch (R08, R11, R17, and R28). Reaches in the lower section of Blood Brook (near the Lake Fairlee inlet) had high impact ratings for channel migration (R16T2.04 and R16T2.05). The most downstream reach on Middle Brook (R16T2.03S1.01) and the reach just upstream of the wetland area (R16T2.03S1.06) also had high impact ratings. This active movement of the stream channel is an indicator of significant channel adjustment. Thirteen reaches that showed few occurrences of channel migration, avulsion, and neck cutoffs were classified as having low impact from channel migration. These reaches are located on the main stem of the Ompompanoosuc, the West Branch of the Ompompanoosuc, Abbott Brook, Middle Brook, and Tributary three to the Ompompanoosuc River. The remaining four reaches, where meander migration was noted, were not significantly impacted. These reaches are located on the main stem of the Ompompanoosuc River, Barker Brook, and the Lake Fairlee outlet.
