Phase 2 Stream Geomorphic Assessment  
Mettowee River Watershed  
Rutland & Bennington Counties, Vermont  
November 2007

South Mountain Research & Consulting

Poultney-Mettowee  
Natural Resources Conservation District  
PO Box 209  
Pawlet, VT 05753

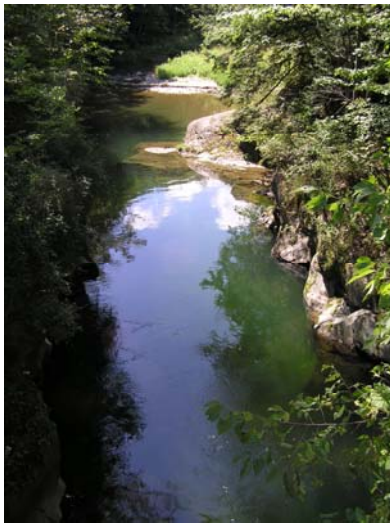
*Figure 3. (M03) Bedrock gorge beneath Route 153 crossing at the Williams Bridge. This channel-spanning exposure of bedrock serves as a vertical grade control for the Mettowee River channel.*

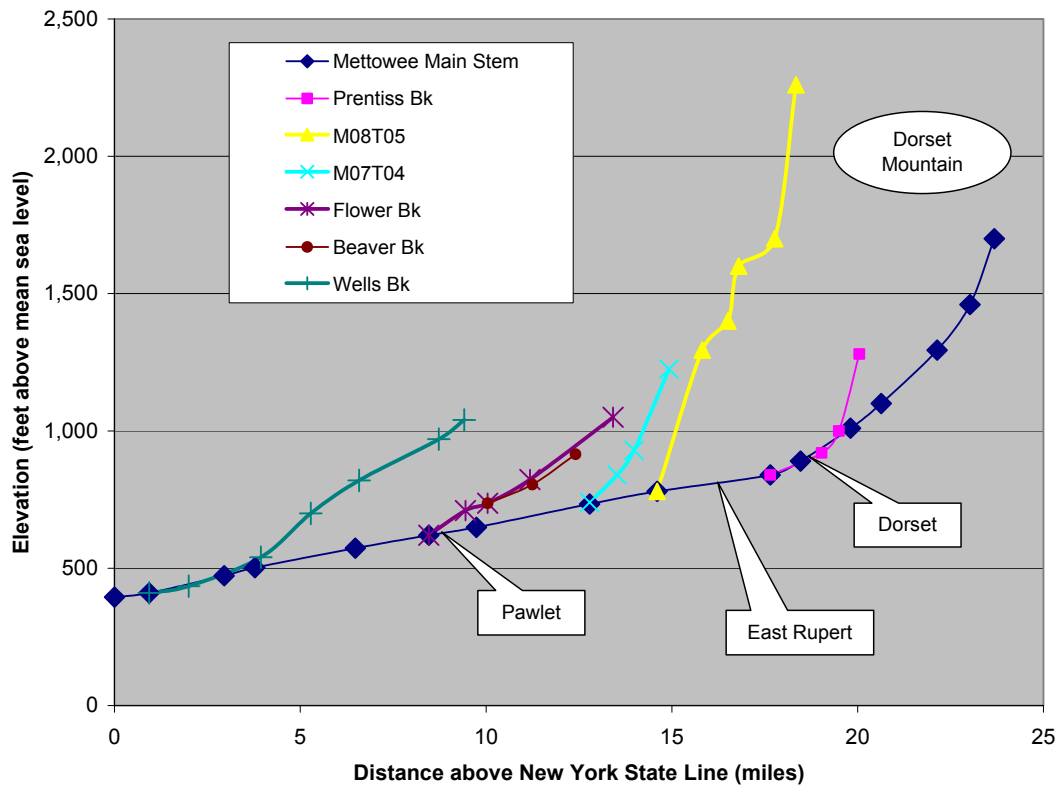
Figure 5. Longitudinal profile of Mettowee River main stem (Vermont portion) and major tributaries.

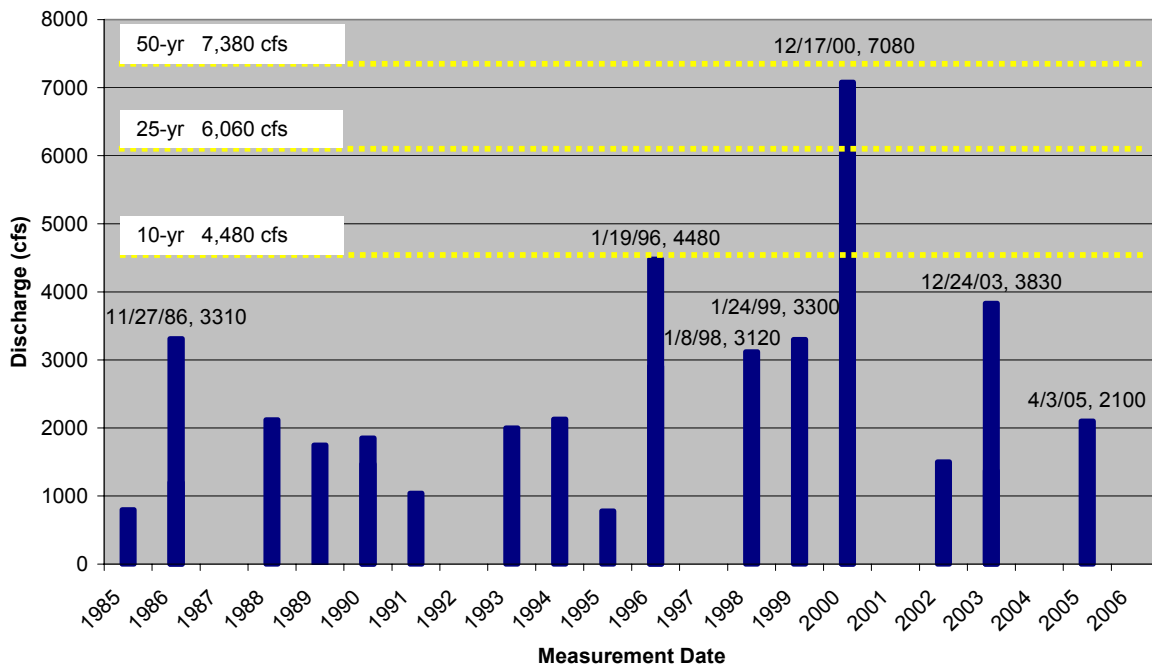
Figure 7. Recorded Peak Flows for Mettowee River, Betts Bridge Gage Station #04280350 (compared to estimated flood peaks after Olson, 2002)

For comparison, the bankfull flow (that event which can be expected to occur once every one to two years) is estimated to be 1,680 cfs at the Betts Bridge gage location (Stn #04280350).

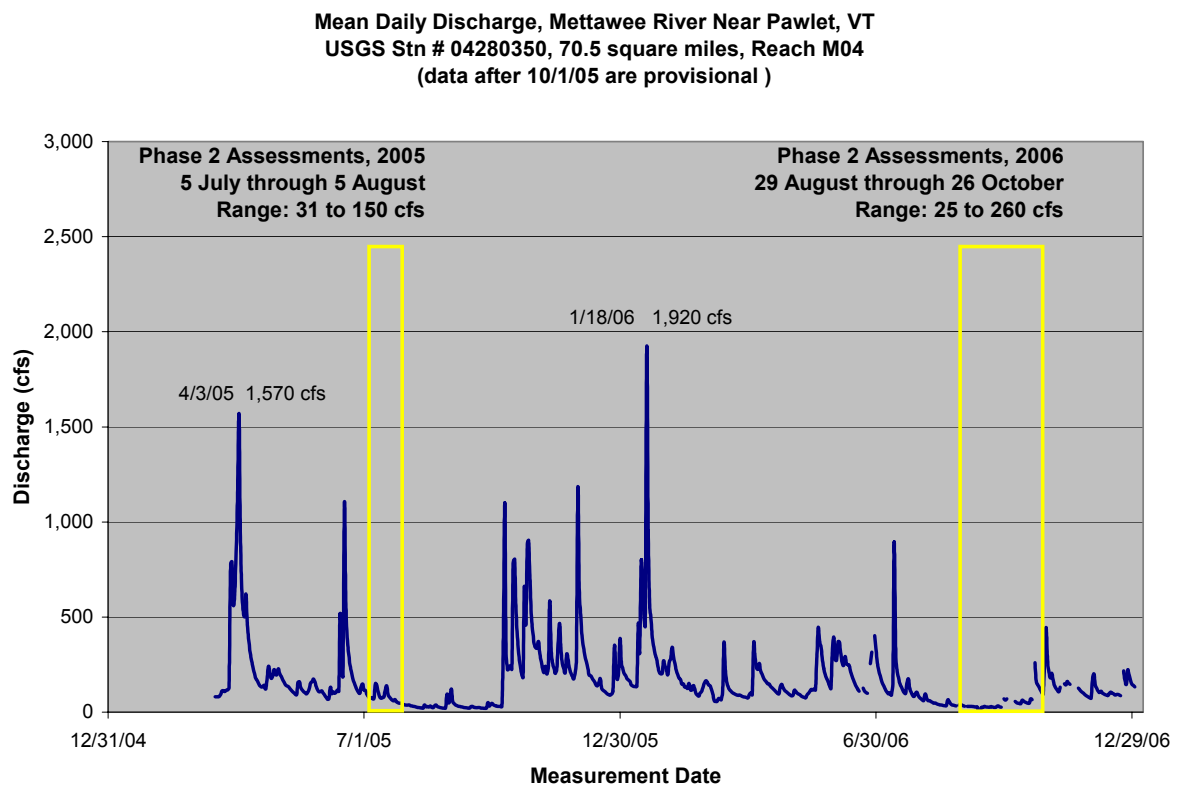
Phase 2 Stream Geomorphic Assessments were completed between 5 July 2005 and 5 August 2005 and between 29 August and 26 October 2006. Flows measured at the Betts Bridge gage during these two time periods ranged from a minimum of 25 cfs to a maximum of 260 cfs based on certified and provisional data available from USGS (USGS, 2006). A few rain storms did occur throughout the assessment period, resulting in "blips" on the hydrograph in Figure 8 (Weather Underground, 2006). Overall, however, flows on the Mettowee during the 2005 and 2006 assessment periods can be considered to represent base flow conditions.

Figure 8. Provisional Daily Mean Discharges for Mettowee River, Betts Bridge Gage Station #04280350, during Phase 2 Stream Geomorphic Assessments, 2005 and 2006.

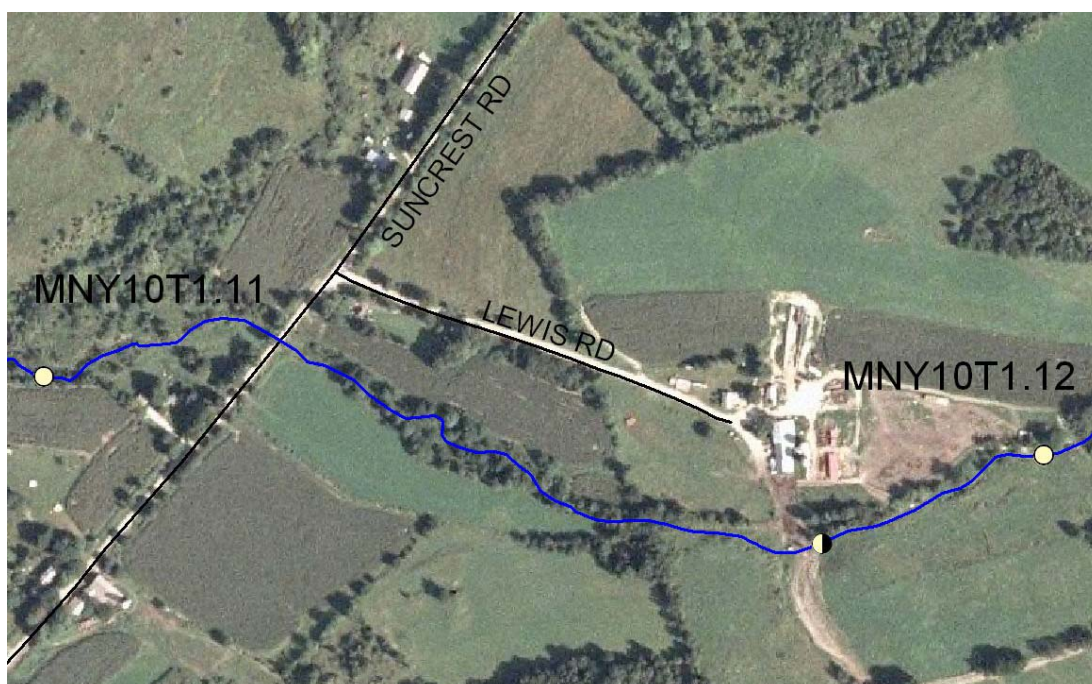
This half-mile reach of Indian River begins just upstream of the farmstead at the end of Lewis Road in the town of Rupert. It flows to the west parallel with Lewis Road extension, and ends approximately 650 feet downstream of the Lewis Road / Suncrest Road crossing (Figure 70). At the upstream end of the reach, Indian River is transitioning out of a Semi-Confined to Narrowly-Confined valley setting of steep gradient (5.6% in reach MNY10T1.12) into a Semi-Confined to Narrow valley of moderate gradient (2.8% overall gradient of reach MNY10T1.11). USDA mapping indicates that soils in the Indian River valley at this location have a glacio-fluvial origin. The upper third of the reach has a cobble, B-step/pool reference stream type, while the downstream two-thirds of the reach appear to have a Cb-step/pool reference stream type due to the lesser degree of channel confinement. Given the slight variation in reference stream type and an apparent difference in incision status of the channel, reach T1.11 was segmented as depicted in Figure 70.

Figure 70. Segmentation of Indian River reach MNY10T1.11.  
(Flow is from picture right to picture left).

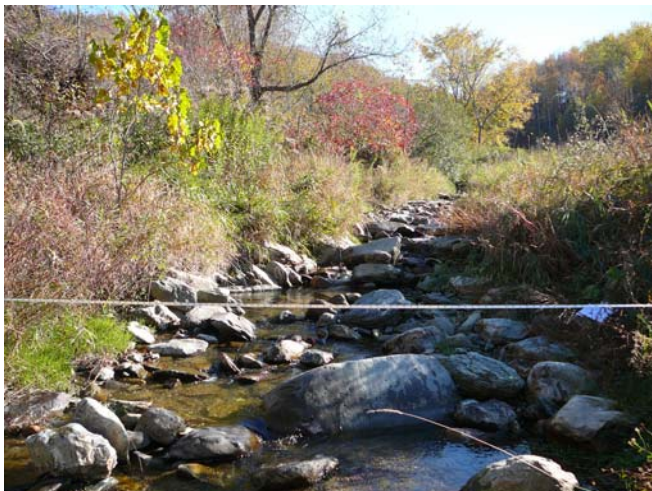
A cross section performed mid-segment confirmed a B3a-step/pool stream type. A very minor degree of incision (historic) was suggested by the measurement of a 1.04 incision ratio. However, it is also possible that bankfull elevation was slightly underestimated. No signs of active incision were noted in the segment. Generally, the segment was in a minor state of adjustment. Very few depositional bars were evident. The segment was rated in "Good" condition following the RGA; a sensitivity of "Moderate" was assigned as the corresponding rating for a cobble-dominated B stream type in minor adjustment.

*Figure 71. Cross section site in Segment B of Indian River reach MNY10T1.11. View upstream, 16 October 2006.*

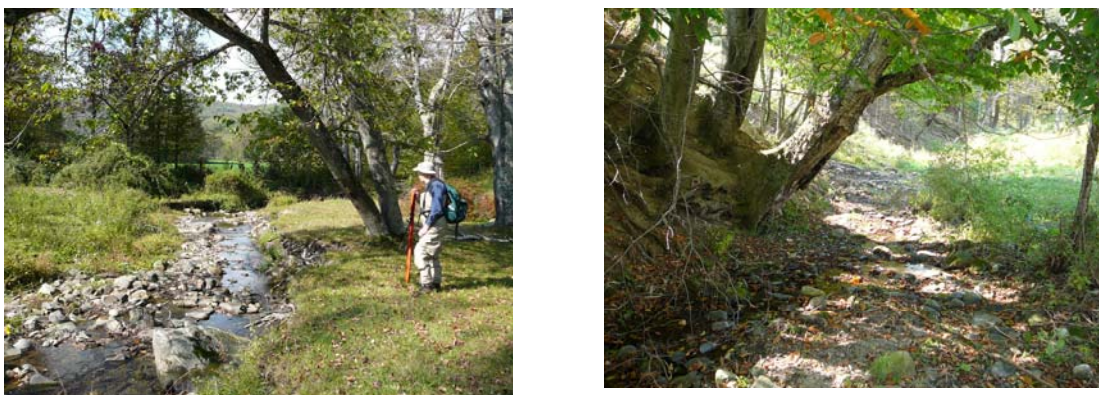
Proceeding downstream, the channel has more floodplain access (2 to 4 times channel width). For approximately 500 feet mid-segment the Indian Brook flows through a pasture area where cattle have direct access to the stream. The stream has ample floodplain access through this pastured section. Former channel positions were observed in both the LB and RB corridors, indicating recent avulsions. GPS waypoints collected on the assessment date (28 September 2006) indicate that the current channel position is offset to the northeast from the planform indicated on the 1994 orthophotograph coverage. Trees are largely absent along both banks, and grasses are closely cropped in the near-bank areas. Low-bank erosion is present, exacerbated by trampling action of livestock.

A second cross section was performed between the pond and the Route 153 bridge crossing, in an area of inferred historic channelization. This cross section indicated historic incision ( $IR = 1.6$ ) and limited floodplain access along the RB. A rock wall running parallel to the stream is elevated above the floodplain and serves as a berm to the flood prone width.

*Figure 74. (a) Indian River flows through a pasture area for approximately 500 feet, where livestock have direct access to the channel. Several flood chutes and recently abandoned channels are visible in the pasture area, such as the former channel position along the left valley wall (b) as depicted on 1994 orthophotos. Segment M10NYT1.10-B, View downstream, 28 September 2006.*

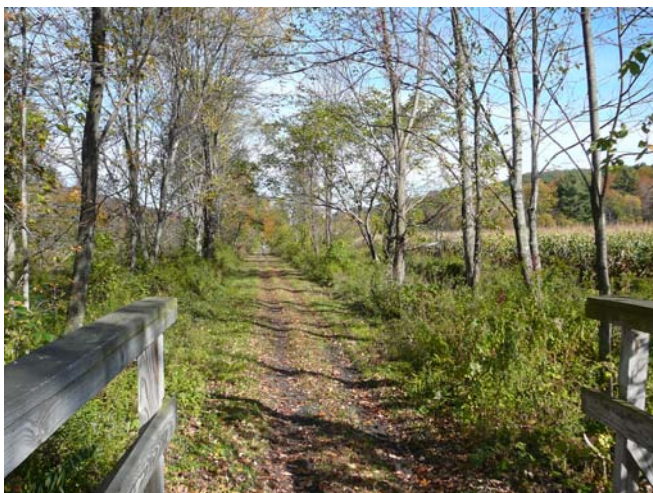
The former Delaware & Hudson railroad is located along the LB corridor upstream of the bridge crossing and along the RB corridor downstream of the crossing (a majority of the segment). The exact construction date of this railroad is unknown, but it is depicted on the 1897 USGS topographic map of the reach, as well as the Beers Atlas (1869) and Walling maps (1856), indicating that the construction date was prior to the late 1800s. Today, this railroad is no longer in service and the corridor is utilized as a "greenway" or rail trail. The railroad encroaches on the Indian River, reducing the available valley width. While the confinement is increased somewhat from "Very Broad" to "Broad", the channel is still considered unconfined.

*Figure 75. Rail trail crossing of Indian Brook in Segment A, reach MNY10T1.10. View to the north, 6 October 2006.*

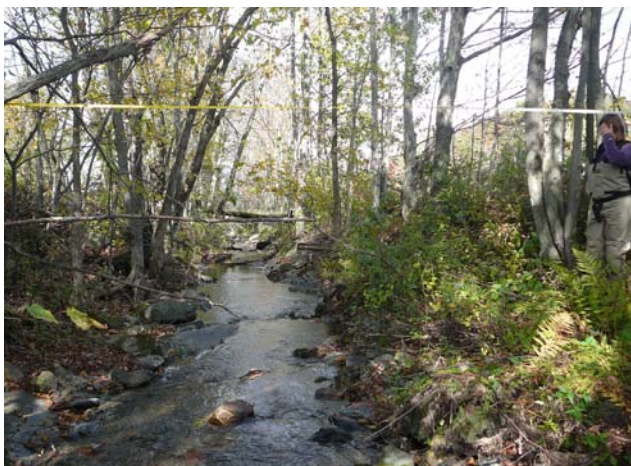
The overall degree of channel incision in Segment C was observed to increase from the upstream reach break to where the channel has been modified to flow directly alongside the D&H Railroad (Figure 76). A cross section completed in the upstream end of the segment indicated an  $IR = 1.8$ ; a cross section in the channelized section downstream of Ike Wright Road indicated a  $IR = 2.2$ . Conservatively, the entire segment was classified as having lost connection to its floodplain, resulting in a stream type departure – from a C4-riffle/pool to F3c-plane bed.

Six separate occurrences of channel-spanning bedrock were recorded through Segment C. Bedrock also constrains the channel along the LB for much of the reach, contributing to the linear planform. In the downstream half where the Indian River was recently channelized, the river is pinned between bedrock on the LB and the high berm and armoring of the railroad bed along RB.

*Figure 78. Cross section site in Segment C, Indian Brook, reach MNY10T1.09. View to the north (downstream), 6 October 2006.*

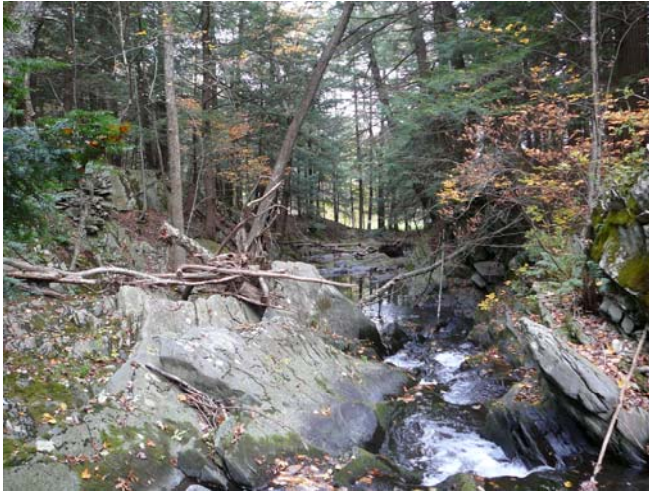
*Figure 80. Short section of bedrock gorge within Segment B of Indian Brook, reach MNY10T1.08 was classified as a single point of "waterfall" grade control. View to the north (downstream), 11 October 2006.*

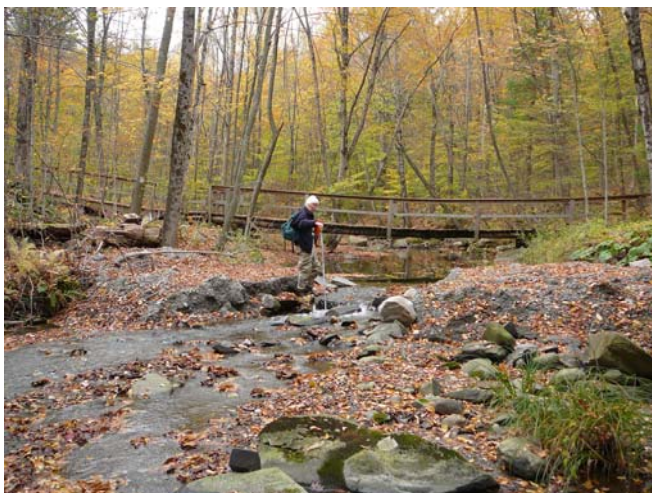
*Figure 81. Small dam or possible ford of fine gravel and sand recently breached by flow in the channel within Segment B of Indian Brook, reach MNY10T1.08. View upstream, 11 October 2006.*

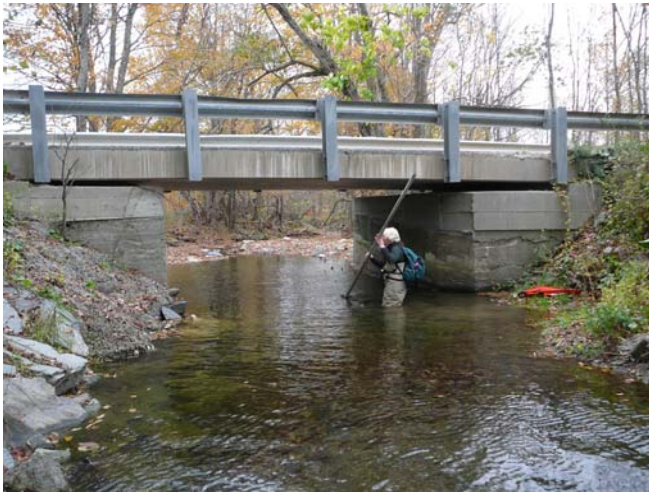
Crop and hay fields encroach on the channel throughout most of the segment length. A narrow buffer of herbaceous cover with sparse deciduous trees is maintained along both banks (perhaps 5 to 15 feet in width). The railroad (a considerably elevated berm) separates the river from agricultural fields in the RB corridor. Until very recently, a berm was present along LB for the majority of Segment E, ranging in height from 1 to 2 feet above the adjacent floodplain. This berm was removed in the Spring of 2007 in a project directed by the VTDEC River Management Section. Consequently, this berm has not been indexed using FIT for this assessment report. (see Appendix D page D19 for more details. Two farm roads cross the channel via bridges constructed of timber decking on steel I-beams. These bridge spans are undersized with respect to the bankfull width. The Sawmill Road bridge also crosses within Segment E near the upstream (southern) end of the reach. This concrete bridge crossing is also a bankfull constrictor and the river approaches the crossing at a pronounced angle. RB rip-rap upstream of the bridge alongside Sawmill Road appears newly installed. Evidence of recent bar and channel dredging was also apparent upstream of the bridge. A newly-poured concrete abutment at the bridge suggests that the bridge height was recently raised. Collectively, these observations suggest that the Sawmill Road bridge was the site of recent flood or debris jam damages.

*Figure 83. Sawmill Road bridge crossing in Segment E of Indian Brook, reach MNY10T1.07. View downstream, 11 October 2006.*

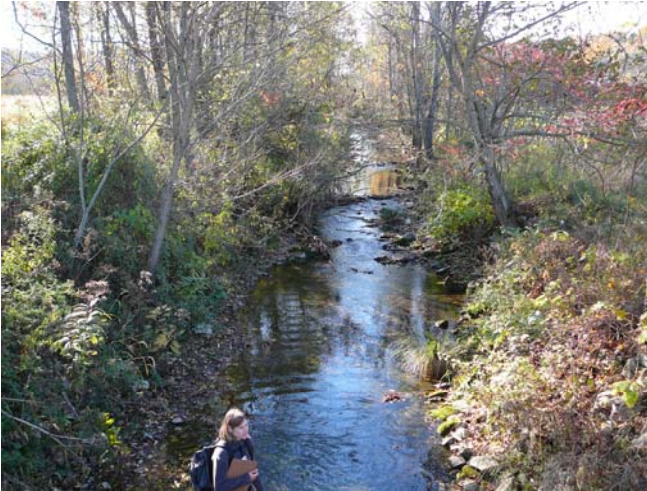
segment length. A very subtle riffle/pool bedform was present, although pools were generally filled by fine sediments. An F4-riffle/pool stream type was assigned, which represents a stream type departure from the reference C-riffle/pool stream type.

*Figure 84. View upstream from farm bridge crossing in Segment E of Indian Brook, reach MNY10T1.07. Rail trail constrains channel on right bank (picture left). 13 October 2006.*

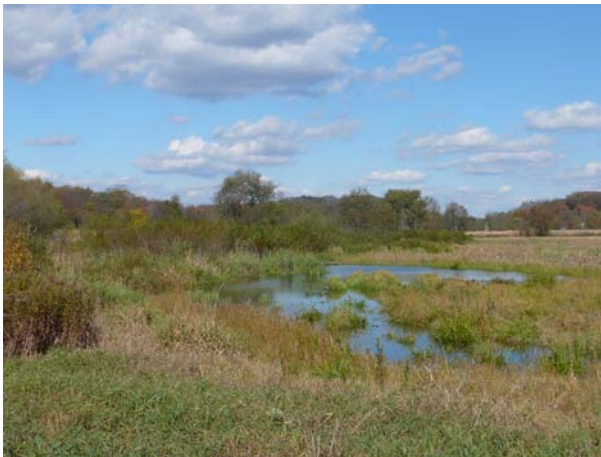
A reference C-riffle/pool channel is suggested by the unconfined setting, shallow gradient (estimated 0.3%), and the moderately sinuous planform. Since Segment D is dominated by wetlands, Steps 2, 5, 6 RHA and 7 RGA and were not completed.

*Figure 85. Segment D of Indian River reach MNY10T1.07 is in an area of mapped hydric soils where the channel is impounded by multiple beaver dams. View downstream toward the north, 13 October 2006.*

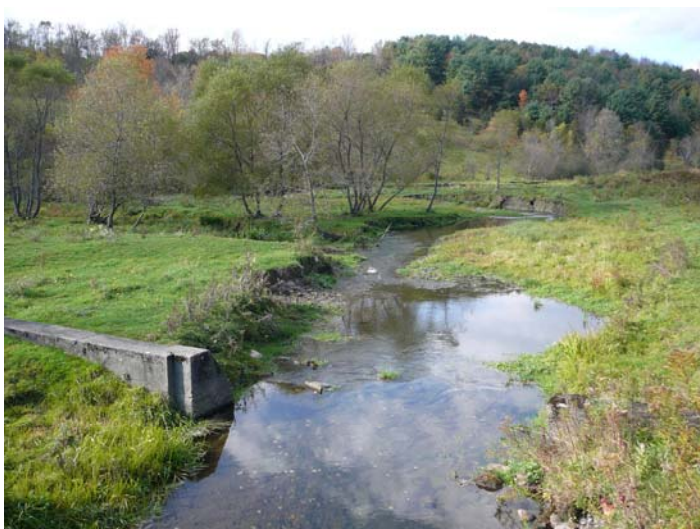
An apparent concrete dam structure is present at the upstream end of the reach (see Figure 86). Two vertical concrete walls are located perpendicular to the channel with an approximate control height of 4.1 feet above the channel thalweg. The concrete structures appear to be positioned to accommodate wooden flashboards. The structure is not impounding water at present. The original purpose of this structure is not known, but it may historically have been utilized to impound water for livestock. The distance between the two concrete walls is approximately 14 feet, and it is expected that this structure would constrict bankfull flows or higher-stage flood flows.

*Figure 86. Possible dam structure at upstream end of Segment A of Indian River reach MNY10T1.07. View downstream through pasture, 13 October 2006.*

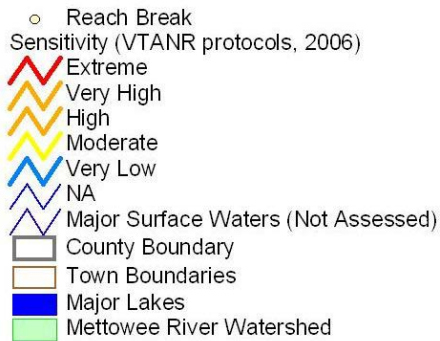
- Main stem segments M10-D, M10-B, and M06-A;
- Sykes Hollow Brook reach M07T04.01;
- Flower Brook segment M05T03.01-C;
- Wells Brook segments M01T02.02-D and M01T02.02-C; and
- Indian River segments MNY10T1.09-C, MNY10T1.09-A, MNY10T1.08-B, MNY10T1.08-A, and MNY10T1.07-E.

Figure 87. Reach / Segment Sensitivity  
 Mettowee River Watershed, 2005 and 2006 Stream Geomorphic Assessments.
