# **Stream Geomorphic Assessment of Lewis Creek Pilot Project Report**

**Department of Environmental Conservation  
May 06, 2004**

# Lewis Creek Geomorphic Assessment Pilot Project Report

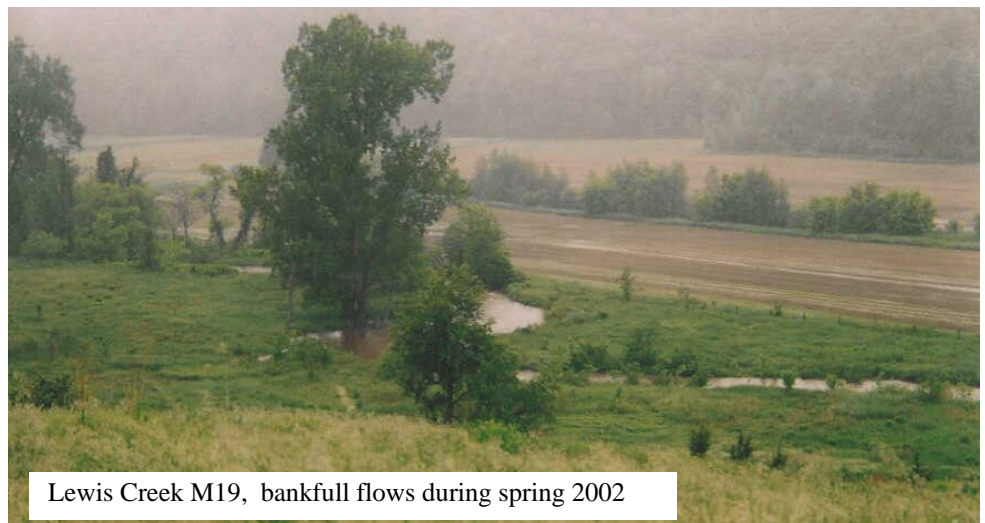
Figure 4: Reach M19, 1942 aerial photograph (left) and 1995 orthophoto (right)

Much of the reach has been managed in the past, in the form of rip-rap and straightening. Evidence of straightening can be seen in reviewing the historic aerial and current orthophotos. The earliest aerial photograph of the area is from 1942; the latest orthophoto is from 1995 (Figure 4). Rip-rap has been used extensively along the

Agriculture was the primary land use within the corridor observed in the 1942 and 1978 orthophotographs. The amount of riparian vegetation has changed over time; with a greater amount of near bank vegetation noted in the 1942 photo than in the 1978 orthophoto. Current land use along the reach is farming and fallow lands. Approximately 4000ft in the downstream section of the reach, from the farm bridge to the State Prison Hollow Rd bridge, has fallow pasture land use within the corridor. There is little near-bank woody riparian vegetation along this section of

stream; however, there are trees now growing up within the fallow fields. Row crops are planted within the corridor of the upstream section. There is a riparian woody buffer of 5ft to 25ft wide along much of this section.

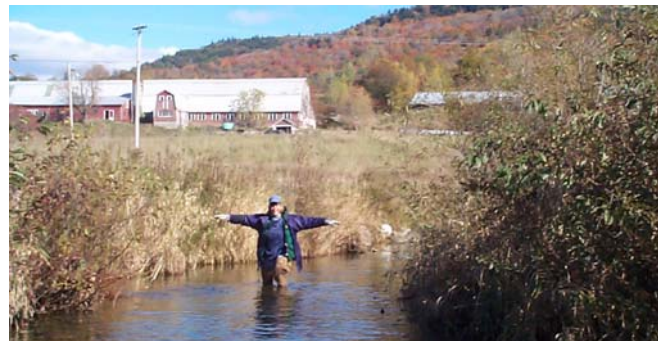
M19-A: Kristen Underwood showing bankfull elevation

Survey data was collected along M19 Segment-A during the 2002 season, while an upper portion of Segment-B was surveyed during 2001. Five cross-sections and a longitudinal profile were done at Segment-A. The valley slope along this segment is 0.46 % and the channel slope is 0.23%. The data on Segment-A suggests that the channel through this section is predominantly an E (width/depth  $\leq 12$ ); with sections that are a C stream type (Table 10). The build up of sediment (aggradation) behind existing beaver dams has increased the width to depth ratio and may be contributing to the change of stream type from an E to a C.

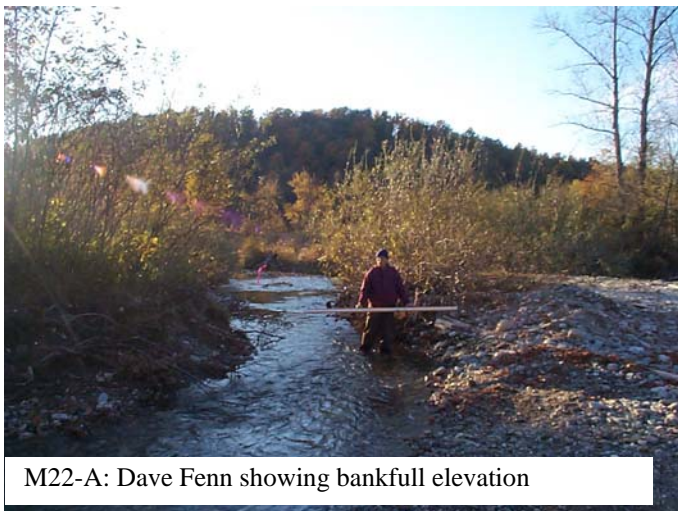
M22-A: Dave Fenn showing bankfull elevation

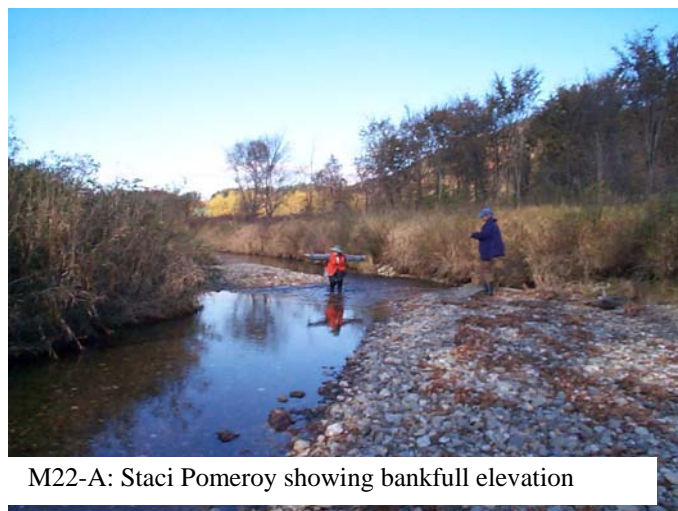
M22-A: Staci Pomeroy showing bankfull elevation

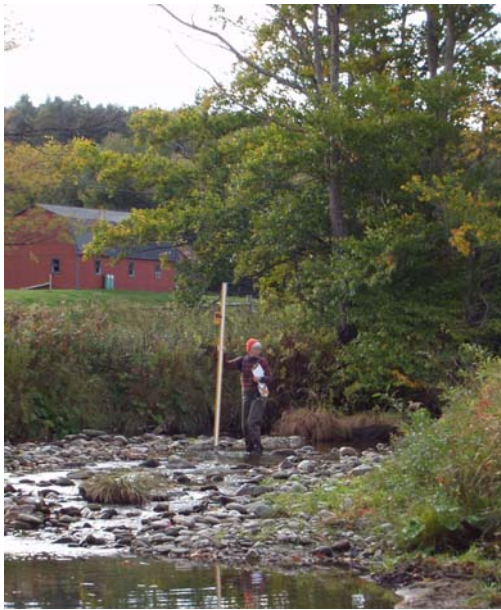
M22-B: Carrie Fenn working survey rod

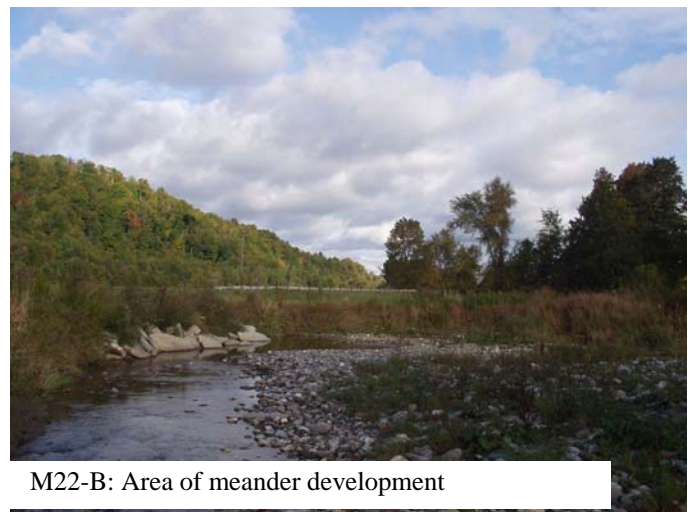
M22-B: Area of meander development

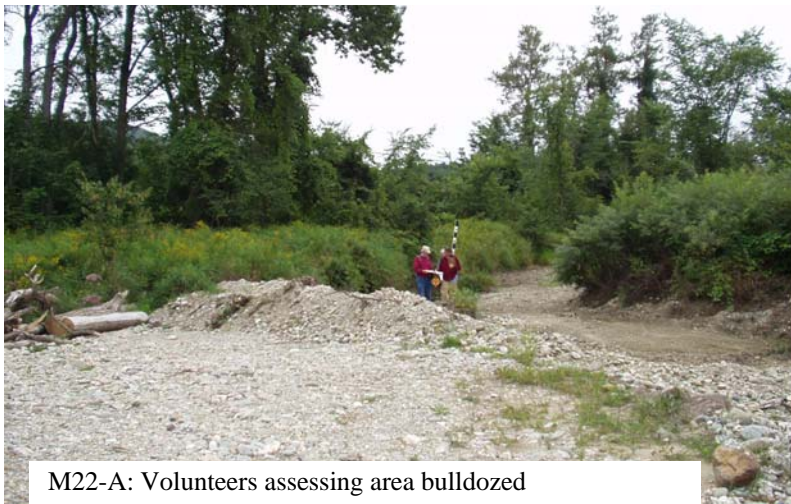
M22-A: Volunteers assessing area bulldozed

Segment-A on M22 is also experiencing conflicts between the current land practices, residential and crop, and the river processes occurring on that segment of the reach. Past channelization and armoring of the banks to

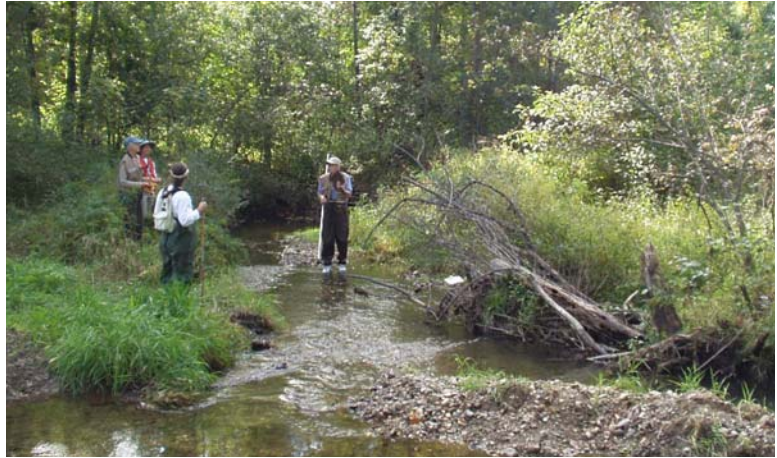
Hollow Brook Trib – T4.1: Volunteers conducting Phase 2 assessment

The upstream segment, Segment-B, is more within the transitional zone of the watershed. A long section, approximately 800 ft, becomes a losing stream for much of the season. This section flows over the kame terrace along the edge of the valley, similar to the losing stream section on M22. A few isolated pools with fish were observed in this section. Two areas of mass failure were noted as likely contributors of sediment to the stream. Segment-B is considered a C stream, and is in good geomorphic condition and fair habitat condition.
