HUNTINGTON RIVER CORRIDOR PLAN UPDATE: REACHES M1-M18; T16, T22 & T26

Prepared for:
Vermont Agency of Natural Resources/
Department of Environmental Conservation
River Management Program

ARROWWOOD ENVIRONMENTAL

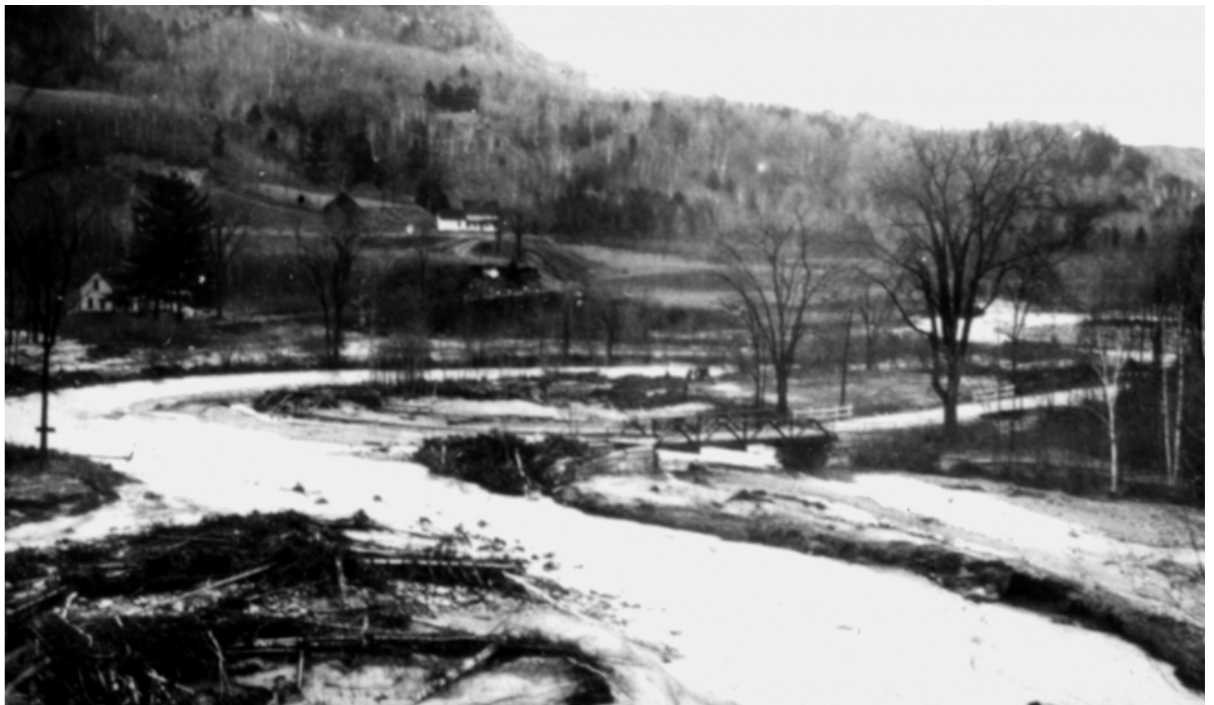
The UVM Landscape Change Program includes a photograph of the Huntington River following the 1927 flood in which it appears that the river avulsed significantly near a bridge, but left the bridge standing (Figure 1).

Figure 1. 1927, avulsed river after flood, UVM Landscape Change Program

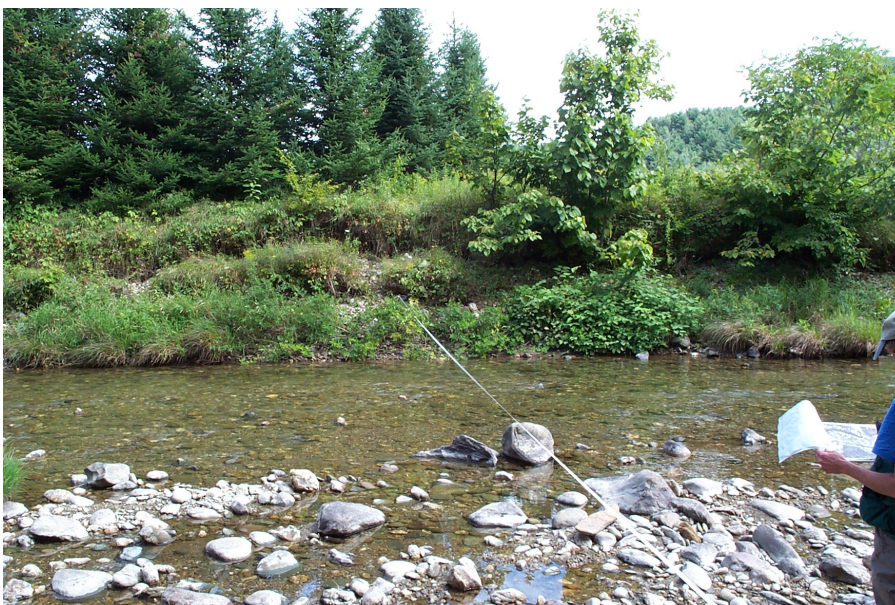
Figure 5. Reach M10 at cross section

River Segment ID	Project	Next Steps and other Project Notes
M10	Plant Stream Buffer	Stream is actively adjusting, so plantings should be set back from the immediate stream bank. Contact landowners, investigate possible grant programs for plantings.
M10	Invasive Plant Removal	Landowner contacts; labor intensive; multi- year project; results may be limited

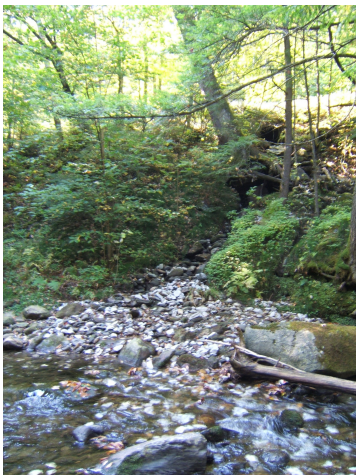
Figure 6. Outfall from a roadside ditch in T26.02.

River Segment ID	Project	Next Steps and other Project Notes
T26.02	Plant Stream Buffers	Stream is still widening so plantings should be set back from immediate stream bank. Contact landowners, investigate possible grant programs for plantings.
T26.02	Stormwater Runoff (5 roadside ditches)	Contact town regarding roadside ditch maintenance procedures.

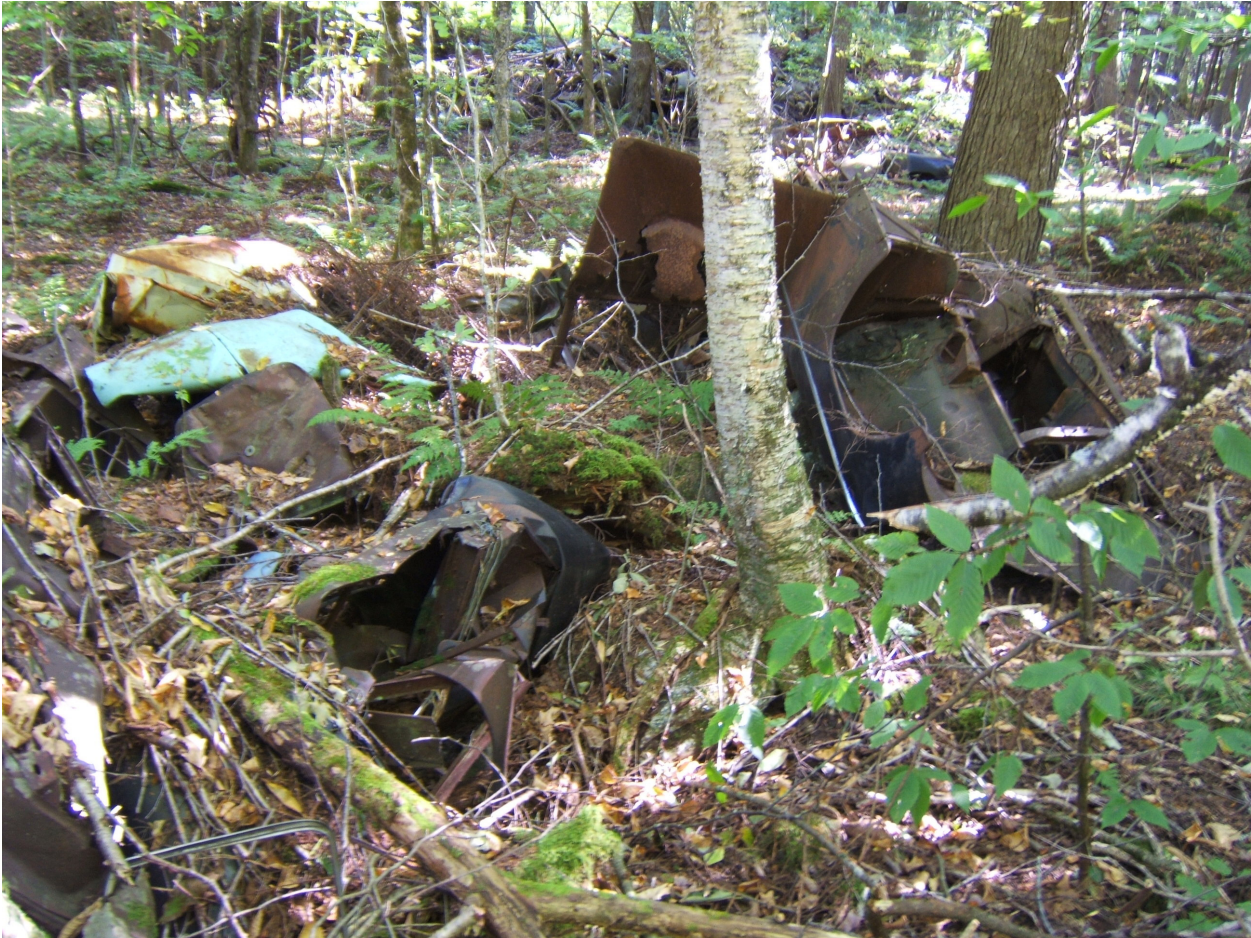
Figure 7. T22.01 dump site. (9/22/08)

Dump Sites: The Phase 2 field assessments resulted in the identification of four riverside dump sites. Two of the sites are located in M17, one each in segments A and B. The segment A site is characterized by wood debris. The segment B site has miscellaneous items. The third site is located in reach T22.01, just upstream of the M12 reach break. The T22.01 site contains old junk cars and metal scraps. The fourth dump site is in M18B at the upstream end of the segment.
