### **West Branch of the Ompompanoosuc River River Corridor Management Plan Strafford, Vermont**

October 30, 2006

Strafford Conservation Commission

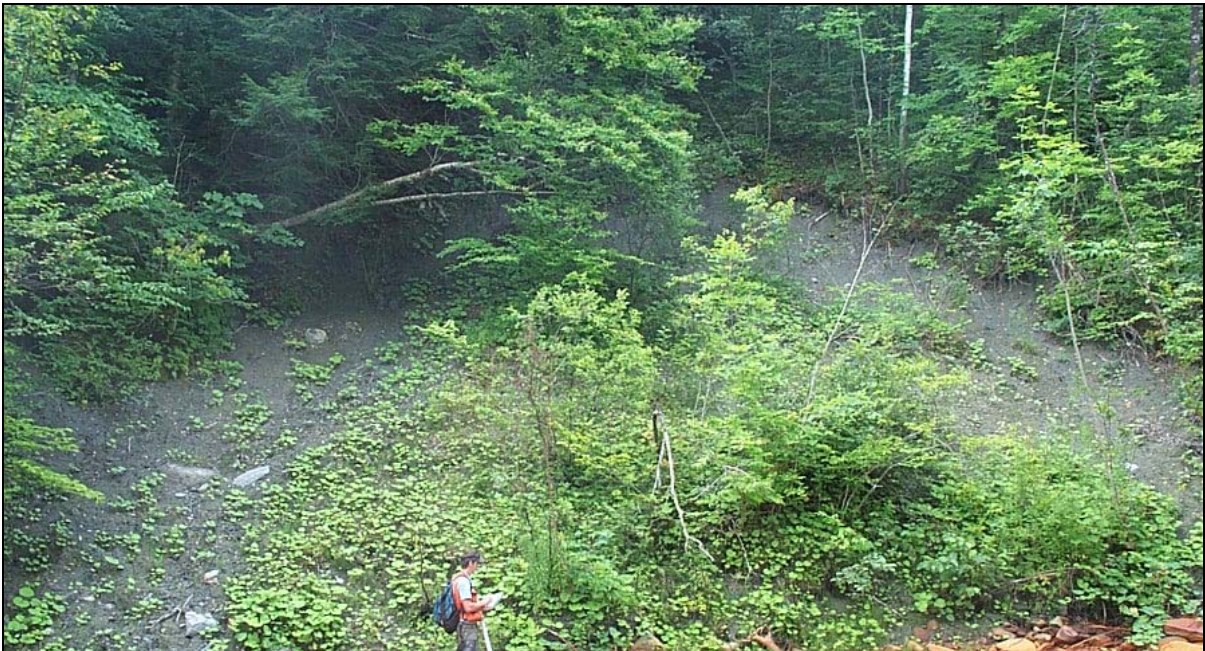
**Figure 2: Glacial lake deposits are found in the lower reaches of the study area.**

As the glaciers retreated, numerous lakes formed between the ice and the high ground. In the Connecticut River basin the very large glacial Lake Hitchcock was formed; it extended all the way up the Connecticut River Valley with fingers reaching up into the Ompompanoosuc River Valley. The shorelines of these lakes were often the receiving area for copious fine sediments shed from the melting ice and surrounding barren landscape. These glacio-lacustrine deposits, as they are known, are often prone to unpredictable shifting and shearing. Near the Strafford/Thetford town line glacial clay deposits begin to appear, evident by the large massive streambank failures that occur when they fail (Figure 2).

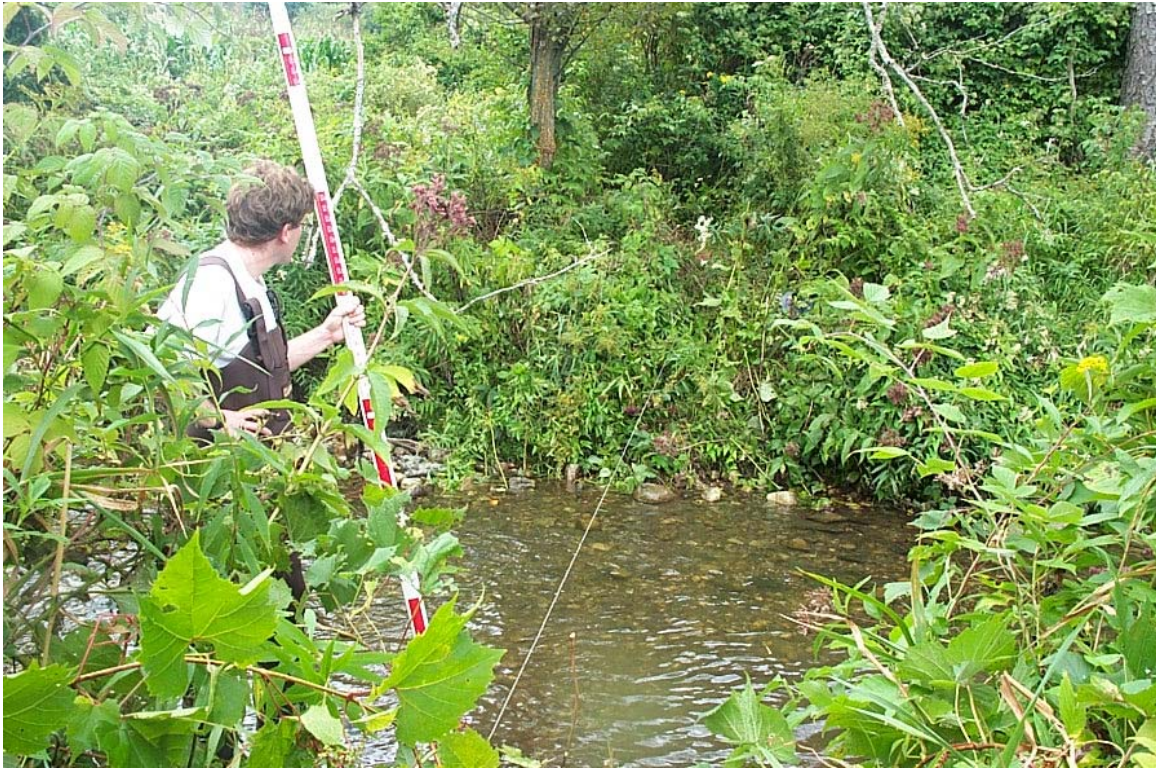
**Figure 6. Ben Copans of the Vermont DEC measures the cross-sectional area of the Upper West Branch during summer 2005.**

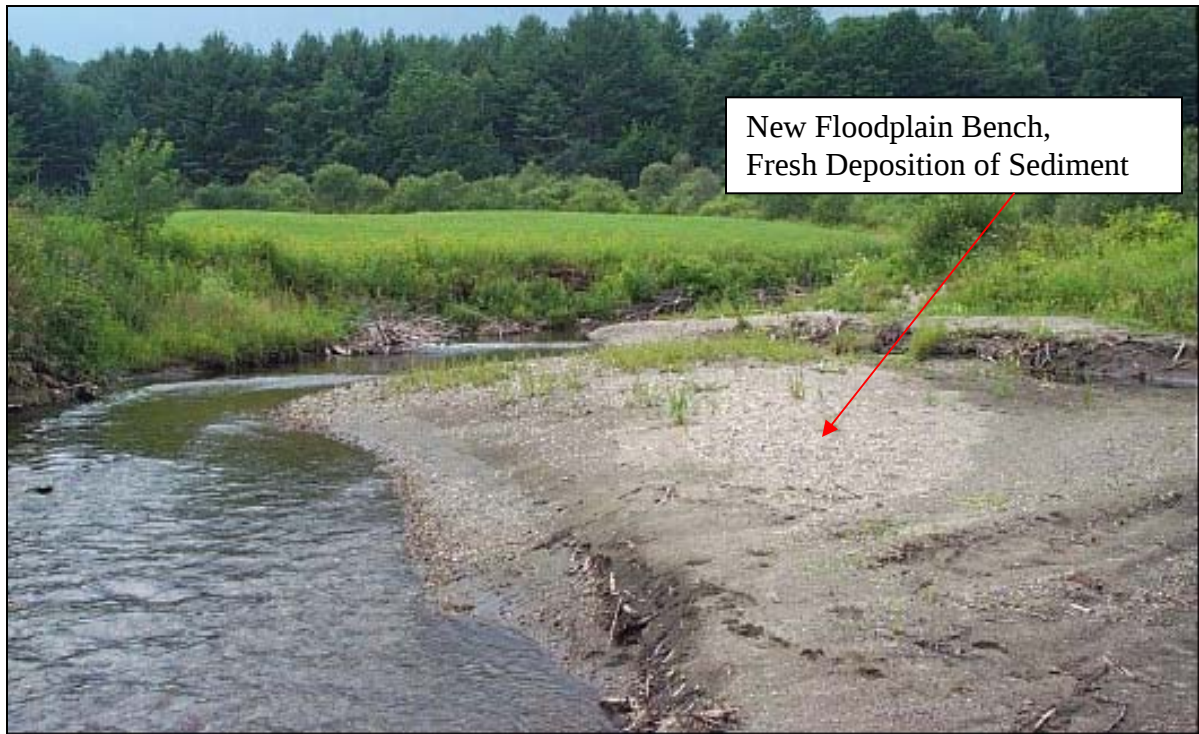
**Figure 8. The West Branch is working to create a new floodplain bench in many areas.**

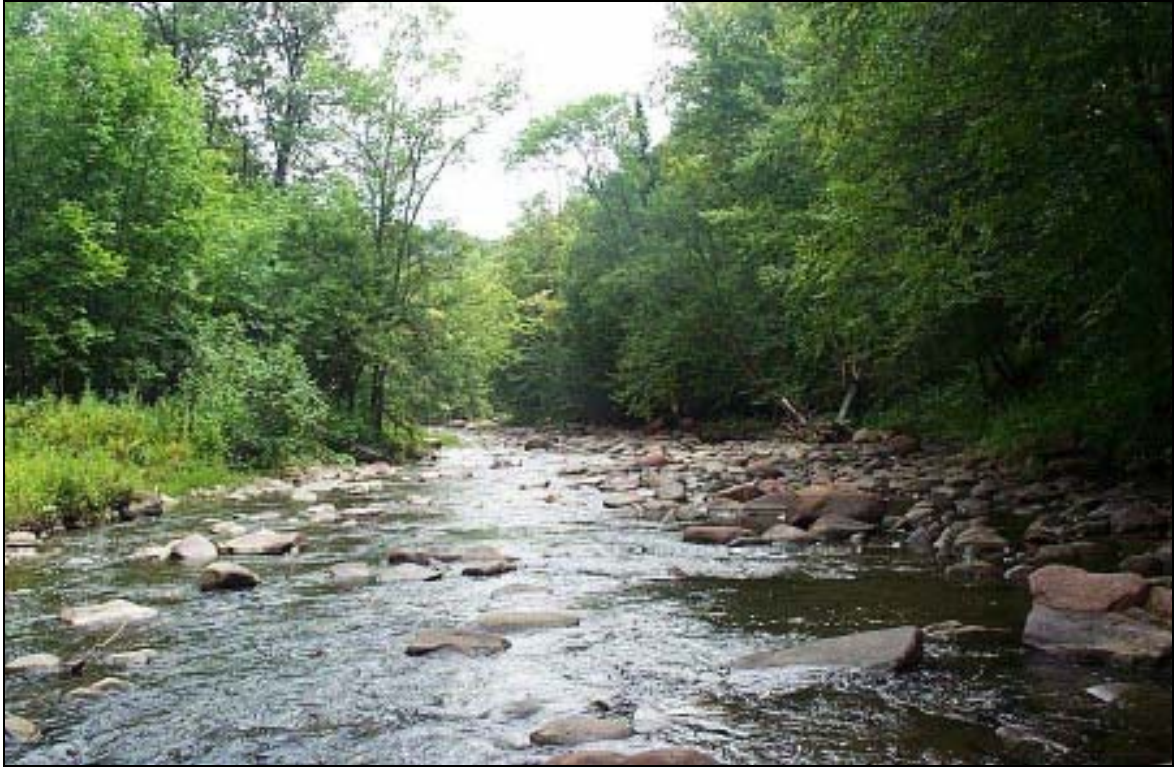
**Figure 15: Reach M03, has a healthy riparian buffer that provides an opportunity for conservation.**

Conservation reaches are generally in stable geomorphic condition and need little restoration work. In Strafford, only two conservation reaches were identified on the mainstem. These reaches typically have a healthy riparian buffer (see Figure 15) which lend to their stability. Conserving a riparian corridor along these reaches is good policy. General strategies for restoration may include the following:

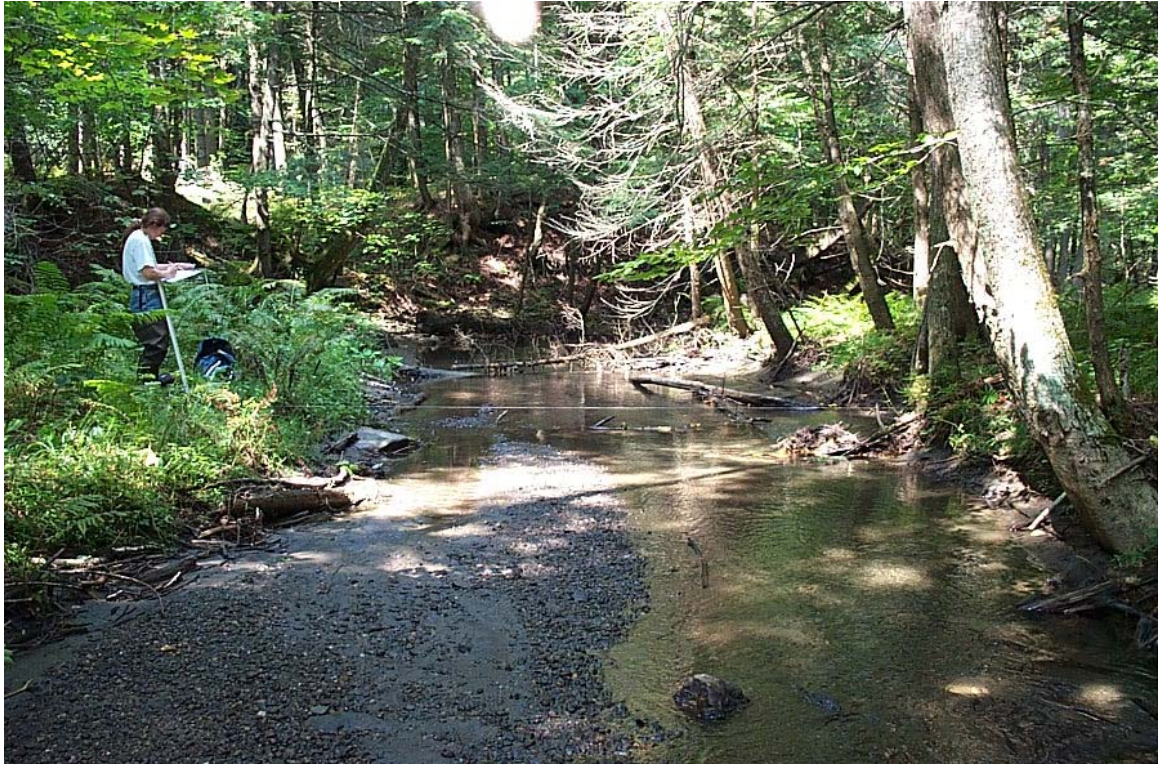
**Figure 16: Reach T2.01-B, Downer Forest Brook, is an exemplary high recovery reach.**

High recovery reaches are generally in good to fair geomorphic condition and exhibit expected channel dimensions, profile, and patterns (Figure 16). These reaches may have already undergone significant adjustment or may be prevented from undergoing a major adjustment process through proactive work. Restoration of these reaches is best approached with a passive or light active approach to restoration. General strategies for returning these river segments to health may include the following:

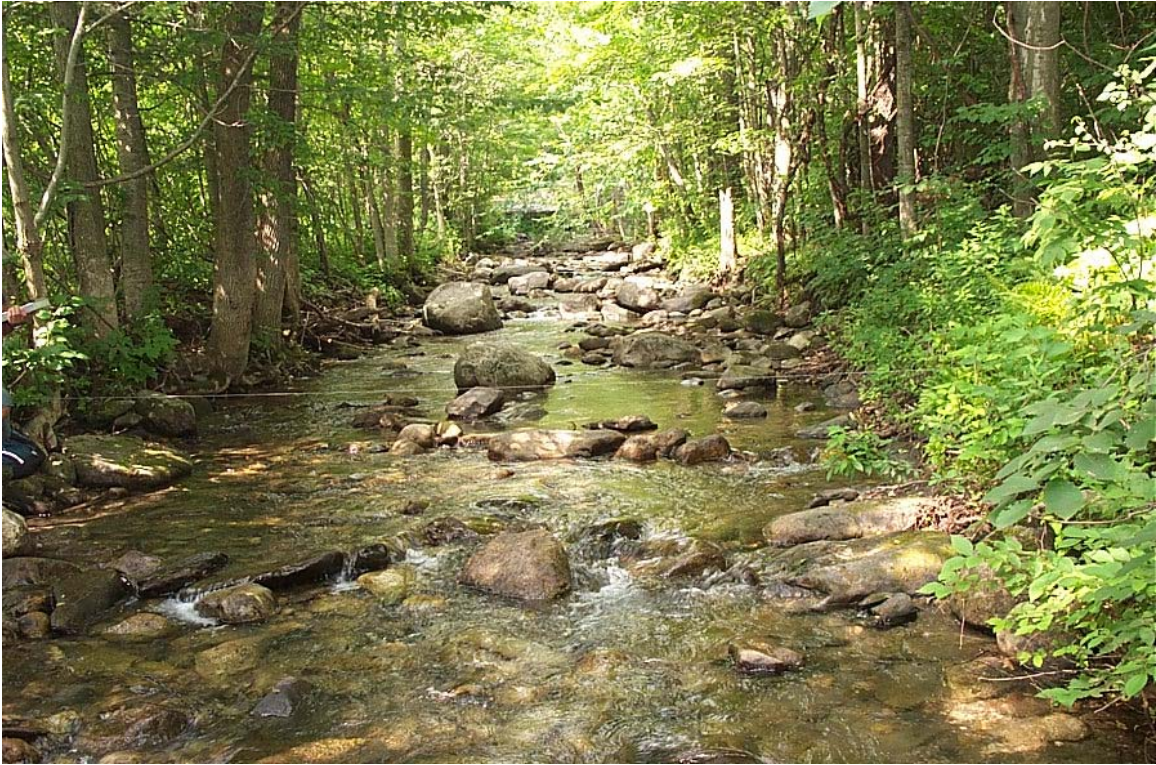
**Figure 17: Reach M12, which begins at the confluence of Tunbridge Brook, is moderately unstable.**

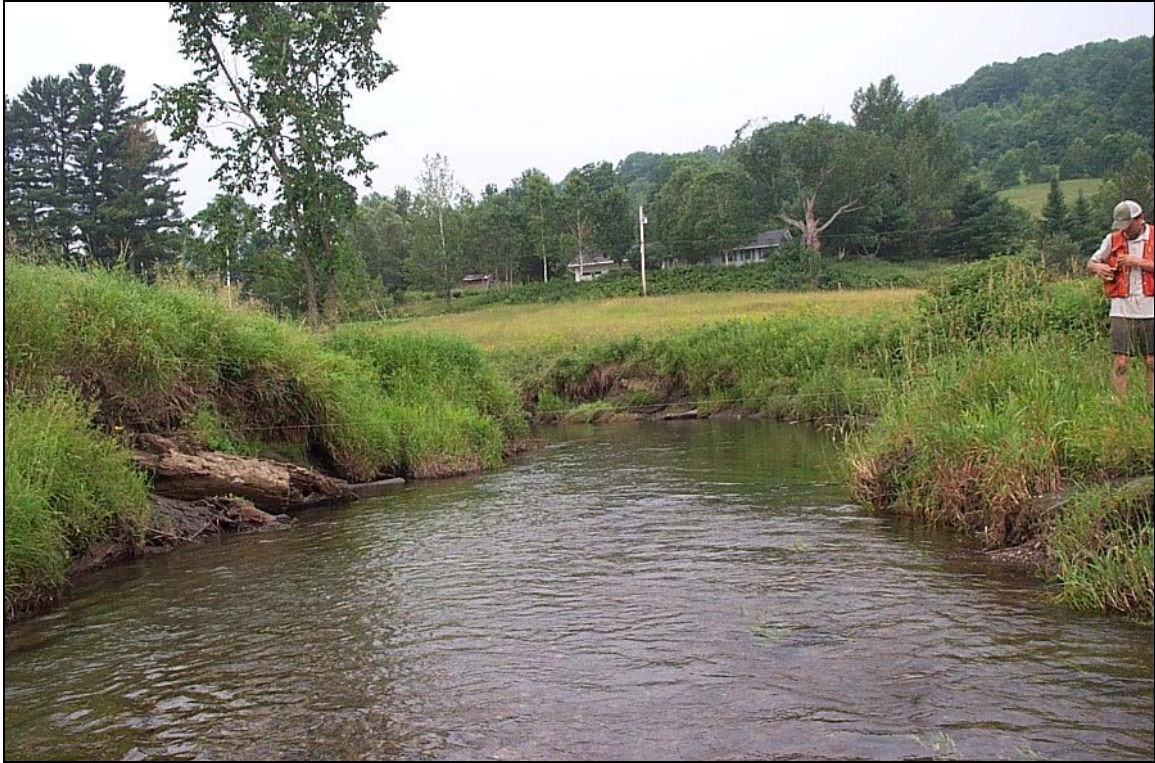
Figure 18: M07 is a highly unstable reach that is undergoing major geomorphic adjustment.

Restoration of highly unstable reaches is best approached with caution. These reaches are often severely incised, aggrading, or exhibiting major planform or widening processes (see Figure 18). Passive restoration techniques are preferred, as active geomorphic restoration of unstable reaches is often very expensive and unsuccessful. The very dynamic nature of these streams lends to the challenge of active restoration. The best technique may be to relieve the stream of obvious stressors such as undersized structures or other impairments to sediment transport and then to look for opportunities to develop a new floodplain. General strategies that are appropriate for these river segments are to:
