### **Phase 2 Stream Geomorphic Assessment West Branch Ompompanoosuc River Watershed Town of Strafford, Vermont**

Final Report  
February 6, 2006

Strafford Conservation Commission

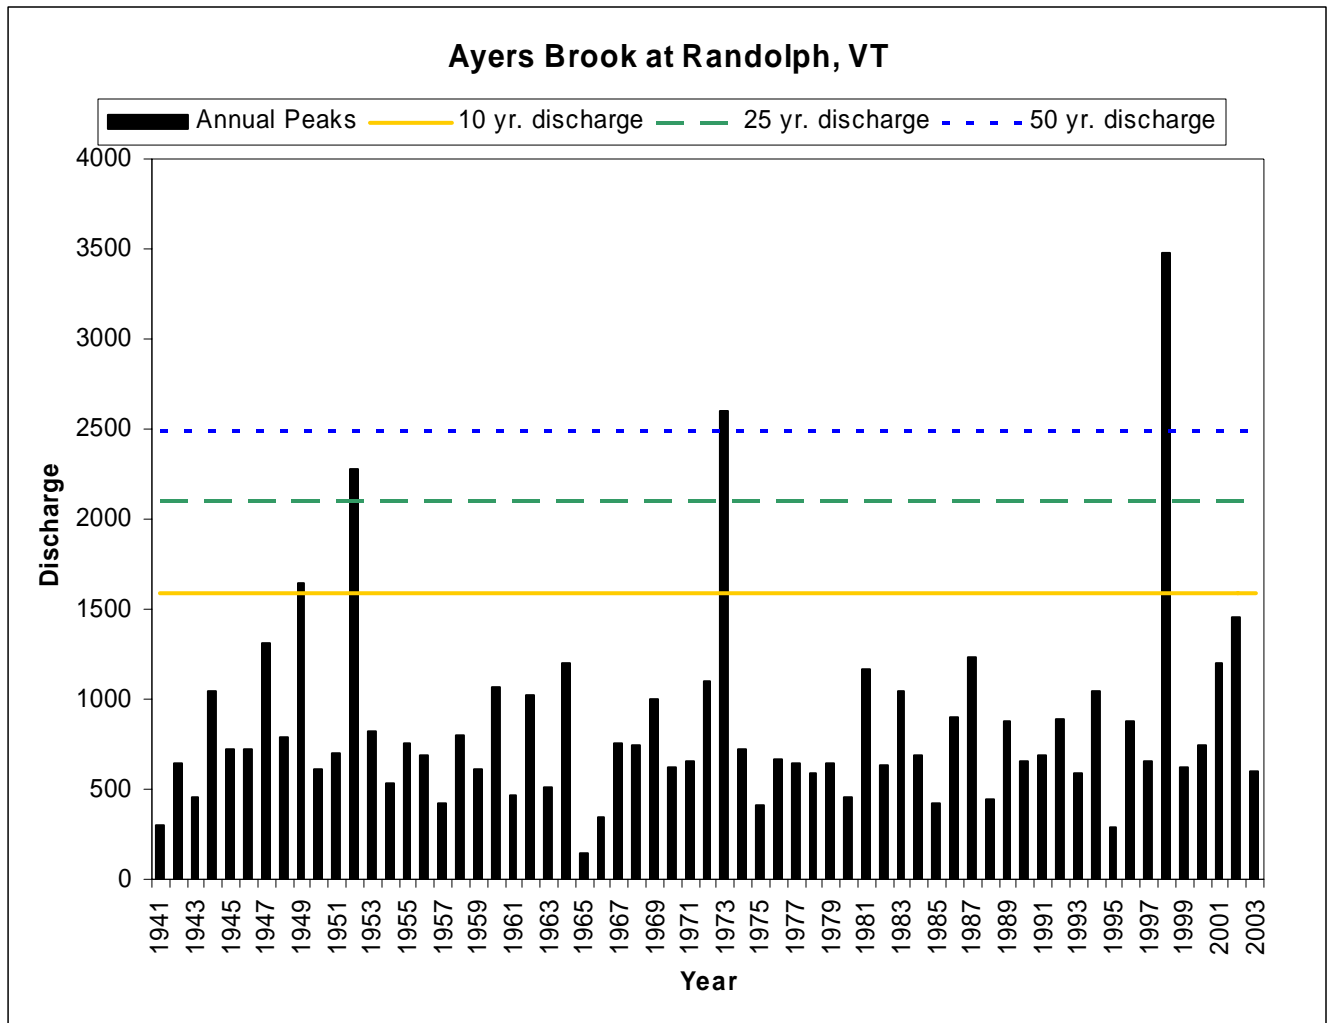
**Figure 4: Flood frequency analysis for USGS 01142500 Ayers Brook at Randolph Vermont. Peak streamflow data from 1940 through 2003 were used in the analysis.**

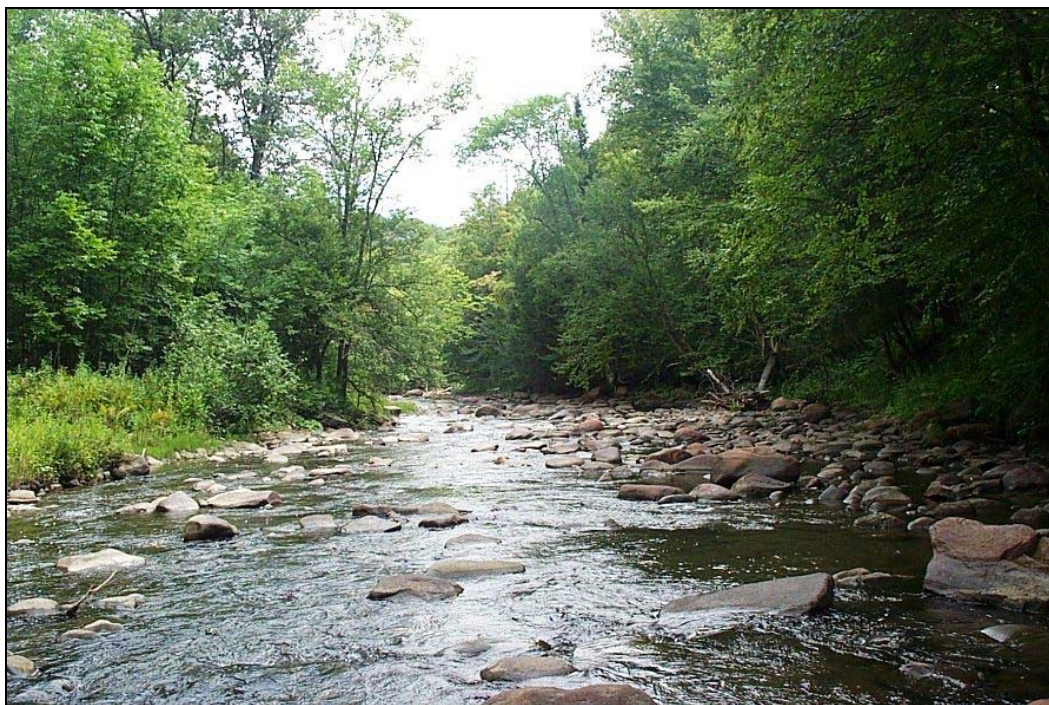
**Figure 5. M03 is a plane bed system dominated by run habitat. The substrate was primarily large cobbles.**

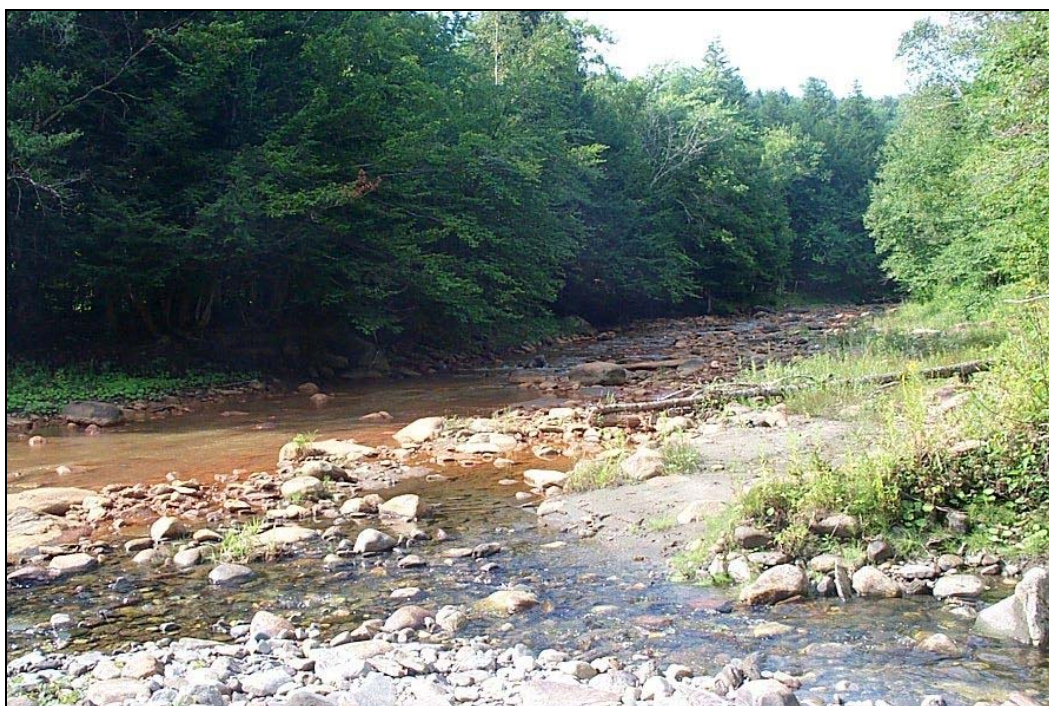
**Figure 6. The water quality of M03 has been drastically affected by the acid drainage from the Elizabeth Copper Mine. Here the clear waters of Abbot Brook converge with the West Branch of the Ompompanoosuc at the beginning of reach M03.**

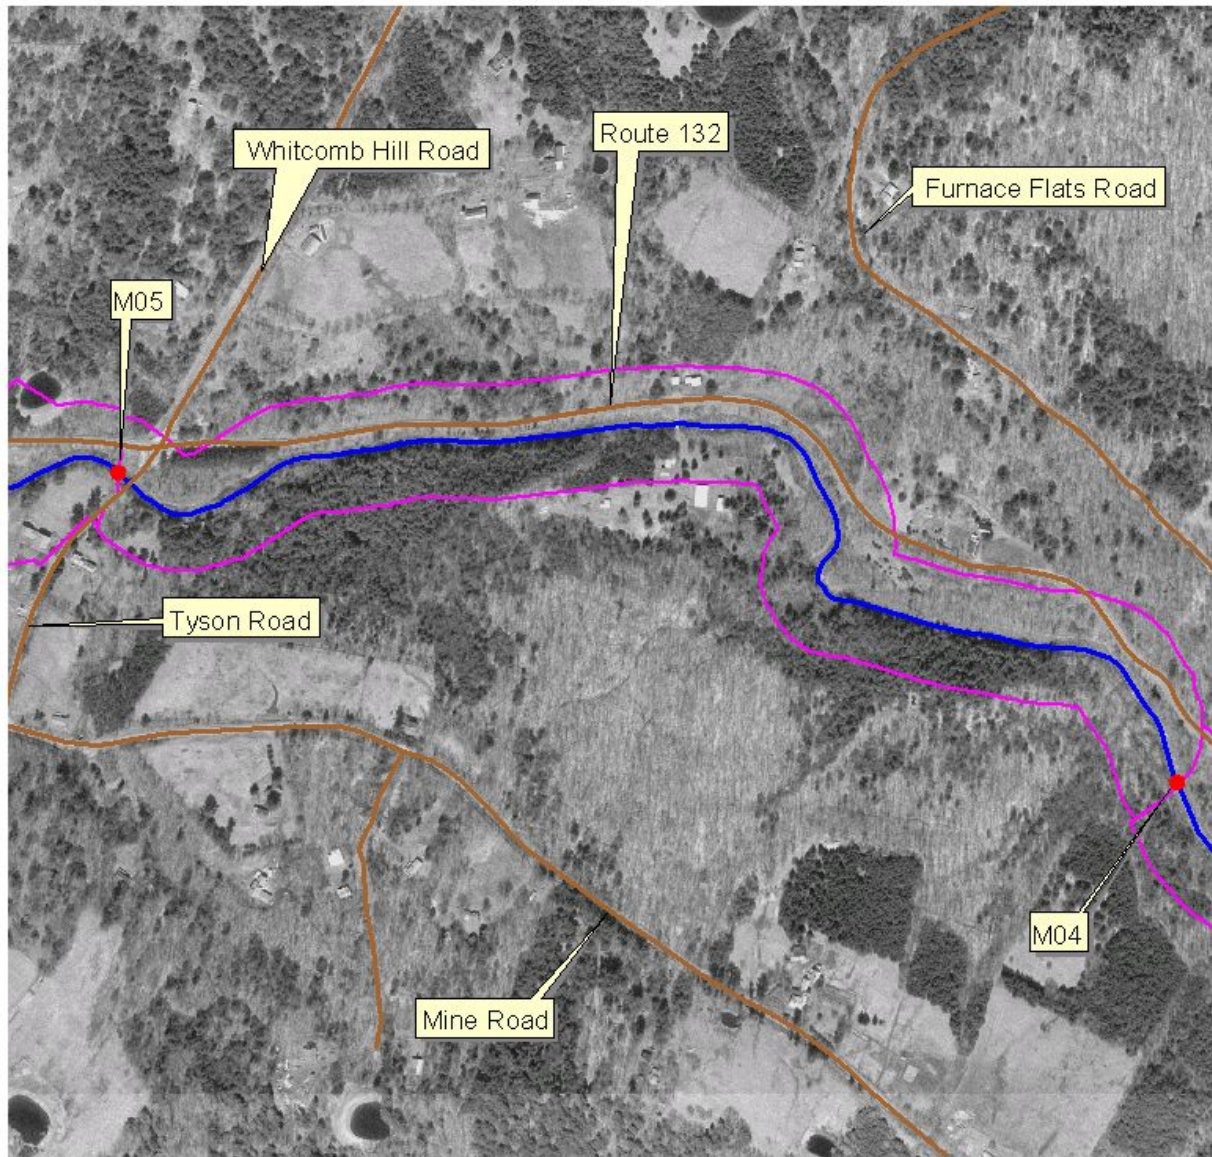
Figure 7. Route 132 Encroachment in the corridor of M04.

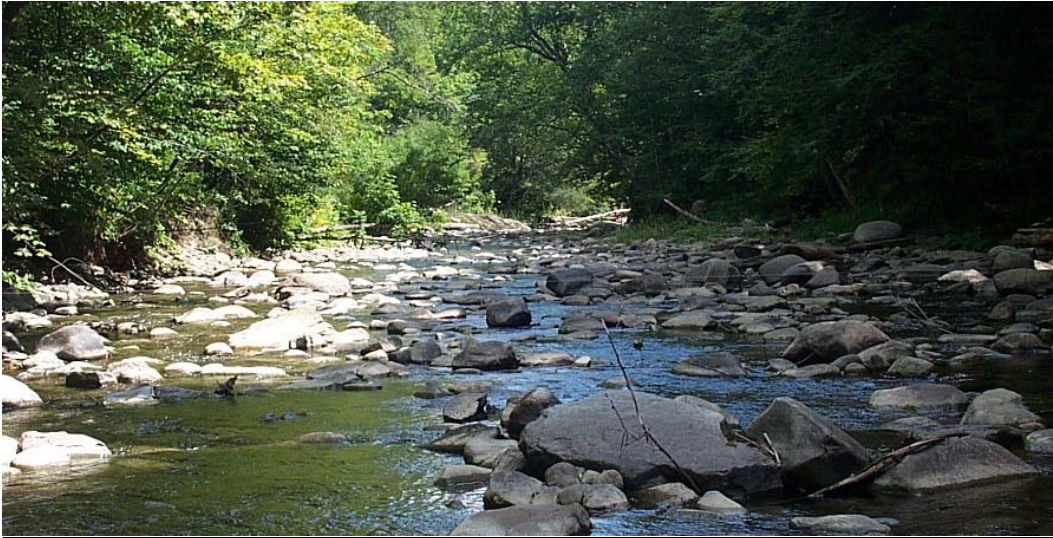
Erosion was moderate in this section and there were several mass failures where the stream has pushed against the valley wall (Figure 8). Although a few residences border this reach and Route 132 runs along much of the left corridor, the predominant land use in the river corridor is forest. The riparian buffer is generally in good condition, except where Route 132 encroaches into it. Figure 9 shows a large mass failure that has occurred downstream of the Tyson Road Bridge.

**Figure 8. M04 has undergone a stream type departure to a “B” channel and is dominated by run habitat.**

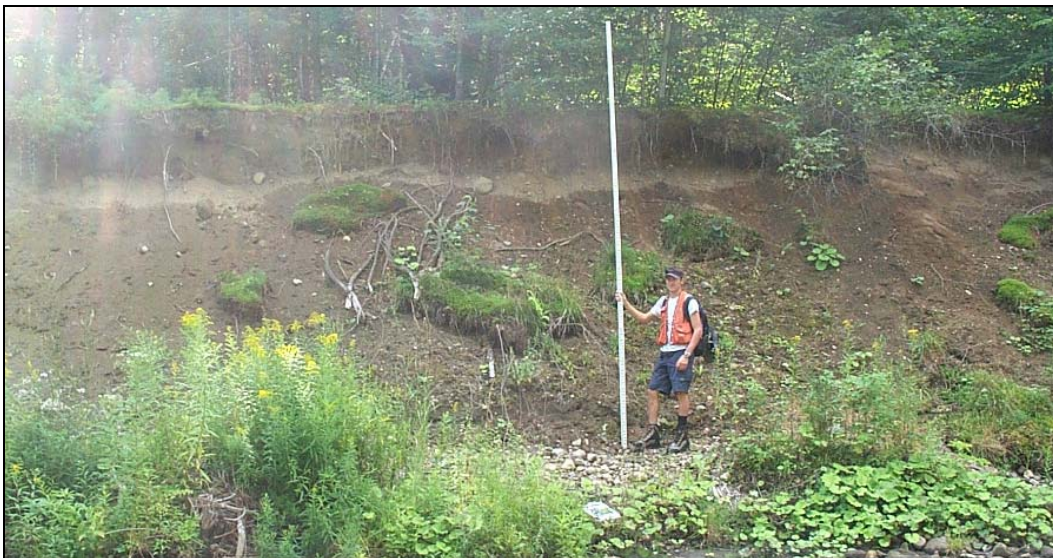
**Figure 9. Massive bank failure downstream of the Tyson Road Bridge.**

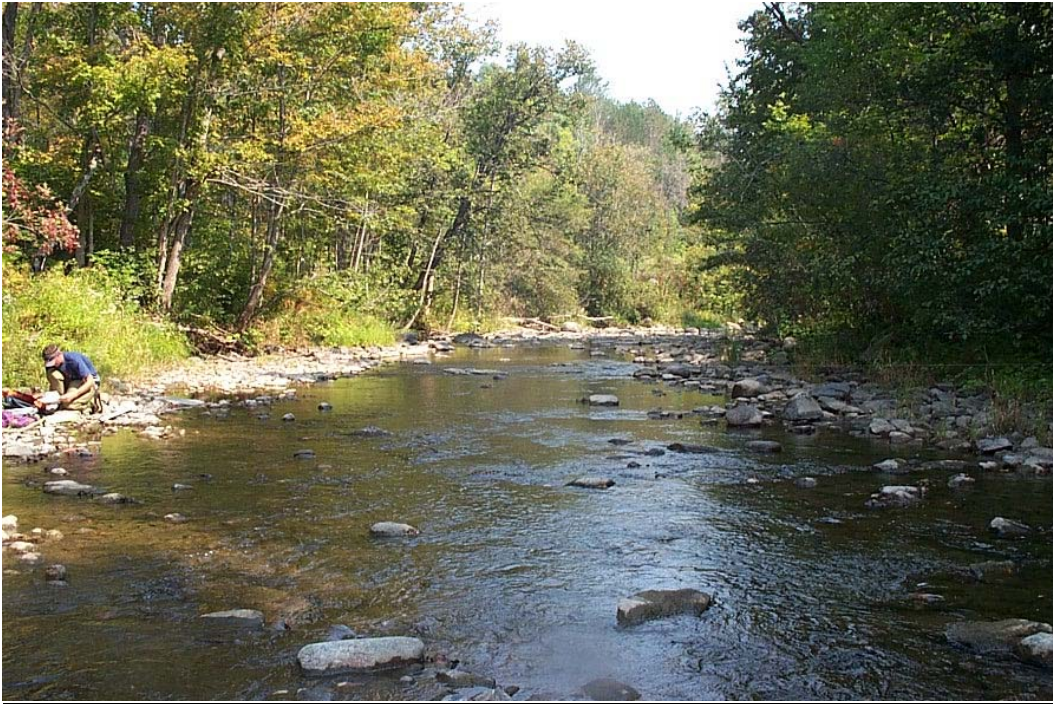
**Figure 10. Reach M05 has undergone historic incision. It has widened and is working to expand its floodplain at a new elevation.**

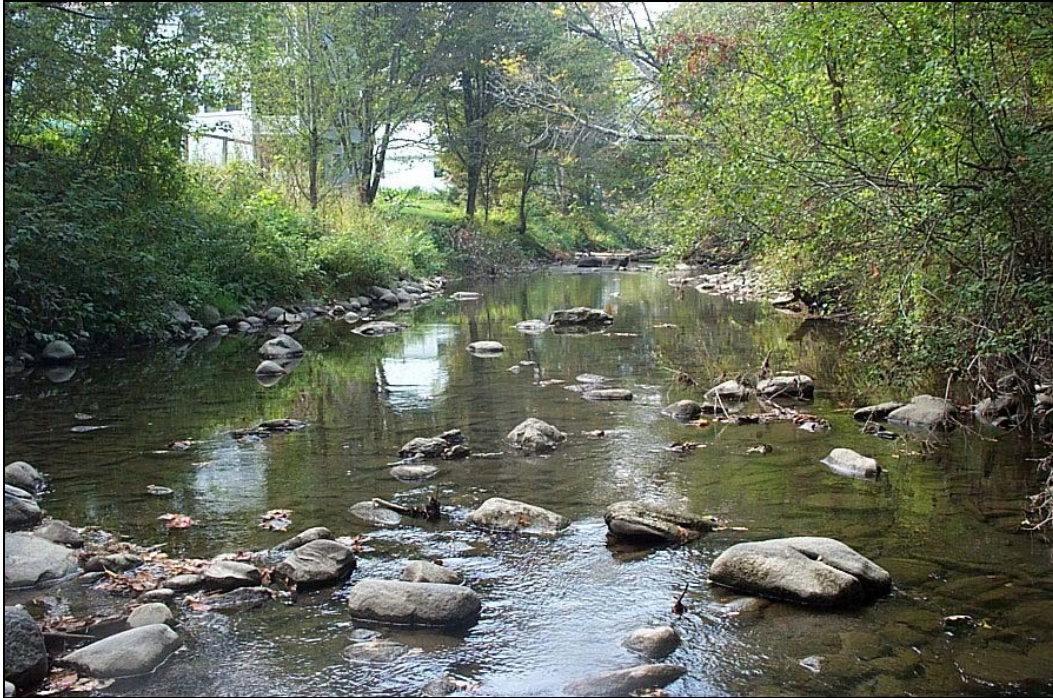
**Figure 11:** The lower end of Reach M06 flows in close proximity to several houses and commercial buildings in South Strafford Village.

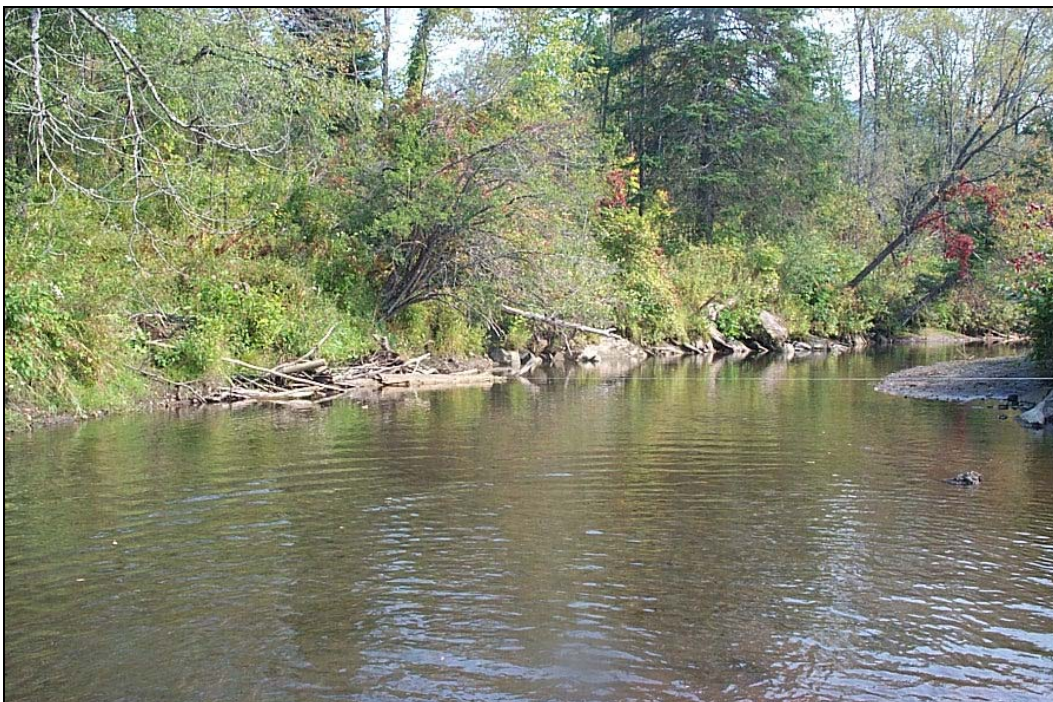
The result of this adjustment process is a weak riffle-pool bed structure that lacks habitat (Figure 12). Additionally, the riparian buffer, on the right bank has been heavily impacted by residential and commercial development. It now only averages about 5 feet wide. Landowners along this reach have reacted to the adjustment process of the river by heavily rip-rapping the right bank (1050 feet). Rock armoring of “E” type streambanks often causes further instability in the system. The left bank, perhaps in response to this armoring, as well as the localized channel adjustment, has 1300 feet of recorded streambank erosion.

**Figure 12.** M06 is an “E” channel that has historically incised and widened. It is currently a “C” channel that is redeveloping a new floodplain.

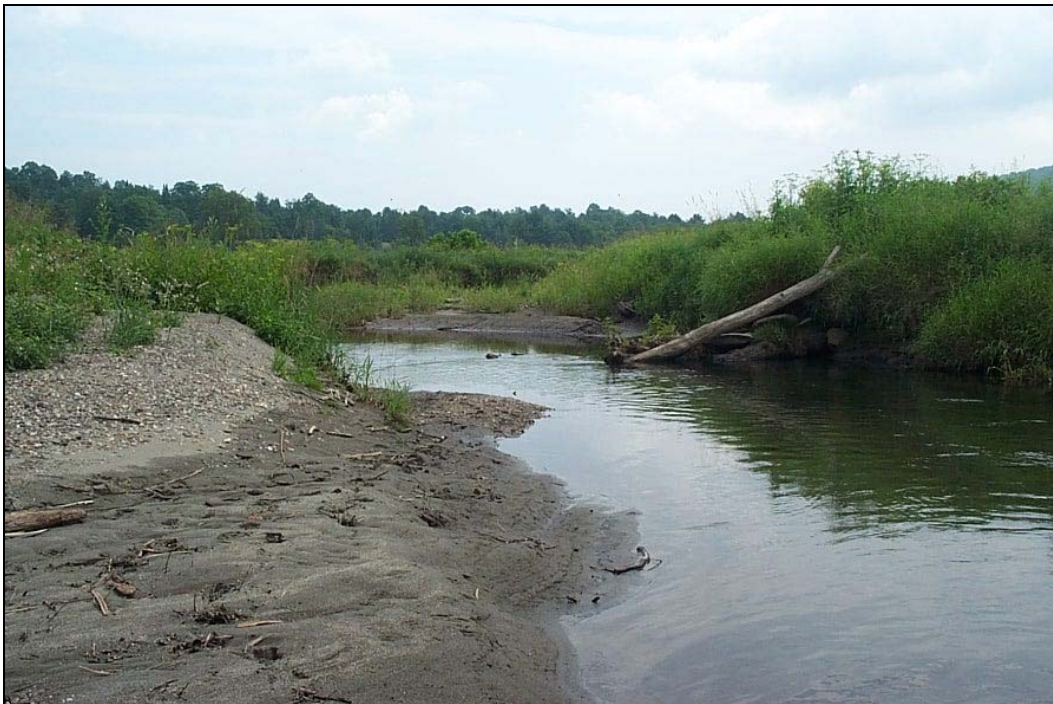
**Figure 13. M07 is an “E” channel by reference. Historic incision has caused major active adjustment as the stream works to redevelop a new floodplain.**

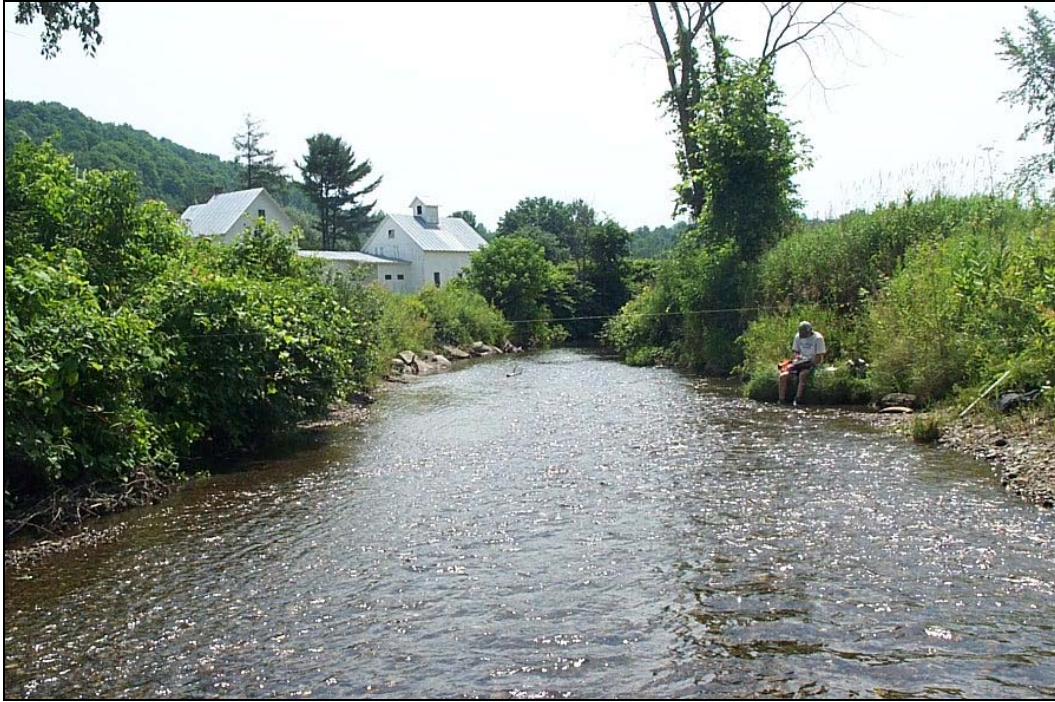
Reach M08 is now actively in a process of widening and planform adjustment as it rebuilds a new floodplain. Aggradation within the reach is likely attributed to autochthonous<sup>7</sup> sediment originating from eroding streambanks. Due to channel widening, the stream was found to have a high width to depth ratio and was therefore classified as a “C” type channel, a departure from its reference condition (Figure 15).

**Figure 15. M08 is an “E” channel by reference. Historic incision has caused major active adjustment as the stream works to redevelop a new floodplain.**

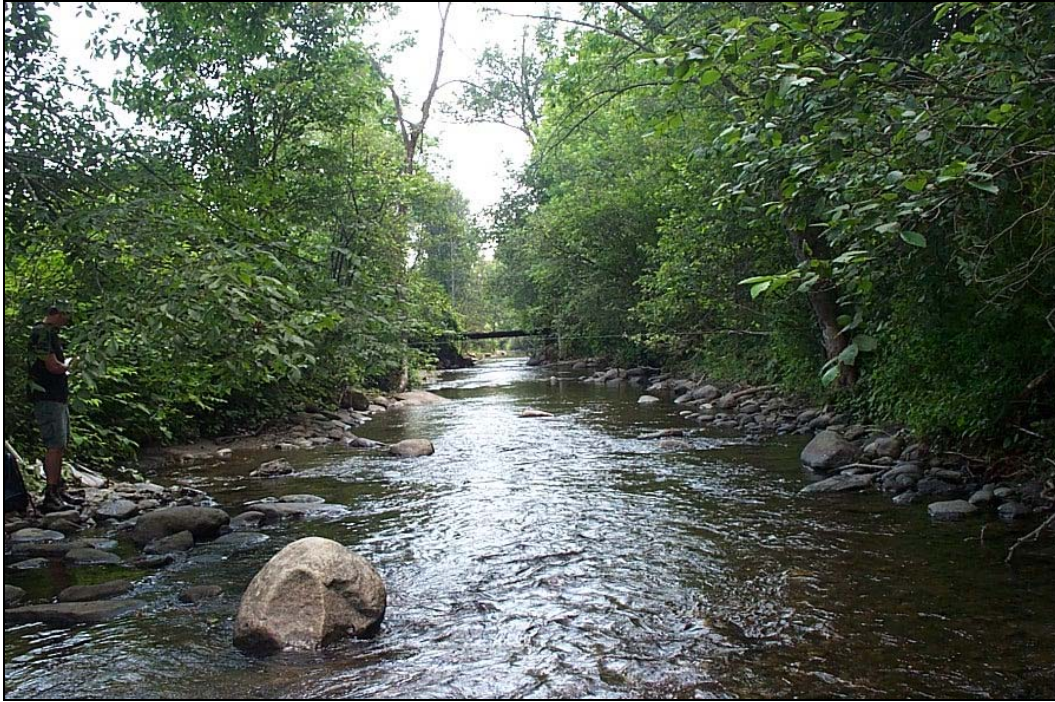
this extensively straightened reach, the stream has few meanders, and is predominately a plane bed stream (Figure 17).

**Figure 17. M09-A is an “E” channel that has been historically straightened. The result has been a conversion to a plane bed system and the loss of pool habitat.**

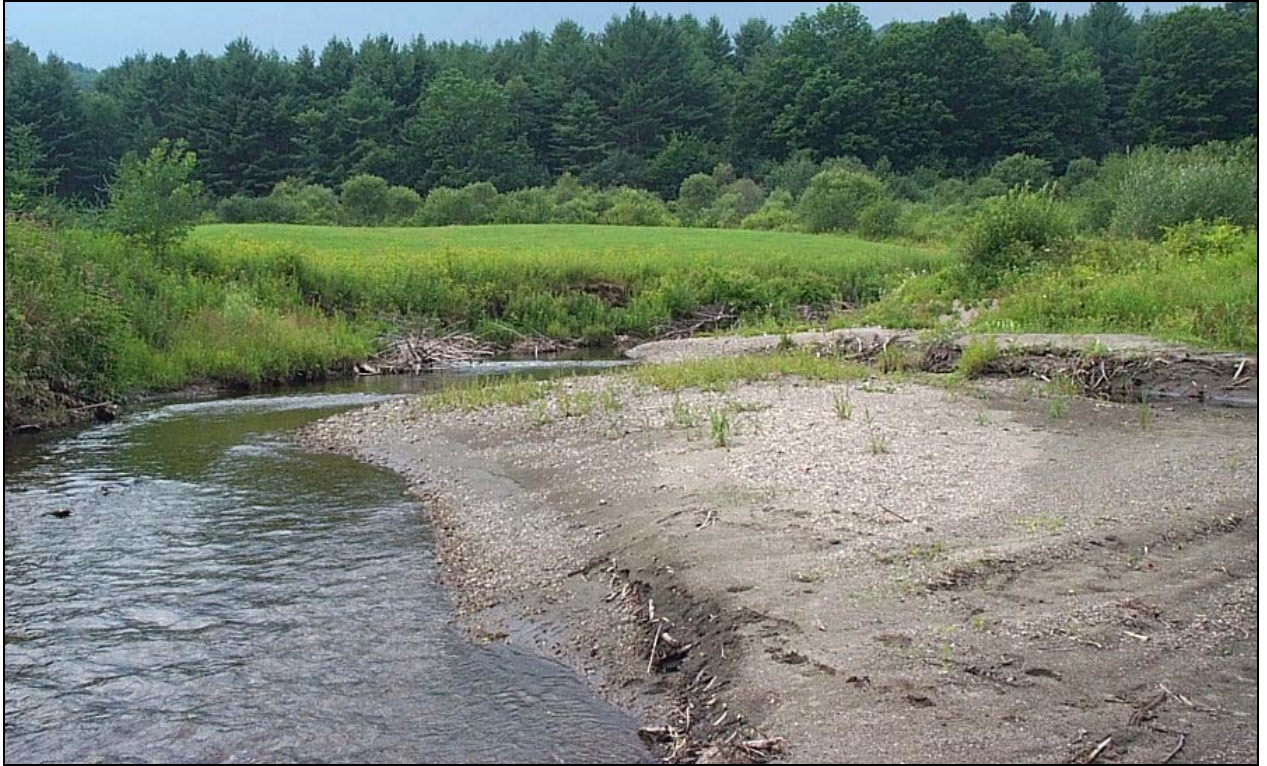
**Figure 18. M09-B is an “E” channel – although in some areas, it is rebuilding a floodplain and has “C” type characteristics.**

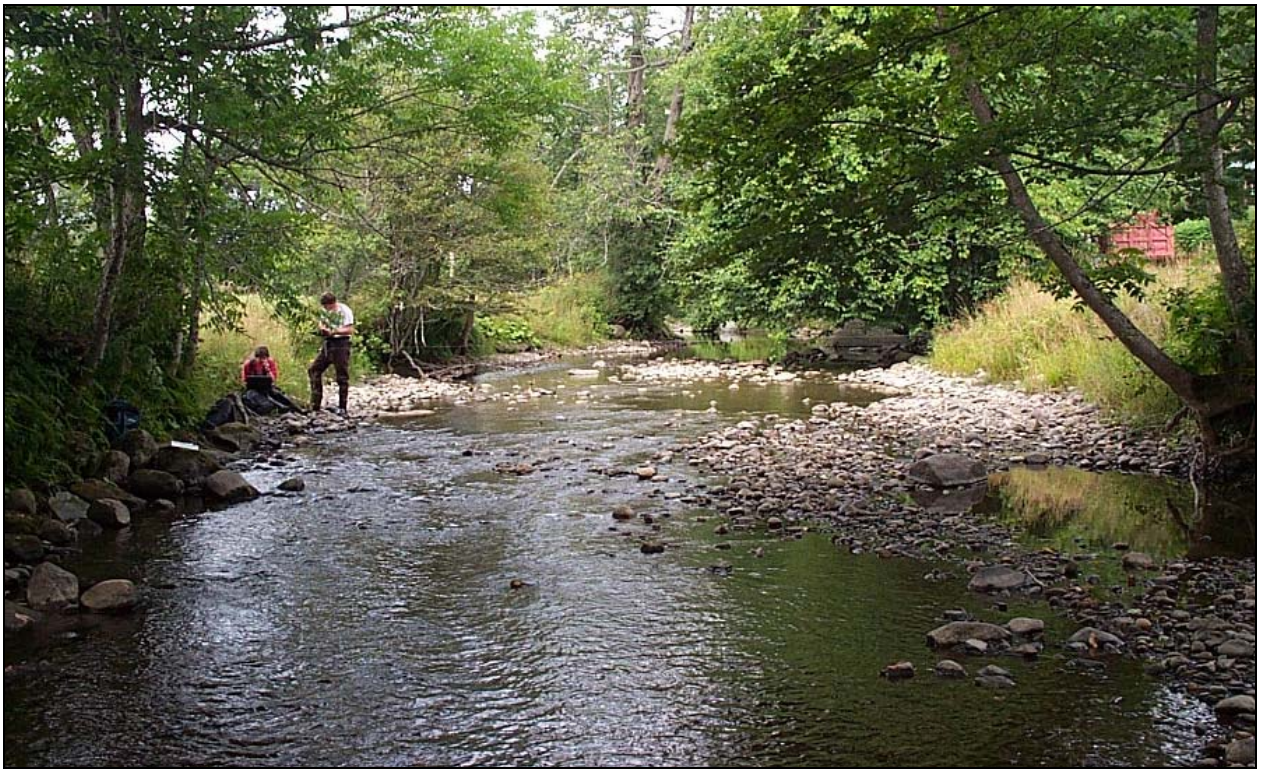
**Figure 19. M10 has been historically straightened. It is over-wide and incised and is a “C” channel with poor habitat features.**

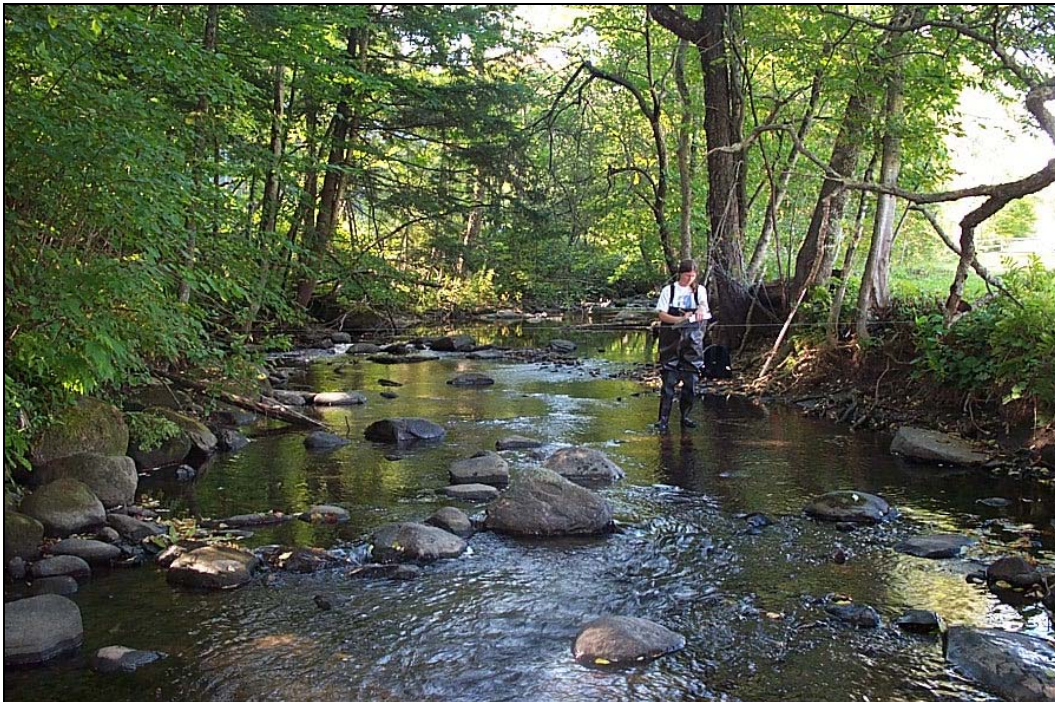
**Figure 21. MII-A is a naturally steep, “E3” channel by reference.**

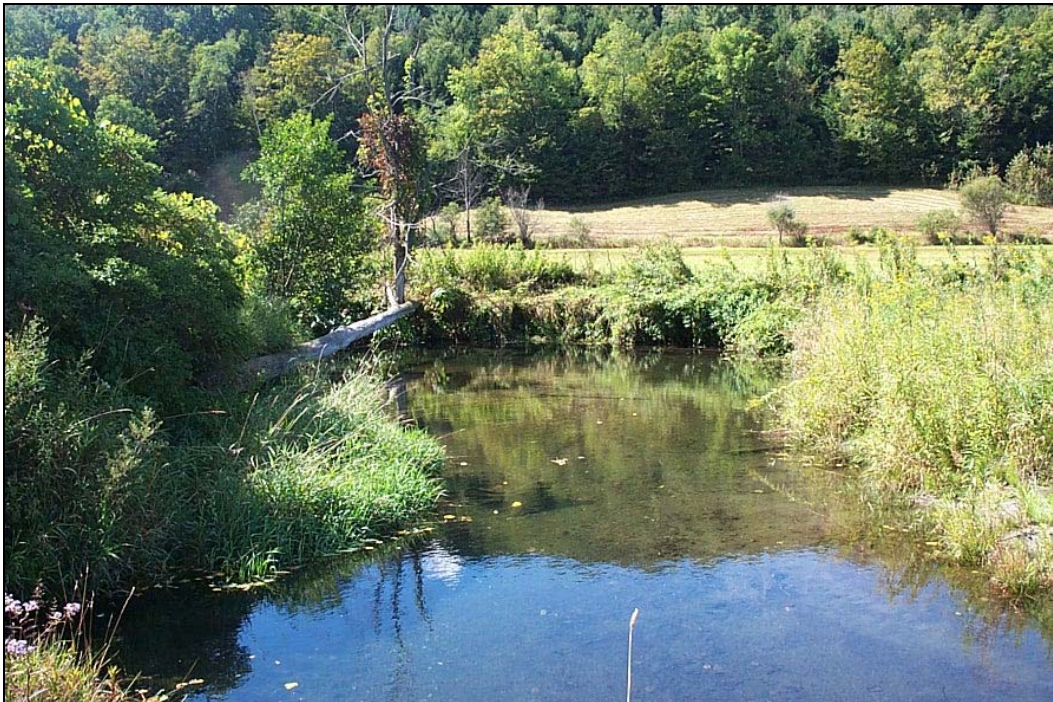
Due to beaver activity, which inhibits water and sediment transport, a full Phase 2 geomorphic assessment was not conducted on segment MII-B (see Figure 22). Overall, the characteristics of this segment are similar to MII-C. The Phase I assessment found this to be an “E” channel by reference. Riparian buffer width ranged from 5-25 feet on both sides of the river and consisted of herbaceous species with a few mixed trees along the top of the bank.

**Figure 22. Flows and sediment transport through segment MII-B were affected by beaver dams at the time of this study.**

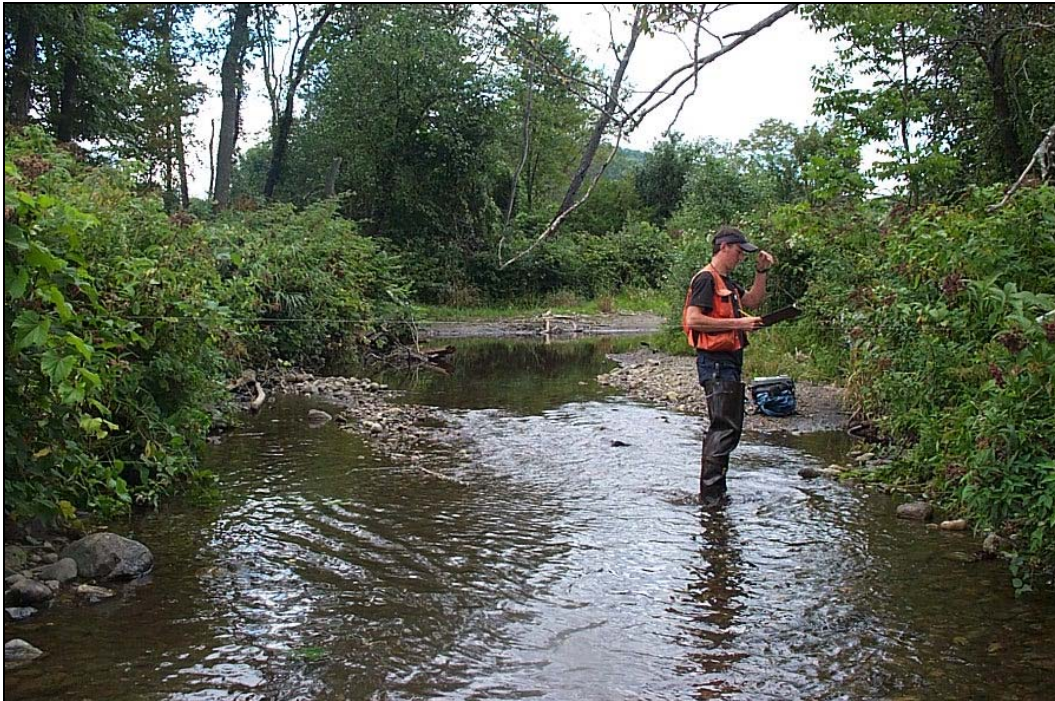
WBOR reach MII-C is a highly sinuous reach that runs through hay and crop fields for about 5000 feet in length until the confluence with Tunbridge Brook (T8.01) (Figure 23). This segment of the main stem of the WBOR is the first reach with a wide, flat valley floor. With a flatter slope and more sinuous planform the reach is responding to sediment coming down from the headwaters streams. The incision ratio of this reach was 1.29 indicating some degree of historic channel degradation. Currently the stream is undergoing major planform adjustment (there are multiple impending neck cut-offs) with minor aggradation and widening. Sediment storage is occurring in the form of

**Figure 23.** M11-C is a highly sinuous “E” type channel.

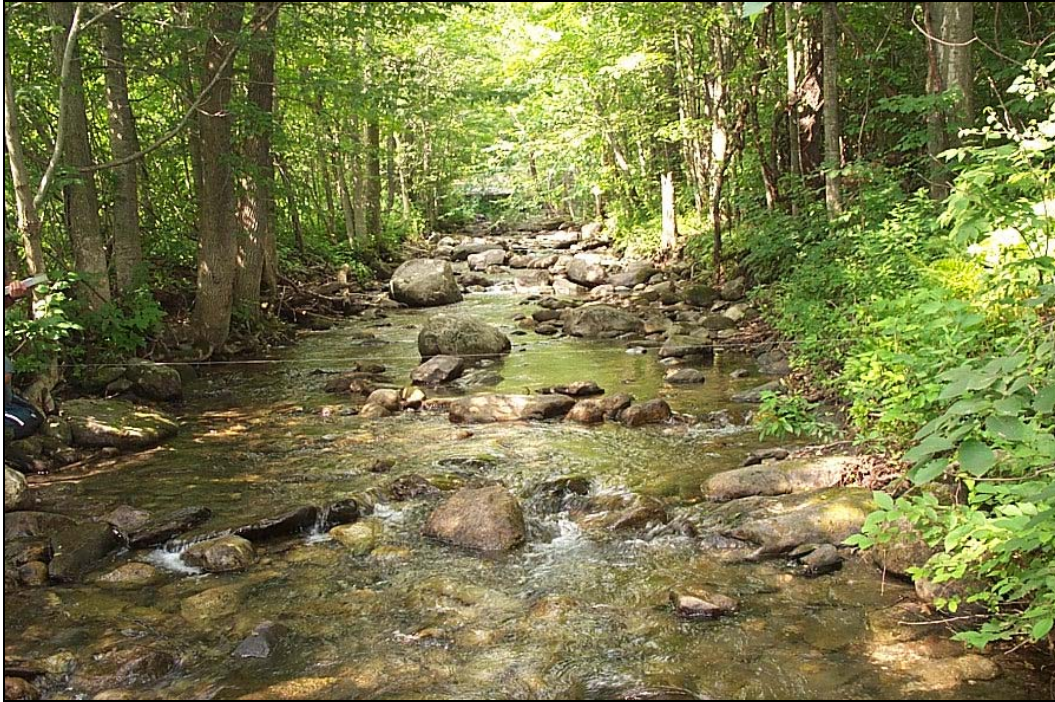
**Figure 24. M12 is in good geomorphic condition, although its riparian buffer is very narrow.**

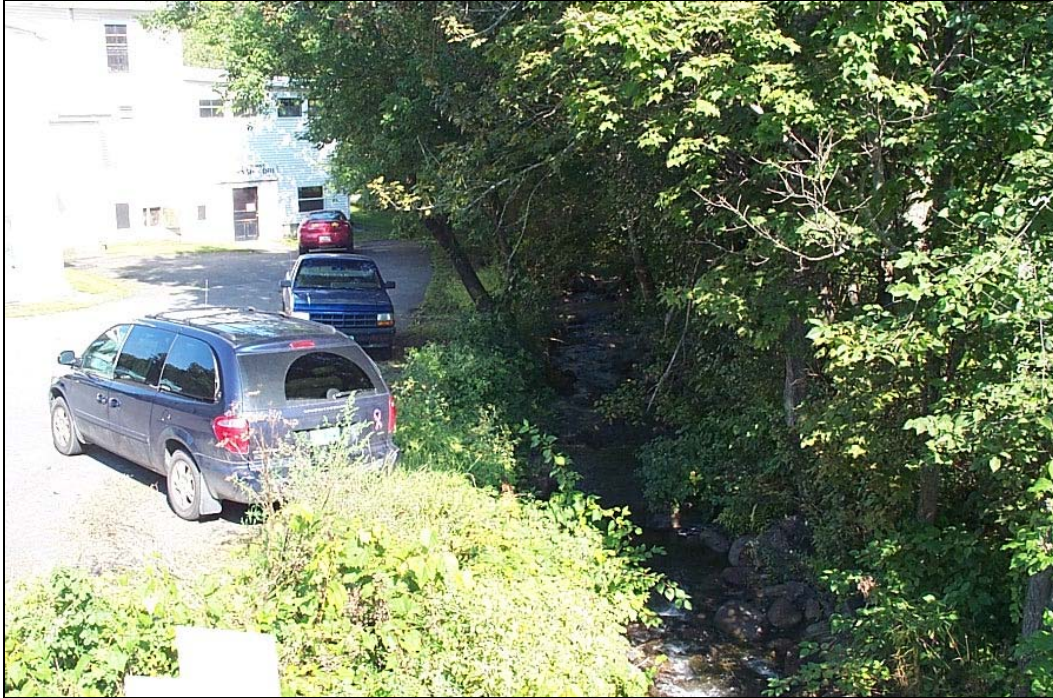
**Figure 25. Segment T2.01-A (Downer Forest Brook) has been extensively straightened and is impacted by land use within the South Strafford Village**

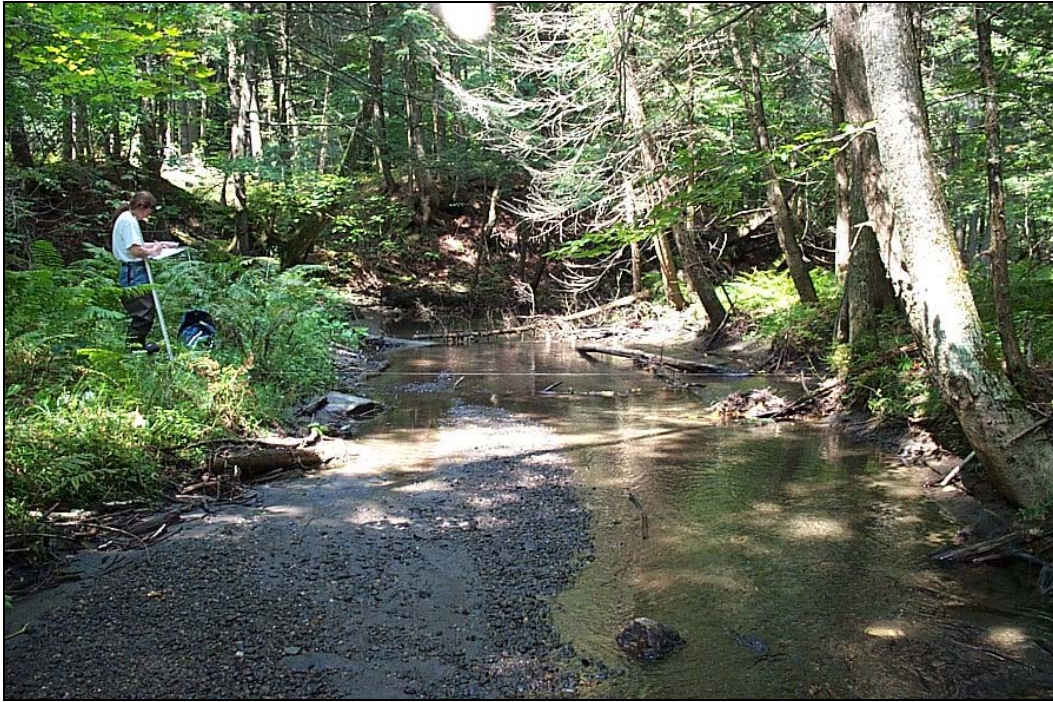
**Figure 26. T2.01-B (Downer Forest Brook) is in fair geomorphic condition due to aggradation of sediment in the stream channel.**

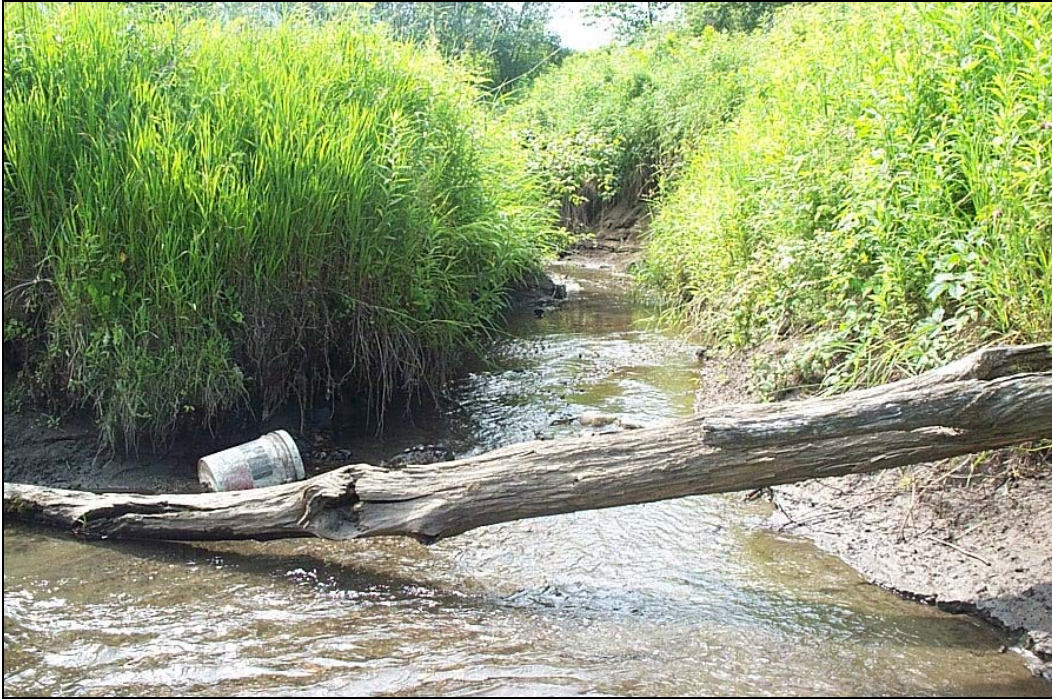
**Figure 27.** At the mouth of T3.01-A (Route 132 Brook), channel incision is still very evident.

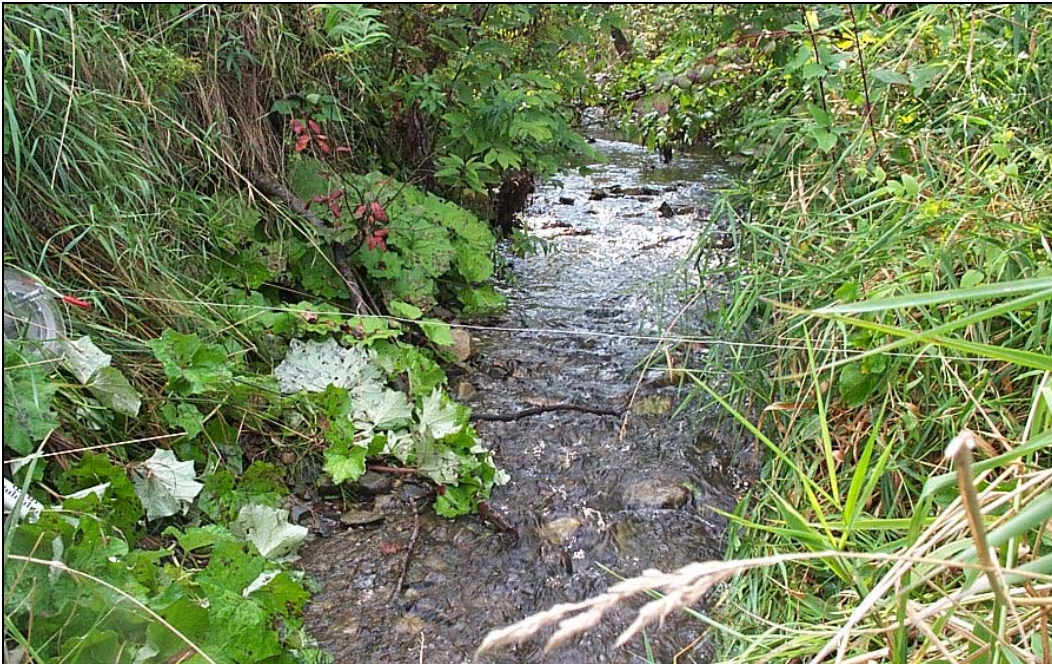
**Figure 28.** T3.01-A (Route 132 Brook) is an E channel with active widening, planform adjustment, and aggradation in response to historic channel degradation.

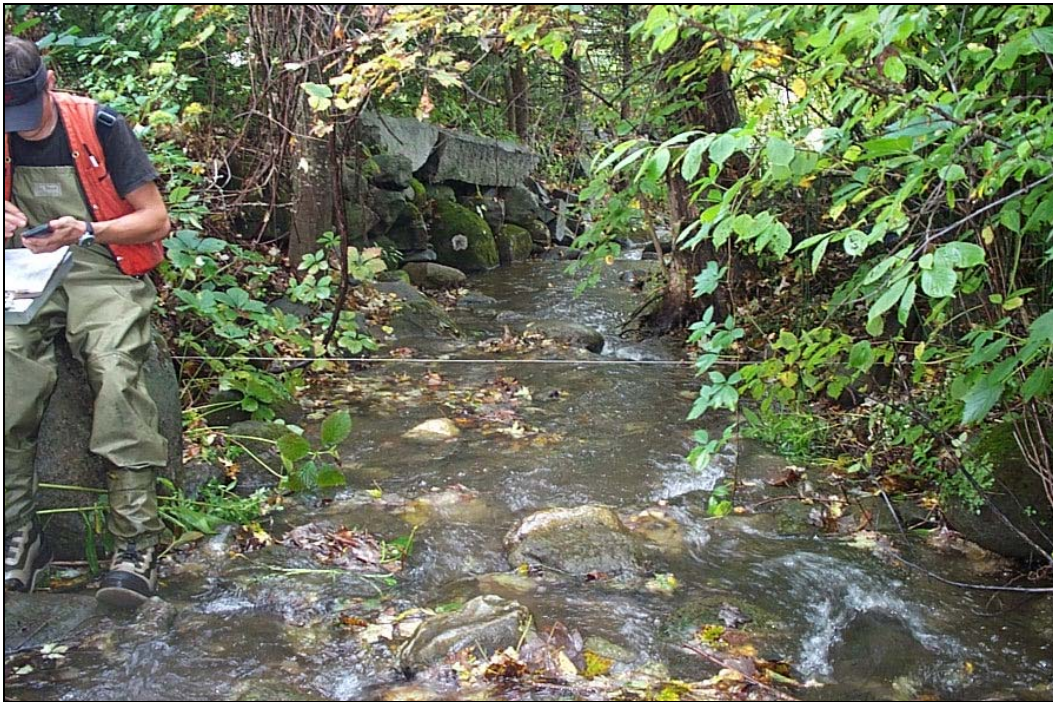
**Figure 29. T3.01-B (Route 132 Brook) is a “G” channel due to historic channelization. The rock wall on the left bank of this photograph is evidence of such activity.**

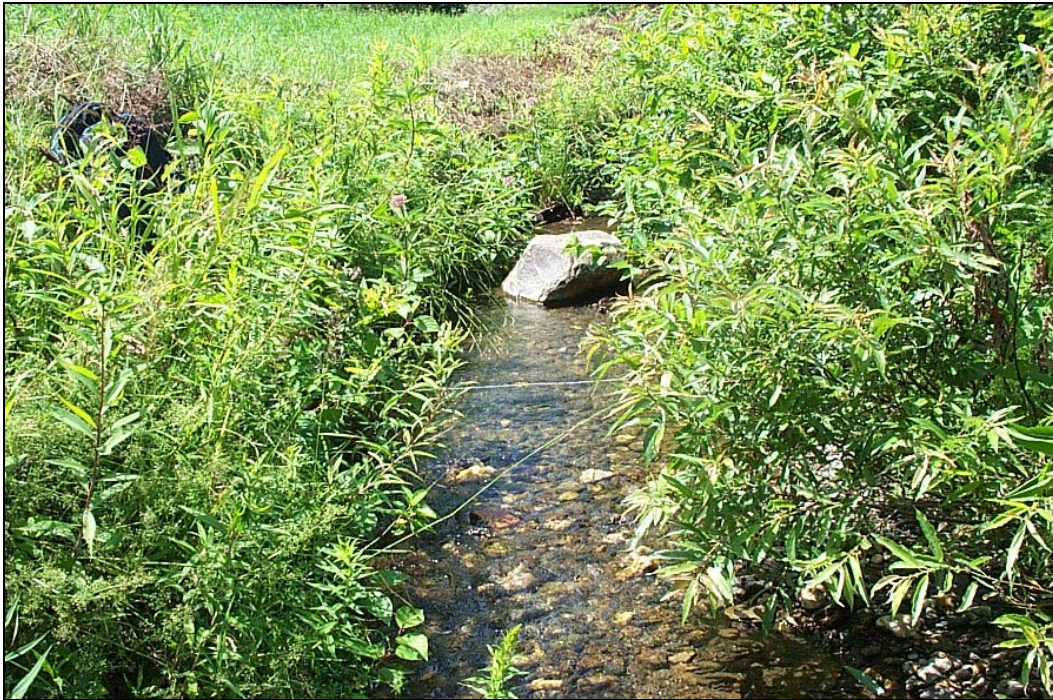
**Figure 30.** T4.01-A (Carpenter Hill Brook) is a “G” channel due to historic channelization and degradation.

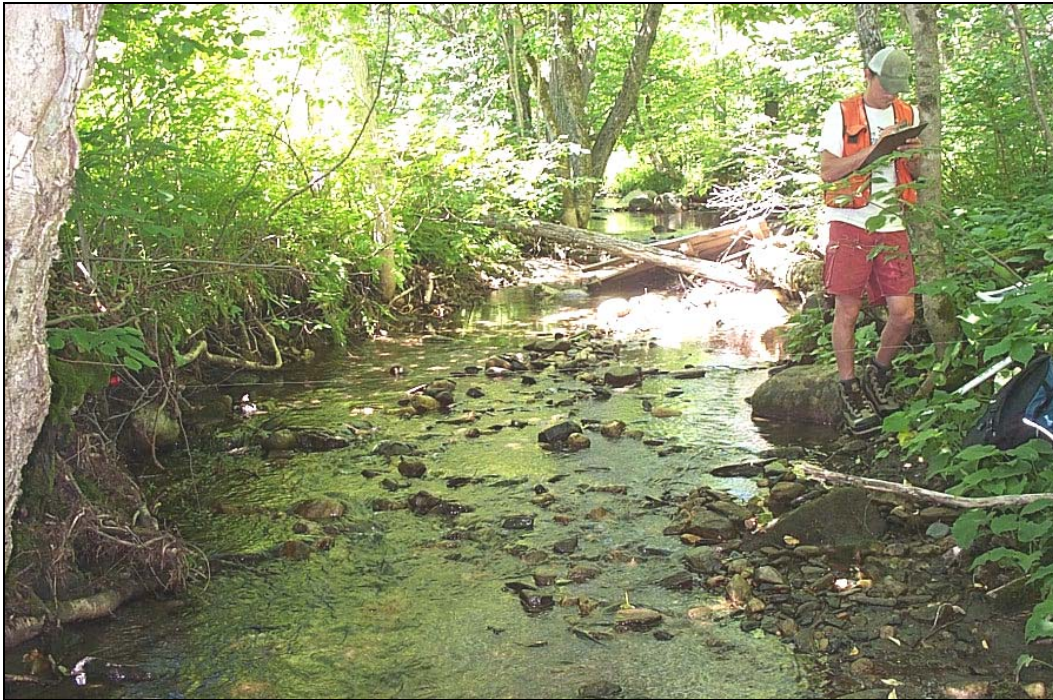
**Figure 31. T4.01-B (Carpenter Hill Brook) is an “E” channel that has retained its riffle-pool bedform.**

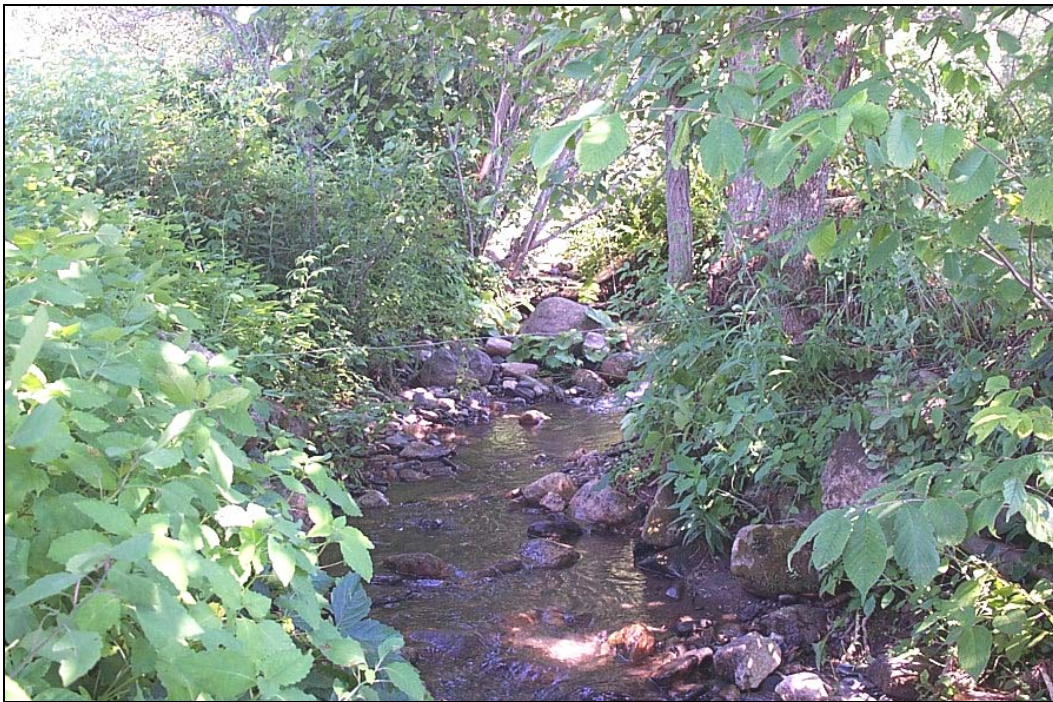
**Figure 32. T5.01, Alger Brook, is an “E” channel that has been straightened.**

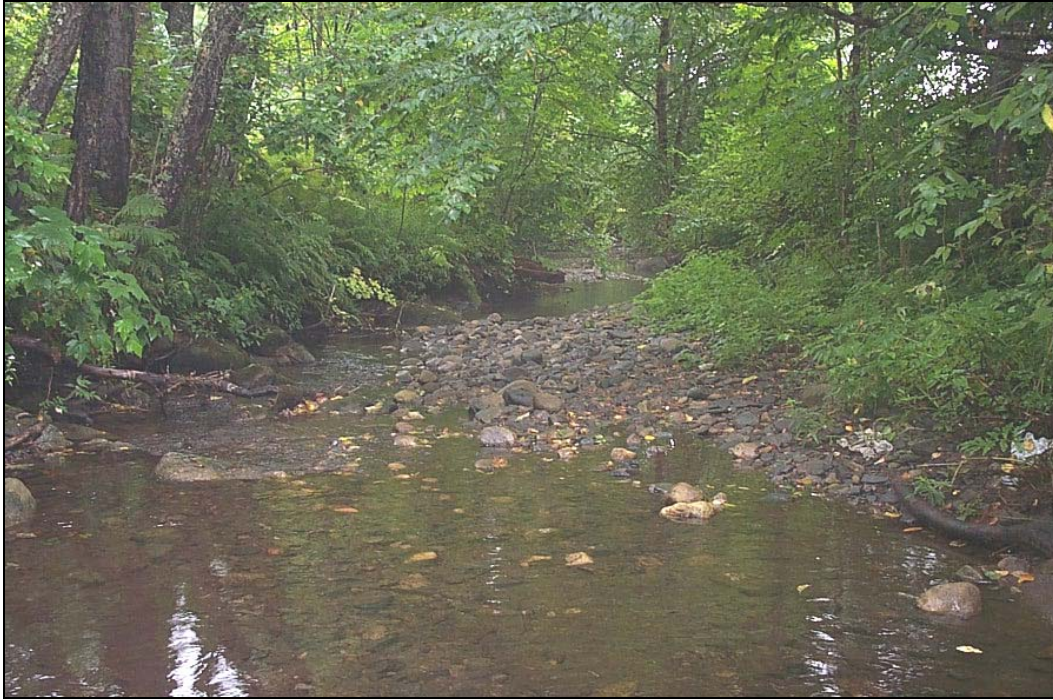
riffles, and multiple point and side bars (Figure 33). The pebble count documented 38% of the substrates to be fine gravels and sands.

**Figure 33. T6.01 (Brook Road Tributary) is a “C” channel that has been rebuilding point bars.**
