### **Phase 2 Stream Geomorphic Assessment West Branch Ompompanoosuc River Watershed Town of Strafford, Vermont**

Final Report  
February 6, 2006

Strafford Conservation Commission

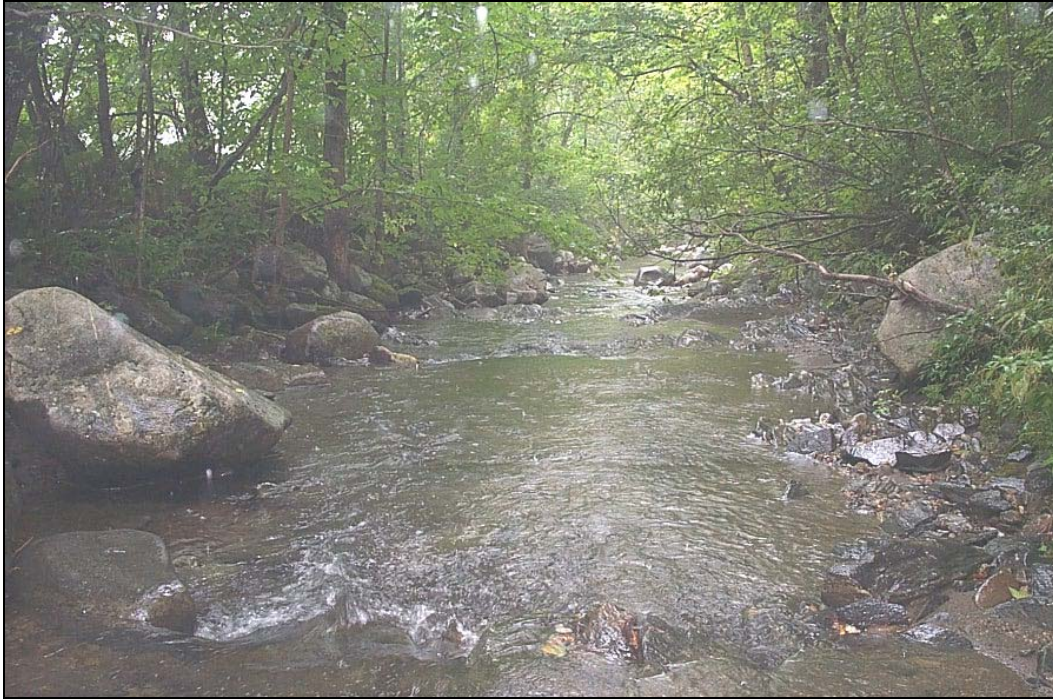
**Figure 34. T7.01, Old City Brook, is a “C” channel with riffle-pool features.**

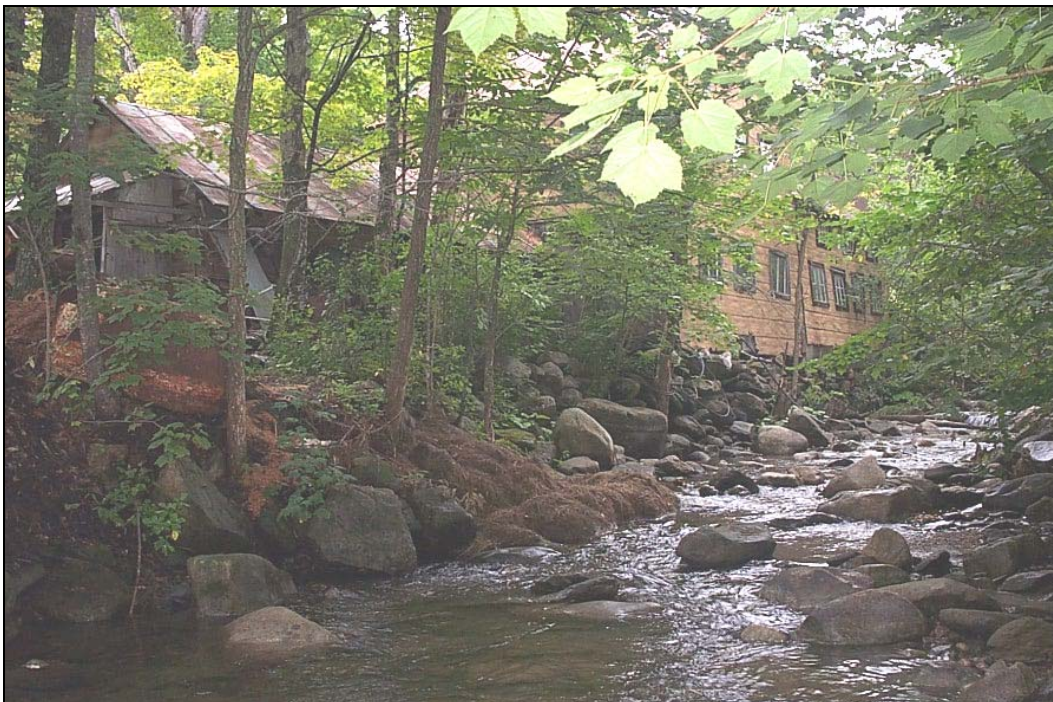
**Figure 35. T7.01, Old City Brook, has several structures located within the stream corridor.**

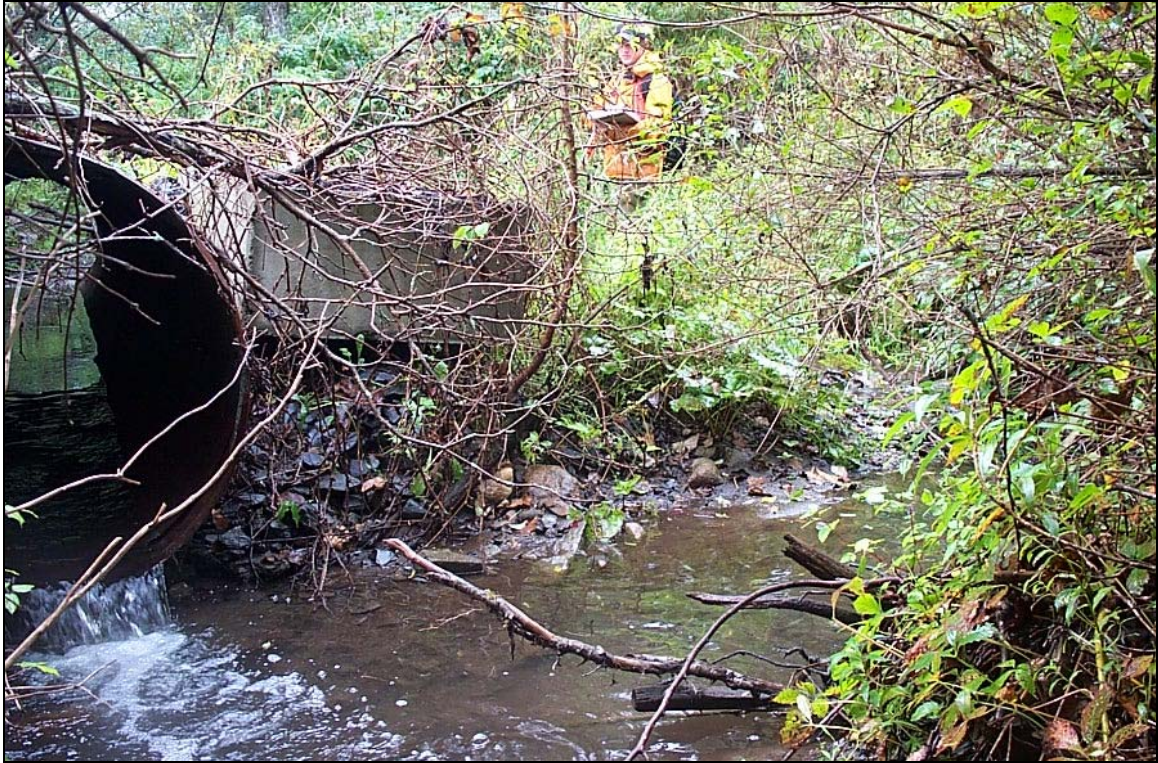
**Figure 36: Undersized culverts disrupt the sediment transport capacity of the stream and may lead to both upstream and downstream destabilization. Improperly sized structures, such as this one on T3.01-A, can become plugged and lead to a channel avulsion.**

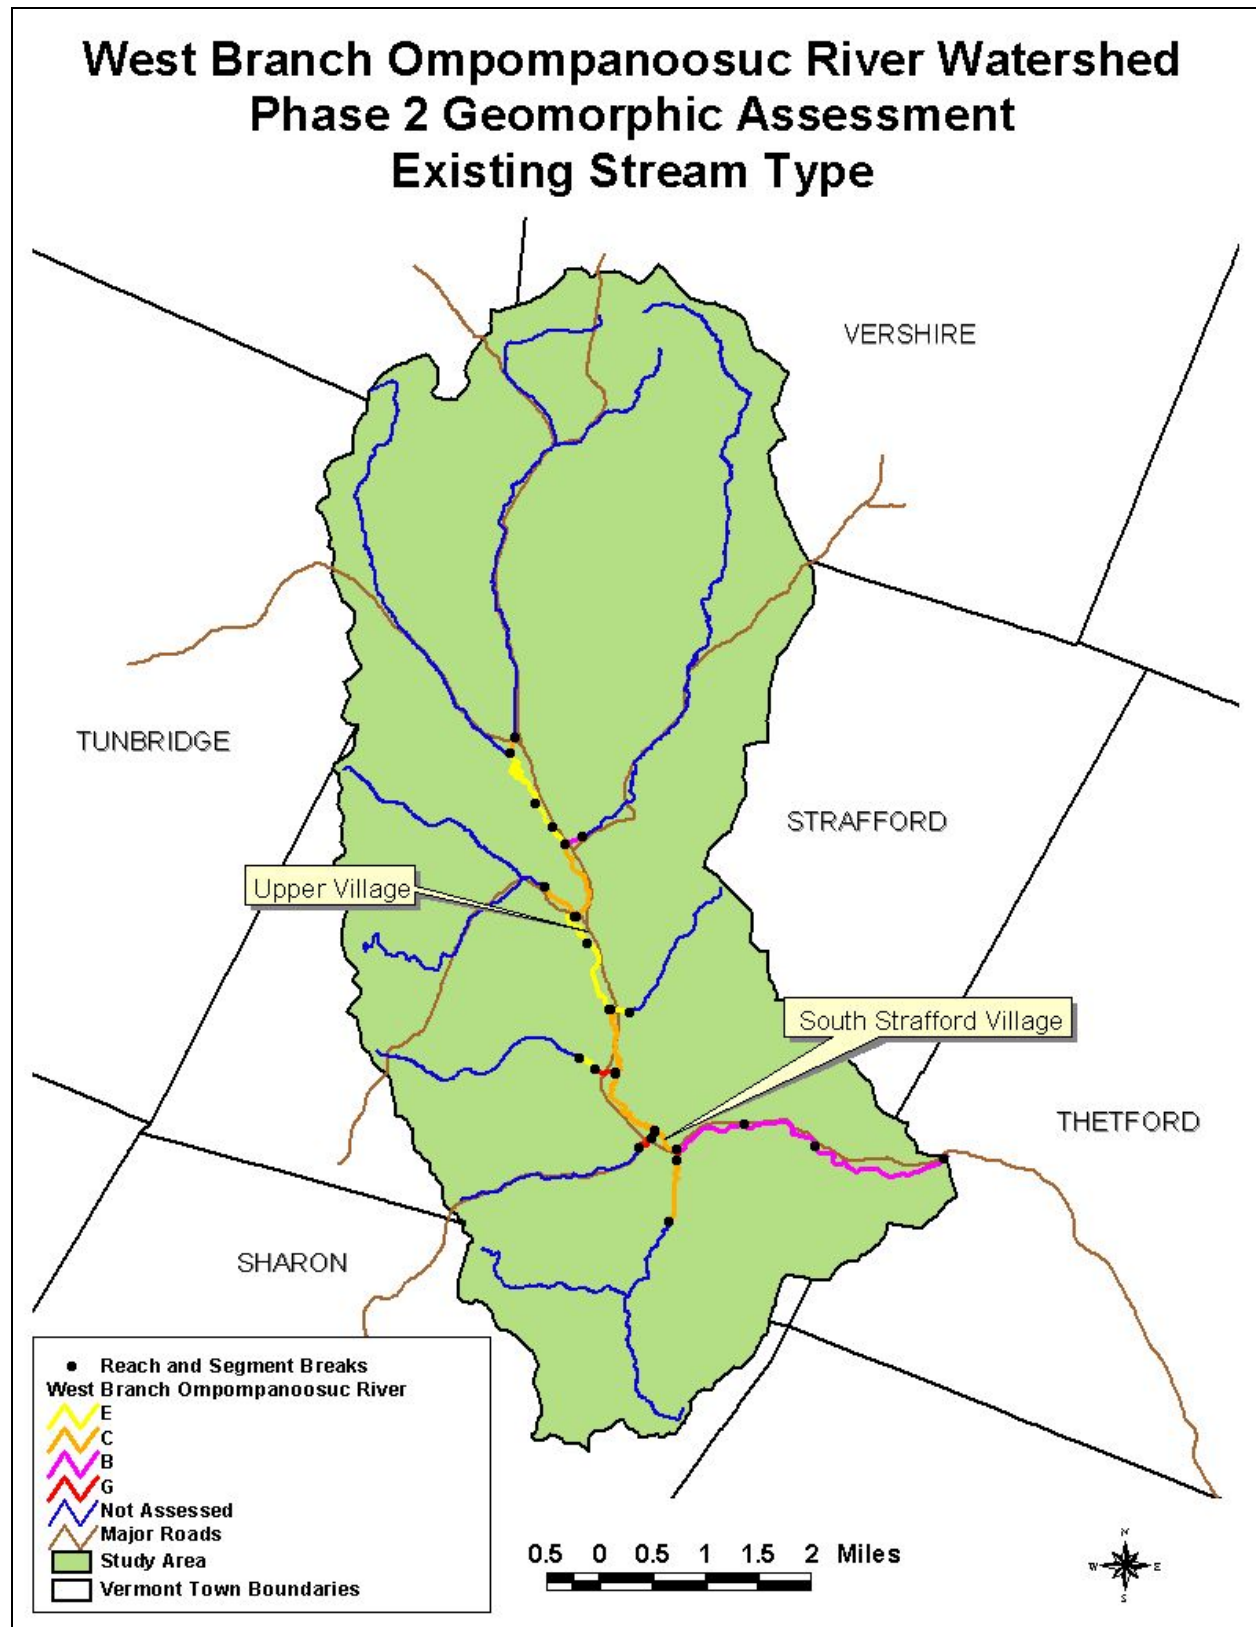
Figure 38 is a map presenting the existing stream types found in the WBOR watershed. The stream sensitivity of these reaches, generalized according to stream type and condition as per the ANR protocol, is depicted in Table 4 and in Figure 39.

Figure 38. Phase 2 Existing Stream Types

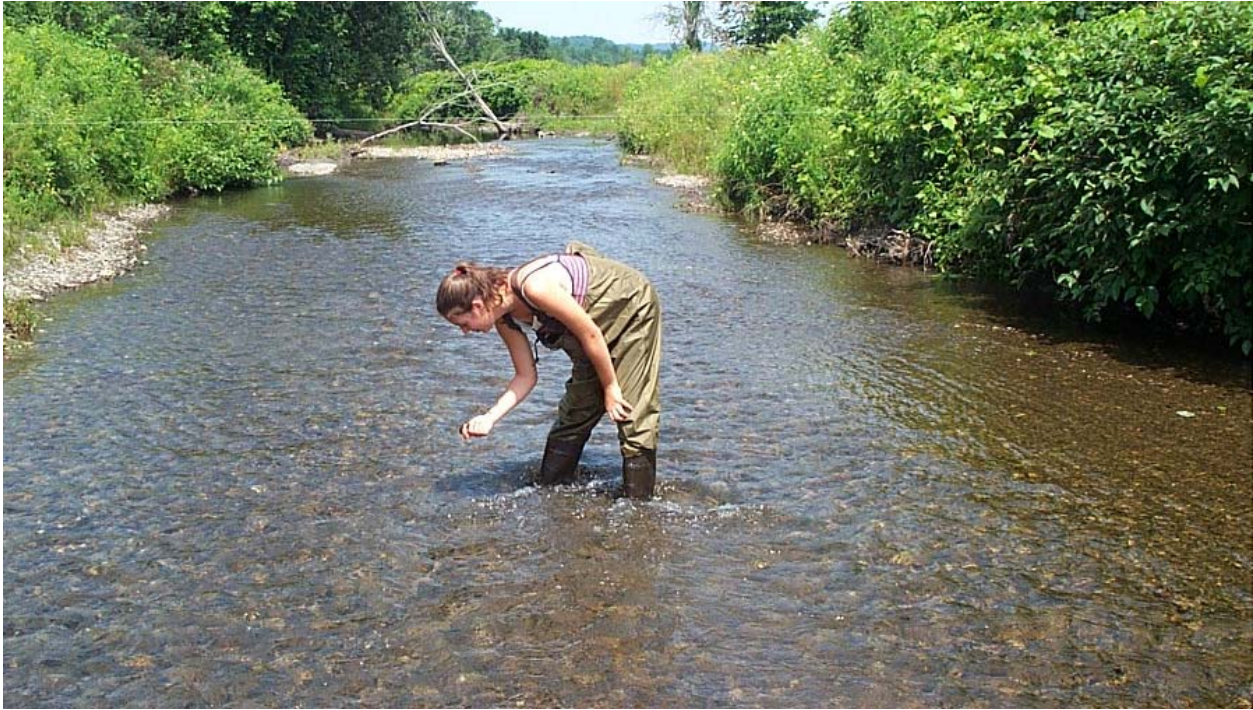
**Figure 40: Reach M08 rated “fair” for habitat. The reach lacked in-stream woody habitat, riparian vegetation, a riffle-pool system due to historic straightening, and was heavily embedded with fine particles of sand, as researched in a pebble count being conducted by BCE scientist Alyssa Borowske.**

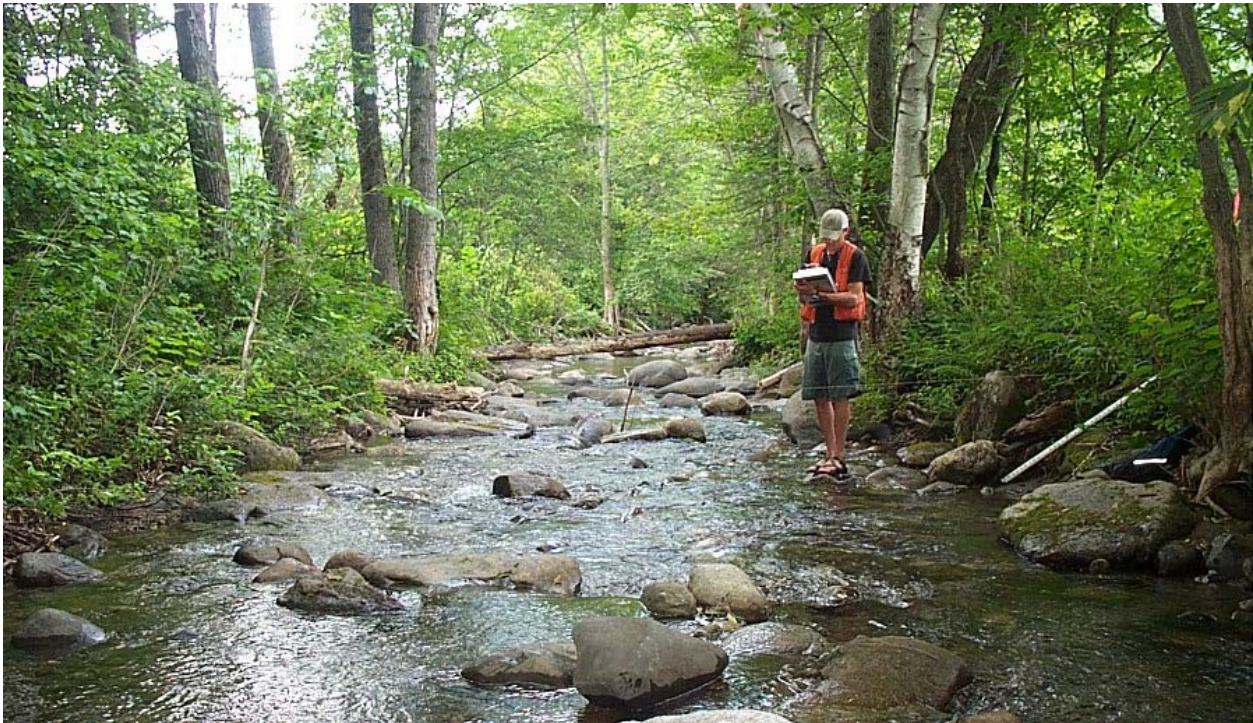
**Figure 41: Reach M12 rated “good” for habitat. The reach had in-stream woody habitat, excellent riparian vegetation and riparian buffer, a diversity of substrates, and a diversity of habitat types including several deep pools.**
