Bear Creek Environmental

Ayers Brook River Corridor Management Plan Brookfield, Braintree, and Randolph, Vermont

June 22, 2007

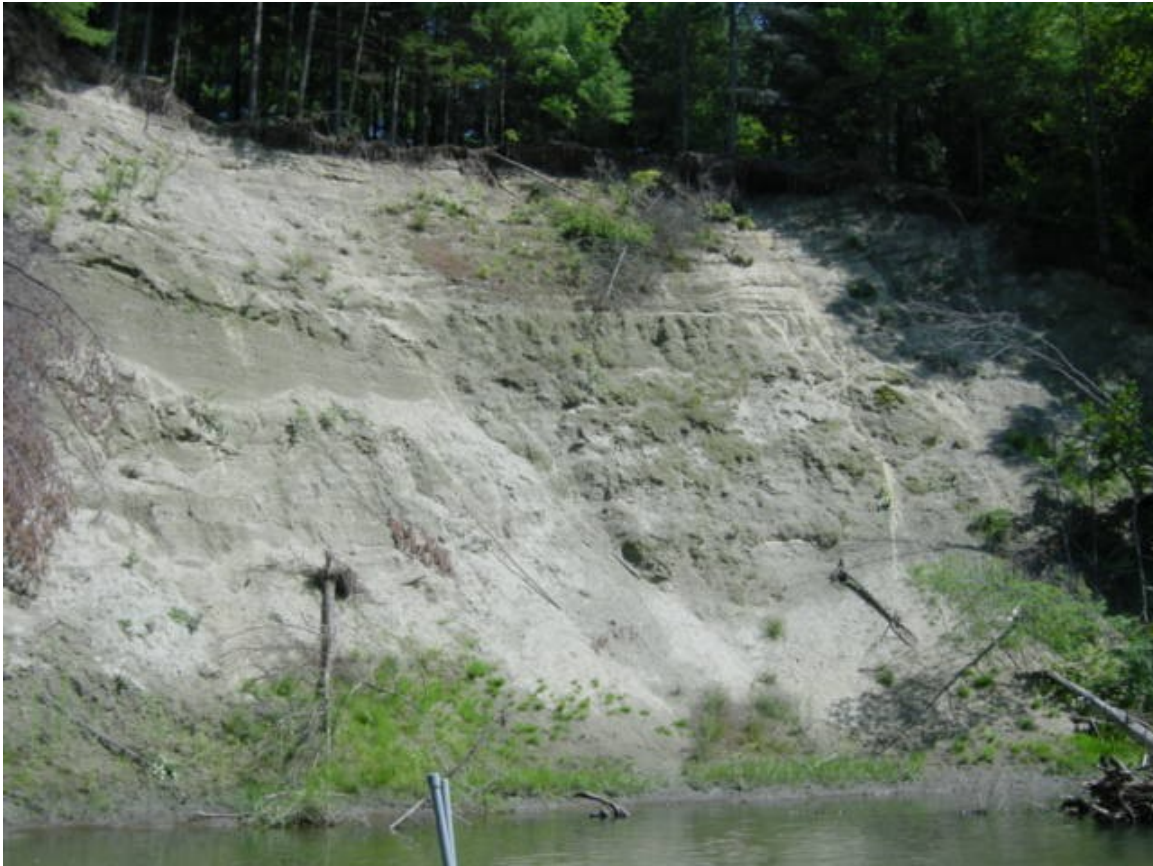
Figure 4: Glacial lake deposits are found in the lower reaches of the study area.

As the glaciers retreated, numerous lakes formed between the ice and the high ground. In the Connecticut River basin the very large glacial Lake Hitchcock was formed; it extended all the way up the Connecticut River Valley with fingers reaching up into the White River Valley. As this glacial lake drained, sandy gravel deposits were left behind in the valley of the Third Branch of the White River. At the confluence of Ayers Brook and the Third Branch, a thick deposit of Lake Hitchcock sands created a large fan deposit (Larsen, et. al., 2004) (see Figure 4). In general, due to the glacial history of the valley, the dominant soil types in the Ayers Brook watershed are glacial lake deposits and till. The upstream reaches of the mainstem, T2.04 and T2.03 had glacial till as a subdominant surficial geology while the lower two mainstem reaches (T2.02 and T2.01) had glacial lake deposits as a subdominant geology.

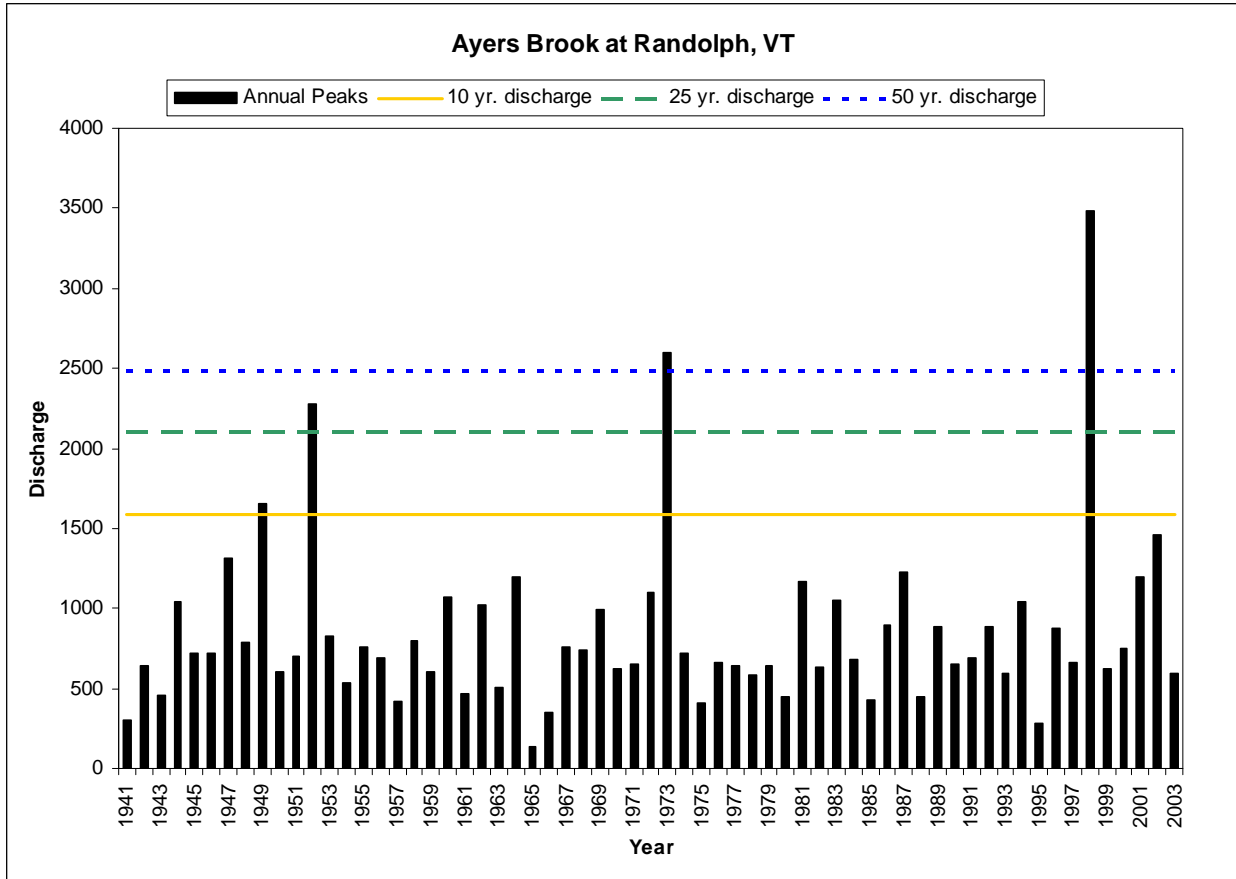
Figure 5: Flood frequency analysis for Ayers Brook.

The long term record for Ayers Brook shows a 10 year discharge occurred in water year¹ 1949 and between a 25 and 50 year discharge occurred in 1952. During water years 1973 and 1998, the peak discharge exceeded the projected 50 year discharge. A graph of the flood frequency analysis is provided in Figure 5 below.

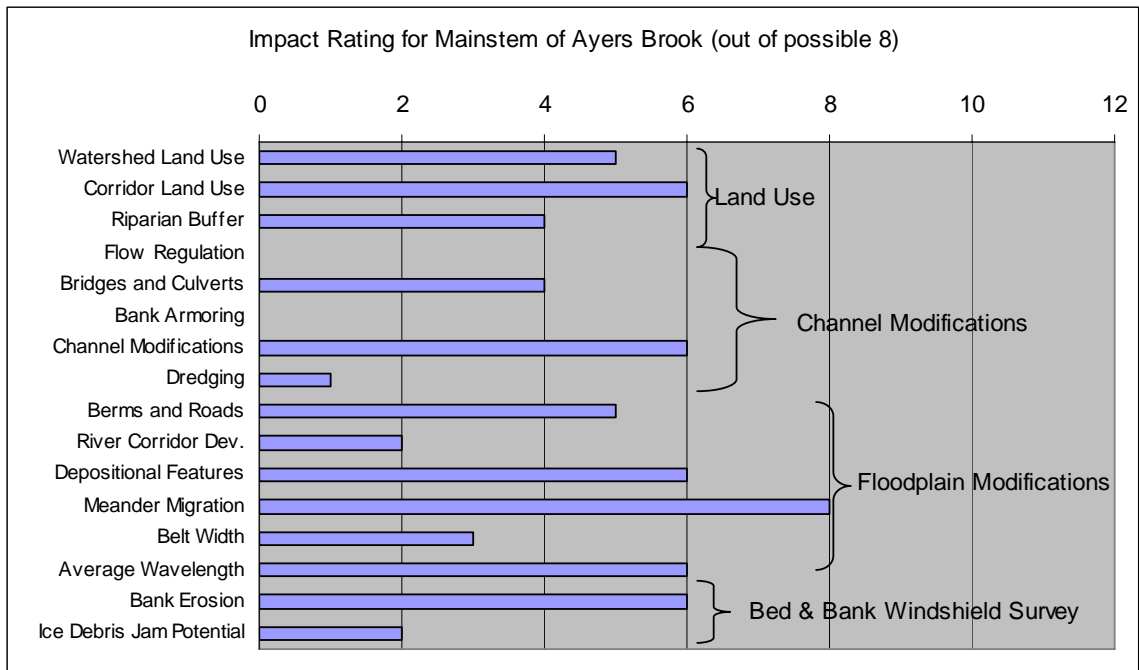
Figure 7. Impact Rating for Ayers Brook Watershed by Parameter and Category

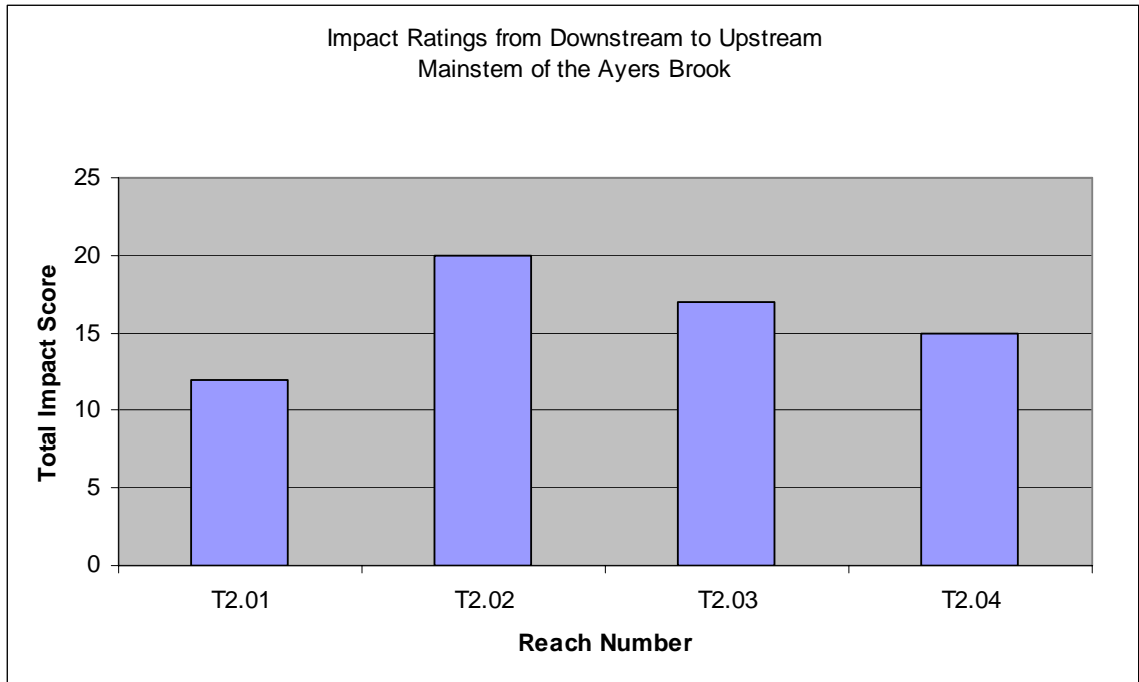
Figure 8. Impact Ratings from downstream to upstream on the main stem of the Ayers Brook.

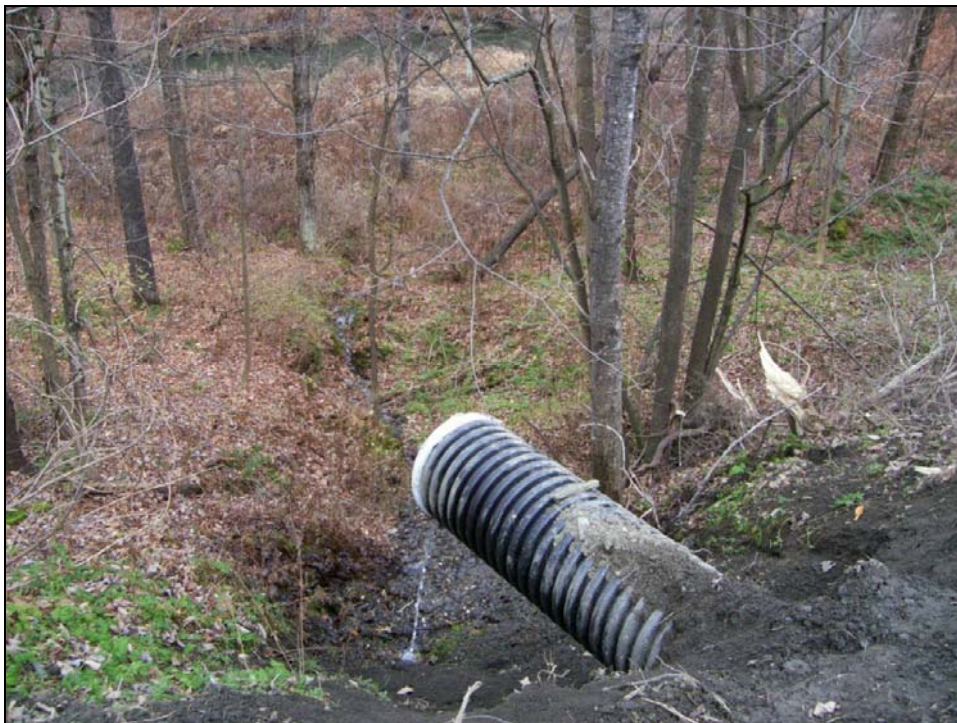
Figure 12: Road drain emptying onto steep erodible soils off of Mason Road, T2.01-C.
