# Miller's Run River Corridor Plan

Lyndon, Wheelock and Sheffield, VT  
October 2009

**Caledonia County Natural Resources Conservation District**

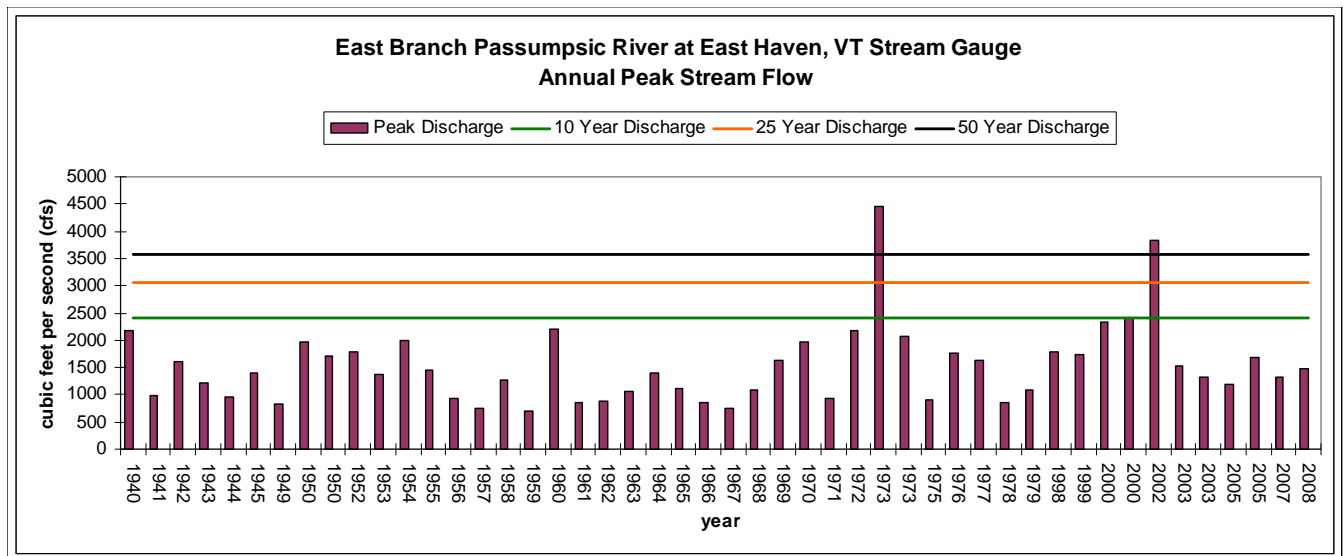
**Figure 3: Annual peak steamflows at the USGS stream gage 01133000**  
 East Branch Passumpsic near East Haven, VT (<http://nwis.waterdata.usgs.gov/nwis/>)

The largest flood measured on record from the East Branch gauging station was in 1973, with the second highest and most recent flood in 2002. According to interviews with Vermont DEC, the 2002 flood caused extensive damage throughout Lyndon and downstream to St. Johnsburry, including property

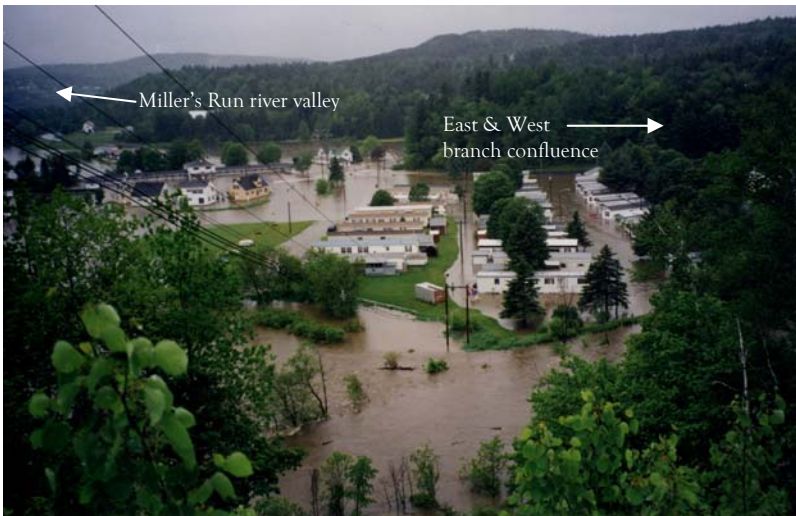
damage, power outages, as well as road and business closures. The photo on the left shows the Passumpsic River main stem near the confluence of the East and West Branches and the Miller's Run River. This is an area of frequent flooding and sediment accumulation, which is additionally challenged by development and transportation routes. As we examine the Upper Passumpsic watershed, it is clear that these three tributaries are critical components in the discussion of flood attenuation in Lyndon.

Figure 4: Photo by Kenneth Mason: 2002 Passumpsic River main stem flooding near junction of Rte 114 and Rte 5 in Lyndon and Miller's Run confluence

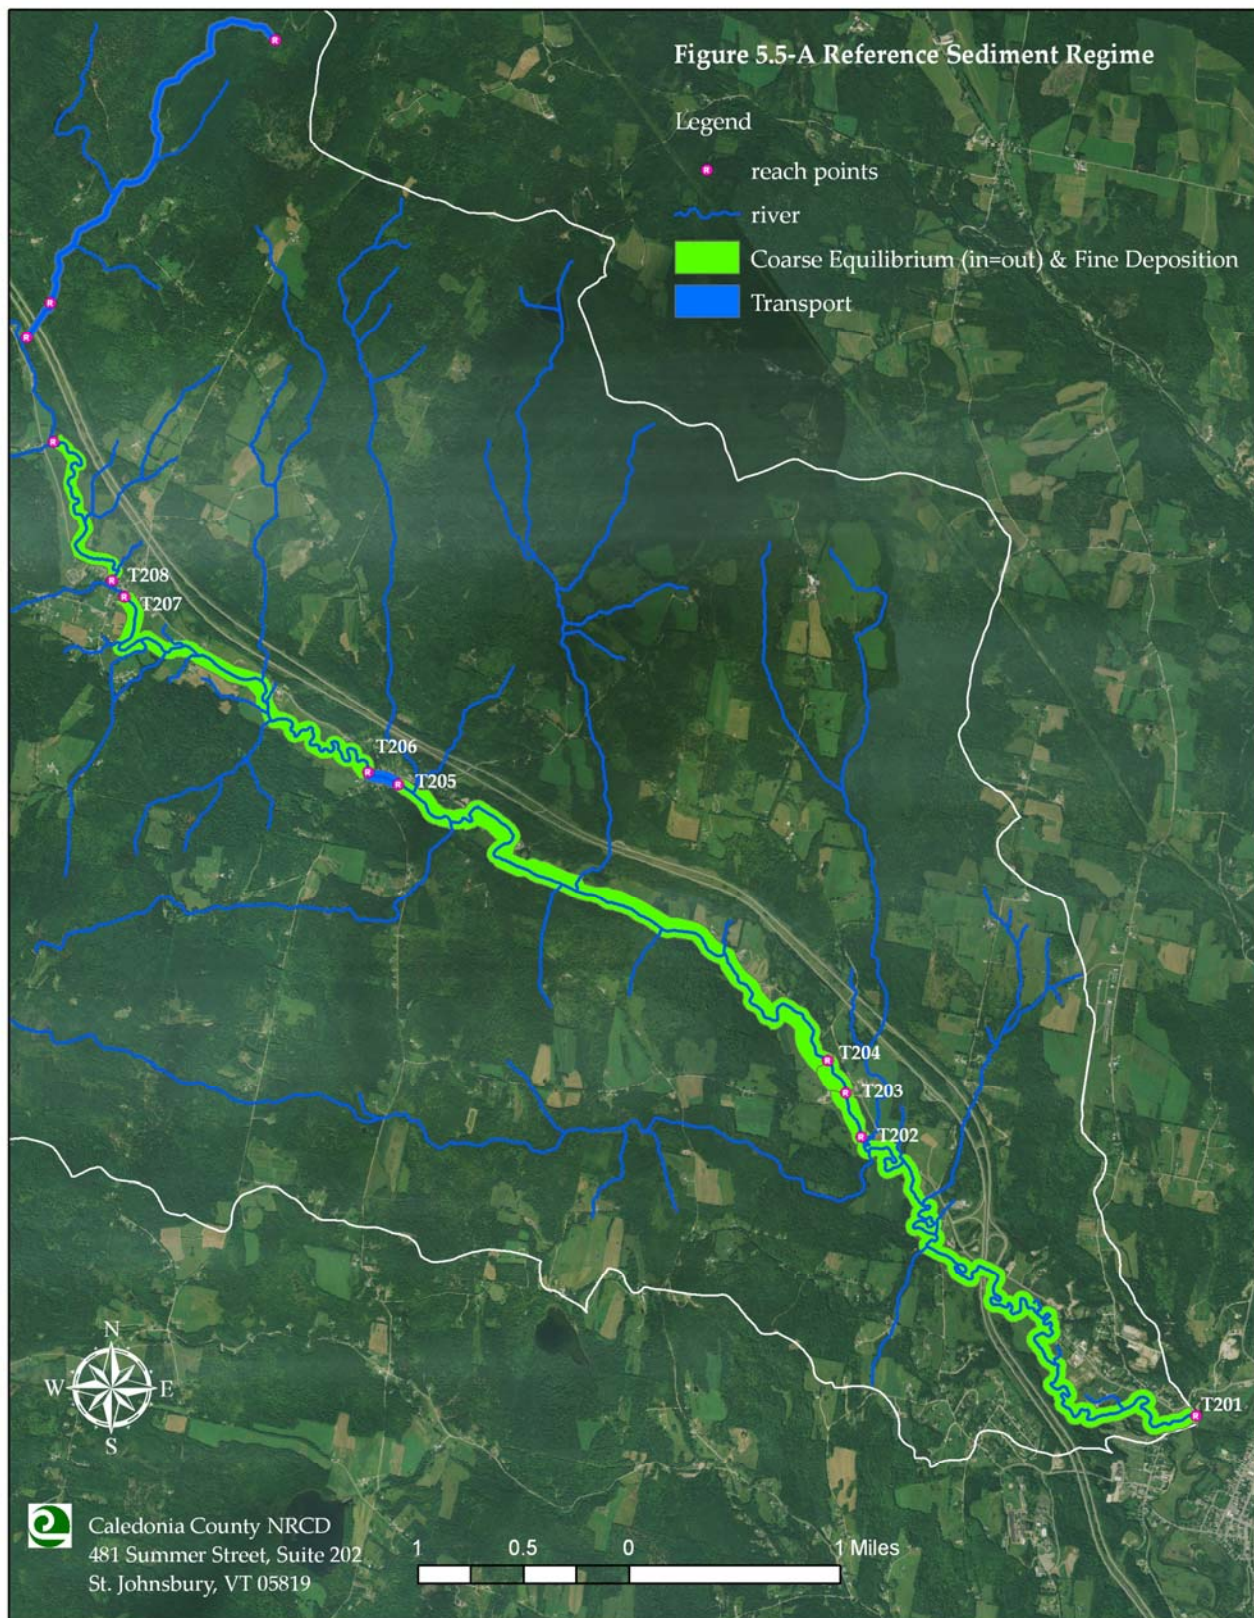
Figure 10: Reference Sediment Regime

Figure 10 displays the reference sediment regime type, which is largely determined by valley confinement and slope. Most reaches on the Miller’s Run, except for T201 which is an e-type stream and the excluded cascade falls in the villages, were determined to be C-type streams in Phase 1. C-type streams are generally in a broader valley with adequate access to their floodplains. Figure 11 shows the existing sediment regime type, and the clearest departure is from a Coarse Equilibrium & Fine Deposition (CEFD) regime to a Fine Source and Transport and Coarse Deposition (FST&CD) condition. The reference CEFD regime generally means that the stream is depositing and transporting sediment in equilibrium. A departure from this regime to the FST& CD regime is largely the result of historic incision, low channel boundary resistance and loss of access to the floodplain. Because of these conditions, the stream is no longer able to store fine sediments on the floodplain, and thereby transports an excess of fine and coarse sediments to downstream reaches, resulting in large sandy bars. Reach T201 is a clear example of this departure.

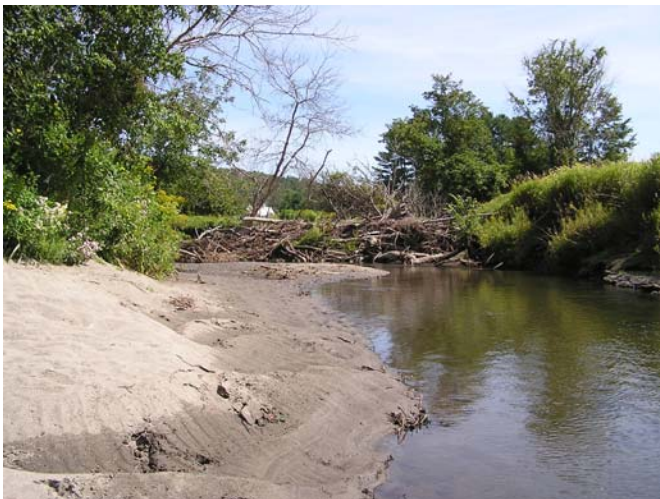
Figure 13: Reach T201 showing fine sediment accumulation, low gradient and debris jam

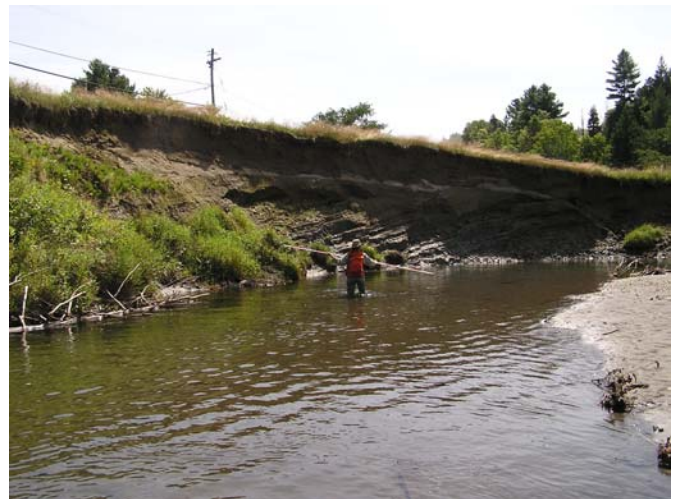
Figure 14: Reach T201 showing mass failure and lateral migration

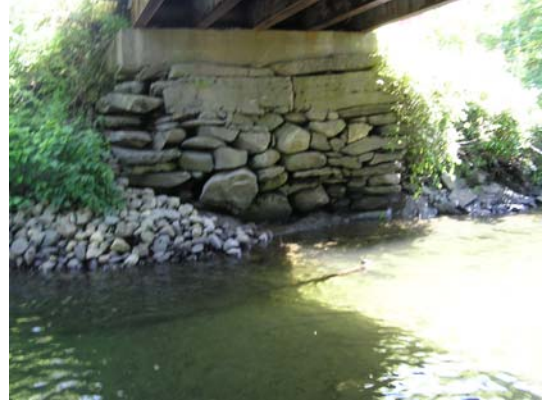
- The two upstream bridge crossings are both channel constrictions and areas of conflict with the potential for debris jam. The bridge pictured on the right shows potential for erosion hazards and structural failure with the footing.

Figure 16: Farm bridge on Miller's Run Reach T201 showing potential for bridge footing failure

T201	Replace existing bridge structures	Moderate	Low	Yes	Two upstream bridges may require attention due to undersized structures. Interstate bridges fine. Covered bridge is historic and often inundated with floodwater. Potential for financial assistance for covered bridge from state programs.
T201	Expand floodplain access	Moderate	Moderate	Yes	Due to elevated incision ratios, and the necessity of increasing floodwater storage capacity, a consideration of floodplain excavation to increase access is recommended. Would require further study.

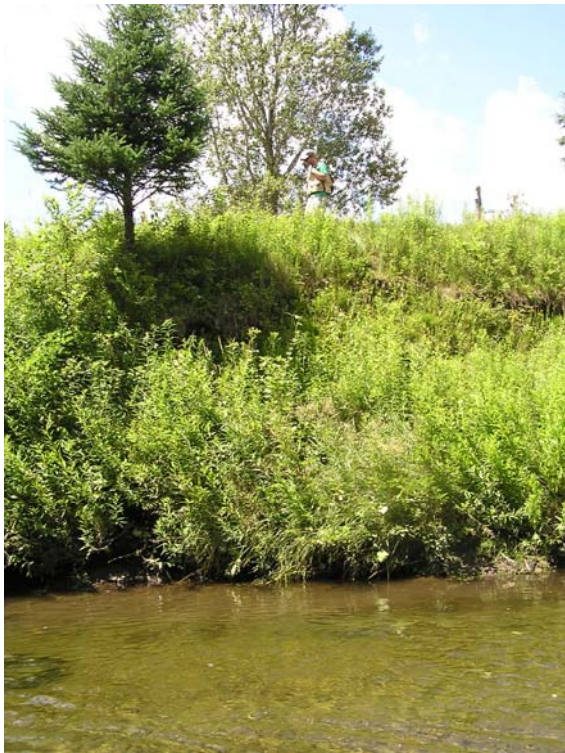
Figure 18: Photo showing right bank of Miller's Run Reach T202 with slumping banks. The gravel operation is along the corridor on this side of the river

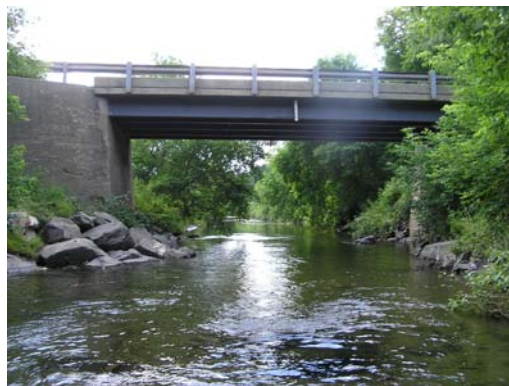
- Hubbard Hill bridge undersized with associated stream bed scour downstream
- Stream sensitivity very high
- Habitat condition of fair
- Bed form is plane bed, with some pools and woody debris in pools
- Dominant buffer width 0-25' on both sides

Figure 19: Hubbard Hill Bridge on Reach T202, channel constriction and associated scour

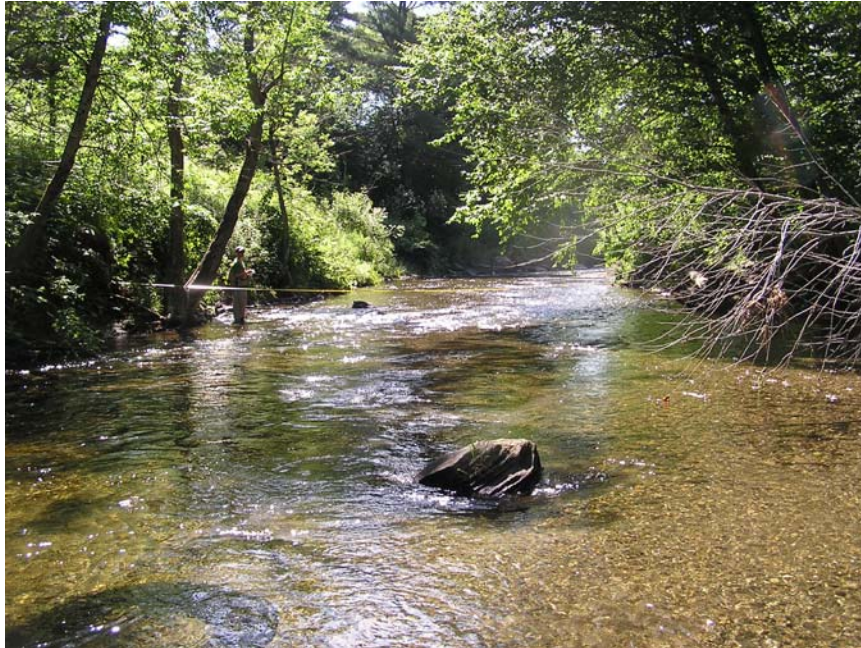
Figure 21: Miller's Run Reach T203 cross section. Photo showing aggrading gravel-dominant plane bed stream, in a semi-confined valley

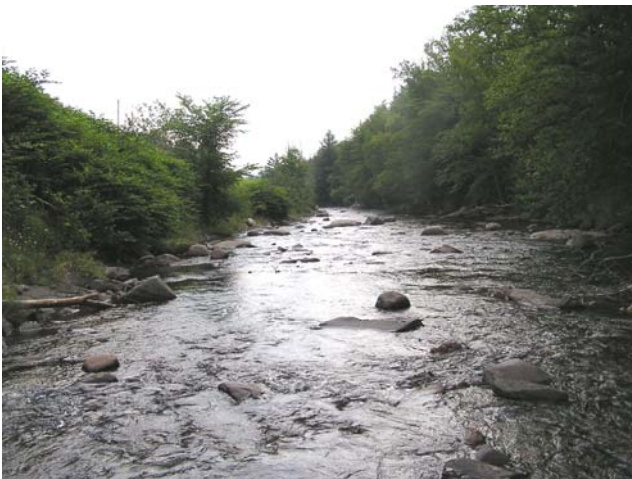
Figure 23: Photo showing reach T204-A with valley wall on right and Rte 122 on left. Lateral movement is minimal.

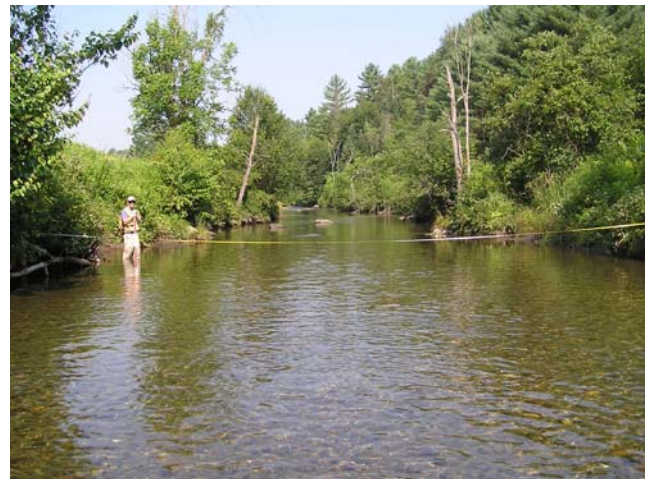
Figure 24: Photo showing cross section of Reach T204-A farther downstream. Increased lateral movement and gravel substrate, but still relatively entrenched

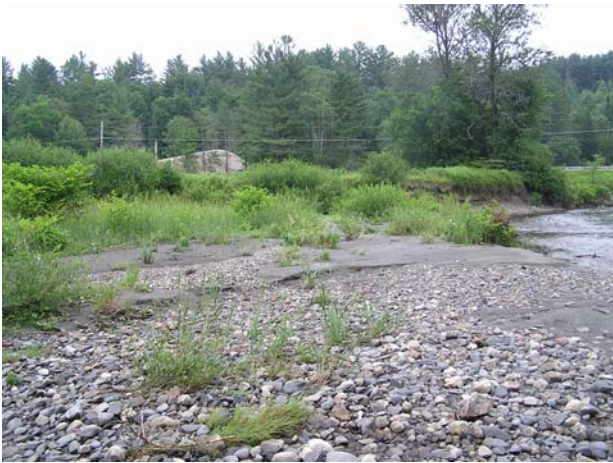
Figure 26: Photo showing Reach T204C upstream of bridge on Rte 122 and its new and old floodplains.

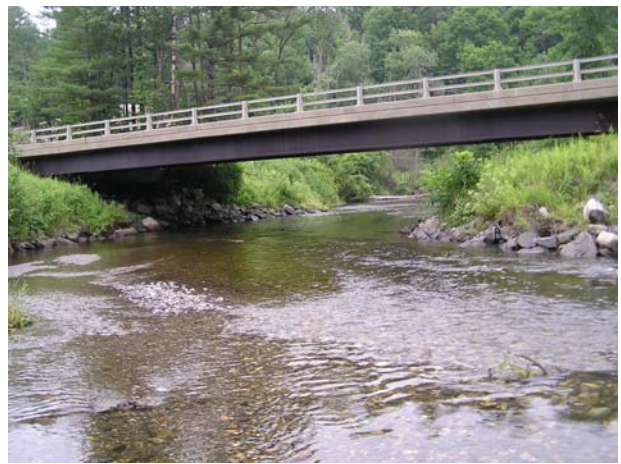
Figure 27: Photo showing Reach T204C and the upstream Bridge on Rte 122. Sediment accumulation upstream of the bridge is visible here, as well as the alignment issues of the bridge itself. While the bridge is 90' wide, riprap constricts the channel width.

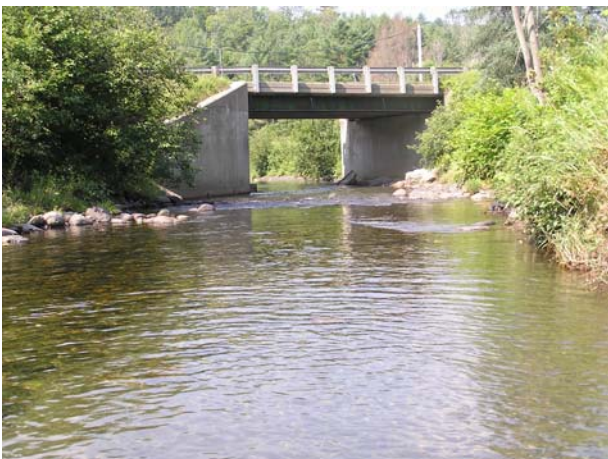
Figure 28: Photo showing the lower Rte 122 Bridge on Reach T204B. Channel upstream of the bridge is straightened the bridge is a channel constriction and long term area of conflict.

Reach T204-B extends for 3100' and encompasses the stream surrounding the lower Rte 122 Bridge. Upstream of the bridge, the segment is extensively straightened and held against the valley wall on its left bank before it makes a sharp turn across the river valley to cross under the bridge. The stream was classified as a C-type stream with gravel substrate and is noted as having historic incision and a current incision ratio of 1.6. The stream bed appears to be aggrading though it was determined the segment was still in stage II channel evolution. There is deposition upstream of the bridge, and scour below the bridge, indicating that the bridge is acting as a channel constriction and is undersized. The width of this bridge is recorded as 33', which is smaller than the segment's bankfull width of 44'.

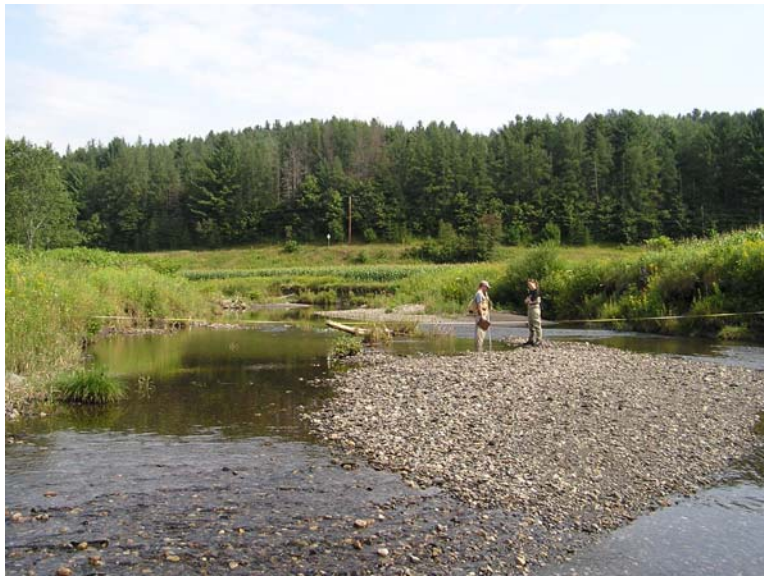
Figure 32: Reach T206-A showing aggradation, mid channel bars and significant lateral migration across the valley

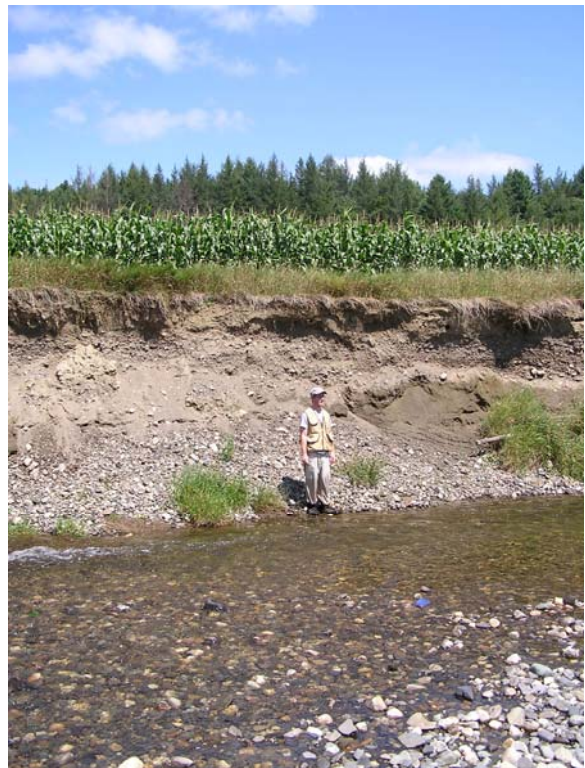
Figure 33: Photo showing Reach T206-A, erosion and high banks with little resistance. Dominant land use is agriculture.

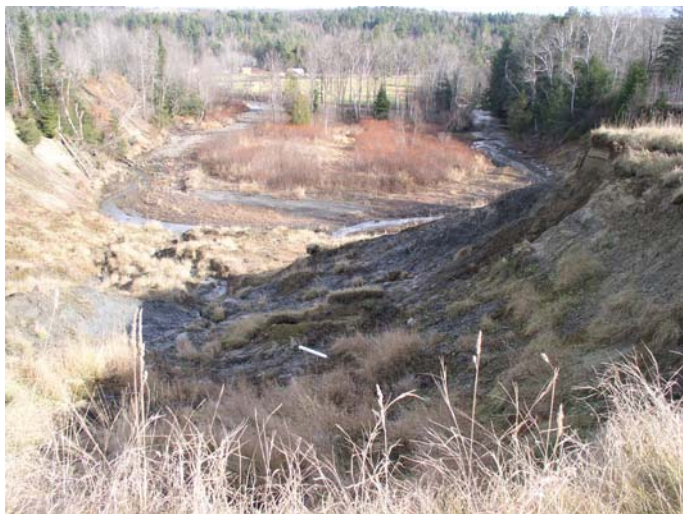
Figure 35: Photo taken in 2003 showing former channel on Reach T206-C. An avulsion occurred sometime before this photo was taken and a small amount of water is still accessing the old channel.

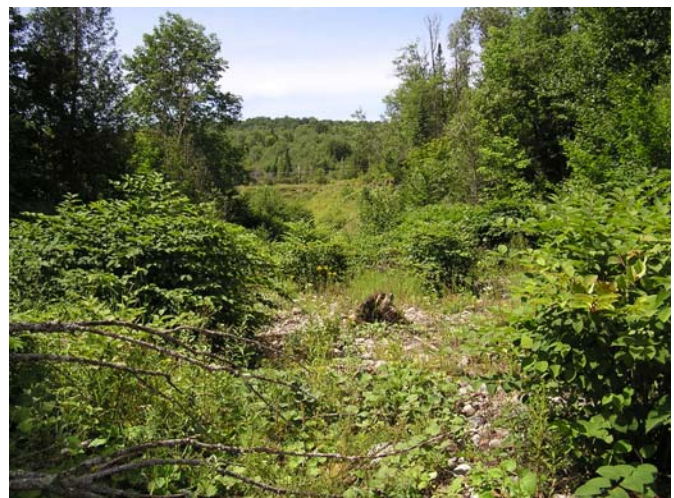
Figure 36: Photo taken in 2007 looking up into former inlet to the clay bank area that is no longer accessed by the river. Area has re-vegetated and fine sediments are transporting.

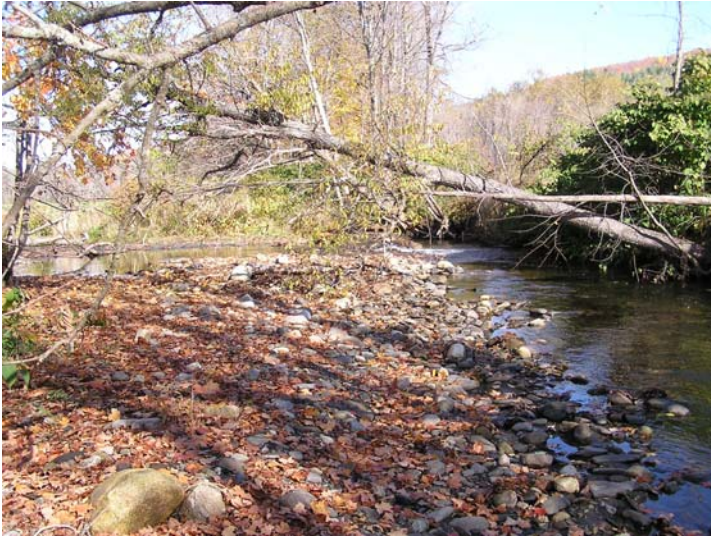
Reach T208 is upstream of Sheffield village, and its bedrock falls which was not assessed (Reach T206). This reach was not segmented though incision ratios increase at the downstream end as it nears the village. The majority of this reach is situated on a wide flat valley with agricultural use on both sides of the river. The downstream end nears Route 122 and encounters development and ledge as it flows into Sheffield village. The reach is a C-type stream with gravel dominated substrate. Aggradation is the current and dominant adjustment pattern with 10 point bars and 8 diagonal bars recorded, and channel

Figure 38: Miller's Run Reach T208 showing aggradation
