**Corridor Planning Project and  
Phase 2 Stream Geomorphic Assessment  
Wanzer Brook Watershed  
Fairfield, Franklin County, Vermont  
December 2005**

Town of Fairfield  
Fairfield, VT

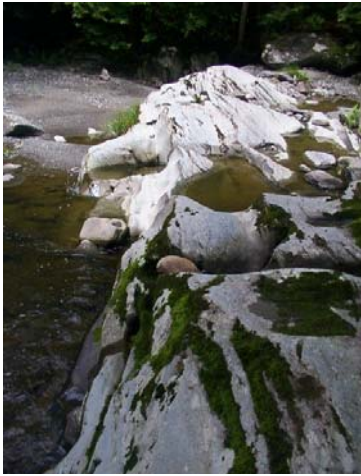
Figure 2. (T3.02) Channel-spanning bedrock downstream of the Wanzer Road crossing of Wanzer Brook main stem.

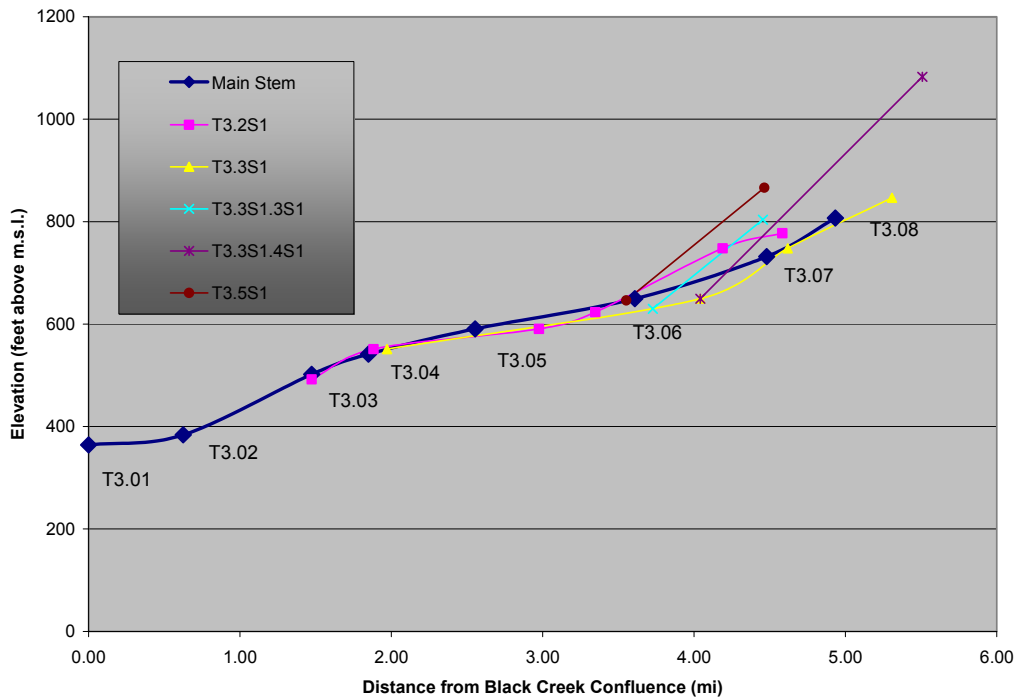
**Longitudinal Profile of Wanzer Brook**

*Figure 3. Longitudinal profile of Wanzer Brook main stem (Black Creek) and Principal Tributaries.*

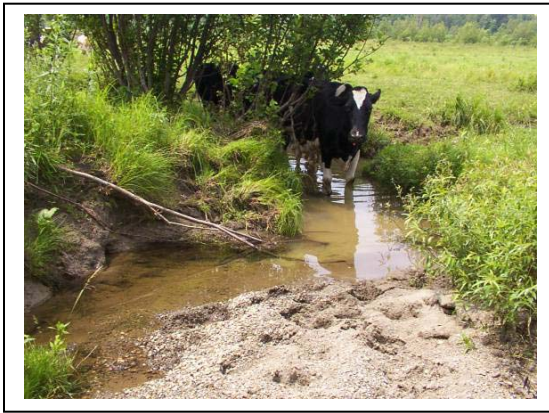
*Figure 5. T3.05-B. Cows are afforded direct access to the Wanzer Brook in pasture areas downstream of the Pumpkin Village Road crossing.*

Phase 2 assessments in T3.05-B indicate active aggradation, widening and planform adjustments (meander extension) in response to past straightening, direct pasturing, and lack of woody riparian buffers. Incision appears minor in degree ( $IR < 1.2$ ) despite past channelization. Cohesive soils may be offering erosion resistance, moderating the degree of incision. No channel-spanning bedrock was observed in the segment. Culvert crossings may offer local grade control in annual to low-magnitude flood events.

Habitat conditions are compromised by the lack of woody riparian buffers which, if present, would offer shading to the channel, as well as recruitment of large woody debris (LWD), detritus and organic material. Streambank erosion is prevalent along both banks, and vegetative cover has been reduced by grazing and hoof damage. Pools are filling with sediments derived from streambank erosion. Direct pasturing and close encroachment by croplands are likely contributing nutrients and sediments to the Wanzer Brook.

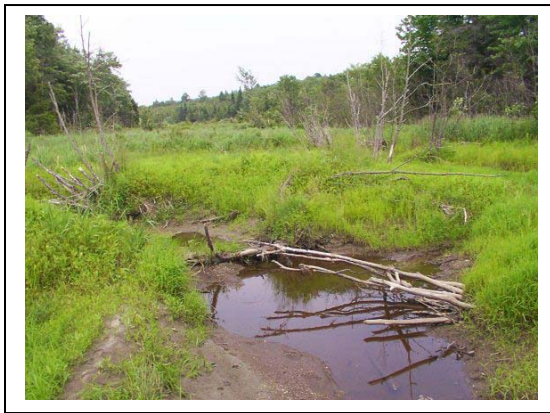
Wetlands (NWI) are mapped within the segment (see Figure 6). Sediment accumulation and LWD recruitment were noted associated with the wetland areas, suggesting that these could serve an important sediment attenuation role in the watershed, isolating downstream reaches from the sediment and nutrient impacts of streambank erosion and pasturing within upstream Segment B.

*Figure 6. T3.05-A. Wetland areas contiguous to the channel in this segment may offer important sediment and nutrient attenuation functions.*

Beaver activity is associated with the wetland areas. A recent breaching of a beaver dam appears to have resulted in a drop in local base levels of 2 to 3 feet. Recently eroded streambanks were noted associated with the breached beaver dam.

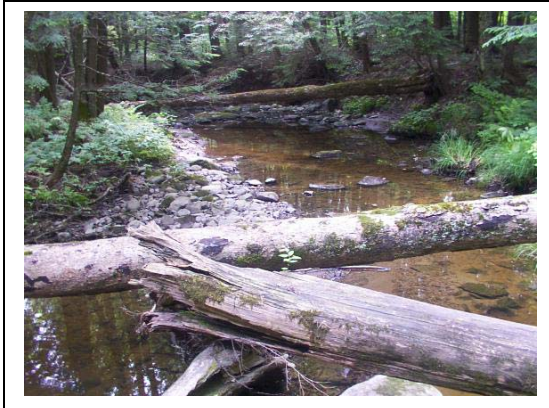
*Figure 7. T3.04. Forested riparian buffers and corridors within the reach provide for recruitment of Large Woody Debris, detritus and organic matter important to aquatic habitats.*

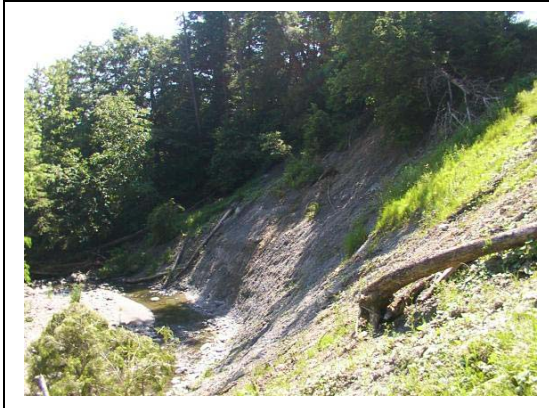
Figure 8. T3.03-B. Mass failure along right bank, mid-reach - approximately 60 feet high and 200 feet long – exposing glacial tills overlain by sandy soils.

Aggradation and lateral adjustments within T3.03-B appear to be driven by both in-reach streambank erosion and mass wasting as well as by water and sediment loading from tributary reach T3.3S1.01. Evidence for the latter includes the geomorphic and adjustment conditions noted during Phase 2 assessments on this tributary (see Section 4.2) and a sizeable “delta” deposit of sediments and LWD of apparent episodic (flood-related) origin at the confluence of T3.3S1.01 with Wanzer Brook.

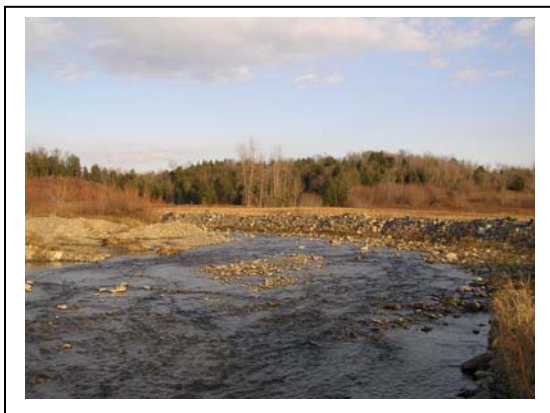
Figure 10. T3.01. View upstream. Boulders / cobbles removed from newly-cleared fields have been used to armor the streambanks (picture right is left bank). Active gravel extraction from enlarged point bars (picture left). Overwidened stream channel at equipment ford sites (picture center).

Habitat conditions within T3.01 are impaired due to the lack of buffers, overwidened channel dimensions and lack of pool/riffle diversity associated with the plane bed morphology, and the degree of streambank erosion and sedimentation.

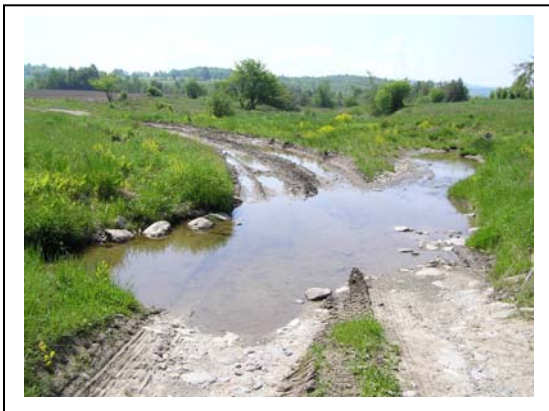
Floodplain encroachments within the reach are fairly limited to an equipment ford and farm road crossing at the upstream extent (see Figure 11) and low-frequency (late-season), low-density direct pasturing by cows. Croplands extend close to the corridor along the top of the valley walls. Tile drains were observed elevated above the channel mid-way up the right valley wall in upstream Segment C. Within the Segment B Subreach, the channel often meets the valley wall and mass wasting is active. Sediments derived from these mass failures have created localized aggradation and planform adjustments. Several steep aggradational riffles were evident. One brief section of channel-spanning bedrock is present mid-segment.

*Figure 11. T3.2S1.01. View to the southeast. Active equipment ford at upstream extent of reach. Farm road providing access to this crossing also conveys stormwater runoff directly to the channel from fields to the west and northwest of the channel. Fine sediments (silts, clays, and fine sands) have accumulated in the channel coincident with the ford crossing.*

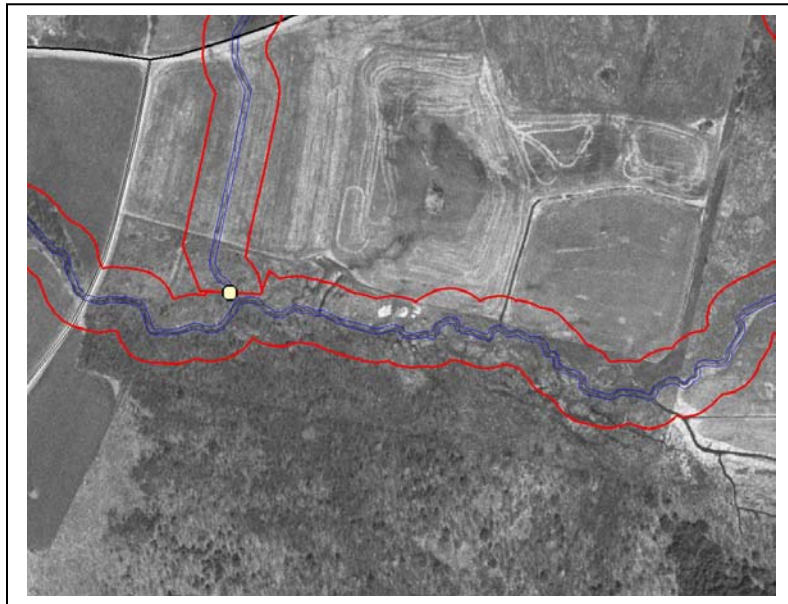
This project was completed in 2003 (a collaborative project between Partners for Wildlife (Chris Smith), NRCS (Kathy Hakey), ACOE). During Phase 2 assessments in 2005, the Project Team noted some limited meander extension, and subtle development of riffle / pool bedforms.

Sediments had recently been deposited on the regraded floodplain surface immediately surrounding the channel. Sedimentation by fines was also noted, and may be related to the active streambank failures in upstream Section E. Two prominent field ditches draining to this Section are also contributing fine sediments, as evidenced by small "delta" deposits at their confluences with the Wanzer Brook tributary.

Figure 13. T3.3S1.01.  
Wetlands restoration project  
on Magnan property.  
(a) 1995 prior to restoration.  
(b) 2003 post restoration.

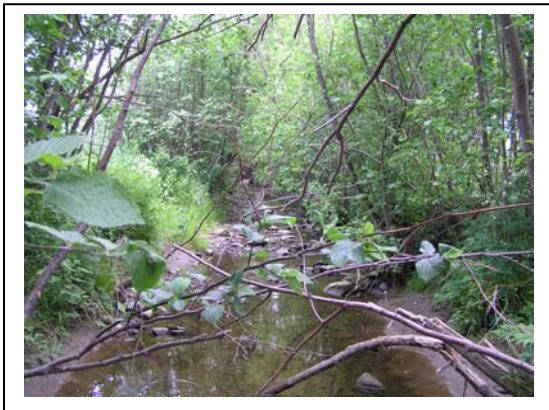
The channel appears transport-dominated, punctuated by the occasional pocket of aggrading and overwidened channel (mid-channel bars, enlarged point bars) with local access to incipient floodplains forming at a lower elevation. Debris jams formed by recruitment of LWD seem to be contributing to these localized areas of meander extension and floodplain building.

*Figure 14. T3.3S1.01 – Section C. "Alder Way" downstream of the Ryan Road crossing. Previously channelized section bordered by hayfields and lined by 5 to 50-foot shrub/tree buffers. Section is beginning to create some sinuosity and build a new floodplain through meander extension, facilitated by recruitment of LWD and debris jams.*

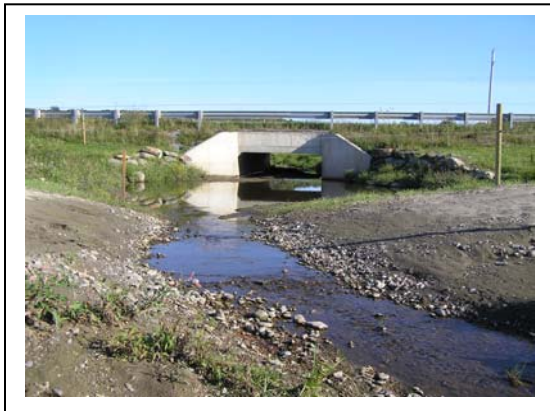
Local instability was noted at the Chester A. Arthur road crossing. Significant lateral and some vertical scour was noted at the downstream end of this box culvert. The current structure was installed in 2002, following a wash-out in the 2001 floods. The former structure was narrower than the current structure, and it is possible that evidence of lateral scour associated with the crossing is related more to the past undersized culvert crossing. Channel overwidening local to the structure may also be, in part, a result of cattle access; cows frequently cross in this location, and one of the new engineered cattle crossings was installed at this location (Figure 15). Sediment has built up within the box culvert structure itself since its installation.

Figure 15. T3.3S1.01 – Section B. NRCS-engineered cattle crossing approximately 75 feet downstream of Chester A. Arthur Road crossing – installed August 2005.

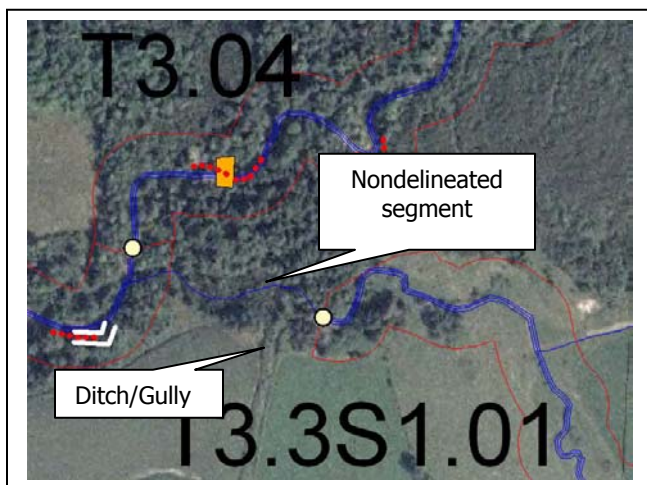
Figure 16. T3.3S1.01. Location of ditch and gully erosion draining to non-delineated downstream segment of reach.

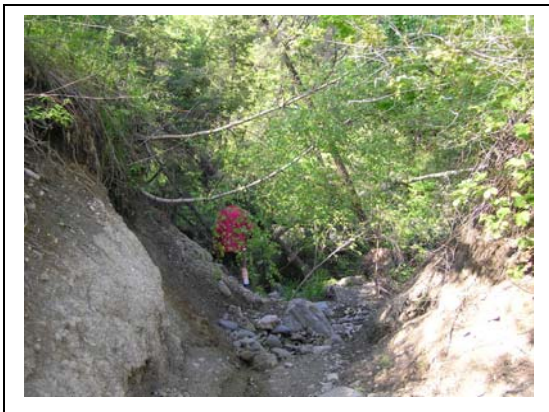
Approximately 500 feet upstream from the confluence, a debris flow was noted at the bottom of a substantial erosional gully in the left valley wall (see Figure 17). The Project Team walked upstream in the gully and came to the adjacent corn field where an agricultural ditch with standing water was observed terminating at the top of the gully.

This drainage ditch / gully serves as a point source of significant quantities of sediment and nutrients to the Wanzer Brook tributary. Debris flows and sediment originating in the gully have contributed to a localized reduction of sediment transport capacity along the Wanzer Brook tributary (T3.3S1.01). Given that this ditch/intermittent tributary is receiving barnyard and cropland runoff from upstream farms, there are likely nutrient contributions as well.

*Figure 17. Erosional gully at the terminus of a field ditch trending northeast through corn fields northwest of Chester A. Arthur Road. Debris flow extends to the confluence with T3.3S1.01, approximately 500 feet upstream of that tributary's confluence with Wanzer Brook main stem.*

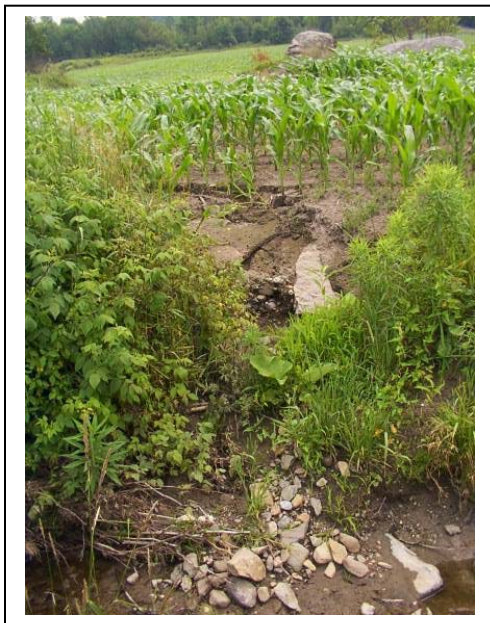
Figure 20. T3.5S1.01. Direct sediment and nutrient runoff from corn fields adjacent to Wanzer Brook tributaries.

Establishment of wider buffers will help to filter sediments and take up nutrients to improve water quality in the receiving channels.
