Québec Portion of the Rock River Watershed: Phase 1 Stream Geomorphic Assessment Report

March 13, 2020

Fitzgerald Environmental Associates, LLC.
18 Severance Green, Suite 203
Colchester, VT 05446

Lake Champlain Basin Program
54 West Shore Road
Grand Isle, VT 05458

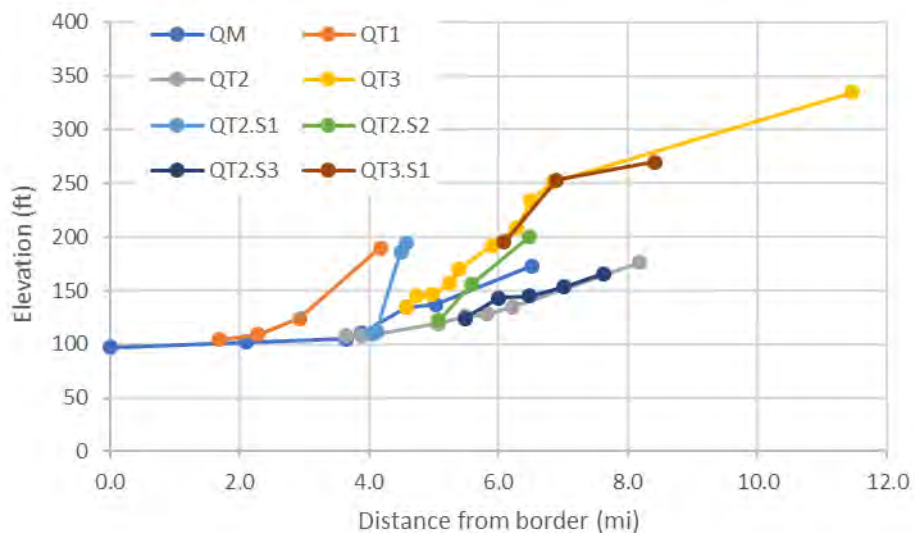
Figure 4. Elevation profiles of the Rock River and its tributaries

Figure 4 below illustrates the Rock River main stem within Québec and its tributaries in longitudinal profiles. The highest elevation is 335 ft at the upstream limit of Brandy Brook to the east. The lowest elevation is 97 ft where the Rock River re-enters the USA, slightly higher than Lake Champlain. Below Table 2 lists the average channel slope of the main stem of the Rock River and its tributaries within the Canadian portion of the watershed. Channel slopes were calculated from LiDAR elevation data.

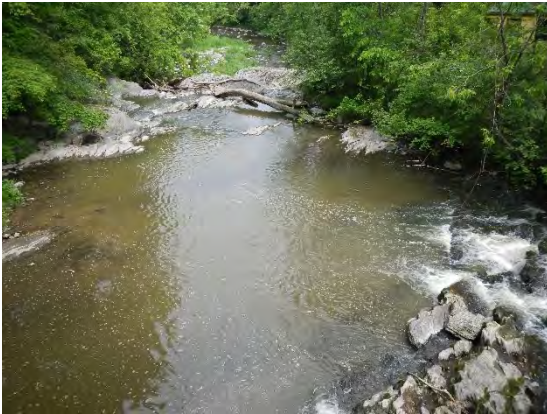
One natural bedrock grade control was identified during the windshield surveys on the main stem of the Rock River on reach QM.06. Figures 6 and 7 illustrates this large bedrock cascade.

Figure 6: Start of bedrock grade control on the Rock River, north of bridge on Chemin Pelletier S.

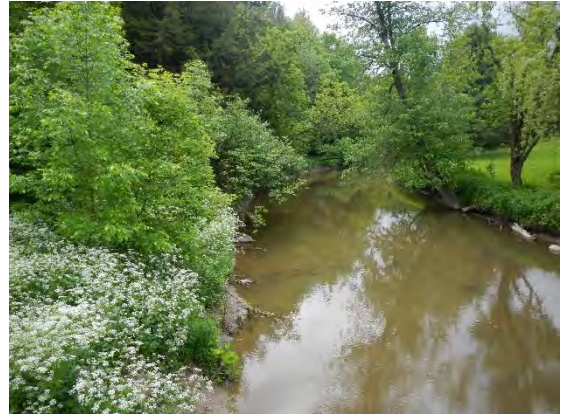
Figure 7: View upstream of bedrock grade control, south of bridge on Chemin Pelletier S.

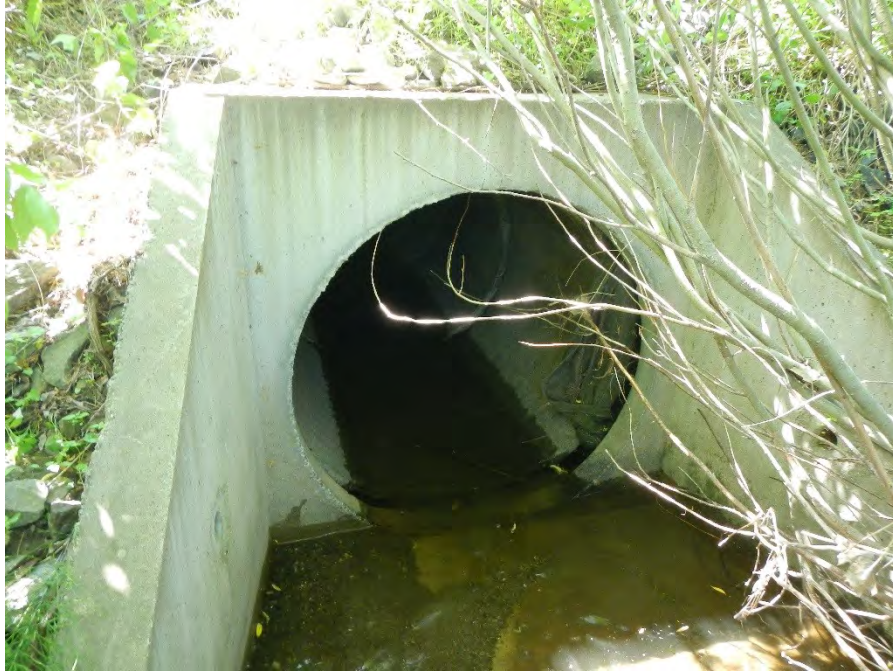
The locations and lengths of bridge and culvert crossings were mapped remotely and were verified in the field where possible (Figure 11). A total of 4 bridges and 18 culverts were noted on the Phase 1 reaches. A long culvert on a short reach (T3.01) produced a “Low” impact score, all other bridges and culverts were a “Not Significant” impact.

Figure 11: Road culvert on QT3S1.01.

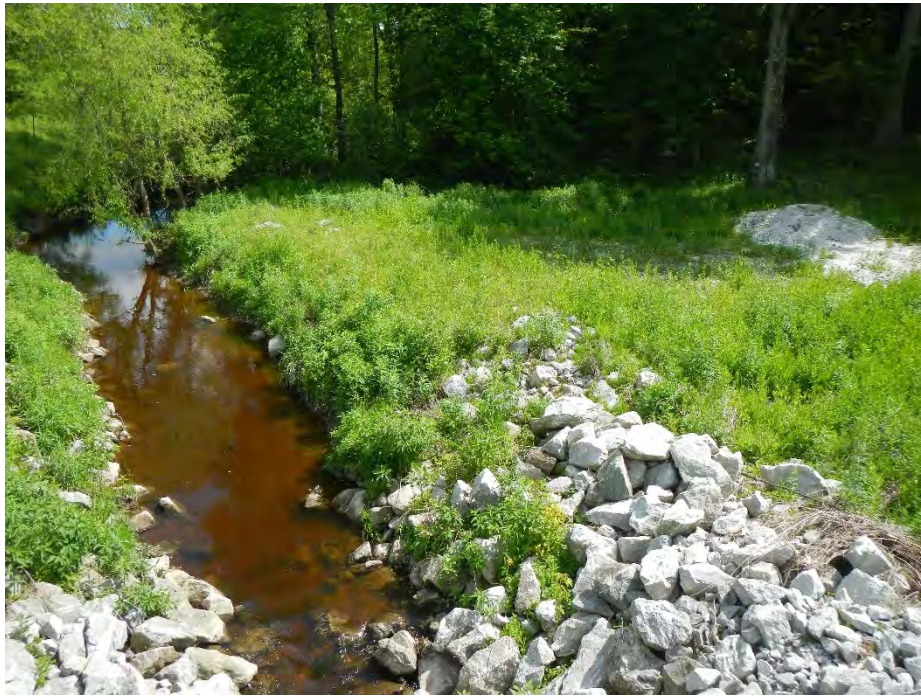
Bank armoring and revetments were observed on two reaches (QM.02 and QT3.01) during the windshield survey and were entered through FIT. Approximately 130 feet of bank armoring along a short reach produced a “Low” impact for QT3.01 (Figure 12).

Figure 12: Bank armoring upstream of the new culvert at Chemin Pelletier S (T3.01).

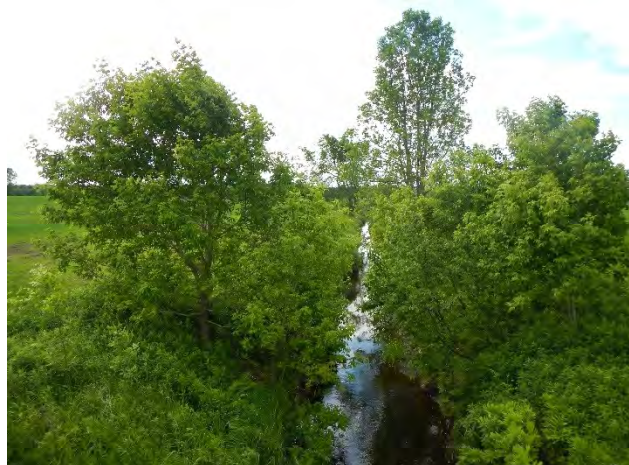
Extensive channel straightening was observed during windshield surveys and from aerial imagery (Figure 13). Twelve (12) reaches were assigned a "high" impact rating and three (3) reaches were assigned a "low" impact (Figure 14). Channel straightening was primarily observed between agricultural fields to effectively ditch the streams. Ten (10) reaches were straightened for over 50% of the length.

Figure 13: Extensive straightening between large agricultural fields along T3.09.

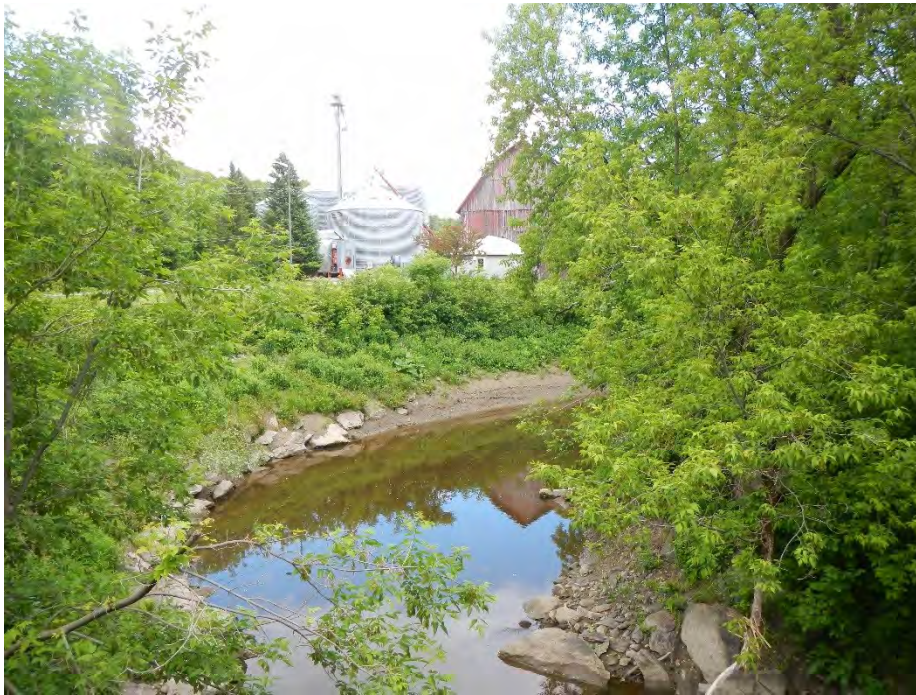
The impact of development within the stream corridor was evaluated using current aerial imagery and was confirmed and/or refined during the field observations (Figure 16). The presence of development was indexed using the FIT, and impact ratings for each reach were developed based on SGA criteria presented in Table 11. Two (2) reaches were assigned "low" impacts for corridor development (QM.02 and QT2S2.02).

Figure 16: Development impacts on the Rock River on reach QM.02.

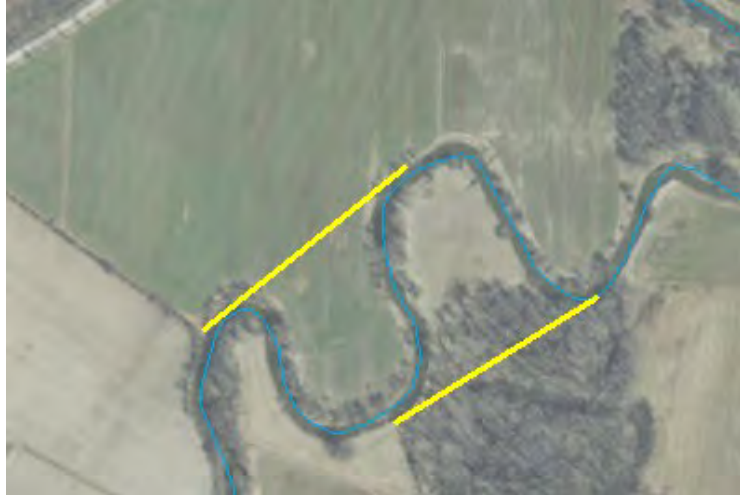
For reaches characterized within unconfined valley settings (C-type or E-type channels), meander geometry was reviewed following the Phase 1 protocols; 24 reaches had valley settings suitable for assessment of meander width and wavelength. Of these reaches, 13 had visible meander features where GIS shapefiles were developed to indicate the areas where meander width and wavelength was measured (Figure 17).

Where the meander wavelengths and widths fell outside of the range of expected values relative to the predicted channel width, impact ratings of high or low were assigned according to the degree of departure (VTDEC, 2009). Only one reach had no significant impacts for either meander width or wavelength (QM.01); 13 reaches had "high" impacts for both meander width and wavelength; 4 reaches had "high" impacts for either width or wavelength. The remaining 6 reaches had low impacts for width and/or wavelength.

Figure 17: Meander geometry assessment on Reach QM.01

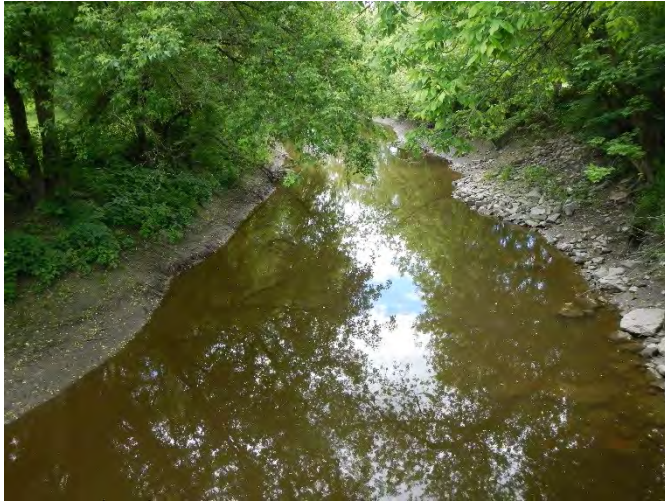
Particular attention was paid to recording bank erosion and ice/debris jam potential at the stream crossings. Due to limited direct accessibility on most reaches, bank erosion assessment along the entire channel length was not practical; rather, bank erosion plainly visible along roads or at stream crossings was indexed using the FIT. Therefore, the relative length of the reach impacted by bank erosion was likely underestimated compared to typical Phase 2 field observations (Figure 18). Bank erosion was observed on 2 reaches, and mass failures were observed on an additional 1 reach (Figure 19).

Figure 18: Bank erosion on QM.05.

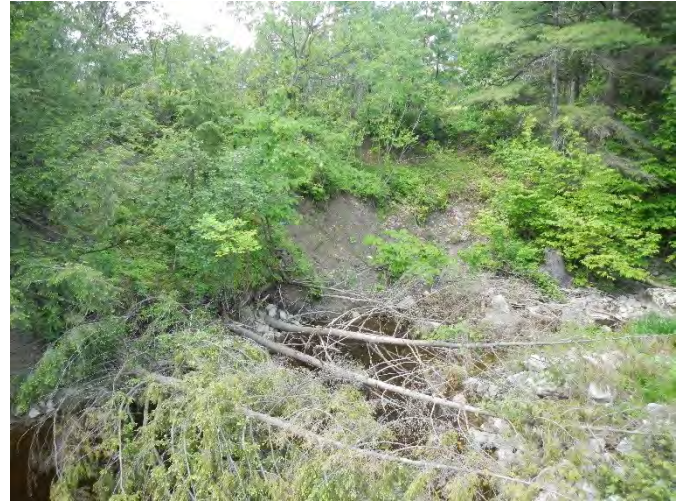
Figure 19: Small mass failure on QT3.01.
