**WAITS RIVER WATERSHED**  
**PHASE 1 and 2**  
**STREAM GEOMORPHIC ASSESSMENT**  
**2007-2009**

January 12, 2010

Prepared by:  
Daniel Ruddell, Elisabeth McLane,  
and Courtney Haynes,  
Staff Scientists, and  
Ben Machin, Principal  
Redstart Consulting

Prepared for:  
Bradford and Corinth Conservation Commissions,  
Waits River Watershed Council, and  
Vermont Agency of Natural Resources/  
Department of Environmental Conservation  
River Management Program

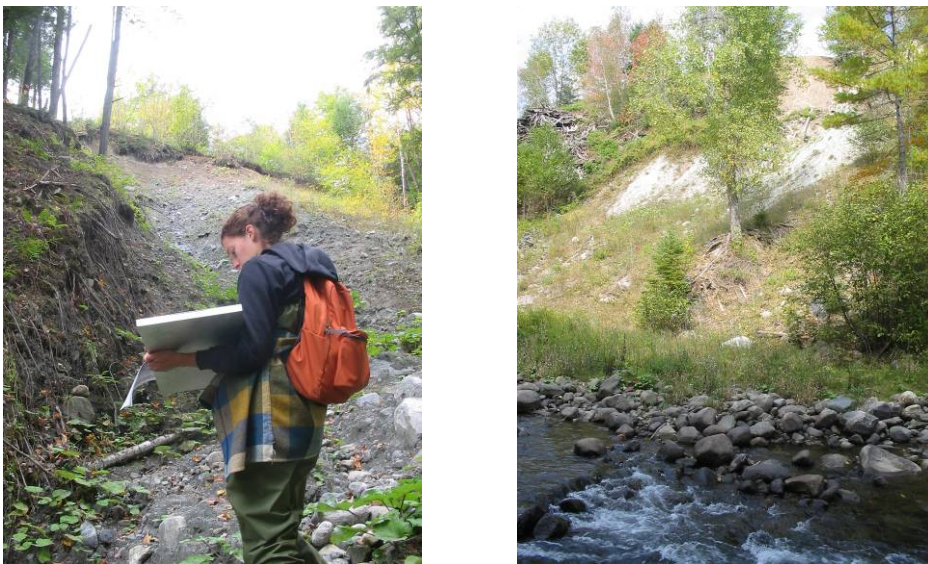
**Figure 4. Sand and gravel deposits in valley walls along the South Branch of the Waits are likely related to the former presence of a high elevation glacial lake, and have been prone to mass failures and gully formation.**

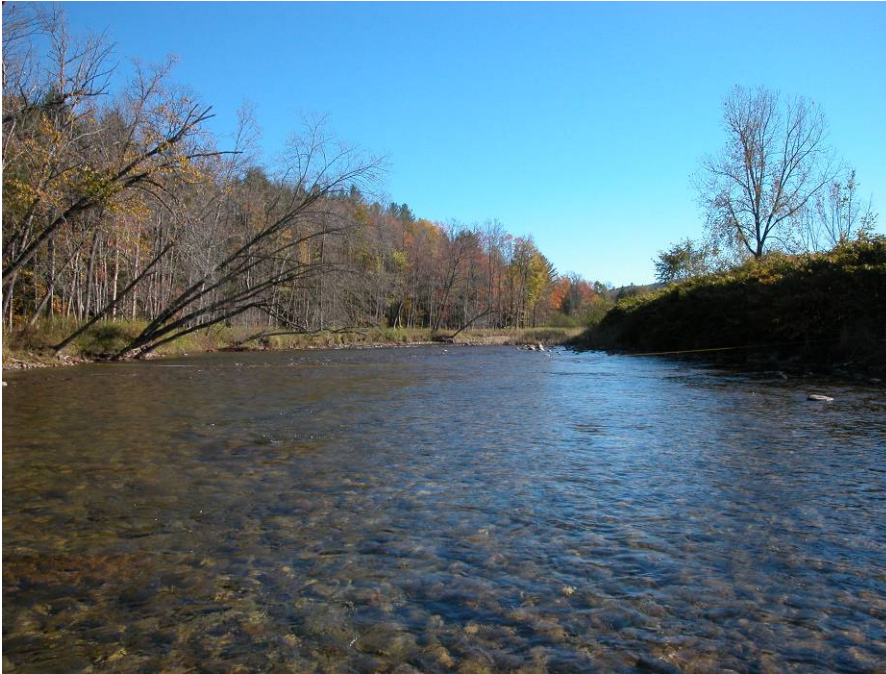
**Figure 6. Cobble “planebeds” lacking many riffle or pool features were frequently observed in the assessed areas.**

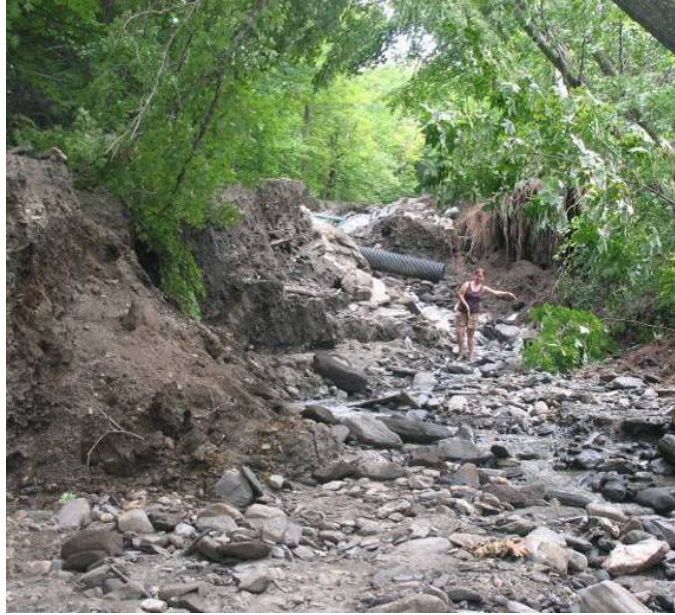
**Figure 12. Sediment from a road taken out by this small tributary off of Ayers Brook in Randolph suddenly became a significant contributor to stream dynamics after an intense thunderstorm in July 2007. The woman at center right is indicating the post-flood width of the stream by her armspan.**

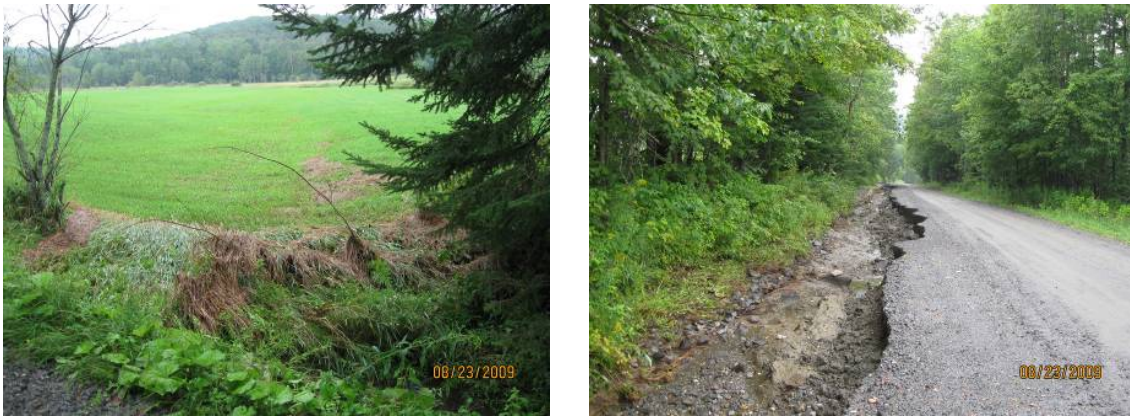
**Figure 15. The field swale at left contributed sufficient water in a heavy downpour to initiate gullying along the road (right), eventually combining with a tributary downhill to wash out a 6 ft. culvert and a section of the road.**

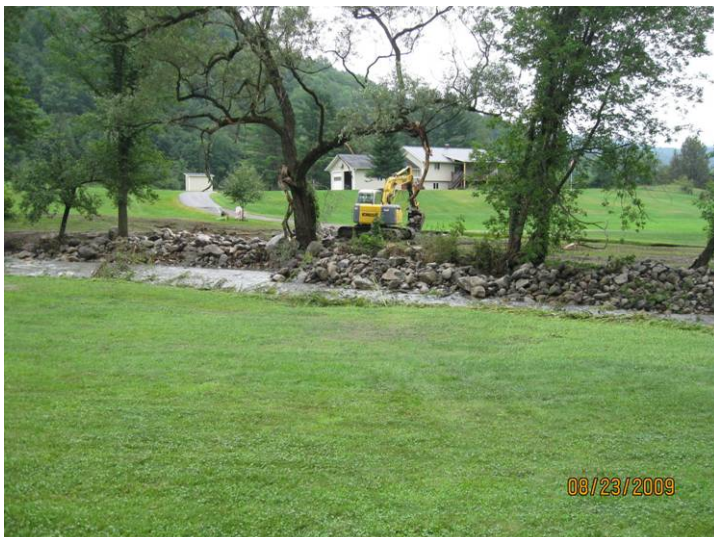
Sediment removal appeared to have occurred in Waits mainstem reach M09 just upstream of the Village Rd. bridge near the confluence of the Tabor Branch in East Corinth, where a good deal of cobble and boulder sediments were windrowed along the banks. It appears likely that some of this activity occurred in conjunction with bridge replacement and/or sediment removal upstream of the bridge following flooding, possibly after the same storm that hit Rowell Brook in 1998 or perhaps in another localized flash flooding event. Such activities are not uncommon in the aftermath of floods, and are frequently undocumented (Fig. 17).

**Figure 17. Windrowing of sediments following flash flooding, particularly upstream of undersized bridges and culverts and similar constrictions, is not uncommon and is frequently undocumented. This can complicate understanding channel evolution and the movement of sediment in a stream system.**

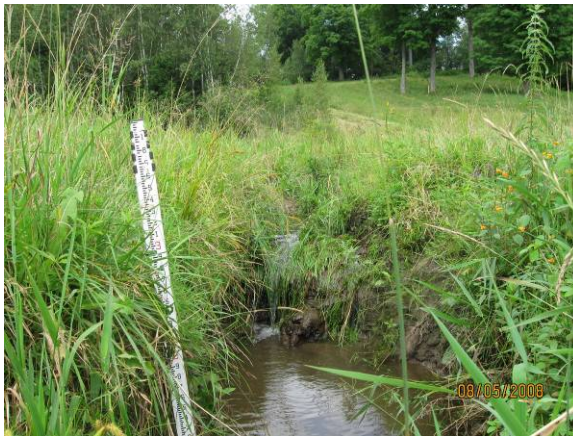
**Figure 18. Tributary rejuvenation contributes sediments to a stream when nick points or headcuts move back up a tributary, as the adjoining trib (such as the small one pictured here) begins to lower its elevation to meet the new elevation of a receiving stream that had previously cut down into its bed.**

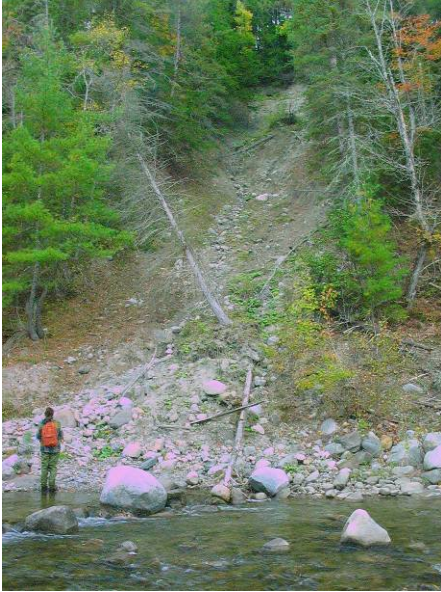
**Figure 19. Sediment contributions from mass failures and gullies were relatively common along the South Branch of the Waits. Pink cast to rocks is just an artifact of poor photo quality.**

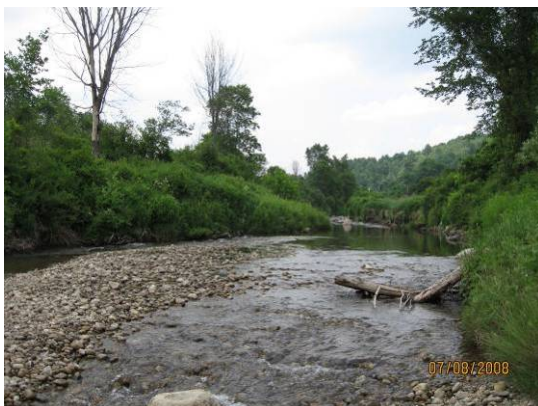
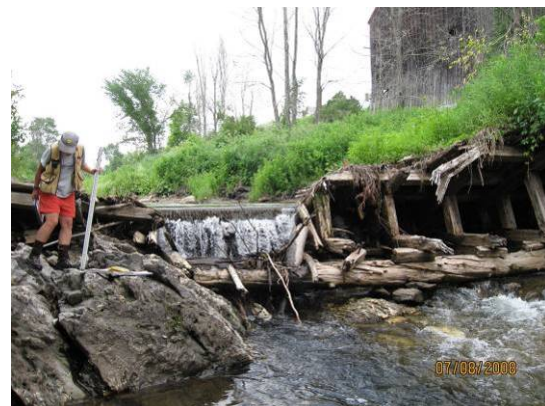
**Figure 20. Aggradation upstream (left) of a partially breached dam (right) on the Tabor Branch indicates likely ongoing “sediment starving” downstream.**

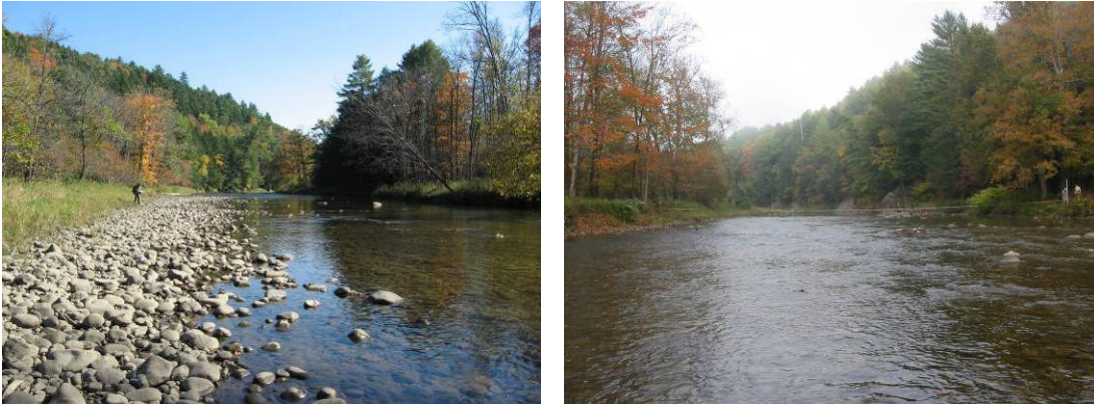
The combination of ice scouring and “pulsing” of flows through the frequently interspersed narrow valleys of the basin (the frequent alternation of these valleys in downstream areas is a distinctive characteristic of the Waits watershed) may be limiting significant build-up of sediment deposits. A dominance of planebed forms with only moderate levels of depositional features (2-5 features/mi., with few areas of significant aggradation) along much of the Waits mainstem is likely related to these dynamics. Field observations indicated a cycling through channel evolution stages, with depositional features beginning to set up in moderately high flows or widened areas but subsequently being scoured out, rather than continuing to accrue in these areas (Fig. 23).

**Figure 23. Frequent alternation of narrow and wide valleys along the Waits mainstem appears to contribute to cycles of channel evolution, with depositional features setting up in moderate flows and at widened areas upstream of constrictions (left, looking downstream) and subsequently being scoured back out in high flows and downstream of constrictions (right, looking upstream).**

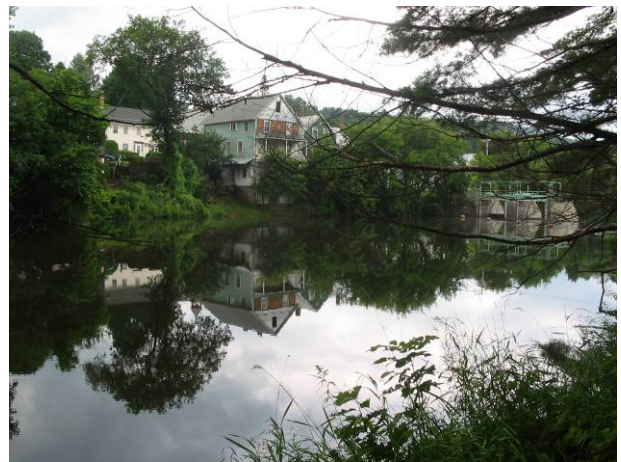
**Figure 31. Reach M03, hydro dam head gate, commercial and residential development along left bank.**

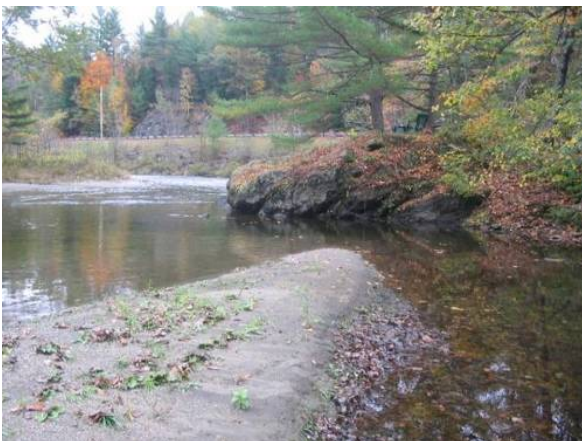
**Figure 37. Segment M05B: Rip rap and Rte 25 road encroachment in background, sidebar downstream of bedrock outcrop in foreground**

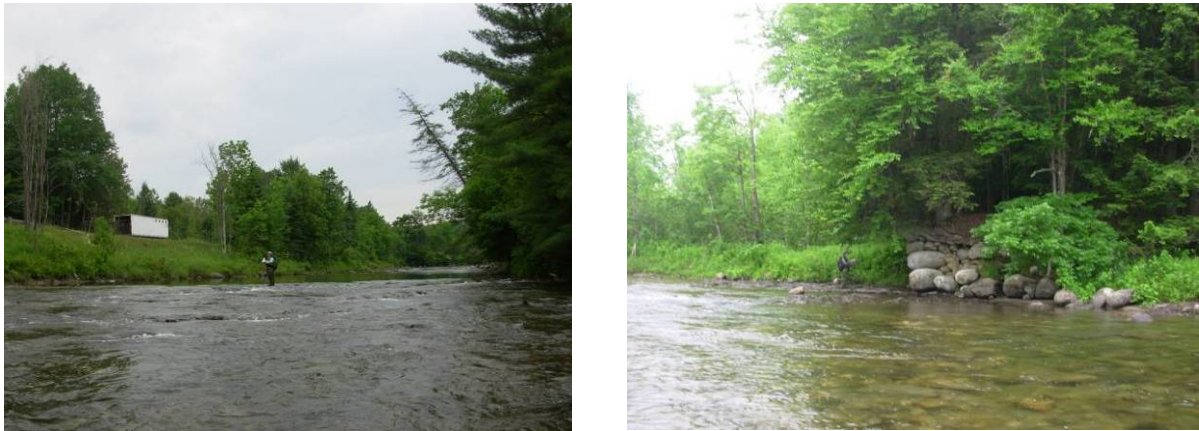
**Figure 42. Waits mainstem Reach M08 showing road encroachment (left) and a boulder pile of undetermined purpose on the left bank (right).**

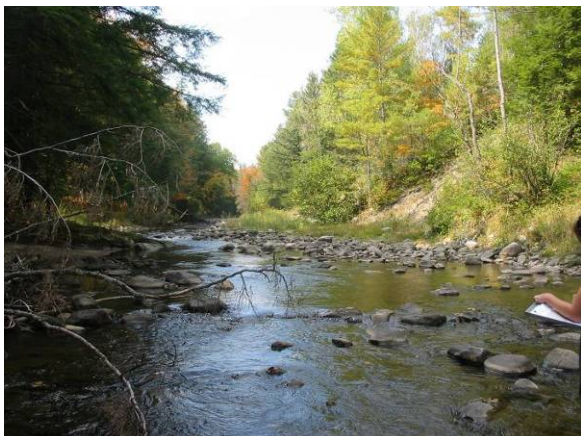
**Figure 53. Reach T1.03 on the South Branch, showing mass failure, steep riffle, and a bedrock outcrop on opposite bank**

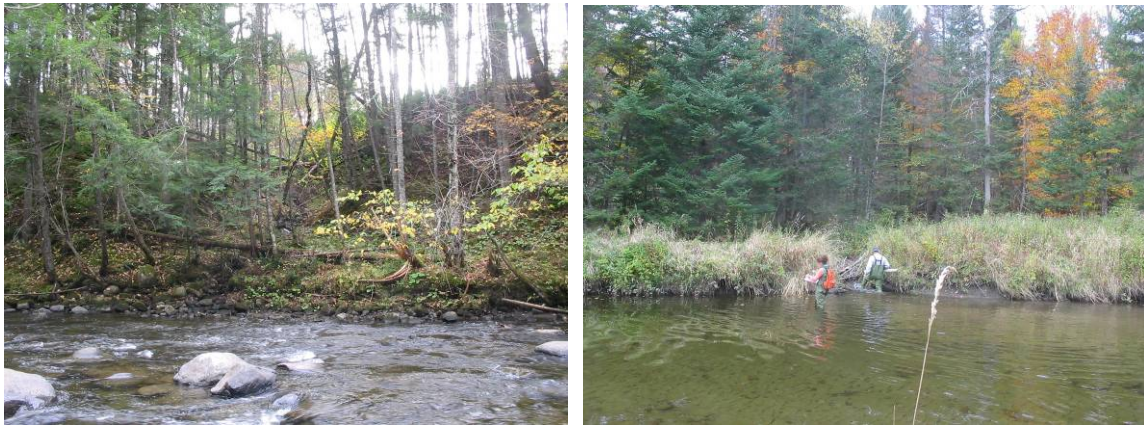
**Figure 55.** Stormwater or overland flow inputs appear to have cut through erodible sideslopes in reach T1.04 (left), where suspected former beaver dams were also observed (right).

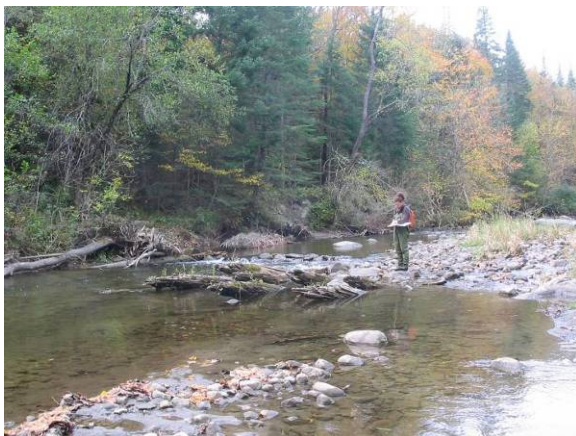
**Figure 60. Reach T1.06 showing old stream ford, bank failure and mid-channel bar**

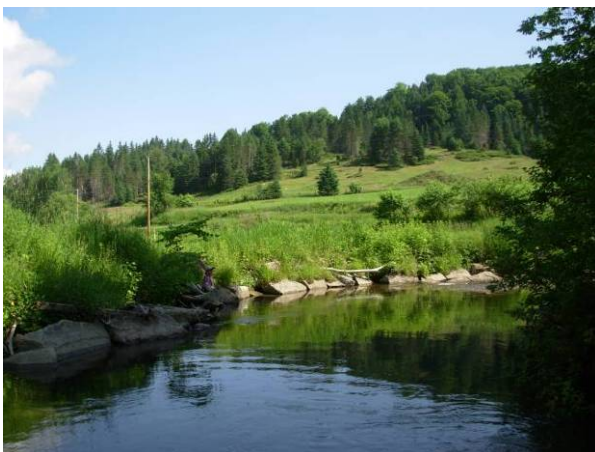
**Figure 63. Reach T1.06S1.01 showing bank toe armoring on the left bank.**

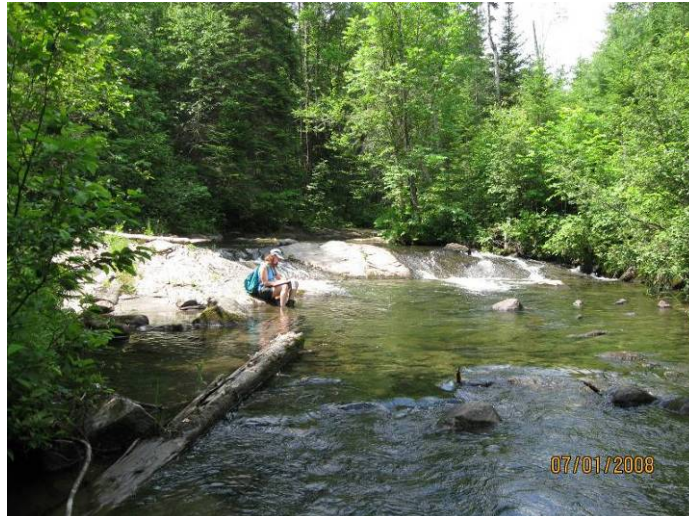
**Figure 65.** Two fords were noted in reach T1.08, and timbers in the stream may have been the remains of a temporary skidder bridge or similar structure for a logging operation

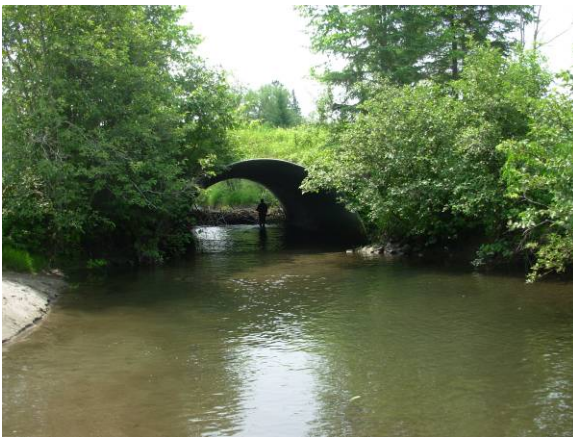
**Figure 66. Arch culvert at Dearborn Hill Rd. in segment T1.09A is partially obstructed by a beaver dam just upstream of the inlet**

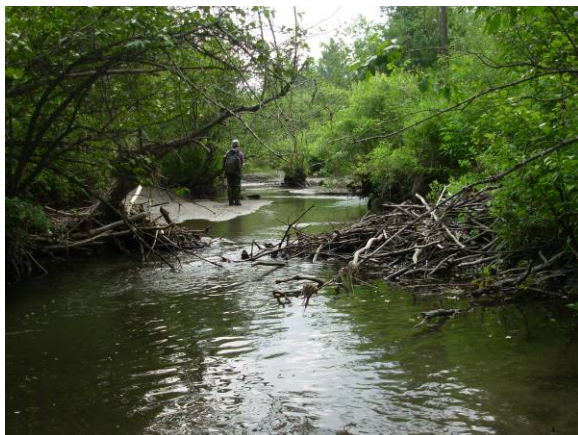
**Figure 68. Beaver dams in segment T1.09B appeared recently blown out.**

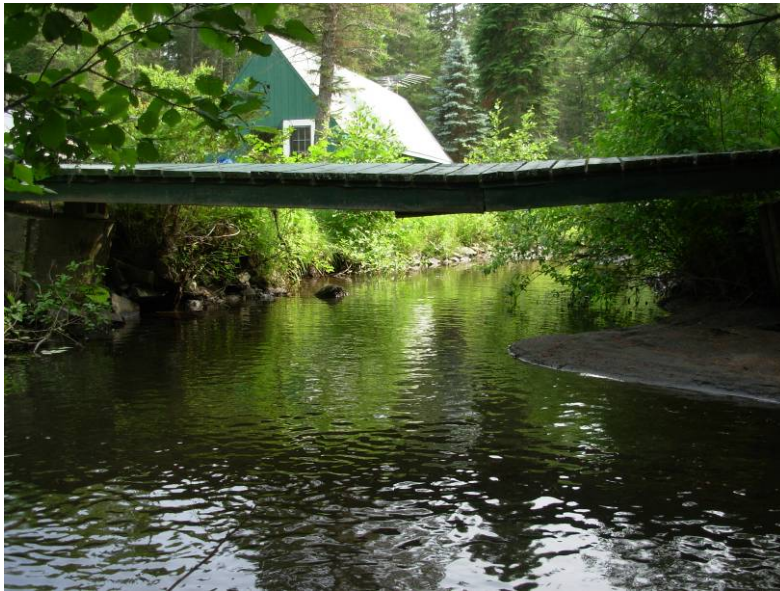
**Figure 69. Development encroachment in segment T1.09C; bank toe stabilization placed on both banks; bridge is a channel constriction with some deposition noted upstream**

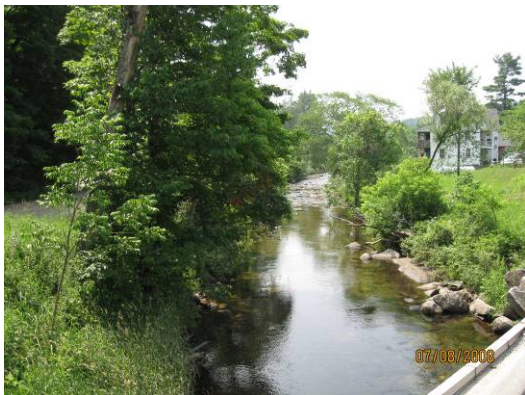
**Figure 71. Encroachments on both sides of T2.02A have obscured terraces that might indicate the extent of access to historic floodplains along the Tabor Branch**

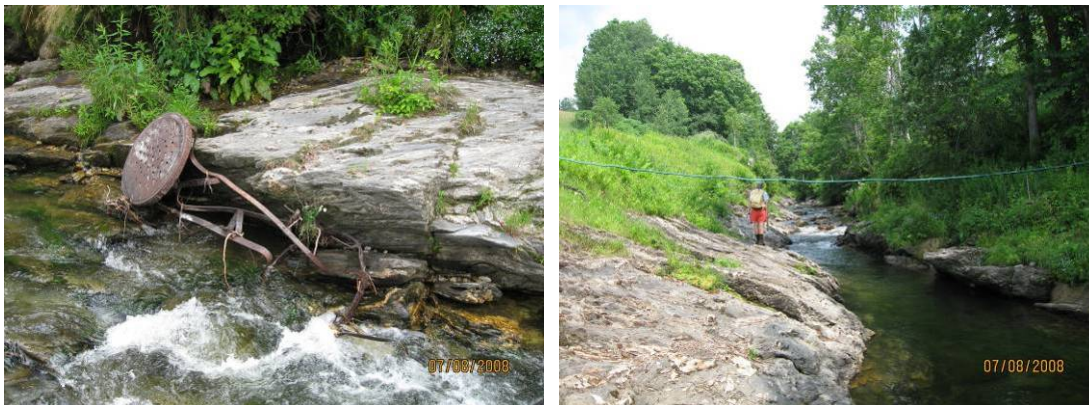
**Figure 73. Tabor Branch segment T2.02B still has old pieces of equipment from mills that operated in this bedrock-controlled section of the stream.**
