Bear Creek Environmental

Phase I and Phase 2 Stream Geomorphic Assessments Moon Brook Watershed Rutland City, Rutland Town, and Mendon, Vermont

Final Report
January 25, 2006

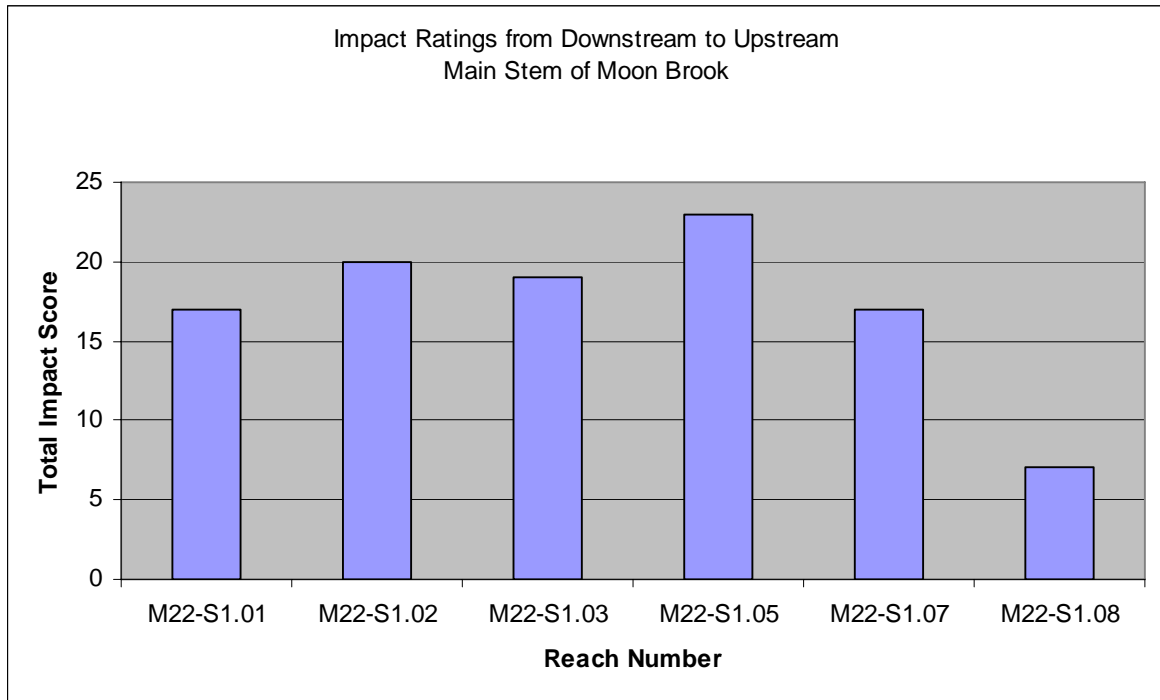
The change in impact rating between the headwaters of Moon Brook (Reach M22-SI.08) and mid to lower Moon Brook is clearly illustrated in Figure 9. This sharp increase in impact rating between Reach M22-SI.08 and M22-SI.07 may largely be due to land use. The watershed land cover drops from 88.3 percent forested in Reach M22-SI.08 to 49.4 percent in Reach M22-SI.07. A similar trend occurs with the corridor land cover/land use. The riparian corridor of M22-SI.07 consists of approximately 60 percent urban land use (i.e. moderate to high density residential, commercial, industrial, roads), while the land use with M22-SI.08 is zero percent urban.

Figure 9. Impact Ratings from downstream to upstream on the main stem of Moon Brook

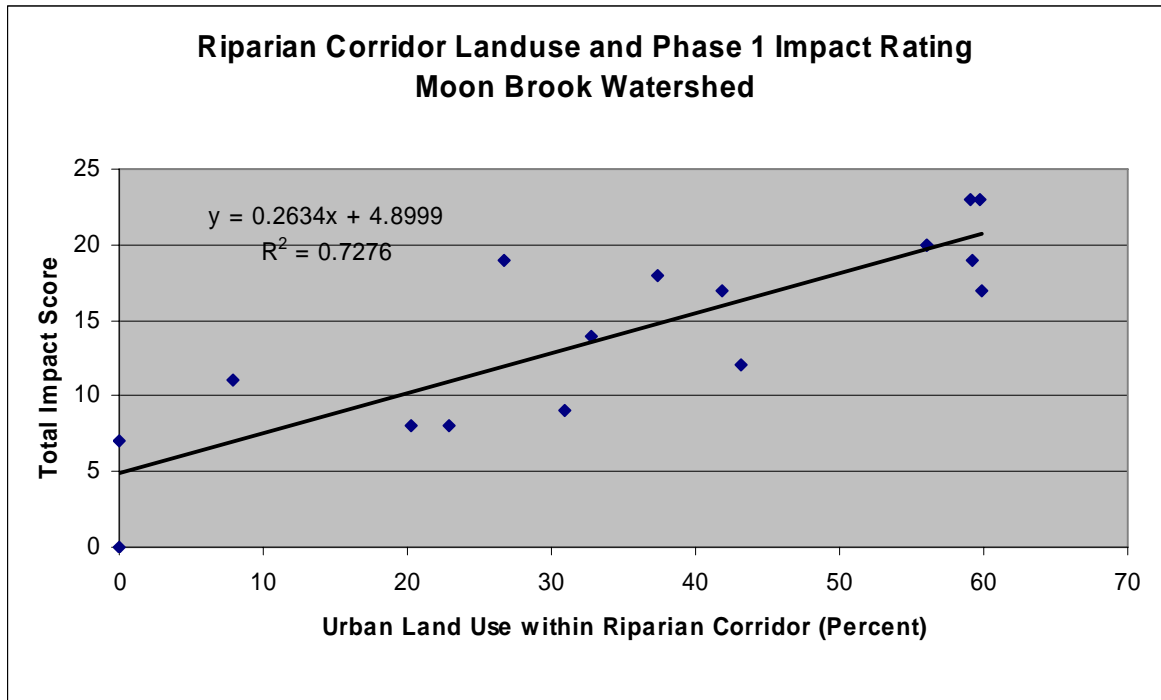
A strong positive correlation was found between the percentage of urban land use within the Moon Brook corridor and the Phase I impact rating. This is not surprising given floodplain encroachment (e.g. berms, roads, railroads, improved paths, and development), channel modification activities (e.g. channel straightening), and buffer disturbance are typically related to the density of development within the corridor.

Figure 10. Relationship between urban land use within riparian corridor and Phase I impact rating.

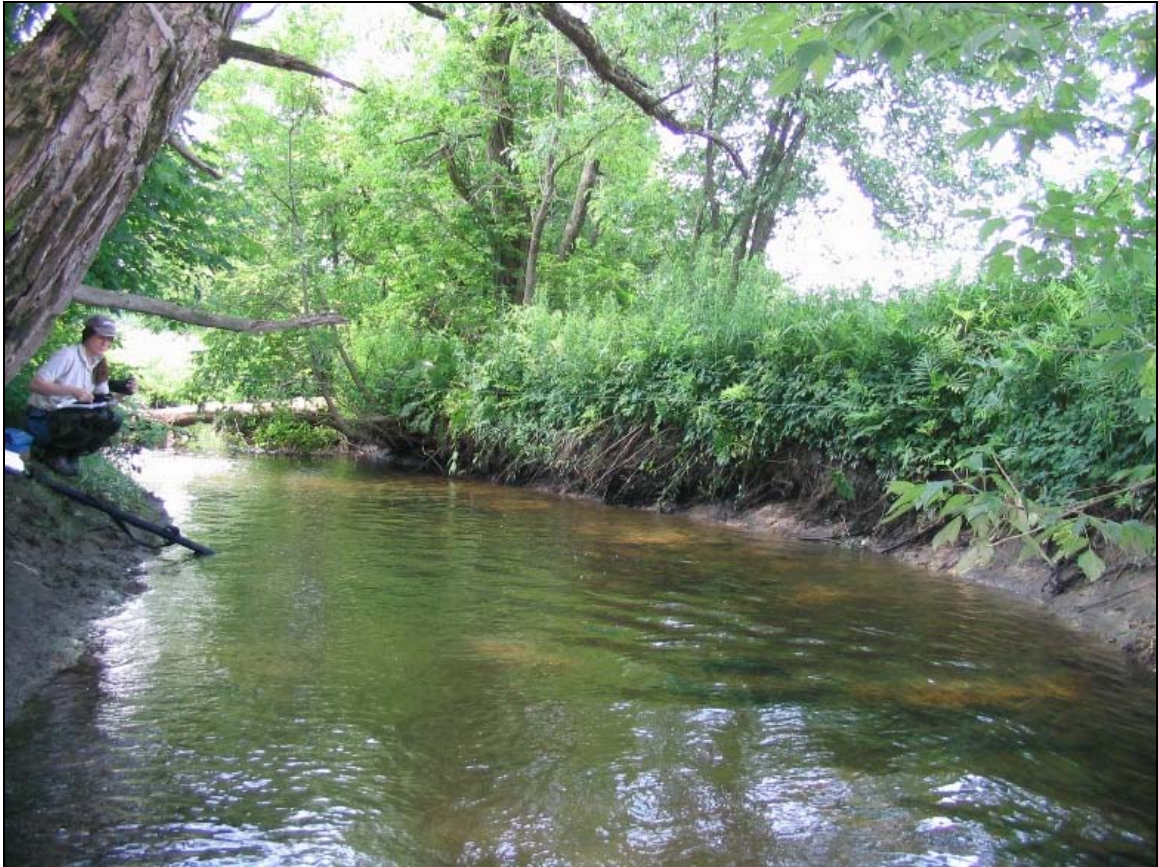
Riparian conditions on the banks of this reach have been influenced by agricultural practices which have removed much of the riparian buffer leaving only 5-25 feet on each side. Orthophotographs and a local landowner have confirmed that this reach had historically been extensively straightened. The reach, however, does not appear to have incised. This may be due to one or a combination factors including; cohesive substrates on the bed and banks, increased sedimentation from upstream that have continued to fill in the channel, and/or grade control provided by the concrete footing of the Forest Street Bridge. The reach is currently undergoing some minor planform adjustment, evident by minor bank erosion on the outside bends.

Figure 11: Typical cross section along M22-SI.01. Note opening of the riparian buffer along the right bank. Also the minor erosion on the outside bank associated with planform adjustment in response to historic straightening.

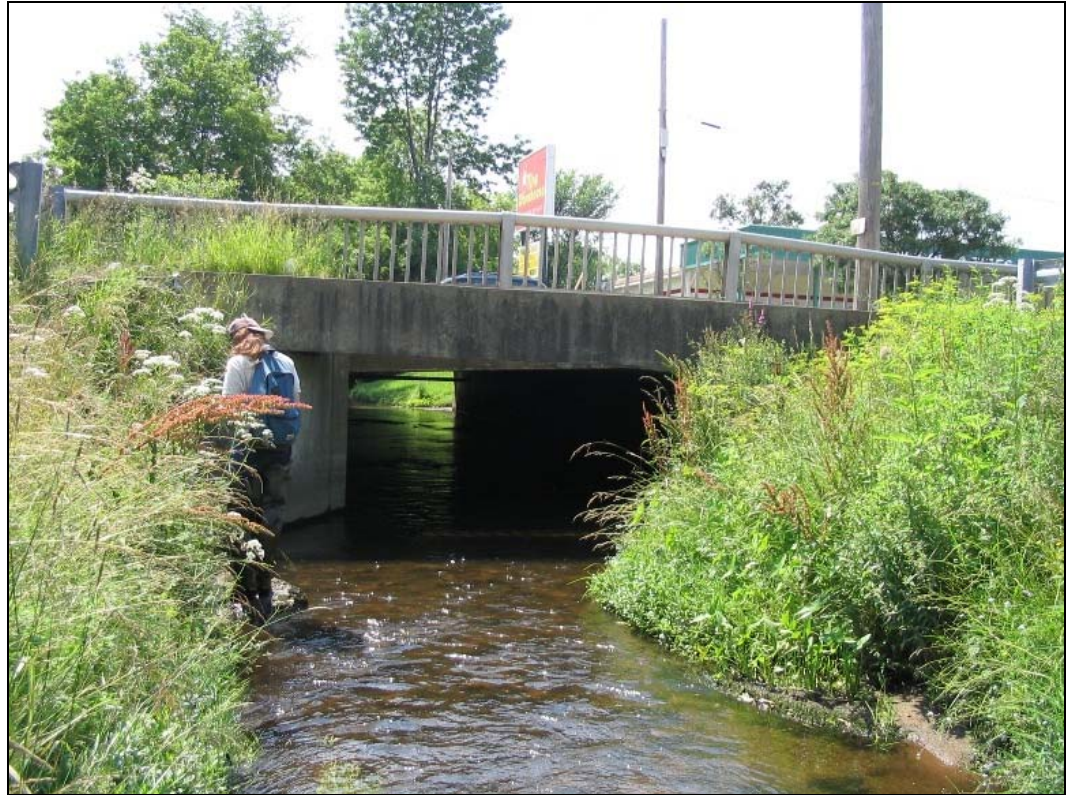
Segment M22-SI.02-B runs through the Route 7 corridor of Rutland City. It is an “E” type channel by reference, however, due to floodplain encroachment (there is quite a bit of fill, development, and retaining walls on both sides of the streambank) and historic channelization, this segment is now an entrenched “G” type channel (Figure 13). In addition to floodplain encroachment, there are also several undersized structures that are constricting the channel and disrupting sediment transport within this reach.

Figure I3. Segment M22-SI.02-B is heavily urbanized and has become an entrenched and extremely sensitive “G” type channel which has lost access to its historic floodplain.

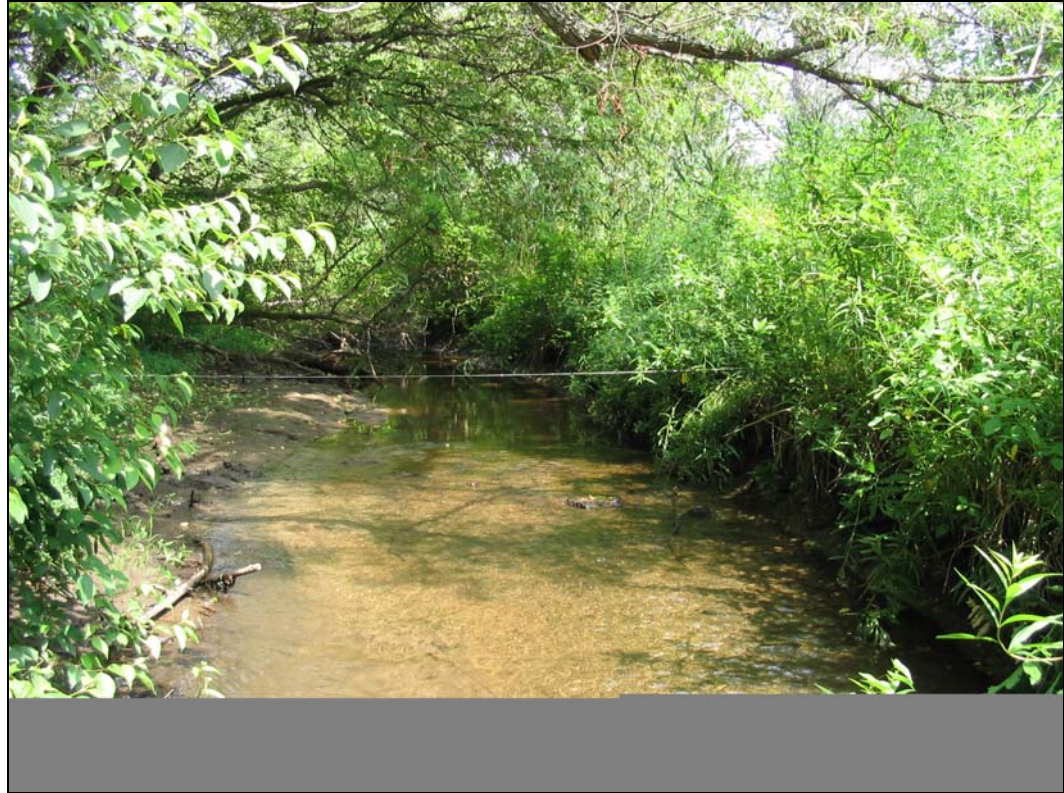
Segment M22-SI.02-C is located between downtown Rutland and White’s Pool. Although the stream corridor is still heavily developed, it is not incised like segment B and therefore has remained an “E” type channel with access to its floodplain (Figure I4). The reach has been impacted by riparian vegetation removal, however, overall is in good geomorphic condition.

Figure 14: Segment M22-SI.02-C is an unentrenched “E” channel with a ripple-dune bedform. Alteration of the riparian vegetation is evident by the amount of sunlight reaching the stream in this photograph.

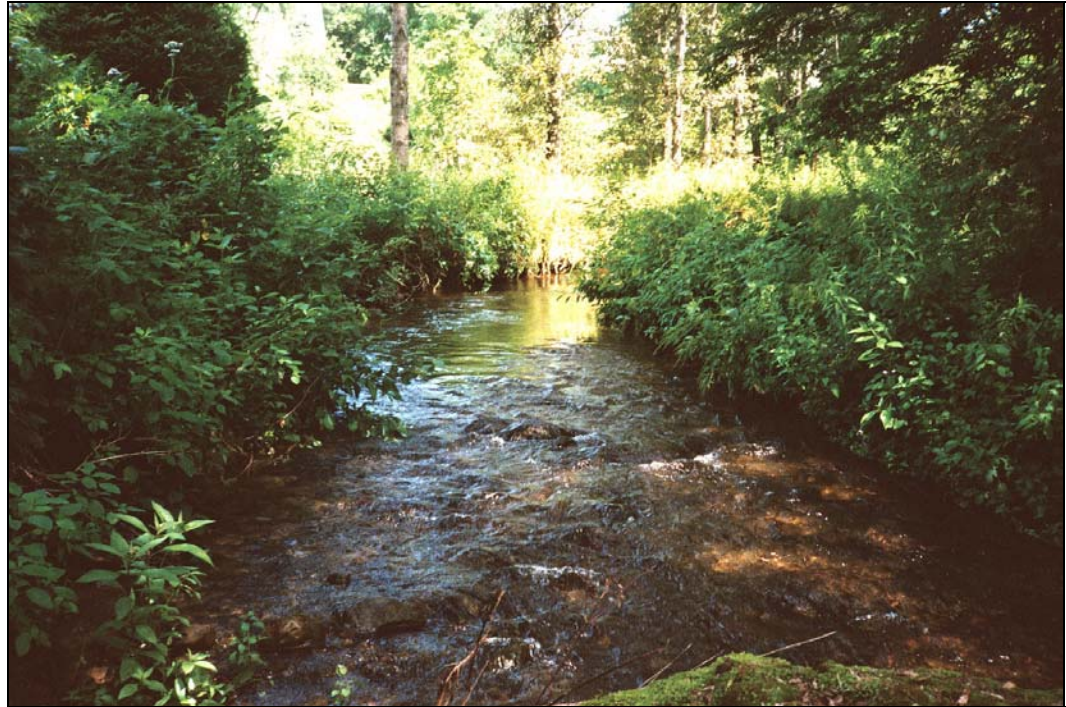
This segment is a moderately sinuous “E” type channel with a healthy riparian buffer that has only slightly been influenced by development in the river corridor. The segment has no bank revetments and the dense vegetation, as depicted in Figure 15, has kept bank erosion to a minimal.

Figure 15: Segment M22-SI.03-A is an E5 ripple dune system with a healthy riparian buffer and moderate sinuosity.

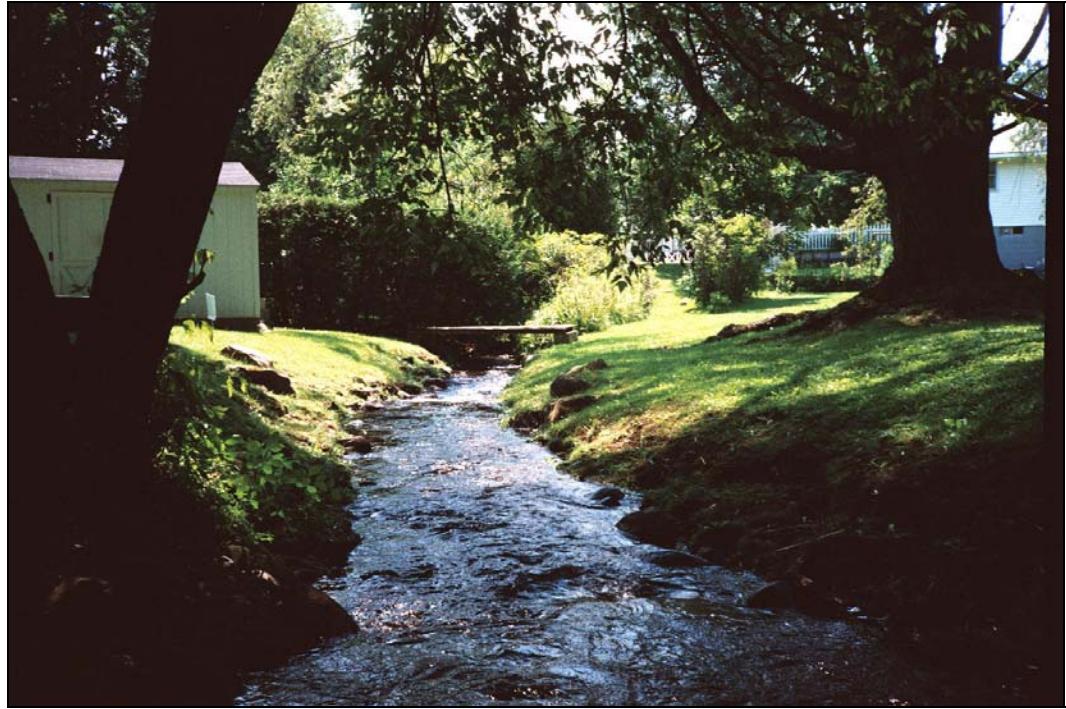
found in this segment. Even with the influence of development, M22-SI.03-B generally has good floodplain access throughout much of this segment.

Figure 16: Segment M22-SI.03-B is an E4 riffle pool system that has been significantly altered by historic channel straightening and development in the floodplain.

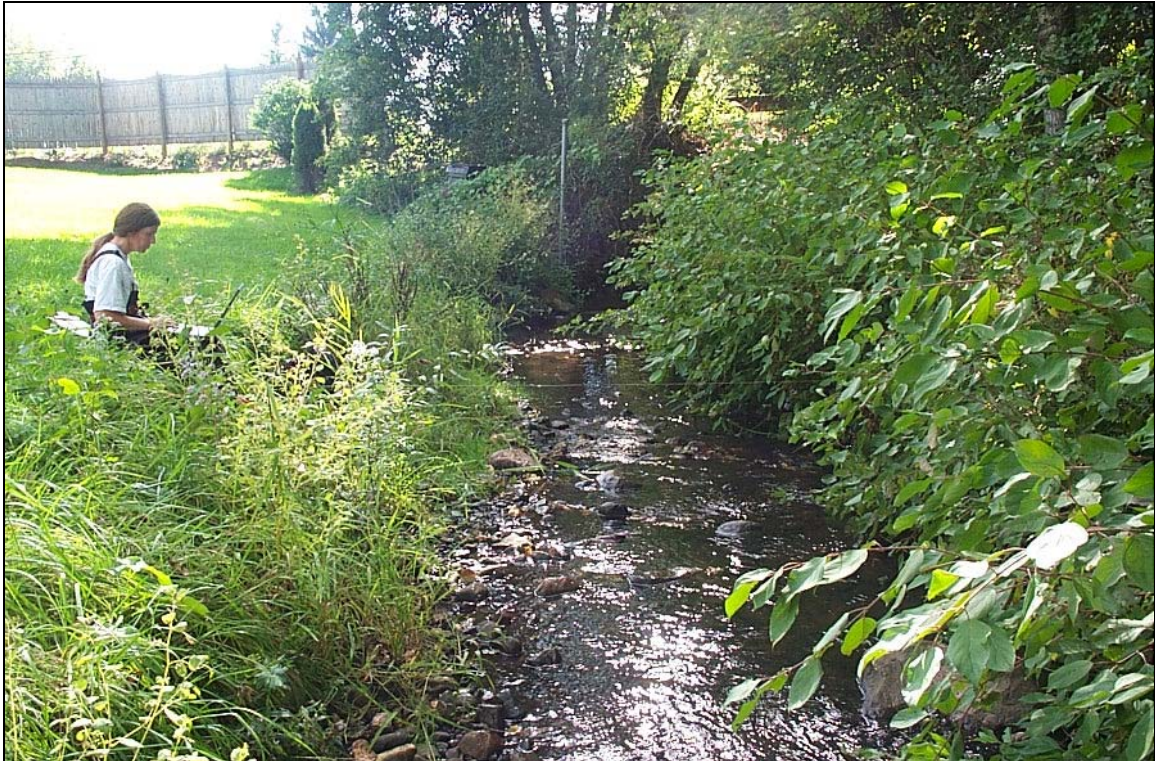
this reach has been largely disturbed and averages between 5 and 25 feet wide (see Figure 17). There are both moderate amounts of erosion and riprap along the reach indicating active planform adjustment and widening. Overall the reach appears to be in fair to good geomorphic condition and would benefit from improved floodplain access and the reestablishment of a healthy riparian buffer.

Figure 17: Segment M22-SI.05 is an E4 riffle-pool system that has been altered by development in the floodplain and historic channel straightening. Streamside vegetation (as along the right bank of the photograph) has been disturbed along much of the reach.

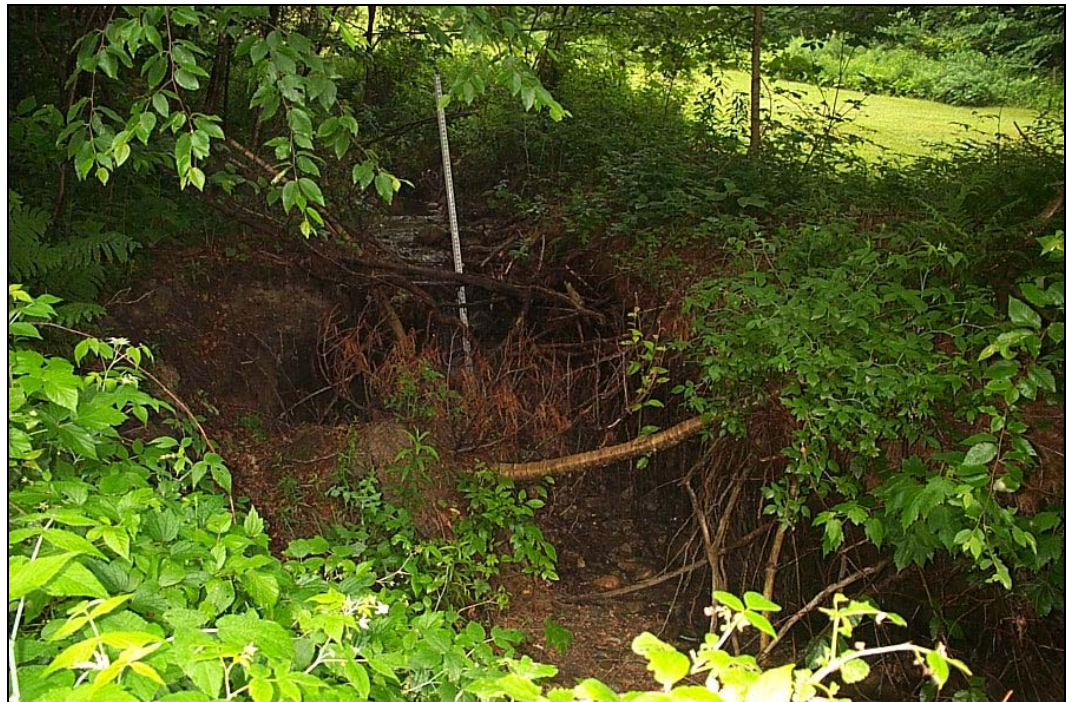
Segment M22-SI.08-A begins upstream of a private on-stream pond and continues for approximately 3000 feet until a major change in slope occurs in the watershed. This lower segment is an “E” type channel with a healthy riparian buffer; however, some floodplain development has occurred. The stream is actively incising through several large head cuts (Figure 19) which have an unidentified origin. Continued headcutting and incision through the reach will be followed by channel widening and planform adjustments as the stream works to redevelop a floodplain at a lower elevation. Property loss may be a concern for several landowners whose land borders this reach (Note yard in Figure 19). Sediments from this active erosion will likely be retained by the pond at the end of this reach. The portions of this segment that have not degraded are in good geomorphic condition (Figure 20). These, however, may be affected in the future as the headcuts migrate upstream.

Figure 19: An active head cut is seen in this photograph of segment M22-SI.08-A. Downstream of the white survey rod the stream has incised approximately three feet exposing tree roots and the streambanks to fresh erosion.

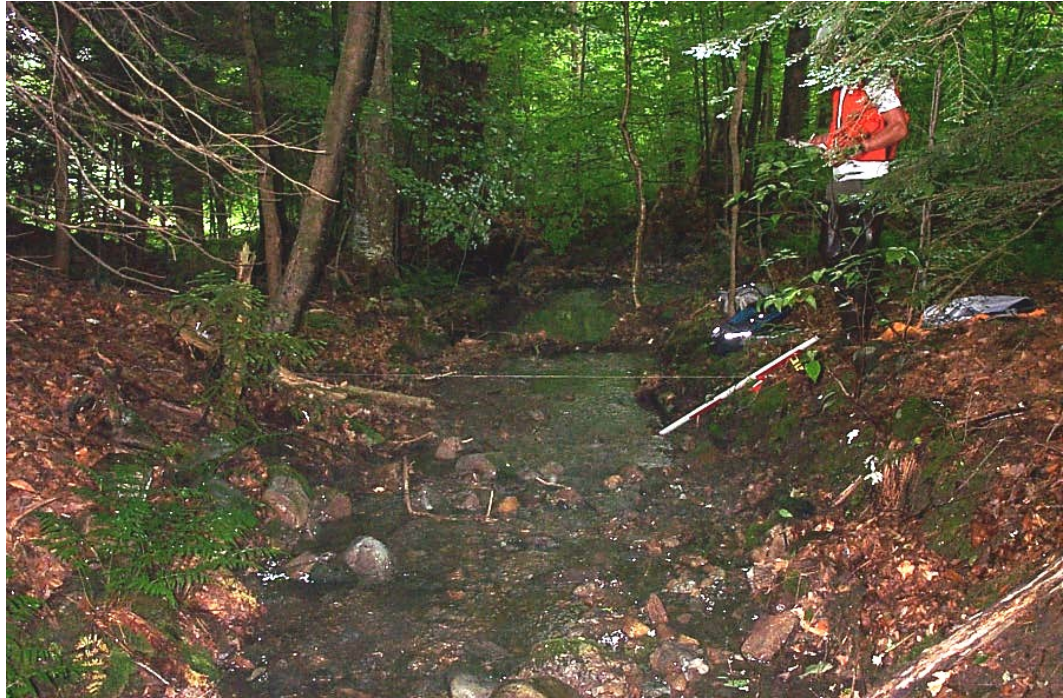
Figure 20: Typical cross section through segment M22-SI.08-A where active headcutting has not occurred.

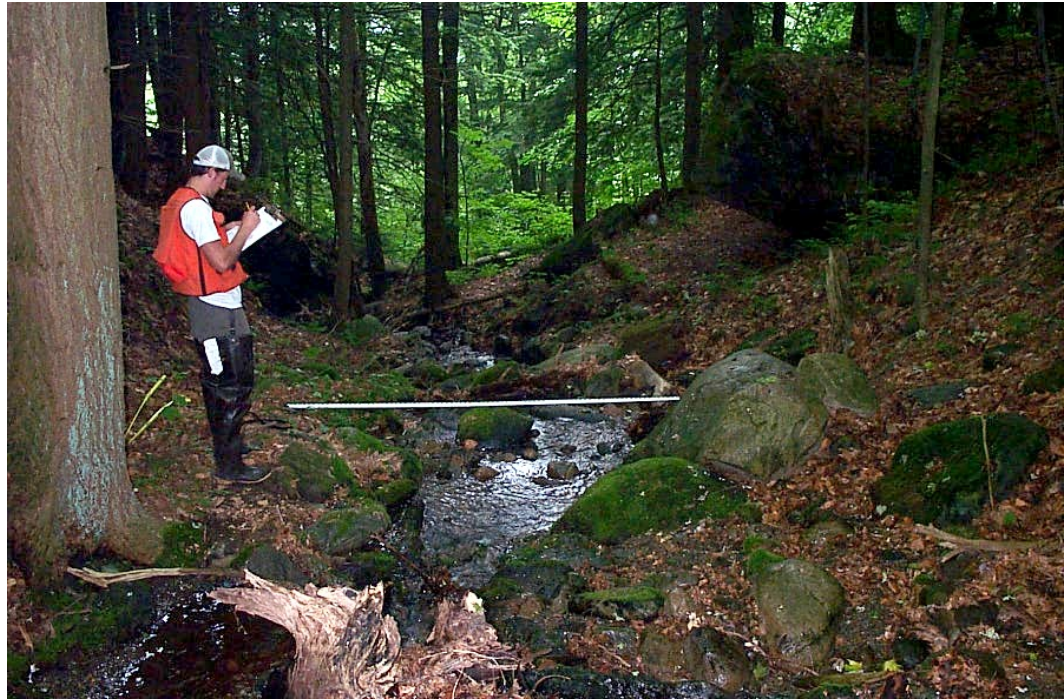
Segment M22-SI.08-B begins at approximately 1100 feet in elevation and continues into the high elevation headwaters of East Mountain. As shown in Figure 21, stream segment M22-SI.08-B is a steep “A” type channel with a healthy riparian forest that appears to have good geomorphic stability.

Figure 21: Typical cross section through segment M22-SI.08-B.

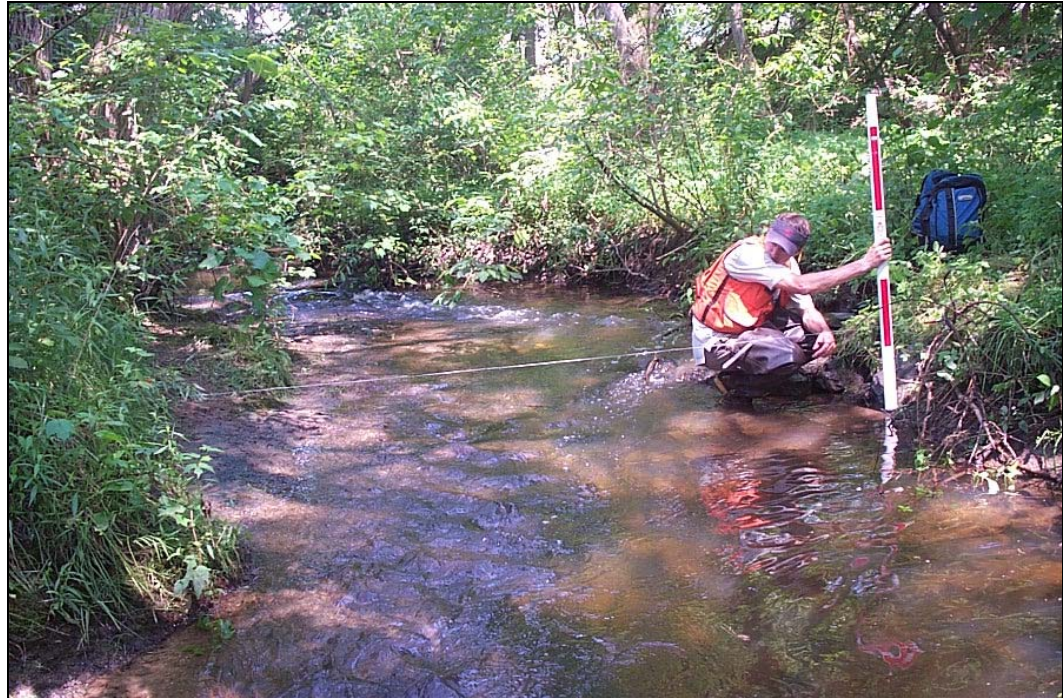
This segment begins at the confluence with Moon Brook and continues upstream to the Rutland railroad tracks. The reach is an “E” type channel with a ripple-dune bedform (Figure 22). Several bridges and culverts create channel constrictions along this reach and may be affecting sediment transport and causing localized flooding. Floodplain encroachment has been moderate through this reach.

Figure 22: Typical cross section through segment M22-SI.01-SI.01-A.

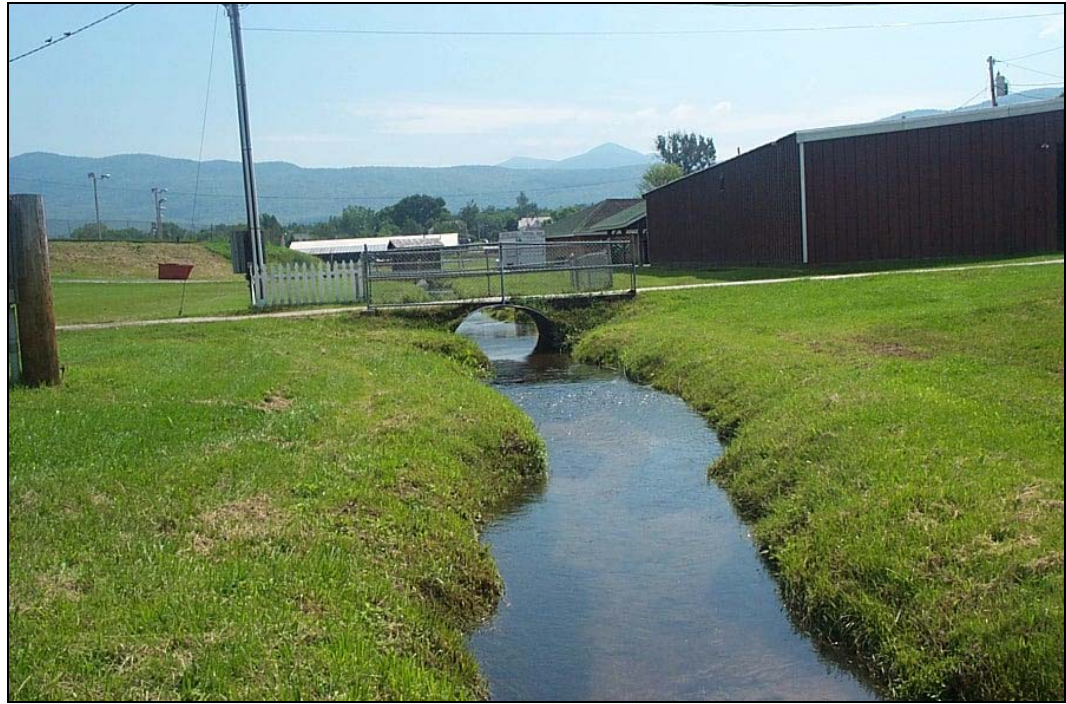
The reach flows through the Rutland Fairgrounds. It begins at the culvert under the Rutland railroad tracks and continues upstream to the cement culvert underneath Route 7. This segment has been greatly altered by floodplain encroachment, floodplain fill, channel straightening, and the disturbance and removal of riparian vegetation (see Figure 23). Bank erosion seems to have accelerated through the reach and the in-stream habitat was the only in the entire study area that received a rating of poor.

Figure 23: Typical cross section through segment M22-SI.01-SI.01-B. Channel straightening, floodplain encroachments, undersized structures, and no riparian vegetation typify this reach.

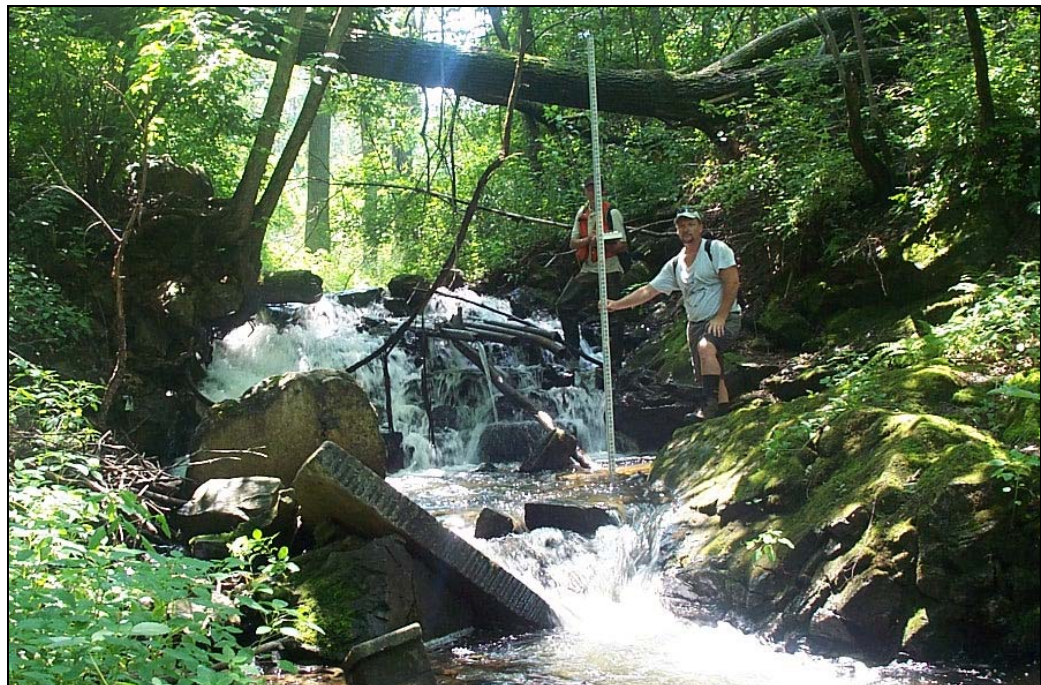
This reach begins at the upstream end of the Fairgrounds and continues upstream to a culvert (Figure 24) that lies just above a bedrock waterfall (Figure 25) below the former Eddy Pond. The reach is an “E” type channel in “fair” geomorphic condition. It has a significant amount (50% on the right bank) of development within the stream corridor. The reach is actively undergoing planform adjustment and aggrading as it works to regain sinuosity and floodplain access that has been altered by this development.

Figure 25: Bedrock ledge provides grade control at the upstream end of segment M22-SI.01-SI.01-C of Mussey Brook.

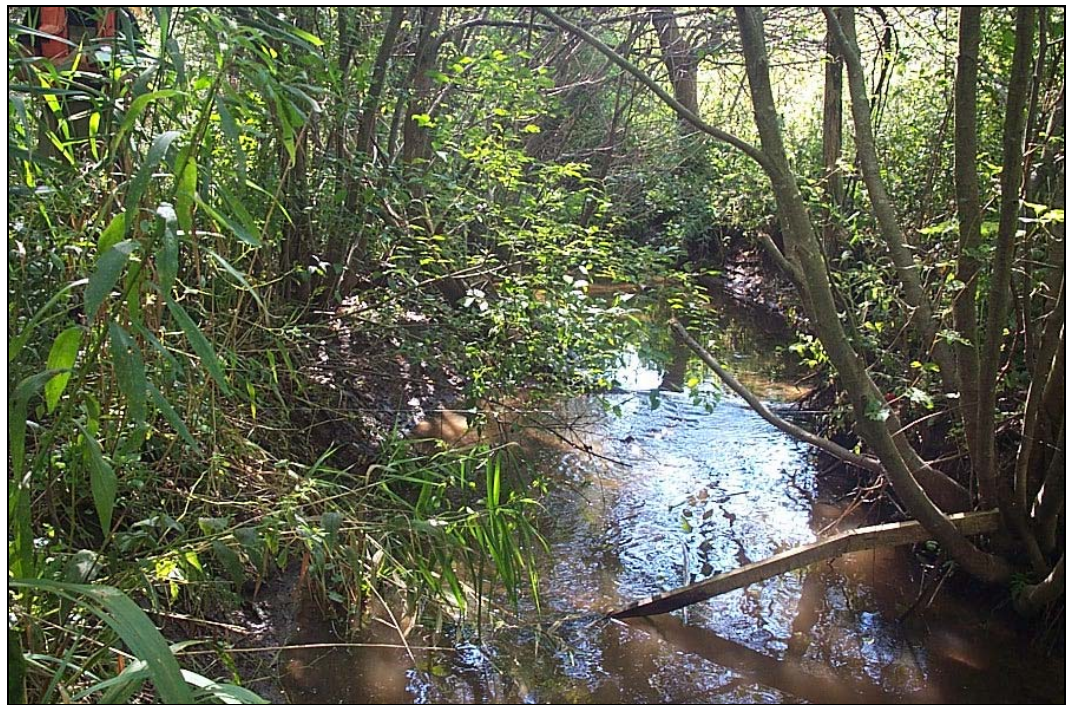
This short (500 feet) segment of Mussey Brook flows through a natural wetland that is created by the bedrock constriction at the downstream end. As shown below in Figure 26, segment M22-SI.01-SI.02-A has a very low slope, high sinuosity, and very dense riparian vegetation. It is an “E” type channel. This is the only reach in the Moon Brook watershed that received a geomorphic condition rating of “reference”.

Figure 26: Dense riparian vegetation stabilizes the narrow, deep, “E” type channel of segment M22-SI.01-SI.02-A.

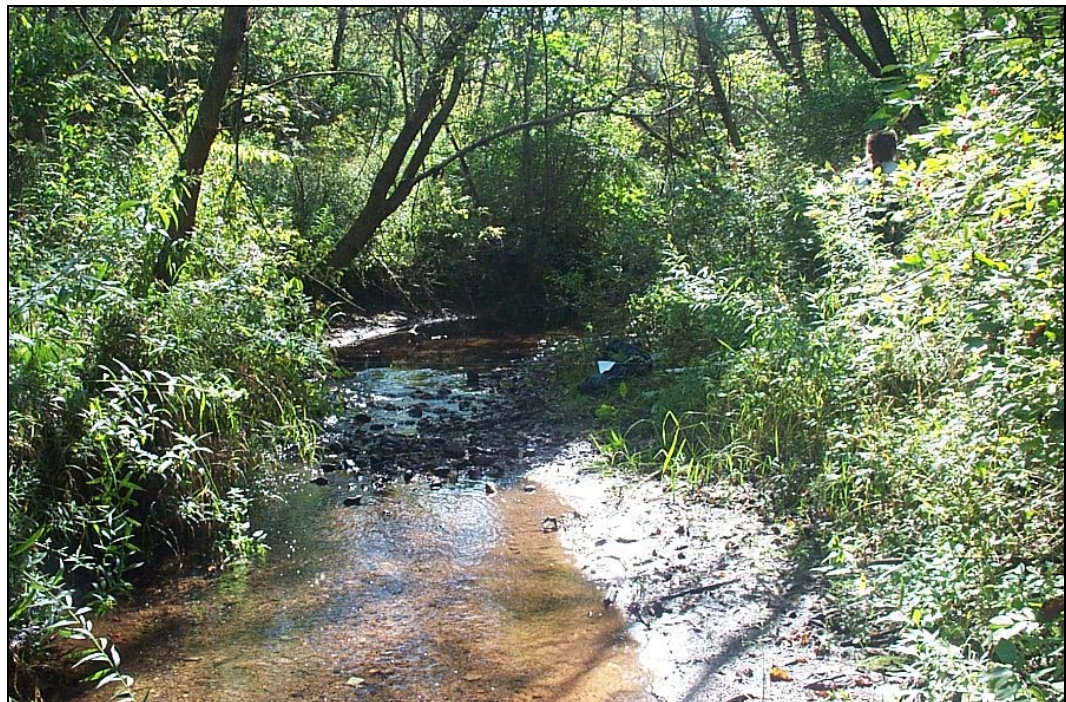
Segment B is also within the area once occupied by a human-made pond. The channel has incised and is in the process of building a new lower floodplain bench through widening and planform adjustment (Figure 27). This segment, with a high width to depth ratio is a currently a “C” type channel, a departure from its reference stream type of “E”. This segment is actively storing sediment through point and side bars and will narrow itself after it has recreated a floodplain. The reach has a healthy riparian forest that will lend to long term stability in this reach.

Figure 27: Segment M22-SI.01-SI.02-B is actively rebuilding a new floodplain bench through widening and planform adjustment. The formation of bars, such as the side bar on the right, is an indicator of this process.

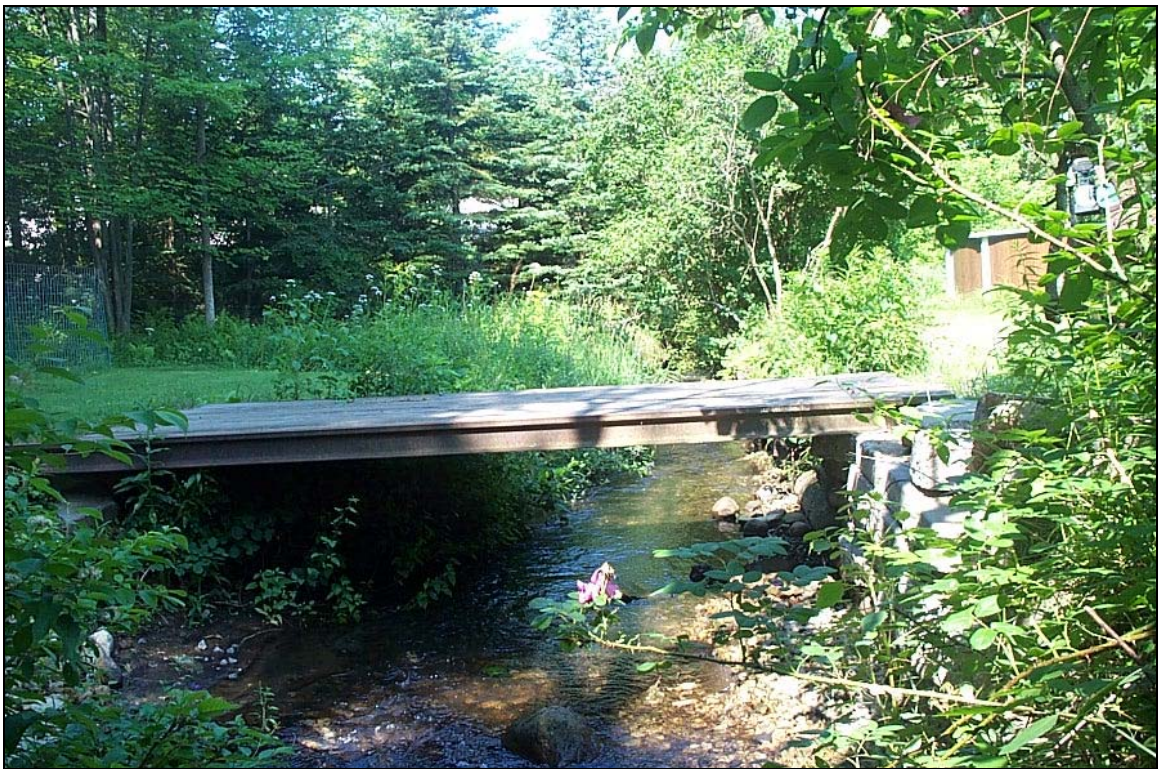
altered by floodplain encroachment and historic channel straightening (Figure 28). It is a C-type channel by reference; however, a human caused change in valley width has created a more entrenched “B” type channel through most of this segment. This stream type departure has also occurred in the bedform of the reach, where it has lost its habitat supporting riffle-pool bedform and is instead a plane bed system. Bank erosion appeared low in this reach in part due to the large cobble materials that lined the banks, stone walls, and log revetments that were installed to prevent channel migration and erosion.

Figure 28: Segment M22-SI.01-SI.03 has been altered by floodplain encroachments and historic channel straightening. It no longer has access to a wide floodplain and has become a plane bed, “B” type stream.

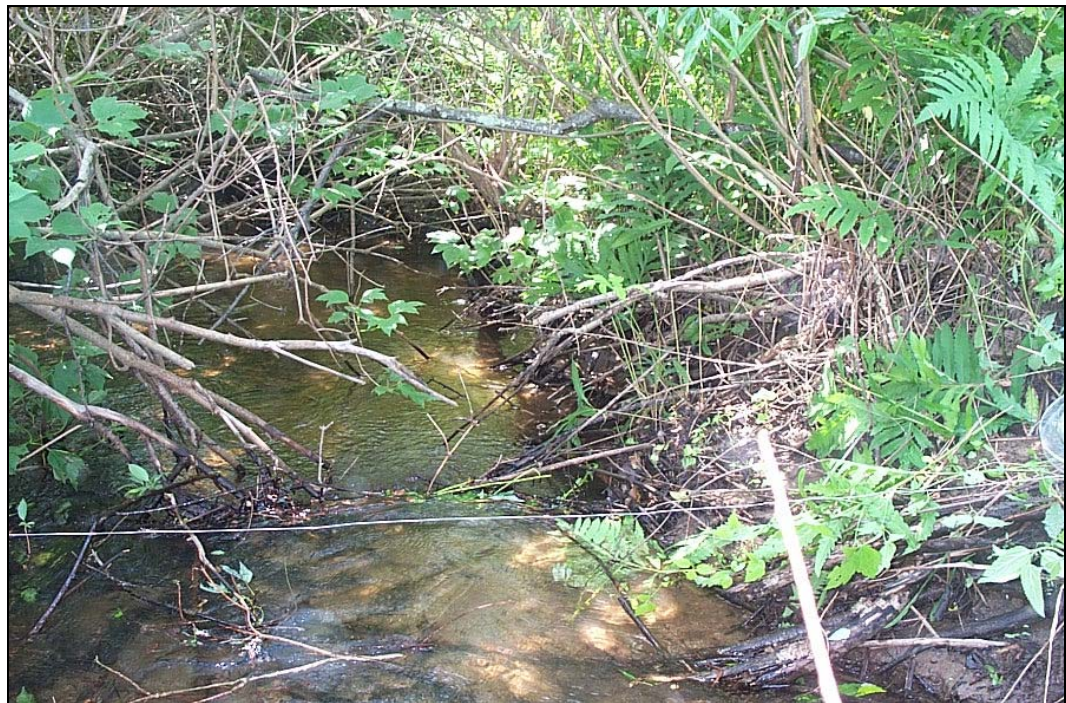
M22-SI.01-SI.04-A begins at the confluence of a major tributary to Mussey Brook. It is in good geomorphic condition, has a healthy riparian canopy and stable stream channel (see Figure 29). The larger riparian corridor, however, is impacted by hay fields. These hayfields have limited the buffer and are only between 5 and 25 feet wide on average.

Figure 29: Dense riparian vegetation stabilizes the “E” type channel of segment M22-SI.01-SI.04-A.

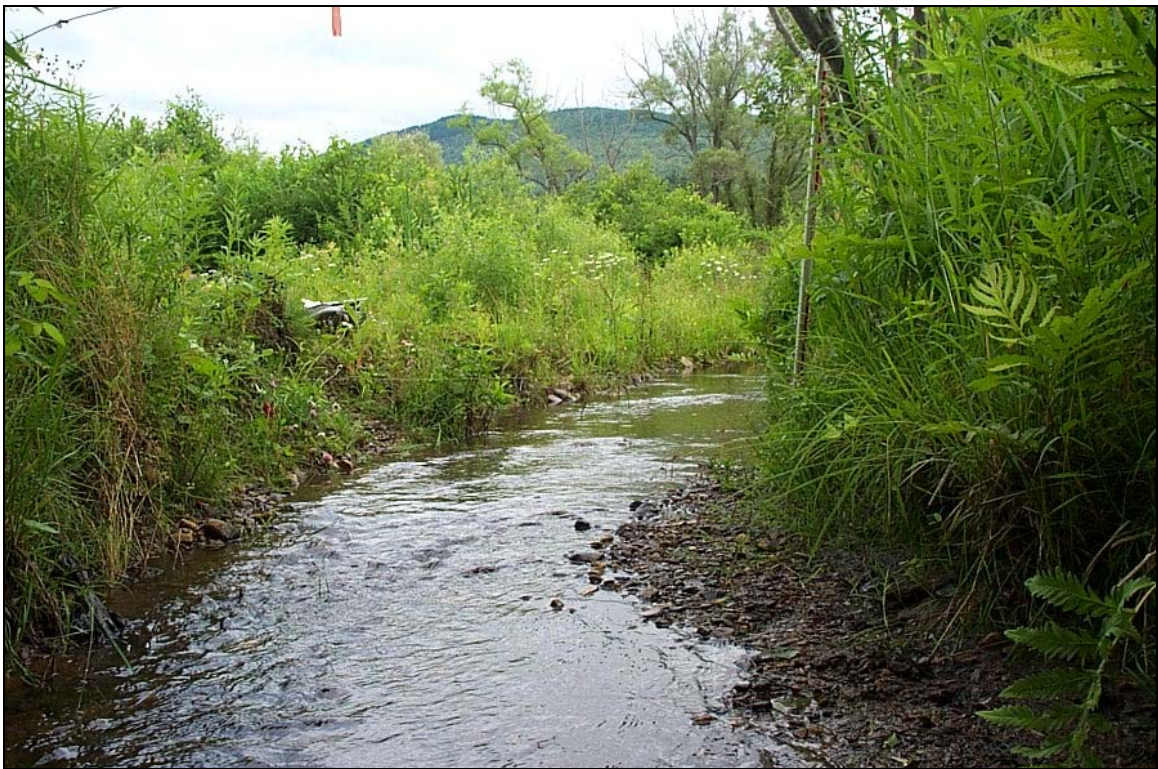
Mussey Brook reach M22-SI.01-SI.06 begins at the upstream end of an on-stream pond and continues just past a culvert on Dailey Road. Although much of the reach has been historically straightened, it appears to be in stable geomorphic condition and is not undergoing any major adjustments at this time (see Figure 31). Future stability might be encouraged by increasing the riparian buffer of this reach, which averages between 5 and 10 feet wide (see Figure 32), as well as by allowing it to regain access to its floodplain by removing berms that line approximately one quarter of the reach. An additional issue with this reach is the culvert at Dailey Road which has blown out in past floods. Residents have reported flooding of nearby buildings.

Figure 31: Cross section near the lower end of M22-SI.01-SI.06.

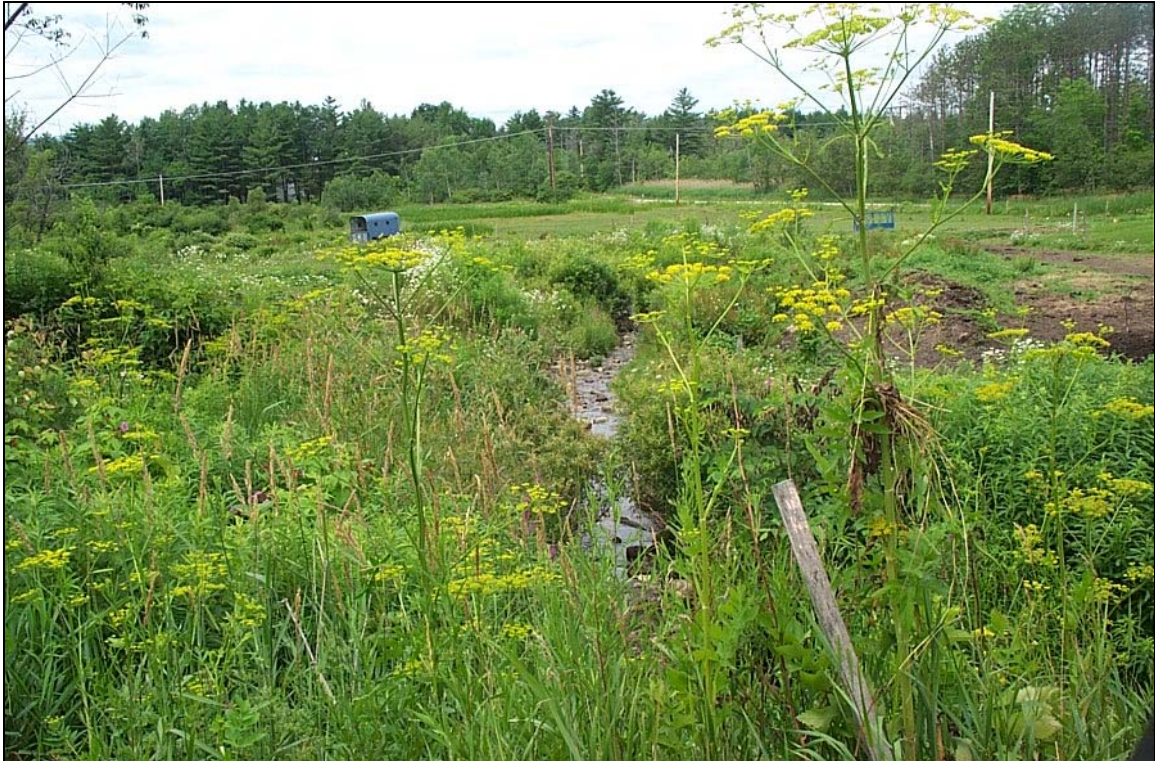
Figure 32: Historic channel alteration as well as development and livestock in the river corridor have affected reach M22-SI.01-SI.06.

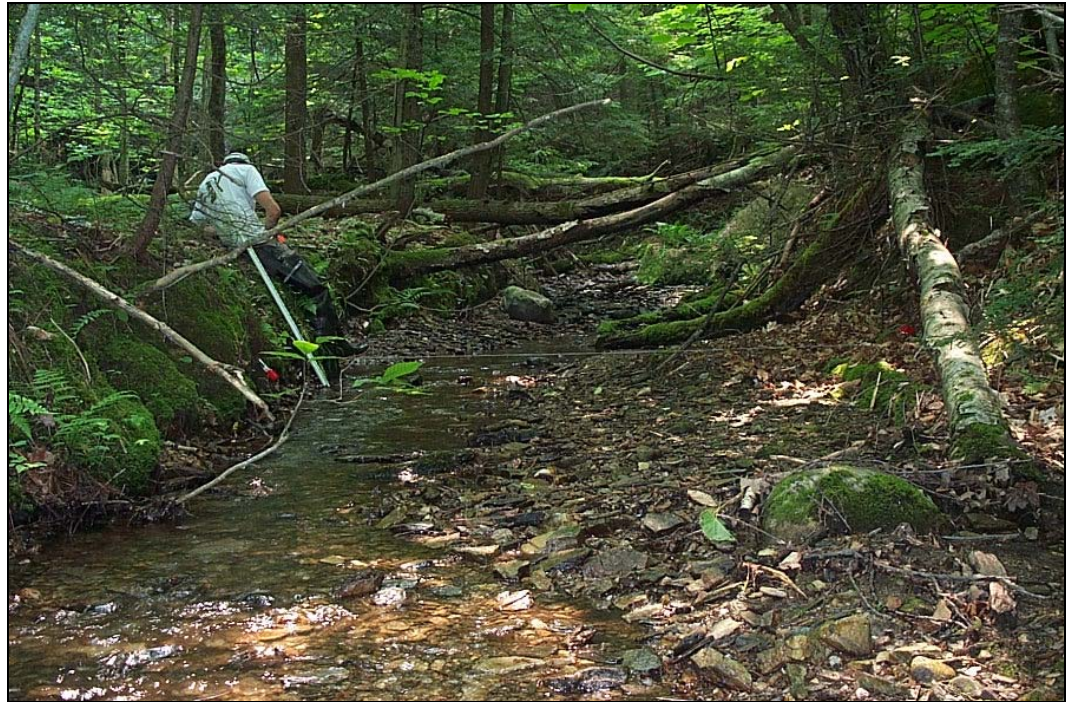
As shown below in Figure 33, segment M22-SI.01-SI.07-A is currently an “F” type channel and will continue to rework its banks and planform as it evolves back into a “C” channel.

Figure 33: Segment M22-SI.01-SI.07-A has incised. It is currently attempting to rebuild a new floodplain through planform adjustment and widening.

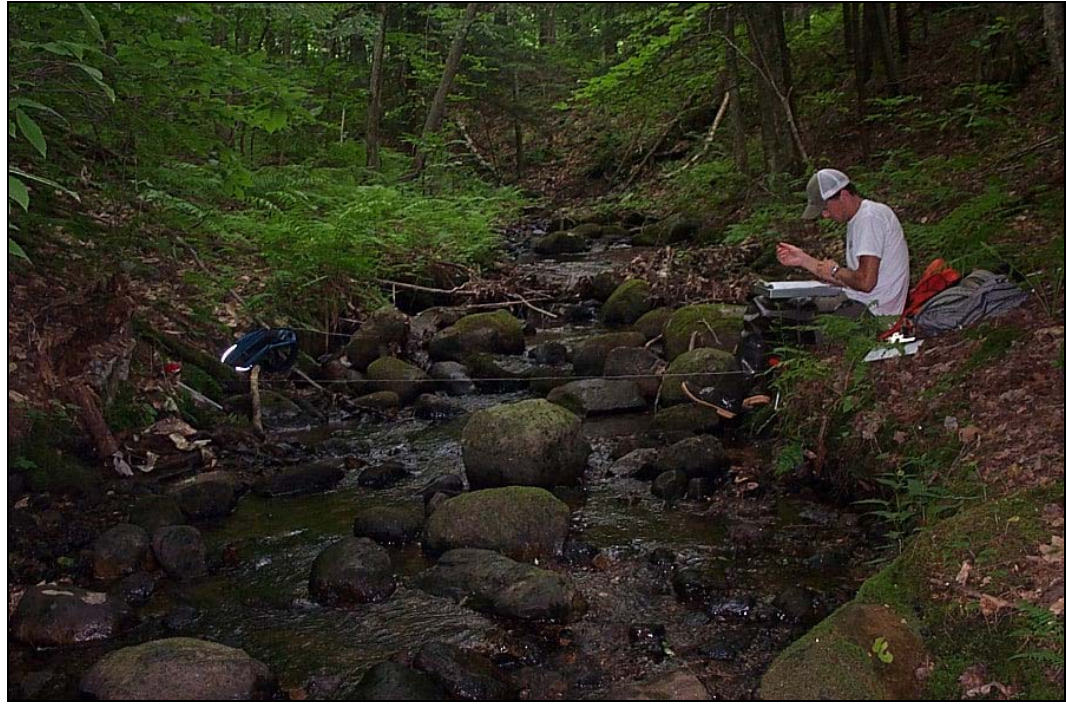
This reach begins at a ledge approximately 2000 feet from the beginning of the reach. The entire segment is dominated by a bedrock bottom stream that is mostly a cascade and step-pool bedform. It is an “A” type channel and is relatively stable. Bedrock control did not exist on the banks, however, and there exists the potential that the stream may widen or go through planform adjustment. As seen in Figure 34, there exists a healthy riparian buffer on both sides of this stream segment that are acting to slow and stabilize geomorphic adjustment processes as well as provide healthy habitat and shade to Mussey Brook.

Figure 34: Segment M22-SI.01-SI.07-B is an “A” channel dominated by a bedrock bottom.

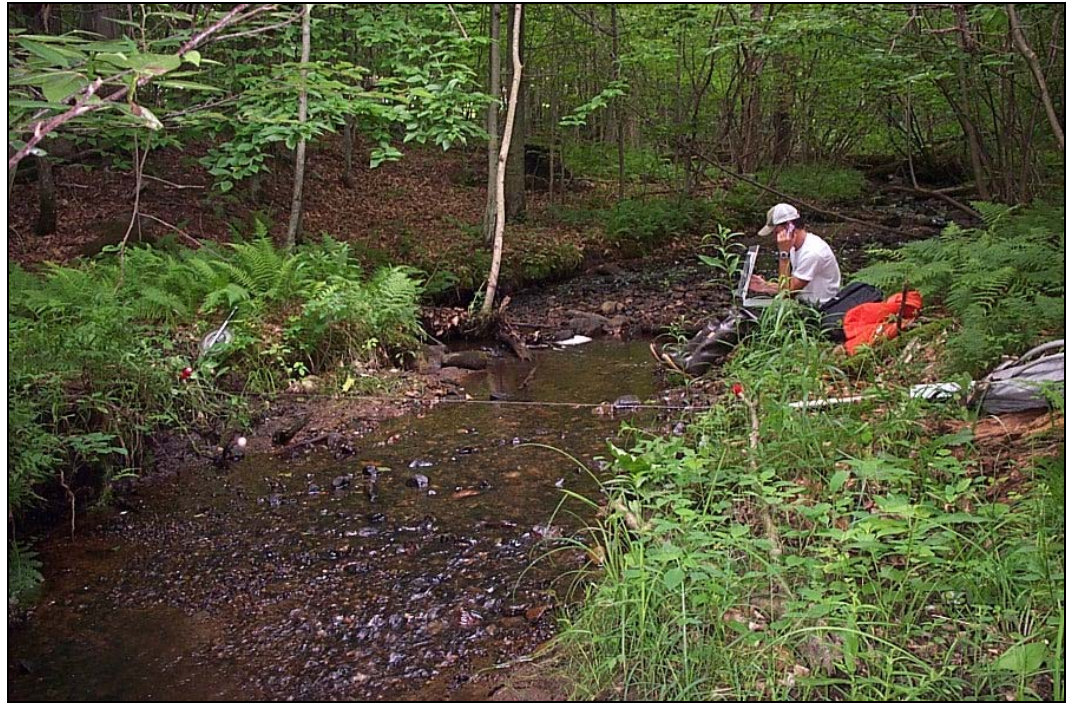
Segment M22-SI.01-SI.07-C is the highest reach surveyed by the Phase 2 team on Mussey Brook. It begins several hundred feet downstream of South Mendon Road where the bedrock control ends and continues to an on-stream pond that is upstream of South Mendon Road. This reach is a “C” type channel with a riffle-pool bedform (Figure 35). The Phase 2 assessment of this reach noted some minor signs of degradation, aggradation, widening, and planform adjustment. The reach has a healthy riparian buffer and floodplain access.

Figure 35: The riffle pool system of M22-SI.01-SI.07-C.
