Bear Creek Environmental

Phase I and Phase 2 Stream Geomorphic Assessments Moon Brook Watershed Rutland City, Rutland Town, and Mendon, Vermont

Final Report
January 25, 2006

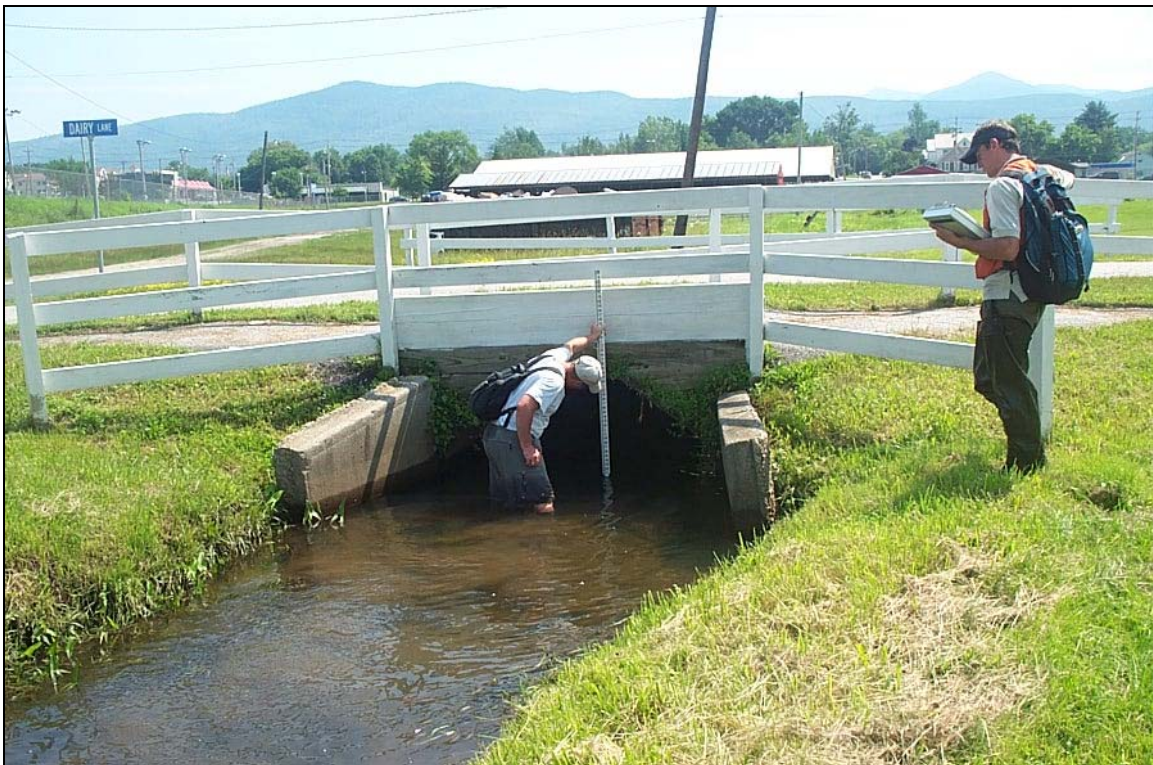
These anthropogenic practices have altered the delicate balance between water and sediment discharges. Channel morphologic responses to these practices contribute to channel bed degradation and/or aggradation that further create unstable channels. These morphologic changes tend to migrate both upstream and downstream contributing to system-wide instability. (Ryan 2001)

Figure 36. Undersized culverts, like this one on reach M22-S1.01-S1.01-B, disrupt the sediment transport capacity of the stream and often lead to both upstream and downstream destabilization.

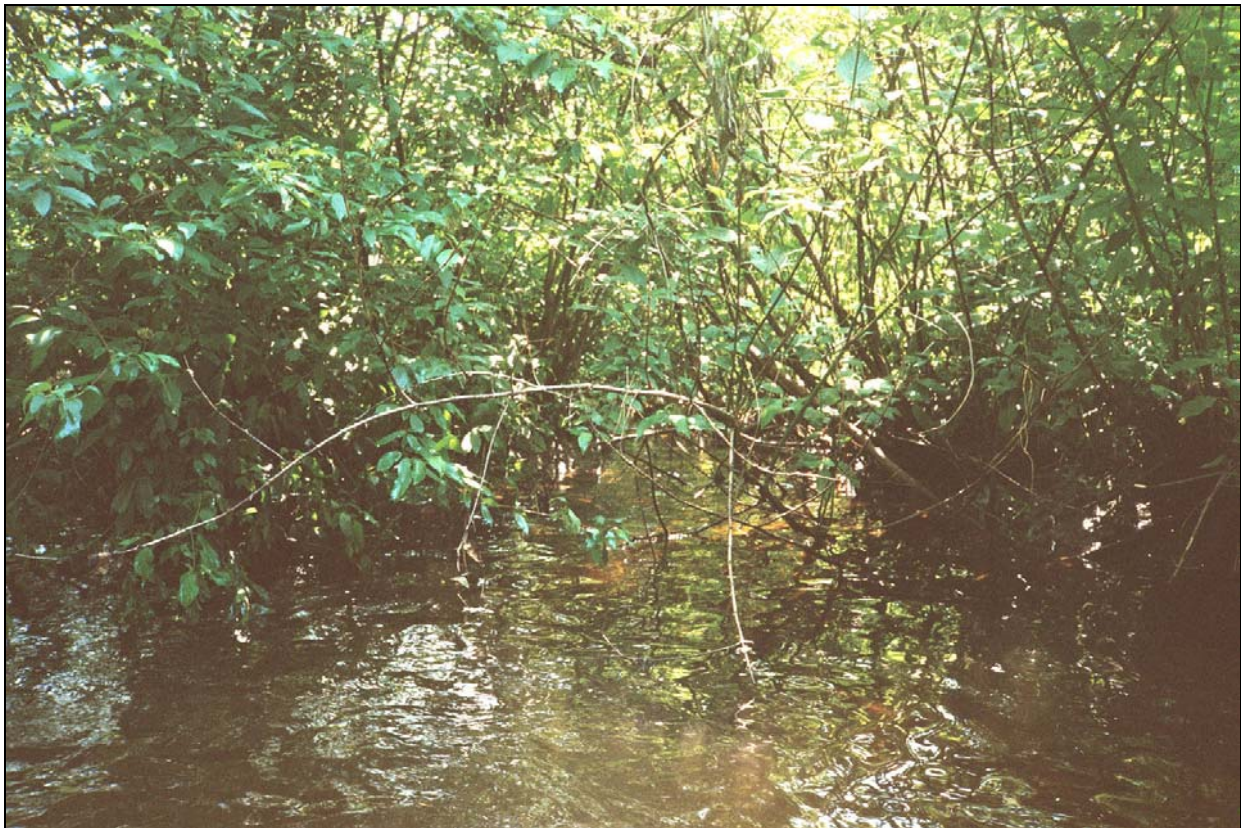
Figure 39. Reach M22-SI.03-A (Moon Brook) rated good for habitat. As depicted in the photograph the stream had an abundance of bank cover, riparian vegetation, and deep pools.

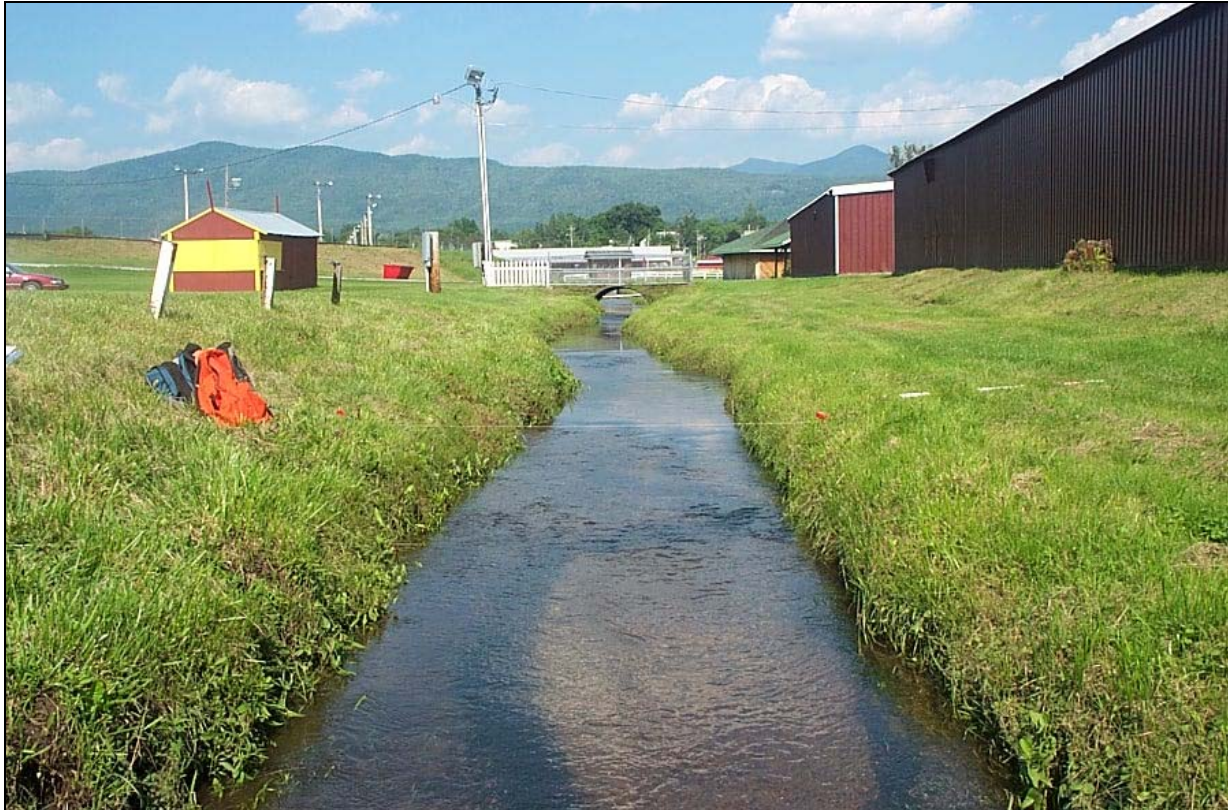
Figure 40. Reach M22-S1.01-S1.01-B (Mussey Brook) rated poorly for habitat. As depicted in the photograph the stream lacked instream habitat, riparian vegetation, a riffle-pool system due to historic straightening, and was heavily embedded with fine particles of sand.
