Bear Creek Environmental

Phase I and 2 Stream Geomorphic Assessments Roaring Brook Watershed Killington, Vermont

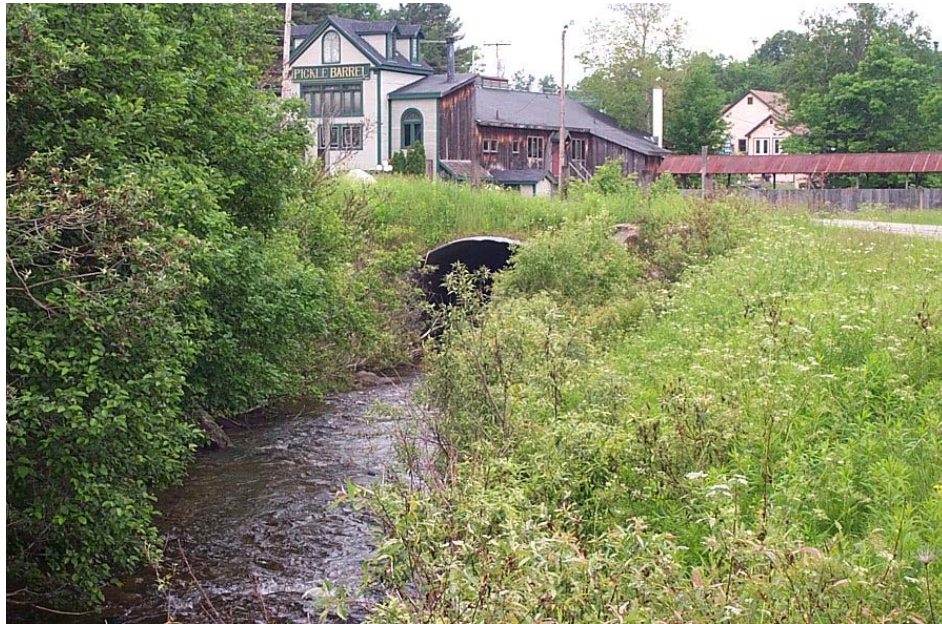
3.1.2 PHASE 2 QA/QC REVIEW	28
3.2 PHASE 2 RESULTS	29
3.2.1 REACH T6.01	29
3.2.2 REACH T6.02	31
3.2.3 REACH T6.03	32
3.2.4 REACH T6.04	33
3.2.5 REACH T6.05	35
3.2.6 REACH T6.06	35
3.2.7 REACH T6.07	37
3.2.8 REACH T6.08	38
3.3 GEOMORPHIC CONDITION SUMMARY.....	40
3.3.1 CHANNEL MANAGEMENT HISTORY.....	40
3.3.2 REACH CONDITION.....	41
3.3.3 CHANNEL EVOLUTION.....	44
3.3.4 STREAM SENSITIVITY	46
3.4 PHASE 2 HABITAT EVALUATION	49
SECTION 4: OUTREACH AND EDUCATION.....	52
SECTION 5: RECOMMENDATIONS	52
SECTION 6: REFERENCES.....	53

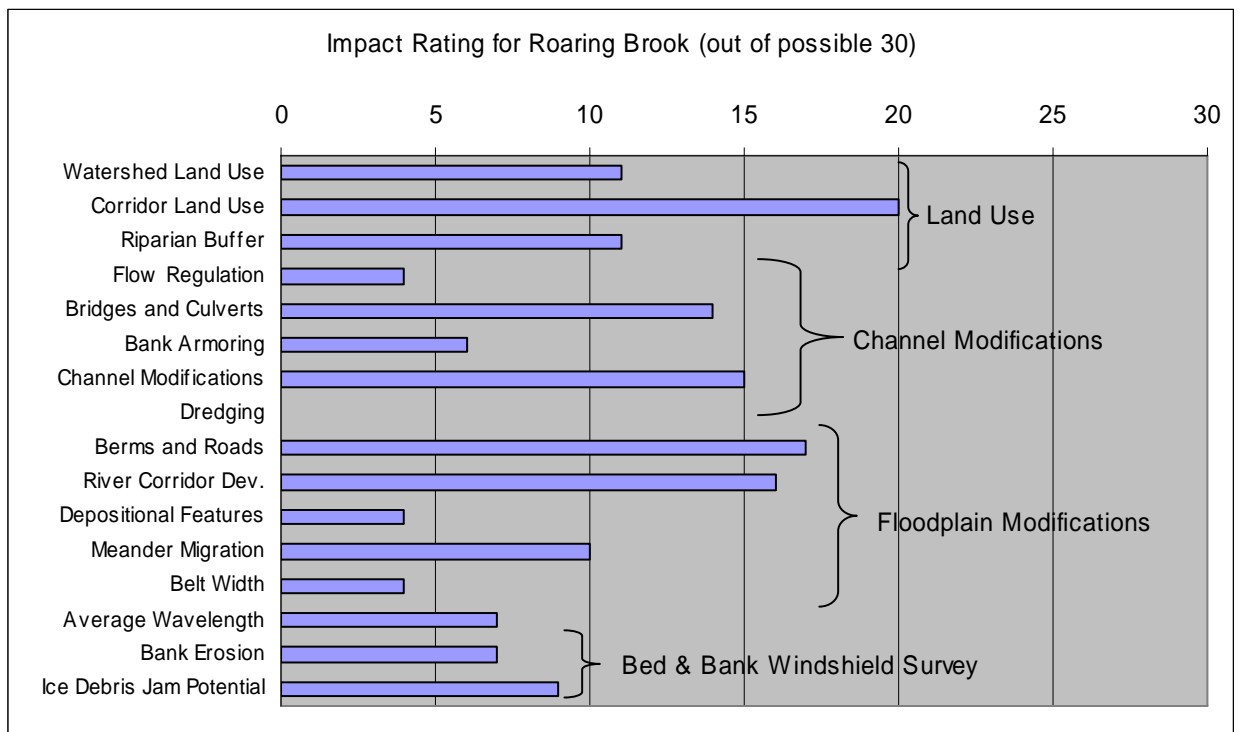
Figure 9: Impact Rating for Roaring Brook Watershed by Parameter and Category

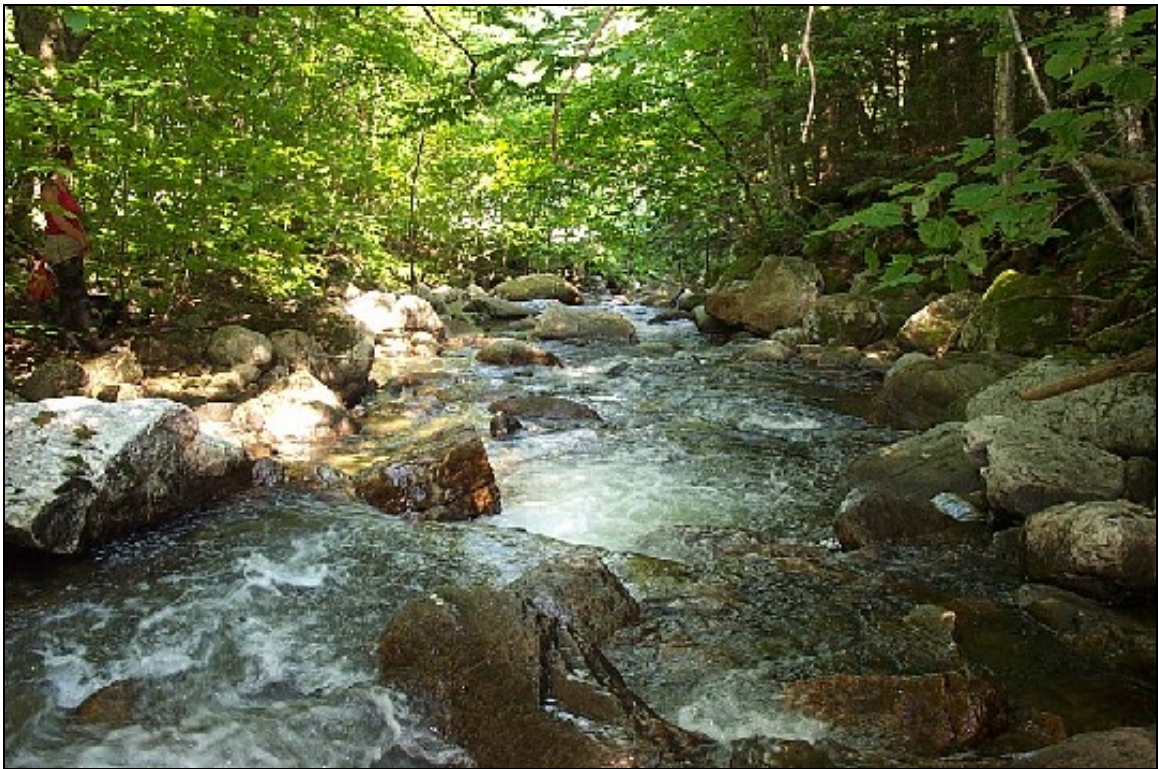
Figure 14: Segment T6.01-B has a step-pool bedform and good riparian conditions.

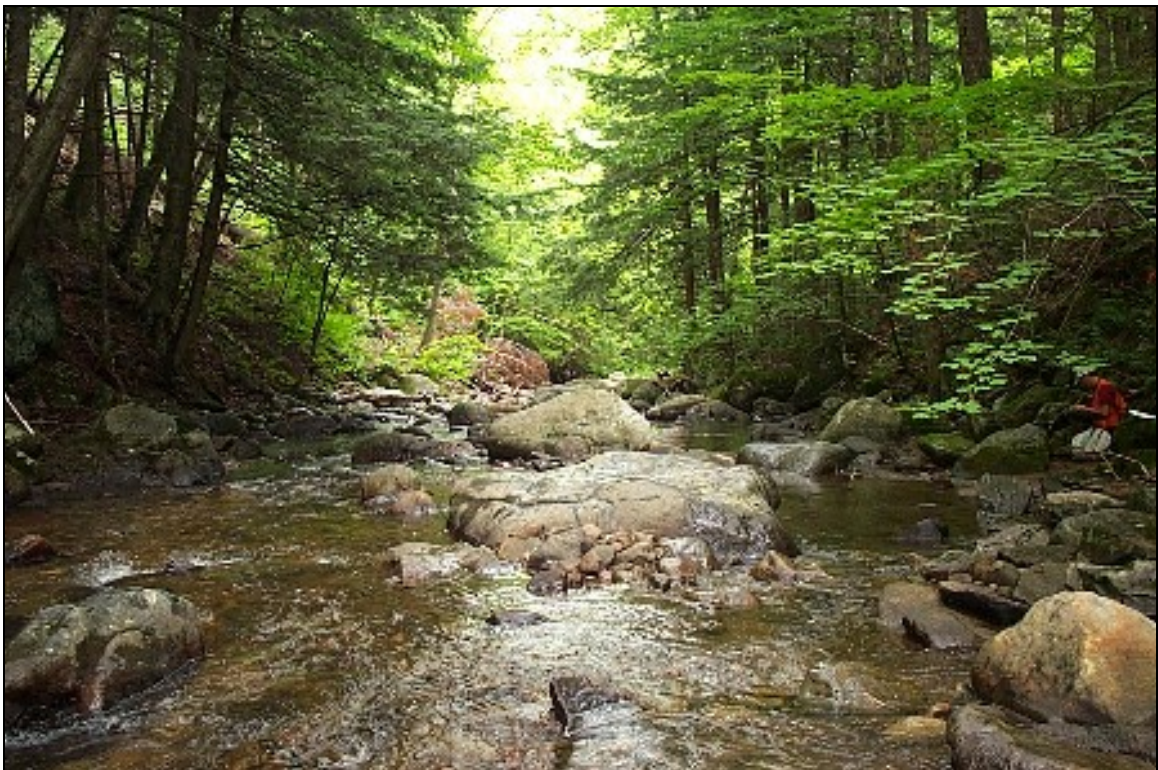
Figure 15: T6.02 is a naturally wide, highly entrenched channel with excellent riparian conditions.

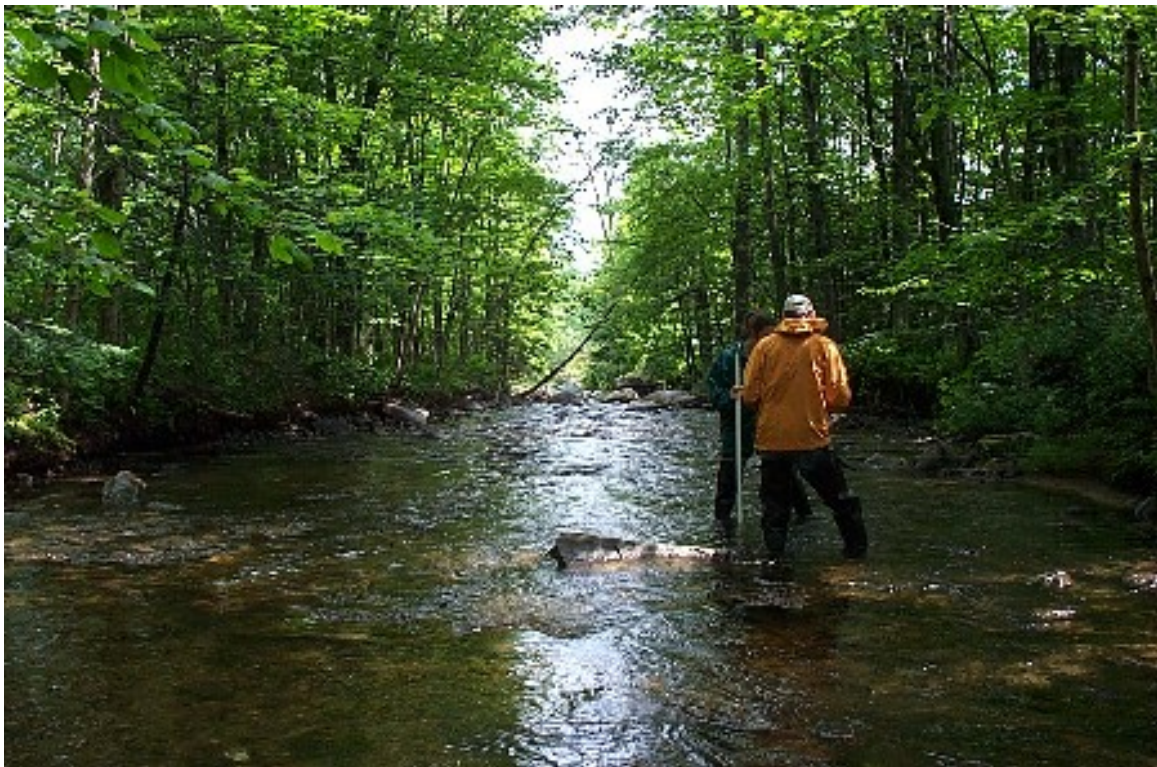
Figure 16: Active aggradation and widening of Reach T6.03.

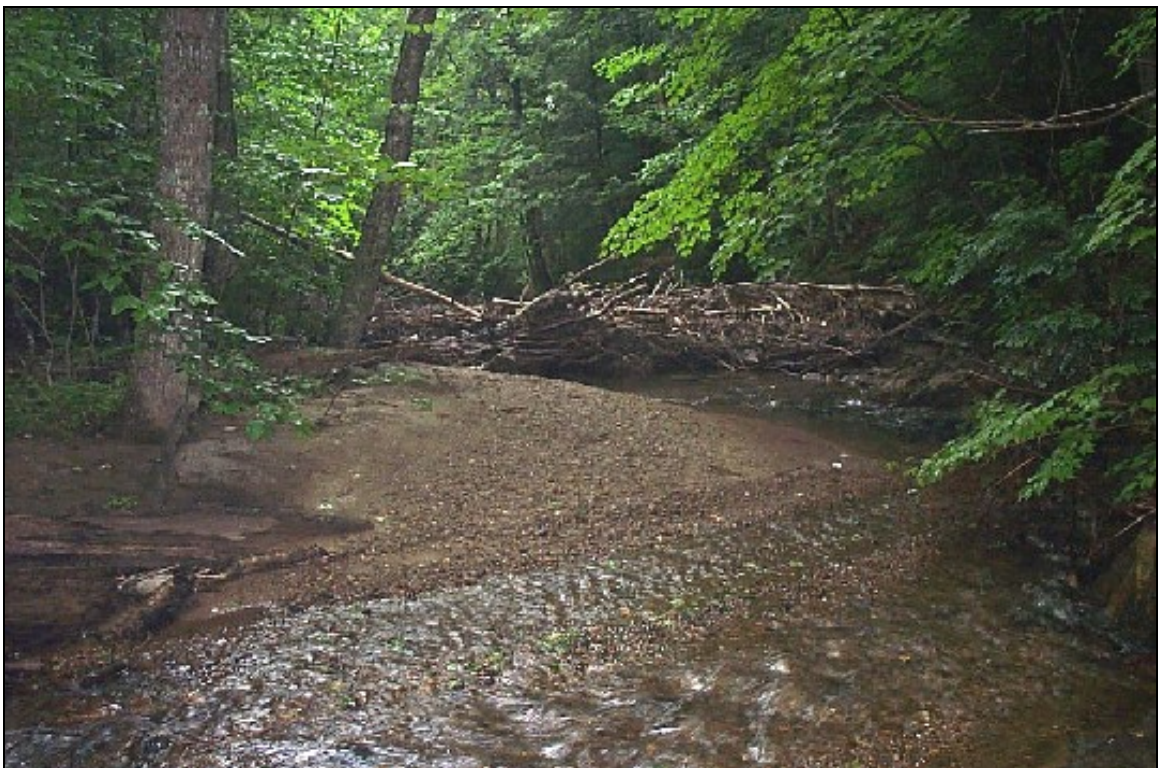
Figure 20: Major sediment buildup at a debris jam along T6.07.

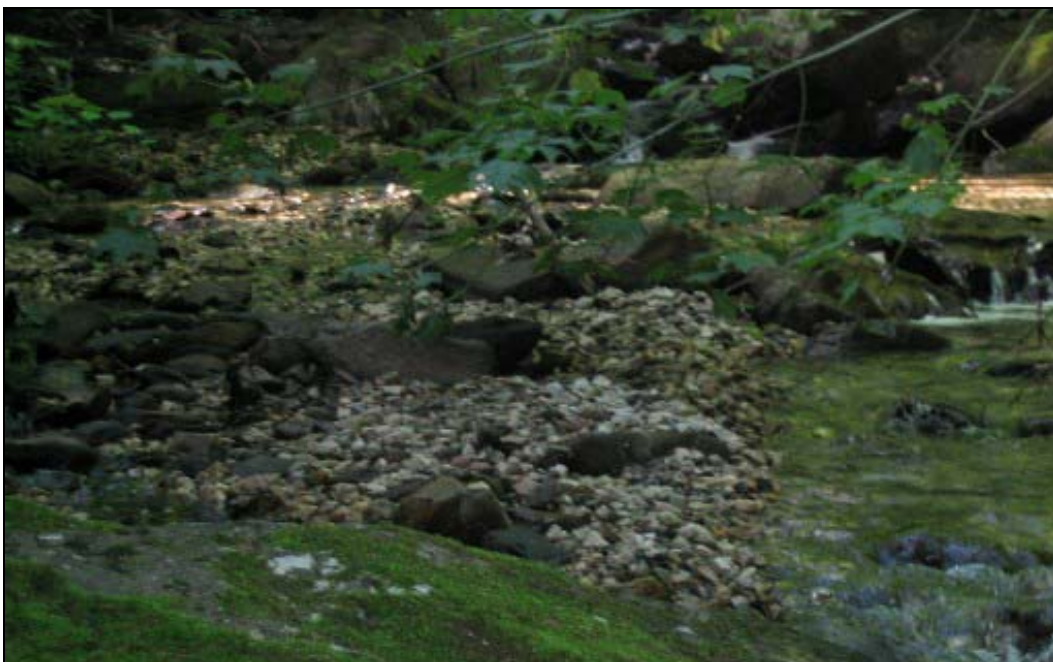
Figure 23: Abundant road gravels and sediment are entering the Roaring Brook system at Reach T6.08.

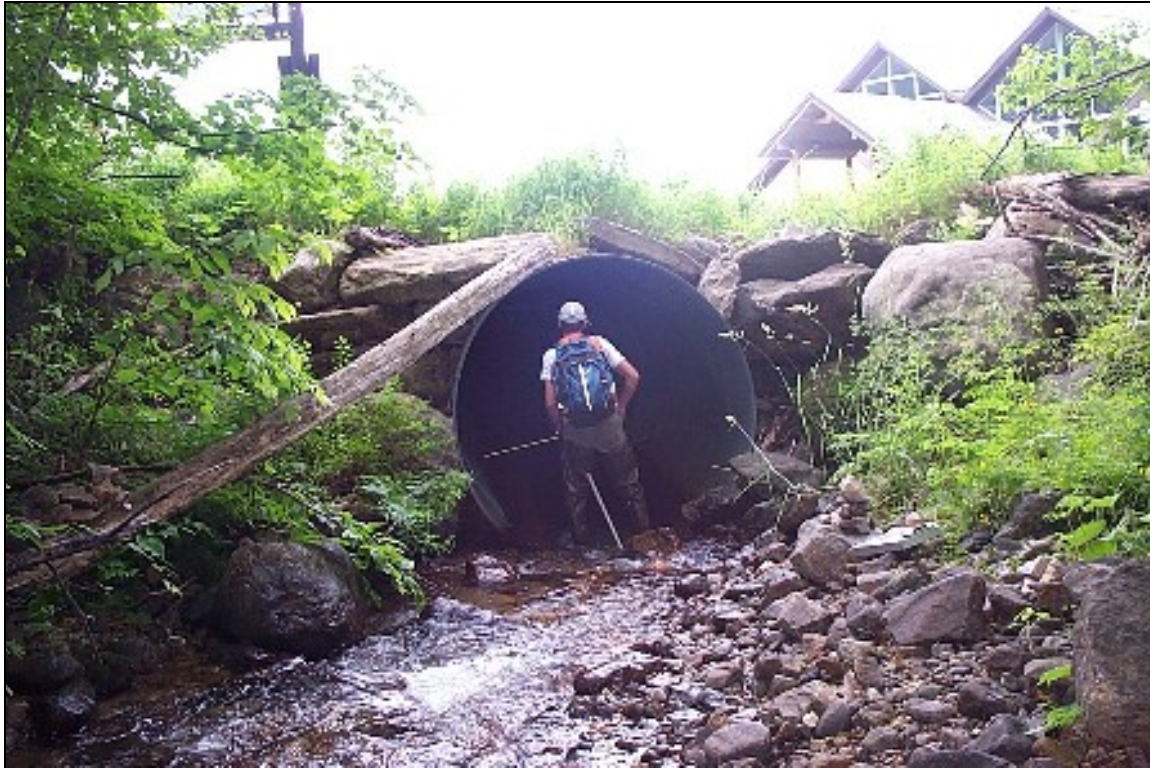
Figure 26: Reach T6.07 rated “fair” for habitat. The reach lacked in-stream woody habitat, riparian vegetation, a riffle-pool system due to historic straightening, and was heavily embedded with fine particles of sand.
