# **Fluvial Geomorphology Assessment of the Lower Winooski River, Vermont**

Prepared for

Winooski Valley Park District  
Burlington, VT

August 2006

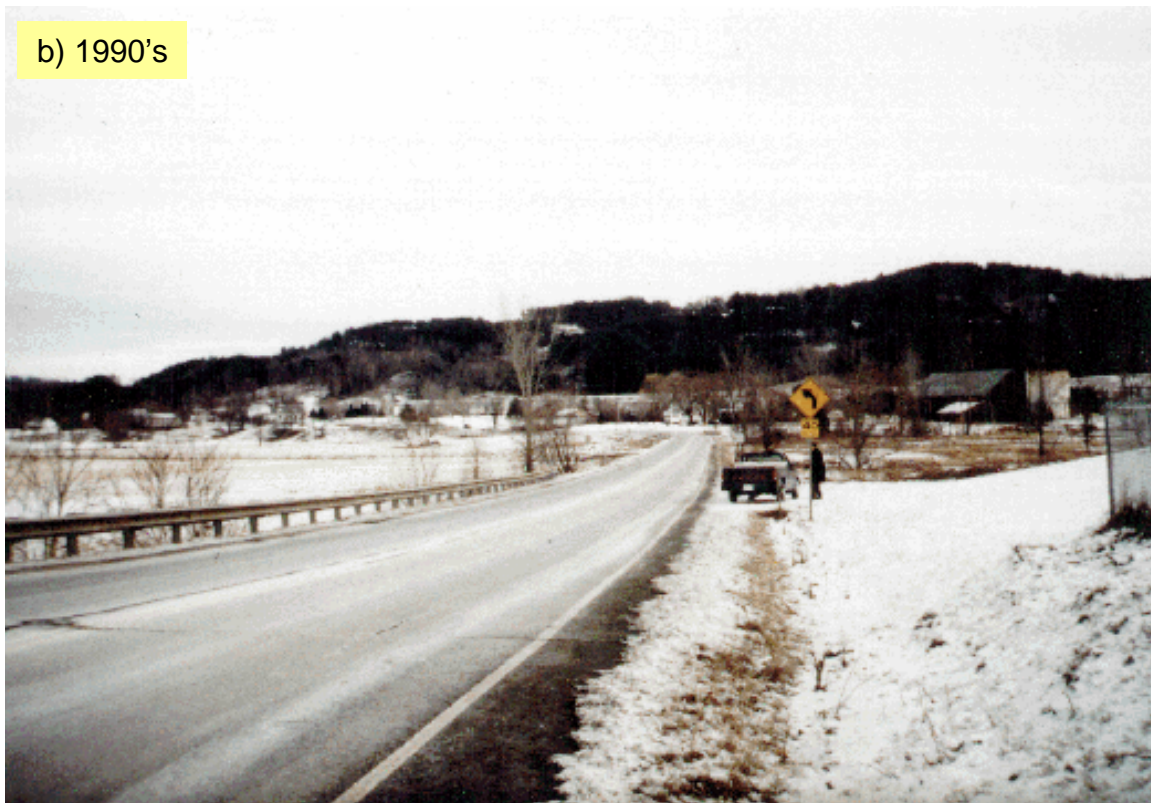
## Changing Land Use in the Winooski River Watershed

Extensive land clearance in the watershed can increase runoff and sediment delivery to the river channel. In the 19<sup>th</sup> Century most of the Winooski River watershed was cleared of its forest cover for agriculture (Figure 6a), a condition that persists today along valley bottoms where agriculture and urbanization are important (Figure 6b).

Hillslopes in the watershed are now largely tree covered (Figure 6b), but the river's morphology may still reflect events that occurred several decades ago. A change to a more forested land cover results in a reduction of peak discharge through increased evapotranspiration. Under the current conditions of forested hillslopes, a National Weather Service study demonstrated that the peak stage of the Winooski River would have been over 4.0 feet lower compared to the 1927 flood for the same amount of rainfall (Greg Hanson, personal communication, 2006). Consequently, the damages wrought by the 1927 flood along the length of the Winooski River would have been greatly reduced had there been a greater forest cover throughout the watershed (Figure 7).

Note: Photos taken at same location in Richmond, VT. Note increased forest cover on hillslopes. Courtesy of NRCS.

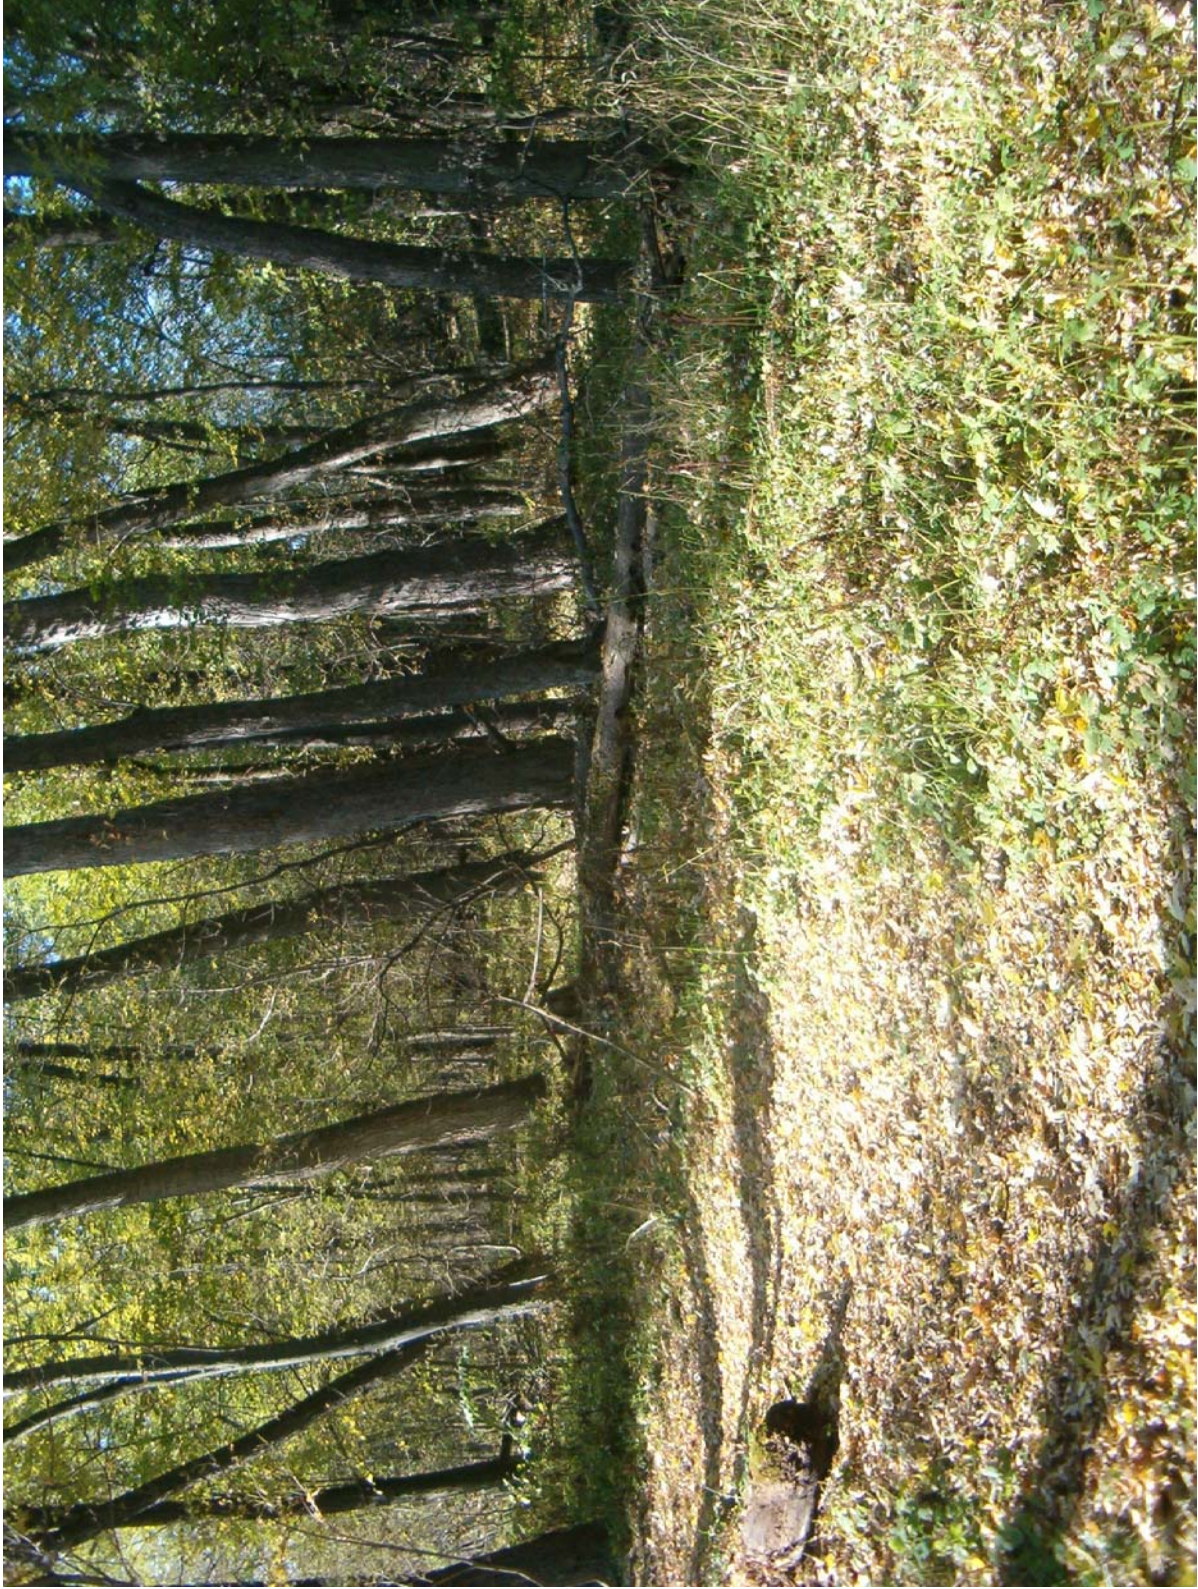
Forest Growing on Gravel Bar Deposited During 1927 Flood

The high incision ratio ( $> 1.4$ ) in the reach reflects the difference in height between the remnant floodplain and the gravel bar (i.e., the emerging floodplain). While a high incision ratio is sometimes symptomatic of a direct response to human activities such as channel straightening, the condition in Subreach R02-B appears to be the result of a single large flood in November 1927. The dramatic effects of the flood, however, may have been amplified by the removal of the riparian buffer along the stream, land clearance in the larger watershed, and other human activities.

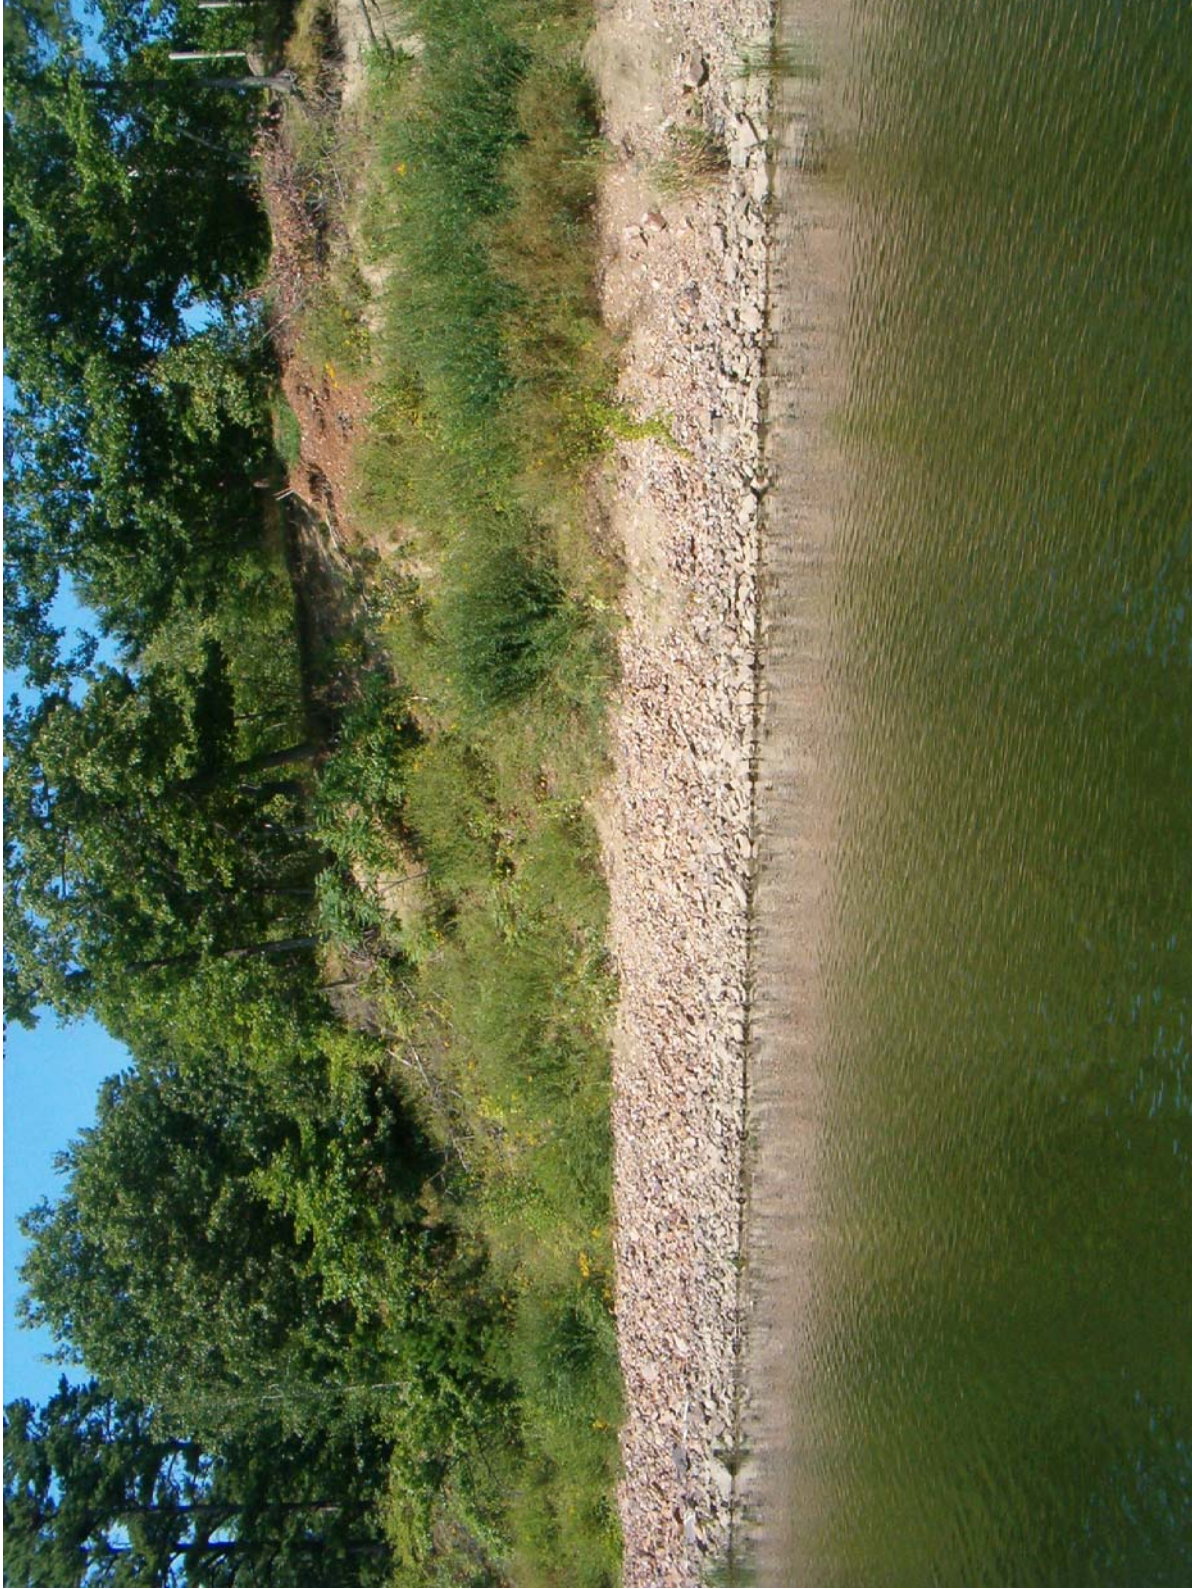
## Rock Revestment in Intervale (Reach R01)

Bank armoring with large rocks (i.e., riprap) can prevent bank erosion where applied, but can also create channel instabilities that transfer the erosion to adjacent portions of the river bank. Bank armoring is observed in all of the reaches, even in the bedrock lined Winooski Gorge at railroad bridge abutments (Reach R03)(Appendix 2). The total amount of riprap in any one reach is less than 10 percent of the reach length such that the bank armoring impact rating is “not significant” in all six reaches. Much of the armoring occurs at bridge crossings where the rock protects abutments. Although several current or previous crossings are found in most of the reaches (only Reach R04 has no bridge crossings), their spans are sufficient enough to not cause a constriction of the channel that would impact channel morphology during small to moderate floods.

- Promotes accelerated erosion elsewhere
- Expensive if properly constructed
- Inconsistent with natural evolution of channel towards equilibrium condition
- Little infrastructure in immediate need of protection

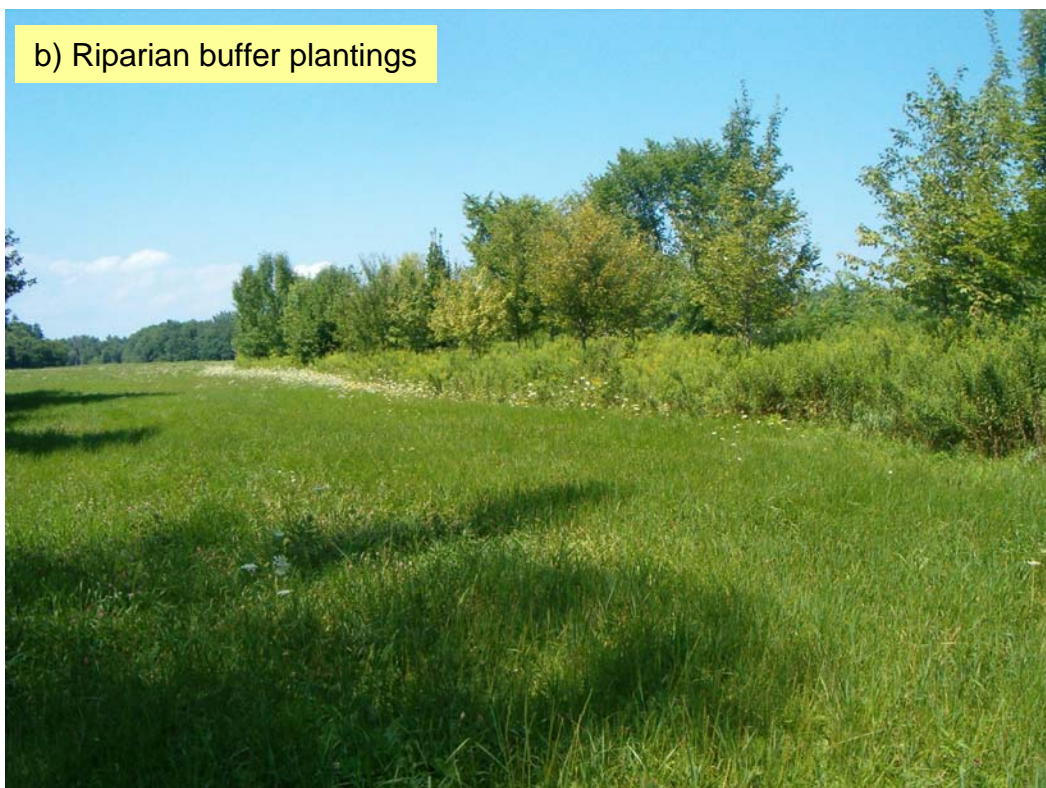
## Bank Stabilization Efforts at Ethan Allen Homestead

Note: Looking upstream. Several other log deflectors removed by erosion towards top of photo

Log deflectors installed in the bank and built out into the river can deflect water away from the bank and prevent or slow erosion. The deflectors also provide cover habitat for fish and pools can be scoured at the ends of the deflectors to provide further cover. Deflectors were installed at the Ethan Allen Homestead in conjunction with riparian buffer plantings in 1999. Most of the deflectors have since been dislodged from the bank or severely damaged (Figure 18a), but recession of the bank in this locality may have been slowed sufficiently to enable the buffer plantings to become well established (Figure 18b). Even where log deflectors are not damaged by bank erosion, they would be only temporary features as they would slowly decompose over time. Consequently, their benefit would be to reduce rates of bank erosion over short time periods while riparian buffer plantings installed with the project had time to mature. Because the log deflectors would deteriorate over time, they would not prevent the long term achievement of channel equilibrium. However, the cost of installation compared to their short-lived nature and higher risk of failure might preclude their widespread use.

- Risk of failure due to continued erosion around and between installed structures
- High cost of installation may prevent widespread application
