White Creek and Mill Brook Corridor Plan Rupert, Vermont

April 11, 2013

Fitzgerald Environmental Associates, LLC.
18 Severance Green, Suite 203
Colchester, VT 05446

**Bennington Country
Conservation District**
PO Box 505, 310 Main St.
Bennington, V T 05201

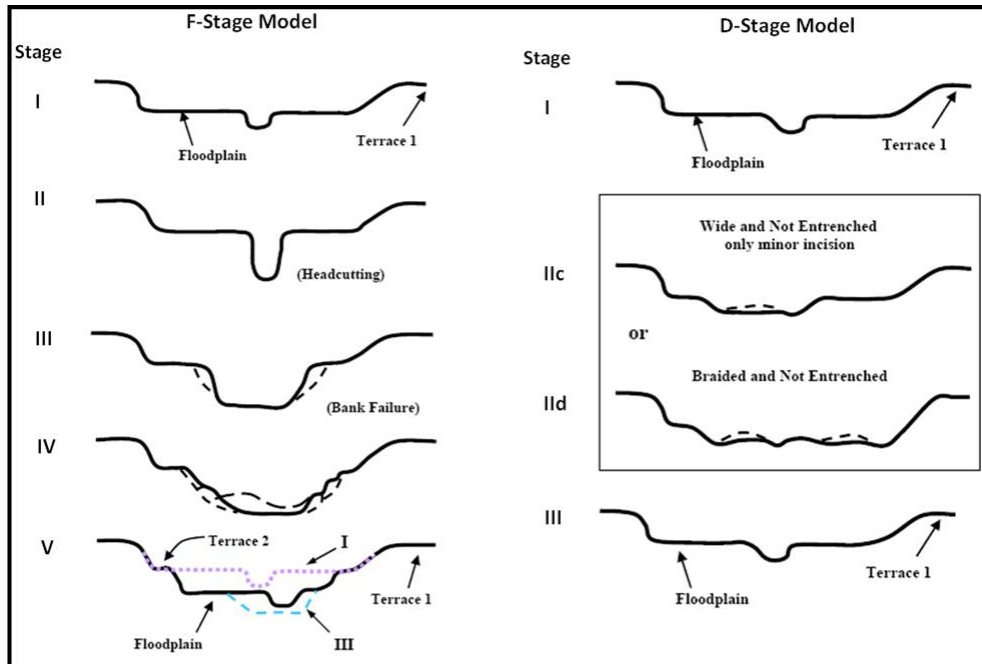
Figure 3.1 Typical channel evolution models for F-stage and D-stage (VTDEC, 2009)

Channel evolution models (CEM) also provide a basis for understanding the temporal scale of channel adjustments and departure in the context of SGA Phase 2 results. Both the “D” stage and “F” stage CEMs (VTDEC, 2009) are helpful for explaining the channel adjustment processes underway in the West Branch watershed. The “F” stage CEM is used to understand the process that occurs when a stream degrades (incises) its bed. The more dominant adjustment process for the “D” stage channel evolution is aggradation, widening and planform change. D-stage CEM typically occurs where grade controls prevent severe channel incision and abandonment of the adjacent floodplain. The common stages of both CEMs are depicted in Figure 3.1 below.

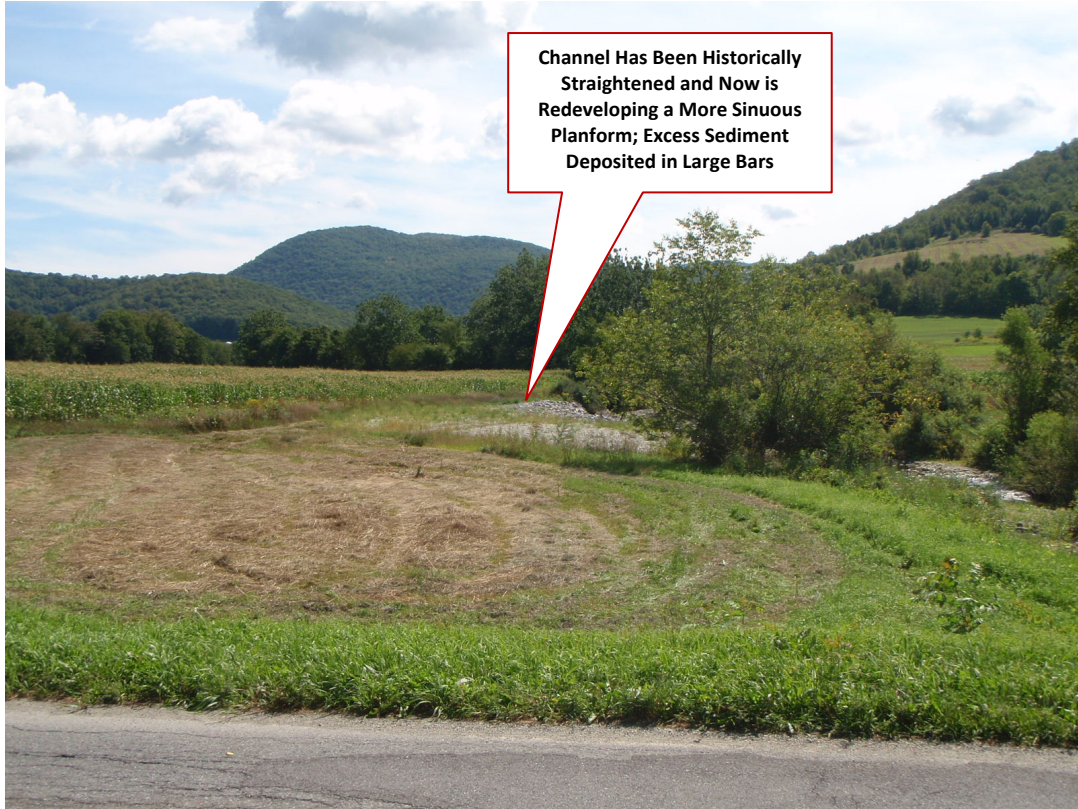
Figure 4.4 Looking upstream at hay and corn fields from VT153 bridge. White Creek Segment M01-B.

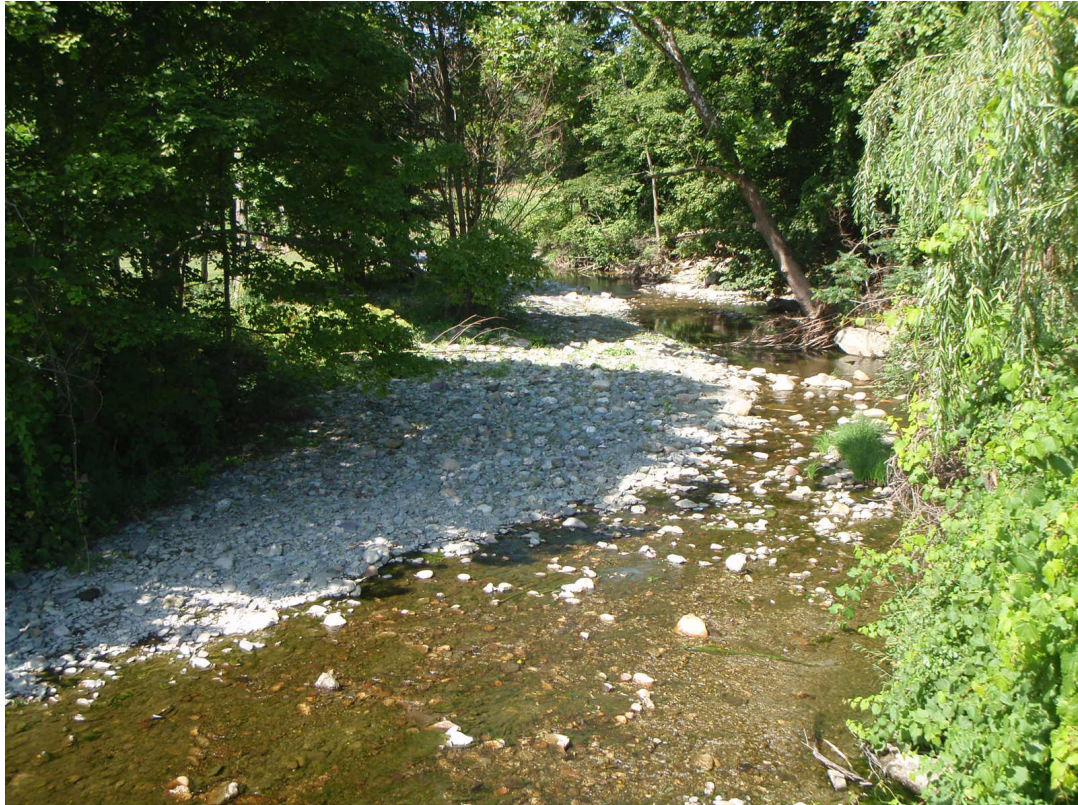
Figure 4.5 Looking downstream from VT153 bridge at depositional features in White Creek Segment M01-A.

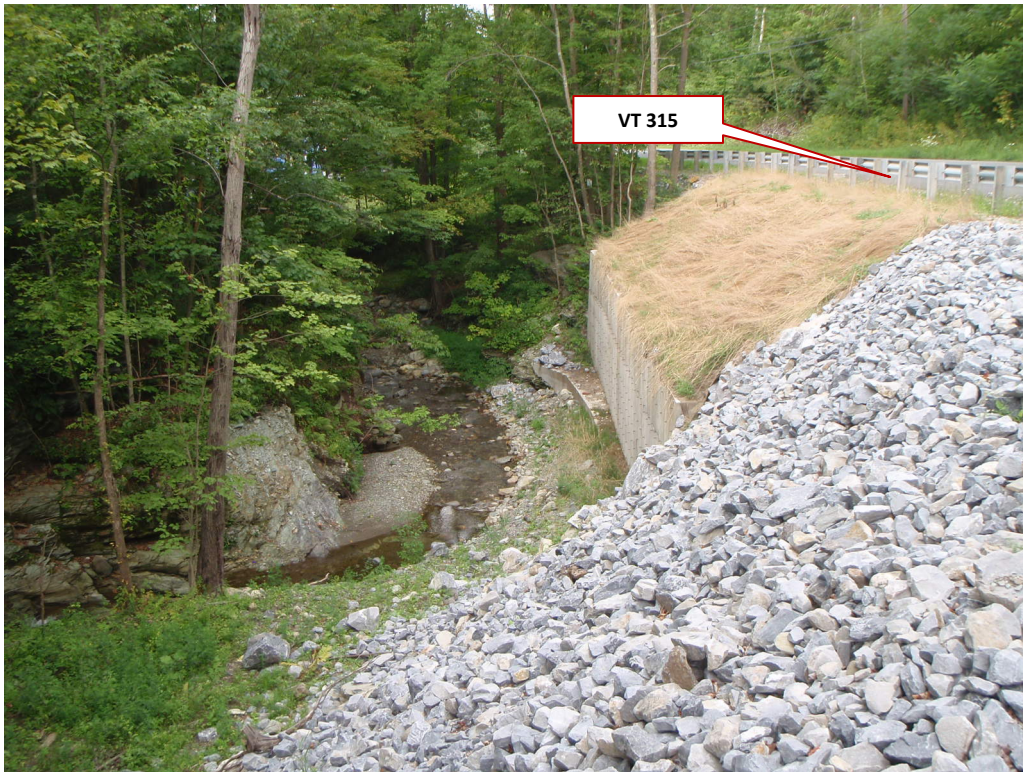
Figure 4.7 Encroachment of VT315 on Mill Brook corridor. Example of using a vertical wall to minimize road encroachment for road-river compatibility. Reach M01T1.03.
