**Town of Richmond Phase I  
Stream Geomorphic Assessment Report**

September 27, 2007

Chittenden County Regional Planning Commission  
South Burlington, Vermont

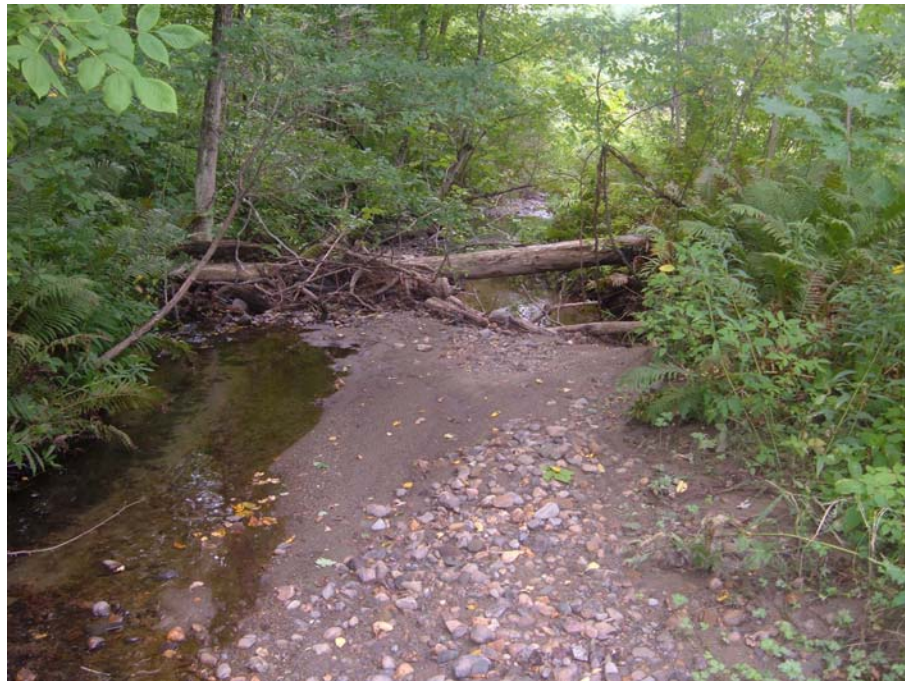
- **R8.S1.03:** This mainstem reach is found to the east of Governor Peck Road upstream of an area of historic beaver activity. The reach is characterized by a moderate-gradient, gravel-bottomed channel with C-type geometry. This reach has received a high impact rating due to the observed changes in planform (28% of the reach has been straightened), and the road encroachment which has led to a reduced floodplain and corridor. Some depositional features were observed during the field visit (Figure 1), indicating the potential for future lateral adjustments.

Figure 1. Depositional feature in reach R8.S1.03

- **Governor Peck Road Tributary:** Seven reaches are recommended for further Phase 2 assessment in this watershed:
  - **Reaches R8.S1.01 to R8.S1.03 (high priority)** should be investigated in further detail to determine the impacts of historic straightening and a lack of vegetative buffer, and to evaluate the potential for stream corridor protection given the encroachment of agricultural, commercial, and residential land uses. This effort would also involve landowner outreach to assess the social constraints to stream restoration.

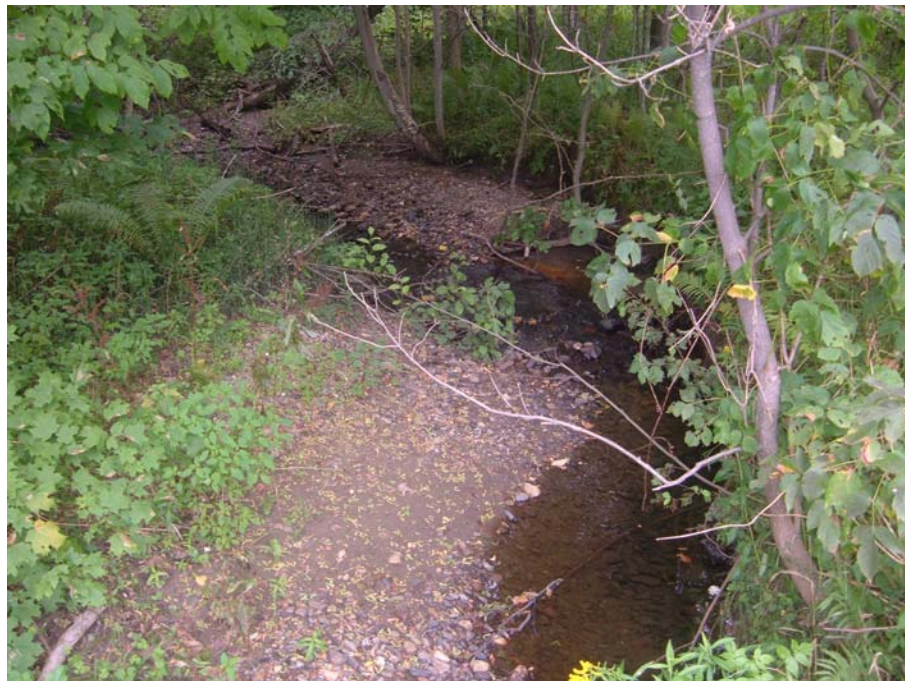
- **R8.S1.05:** This mainstem reach is found along Governor Peck Road from the confluence with the subtributary upstream to where the channel bends to the east away from the road. The reach is characterized by a moderate-gradient, gravel-bottomed channel with C-type geometry. This reach has received a high impact rating due to the encroachments, stormwater

discharges, and undersized culverts associated with Governor Peck Road. Two culvert crossings appear to be inadequately sized, resulting in aggradation of sediment above the structure and scour below. One roadside drainage along Governor Peck Road enters main channel in upper reach and delivers significant amounts sediment to the downstream section. Numerous depositional features were observed during the field visit (Figure 2), indicating the potential for future lateral adjustments. Despite these impacts, numerous brook trout were observed in the reach in plunge pools (at the culvert outfalls) during August, indicating that reach provides important cold water refugia for trout in late summer.

Figure 2. Depositional features in reach R8.S1.05

- **Reach R8.S1.05 (high priority)** contains two culvert beneath Governor Peck Road which appear to be undersized. The culverts should be assessed to determine whether they are a priority for the replacement by the Town of Richmond. In addition, one problematic stormwater discharge was noted (previously described), and multiple depositional features were noted throughout the reach.

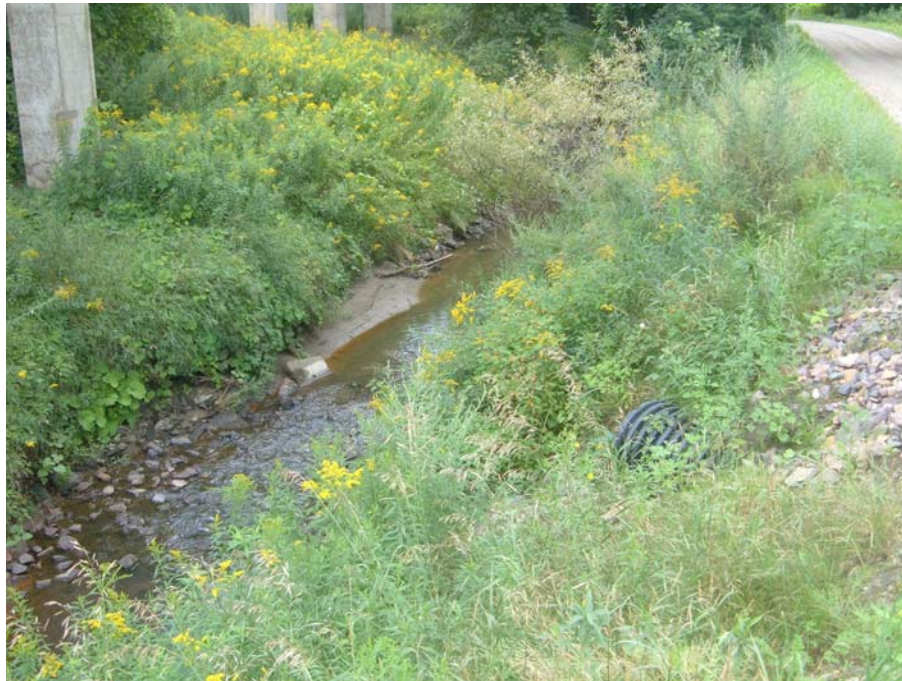
- **R8.S1.01:** This mainstem reach is found from the outlet to the Winooski River up to the reach break approximately 250 feet upstream of the I-89 culvert inlet. This reach has had severe historic impacts to the planform (44% of the channel has been straightened). In addition, a section of the reach in the vicinity of the I-89 crossing lacks a vegetative buffer greater than 25 feet, which likely elevates surface water temperatures during the summer months due to lack of canopy cover.

Figure 3. Stormwater outfall and lack of woody vegetative buffer in R8.S1.01

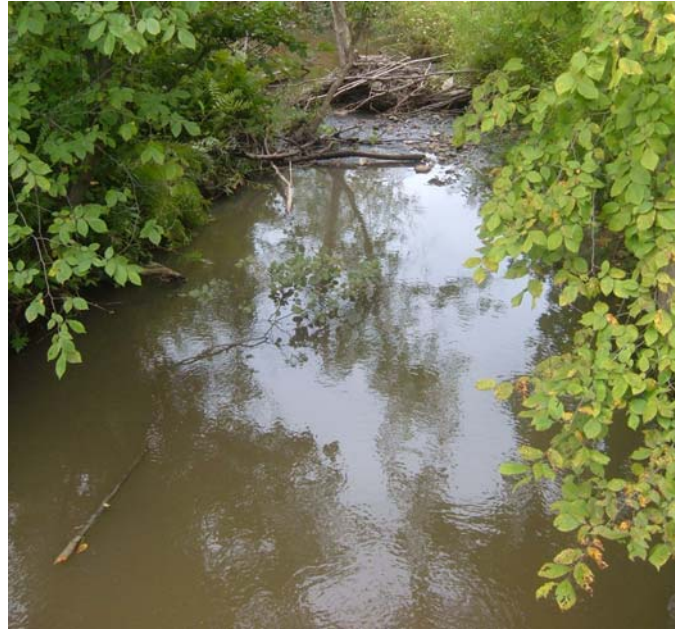
- **R8.S1.02:** This reach is found from the reach break with R8.S1.01 up to an area of historic beaver activity along Governor Peck Road. Although this reach has had limited direct impacts to the channel boundary conditions (channel straightening in 15% of reach), its changes in planform and abundant depositional features indicate that it is undergoing significant lateral migration. Additionally, the adjacent commercial and

industrial land use in the lower reach is causing significant fine sediment delivery to the channel (Figure 4).

Figure 4. Suspended sediments in lower R8.S1.02 during baseflow conditions.

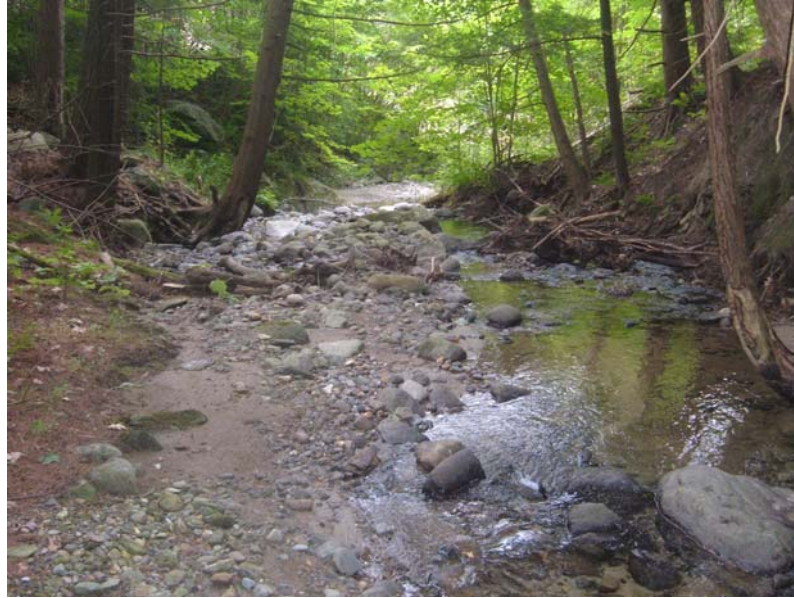
The middle zone of the watershed is found above the I-89 crossing up to the crossing with Jericho Road. Throughout this watershed zone the mainstem reaches are characterized by coarse-bottomed channels with A and B-type geometry found in confined valley settings. The two subtributaries stemming from the second (R8.S2.02.S1) and third mainstem (R8.S3.02.S1) reaches are found in very steep terrain (channel slopes greater than 5%) in confined valley settings. Sedimentation impacts from road and ATV trail encroachment (Figure 5) and failing valley side slopes were observed in this watershed zone during the windshield survey. Although no reaches have been identified as having high impact ratings, four reaches impacted by the stressors described above have a medium priority for further assessment, and are included in the list of recommended reaches for Phase 2 assessment in Section 6.0 of this report.

Figure 5. Deposition of fine sediments in R8.S2.02

- would also involve landowner outreach to assess the social constraints to stream restoration.
- o **Reaches R8.S2.02 to R8.S2.04 (medium priority)** should be assessed to investigate the sedimentation impacts from road and ATV trail encroachment and failing valley side slopes that were observed during the windshield survey. In addition, the I-89 culvert should be evaluated for impediments to fish passage, given that no brook trout were observed in this tributary during August (unlike in the Governor Peck Road tributary).

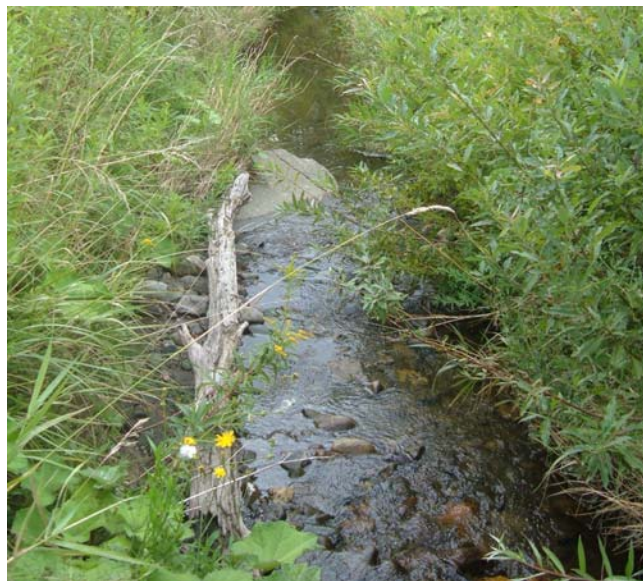
The lower watershed zone is encompassed by a single reach, R8.S2.01. This reach is found in the alluvial setting of the historic Winooski River floodplain where the mainstem channel slope is much less than upslope reaches (reach slope is 0.6%) and agriculture has impacted the channel planform and buffer conditions for over a century. This reach has been identified as having a high impact rating and a high priority for further assessment.

Figure 6. Coarse substrate downstream of Rt. 2 crossing in reach R8.S2.01

- **R8.S2.01:** This mainstem reach is found from the outlet to the Winooski River up to the reach break approximately 150 feet downstream of the I-89 culvert outlet. The channel is characterized by E-type geometry with sand substrates, with the exception of an area of coarse substrate downstream of the Route 2 crossing (Figure 6). This reach has had severe historic impacts to the planform (68% of the channel has been straightened). In addition, much of the reach lacks a vegetative buffer greater than 25 feet, which likely contributes to the direct input of sediment and nutrients from the adjacent agricultural fields, and also elevates surface water temperatures during the summer months due to lack of canopy cover.

- **Jericho Road Tributary:** Six reaches are recommended for further Phase 2 assessment in this watershed:
  - **Reach R8.S2.01 (high priority)** should be investigated in further detail to determine the impacts of historic straightening and a lack of vegetative buffer, and to evaluate the potential for stream corridor protection given the encroachment of agricultural and residential land uses. This effort

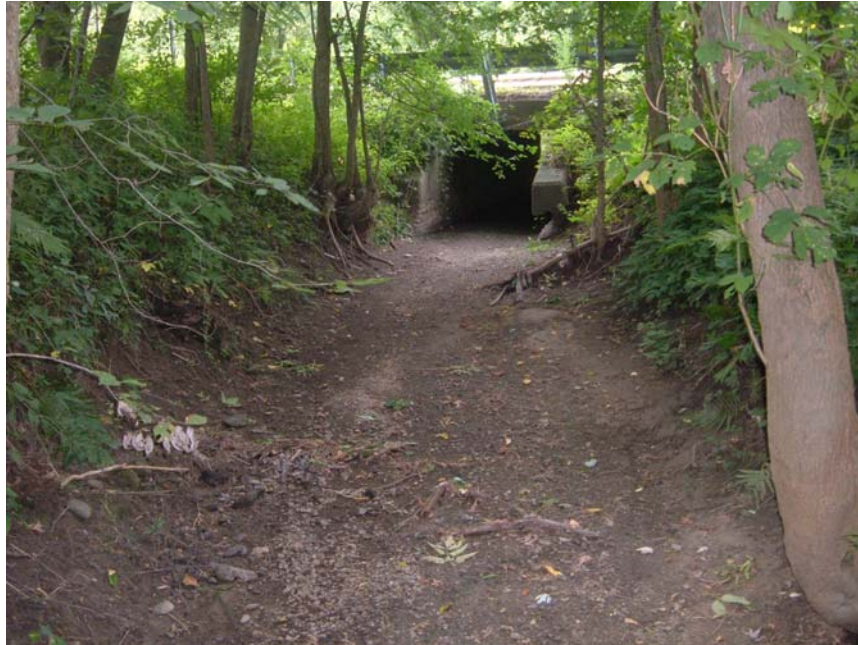
- **R9.S2.01:** This reach is found from the tributary outlet up to a 90 degree bend in the channel at the upstream reach break. The reach is characterized by a low-gradient, sand and gravel-bottomed channel with C-type geometry. This reach has received a high impact rating due to the observed changes in planform (20% of the reach has been straightened), the encroachment on the corridor by adjacent agricultural and residential land, and the depositional features causing lateral channel migration. In addition, the channel was observed to be dry during the field visit in August, 2007 (Figure 7).

Figure 7. Dry channel below Rt. 2 box culvert in reach R9.S2.01

- **Stage Road Tributary:** Three reaches are recommended for further Phase 2 assessment in this watershed:
    - o **Reach R9.S2.01 & R9.S2.03 (high priority)** should both be investigated in further detail to determine the impacts of historic straightening and a lack of vegetative buffer, and to evaluate the potential for stream corridor protection given the encroachment of agricultural and residential land uses. This effort would also involve landowner outreach to assess the social constraints to stream restoration.
