PHASE 1 STREAM GEOMORPHIC ASSESSMENT

Mill River, Rutland County Vermont

Final Report

RUTLAND REGIONAL PLANNING COMMISSION

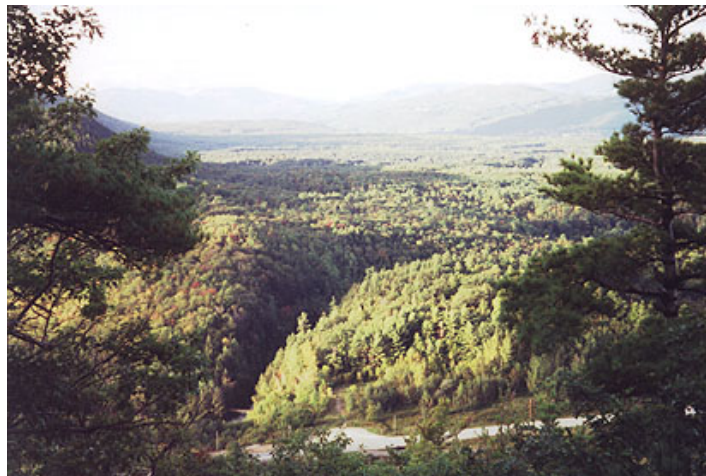
Figure 2: *Looking southeast down to Clarendon Gorge, Mill River reach M04.*

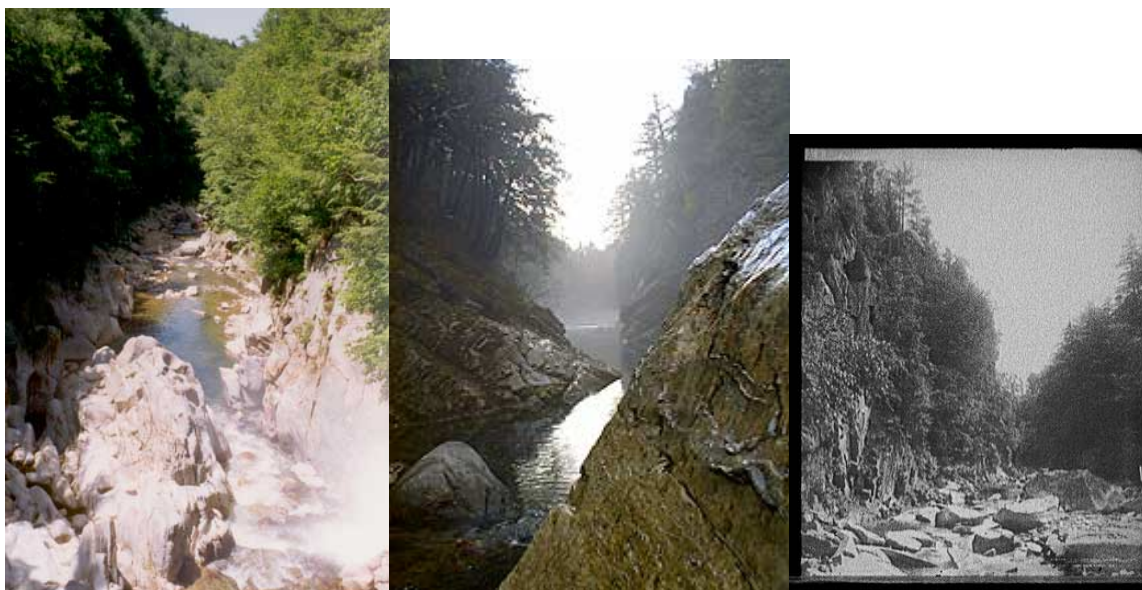
Figure 3: Various photos of the Clarendon Gorge area, both old and new, reaches M02,M03, and M04 of the Mill River, Clarendon, VT.

Reaches M02, M03 and M04 cover a section of the river know as Clarendon Gorge. It is approximately 2.5 miles of natural beauty and actually consists of two gorges, an upper and a lower. The upper gorge is about one third of a mile long and consists of several pools connected by small drops. A small cascade exists on a genteler river section between the upper and lower gorges, The cascade drops about 20 feet in 3 steps, the last being the largest. The lower gorge is also a series of drops. The first drop, locally known as Devil's Gorge is beautiful. The lower gorge is extremely narrow (less than 10' in places), with higher, darker walls (80-100') and slightly bigger drops than the upper gorge. This scenic resource is an area used for all types of outdoor recreation. See *Figure 3*. The following quote attempts to describe the gorge area:

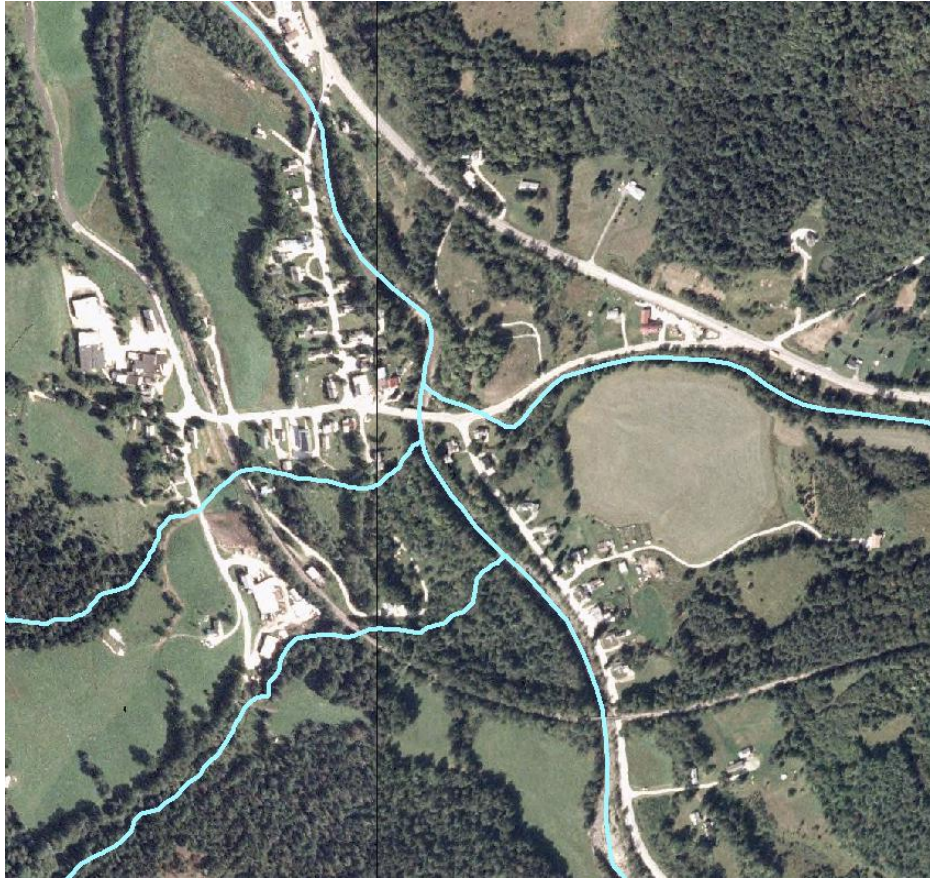
Figure 4: East Wallingford, the Mill River and tributaries reaches M10 and M11, a more settled section along the river, Wallingford, VT.

Dominant land cover in the stream corridor is forested land and or water coverage, in almost every reach; reach M10 is urban. Percent forested land ranges from 7.0 percent to 92.0 percent of the reach corridor with water covering from 7.0 to 52.0 percent. Urban areas comprise the next highest land cover percentages in the corridor, ranging from 0.0 to 60.0 percent. See *Figure4*.

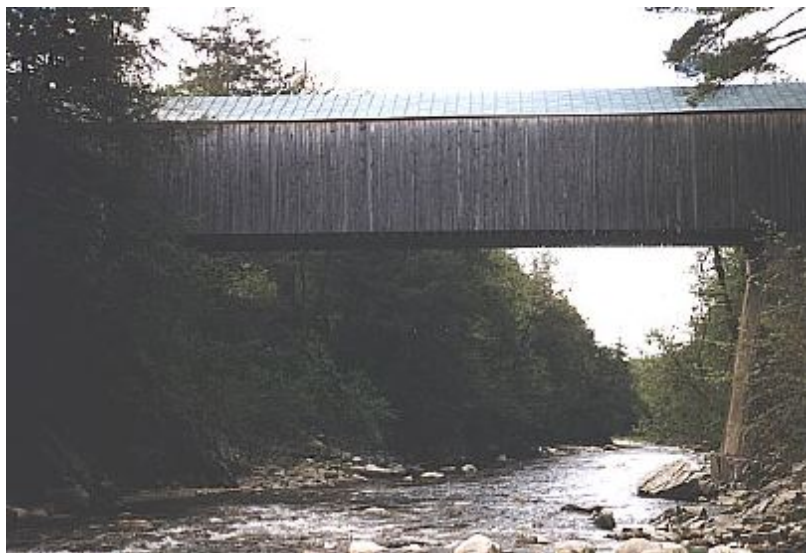
Figure 6: Looking downstream at Kingsley Bridge, Clarendon, VT. Mill River, reach M03.

Bridges and culverts seem to be the modifications effecting the river most. 25 reaches have no bridges or culverts, leaving 34 reaches with bridges and or culverts ranging from 1 to 4 per reach. Only six reaches, about ten percent, have a high impact rating from culverts and bridges. Of special interest is Kingsley Bridge, an historic covered bridge built in 1836, it carries Congdon Road, also known as the East Street Extension across the river. It is an often photographed historic marker found on the National Register of Historic Places. See *Figure 6*.

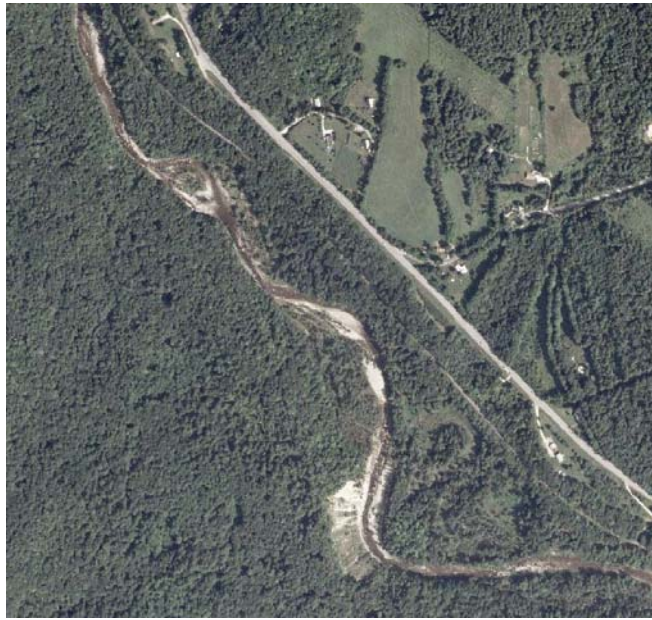
Figure 8: *Point bars along reach M05 of the Mill River, Shrewsbury, VT.*

Depositional features appear in 18 reaches with 4 having a high impact rating and 11 having a low impact with the remaining rated as not significant. The most common deposits are point bars and mid-channel bars. See *Figure 8*. The fact that almost one third of the reaches have some type of deposition is a good indicator that something is happening upstream.

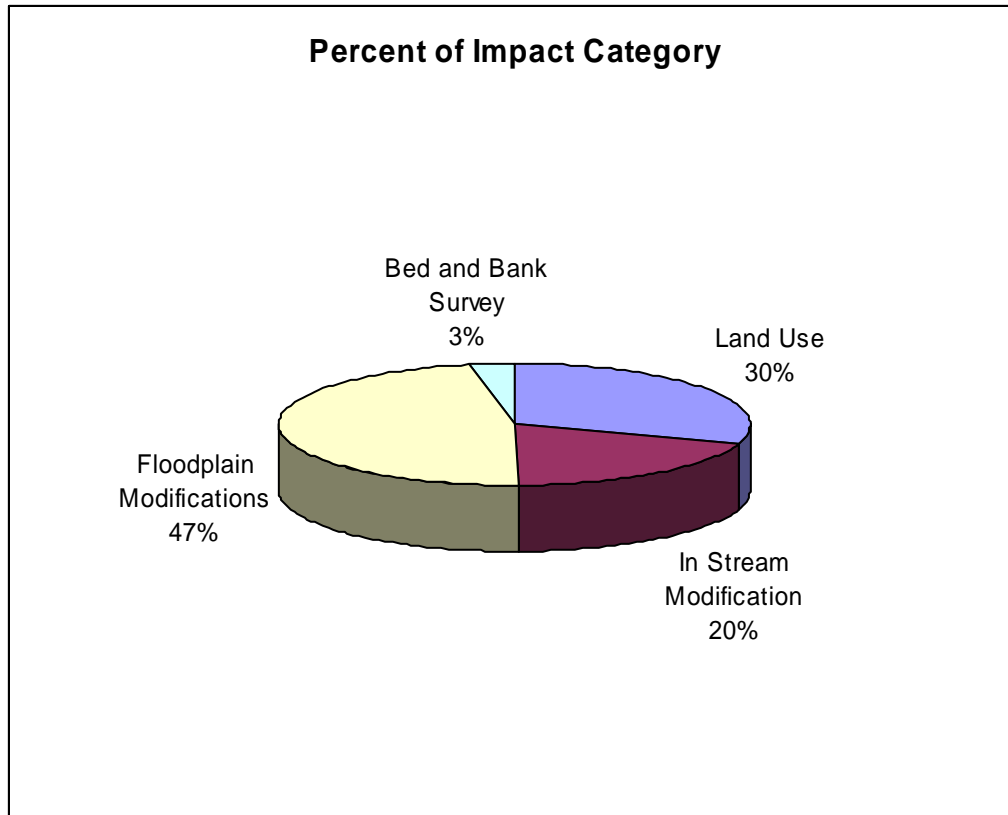
Figure 10 : *Percent of each impact category of the total impact score*
