**Phase 1 Stream Geomorphic Assessment  
Black River Watershed  
Windsor & Rutland Counties, Vermont  
June 2007 (Revised September 2007)**

South Mountain Research & Consulting  
2852 South 116 Road, Bristol, VT 05443  
802-453-3076

Southern Windsor County  
Regional Planning Commission  
P.O. Box 320  
Ascutney, VT 05030

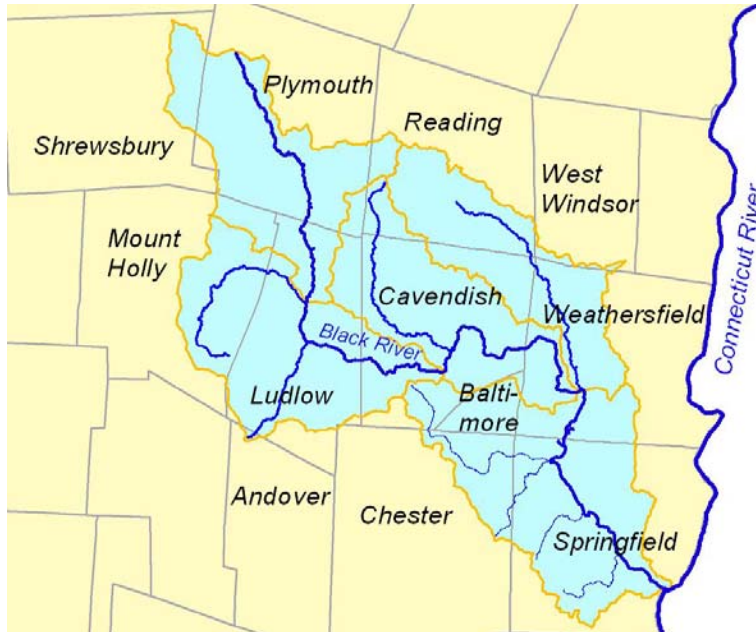
Figure 2. Location of Black River watershed within towns of Rutland and Windsor Counties, Vermont

Approximately 90% (183 square miles) of the Black River watershed is located in Windsor County, while 10% (21 square miles) is located in Rutland County (see Figure 1). Portions of twelve towns are contained in the watershed (see Figure 2). Five towns occupy a majority of the land area (Table 1): Plymouth, Ludlow, Cavendish, Weathersfield and Springfield.

Figure 9. Occurrence of buffers less than 25 feet wide along either the left bank or right bank, or both – Phase 1 delineated reaches of the Black River watershed. (town boundaries in brown – see Figure 2 for town identifications).

Figure 13. Occurrence of known or inferred channel straightening on the Black River main stem, and the North Branch, Twentymile Stream, Jewell Brook and Branch Brook tributaries. (town boundaries in brown – see Figure 2 for town identifications).

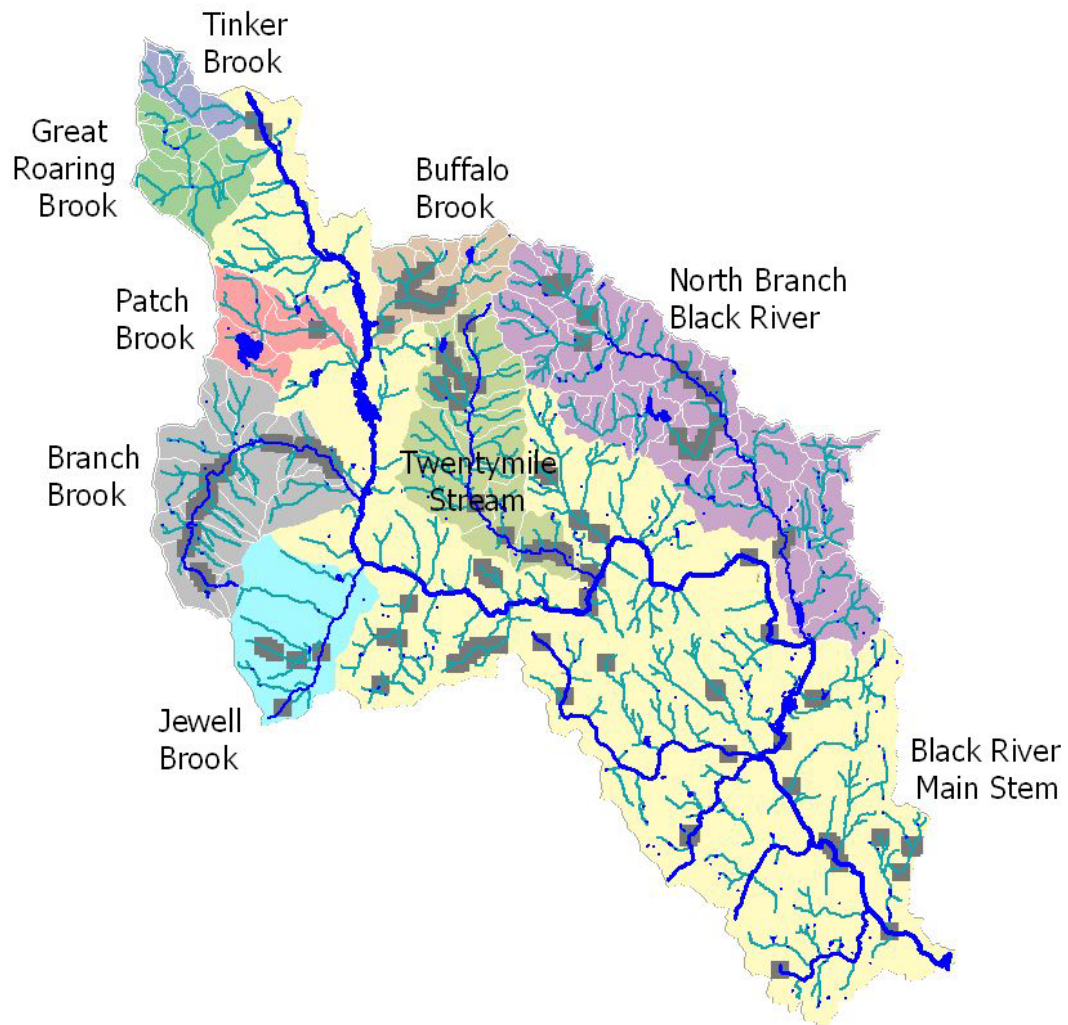
*Figure 5. Locations of channel-spanning bedrock grade controls in Black River watershed (on Phase 1 delineated reaches only).*

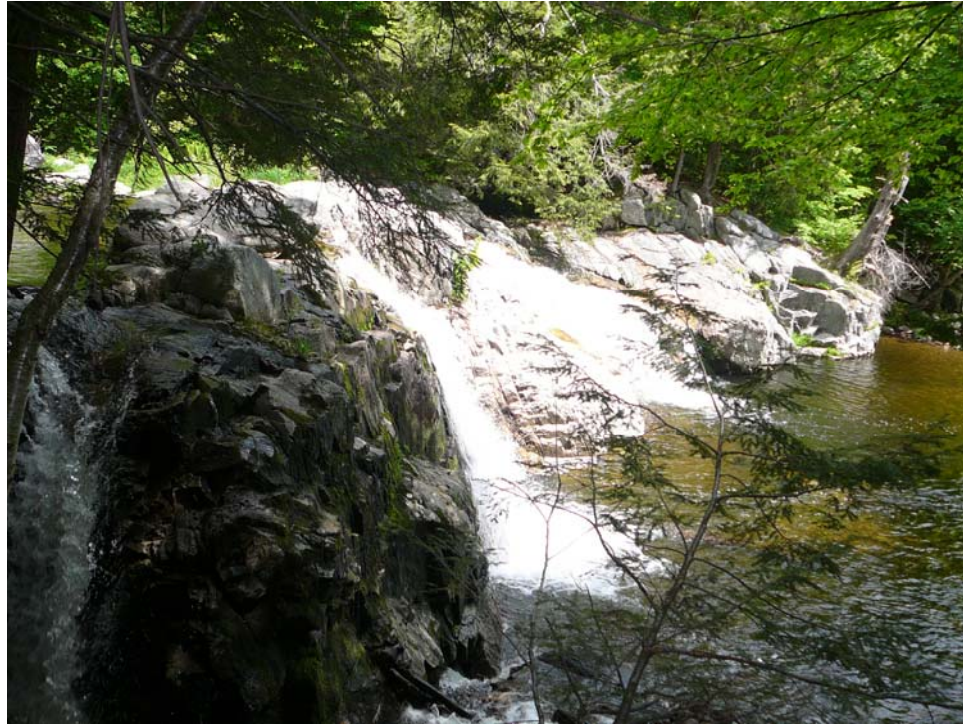
*Figure 6. One of three main tiers which comprise the Buttermilk Falls on Branch Brook in the town of Ludlow (reach M36T4.05).*

- ◆ Buttermilk Falls on Branch Brook in Ludlow (reach M36T4.05; Figure 6);

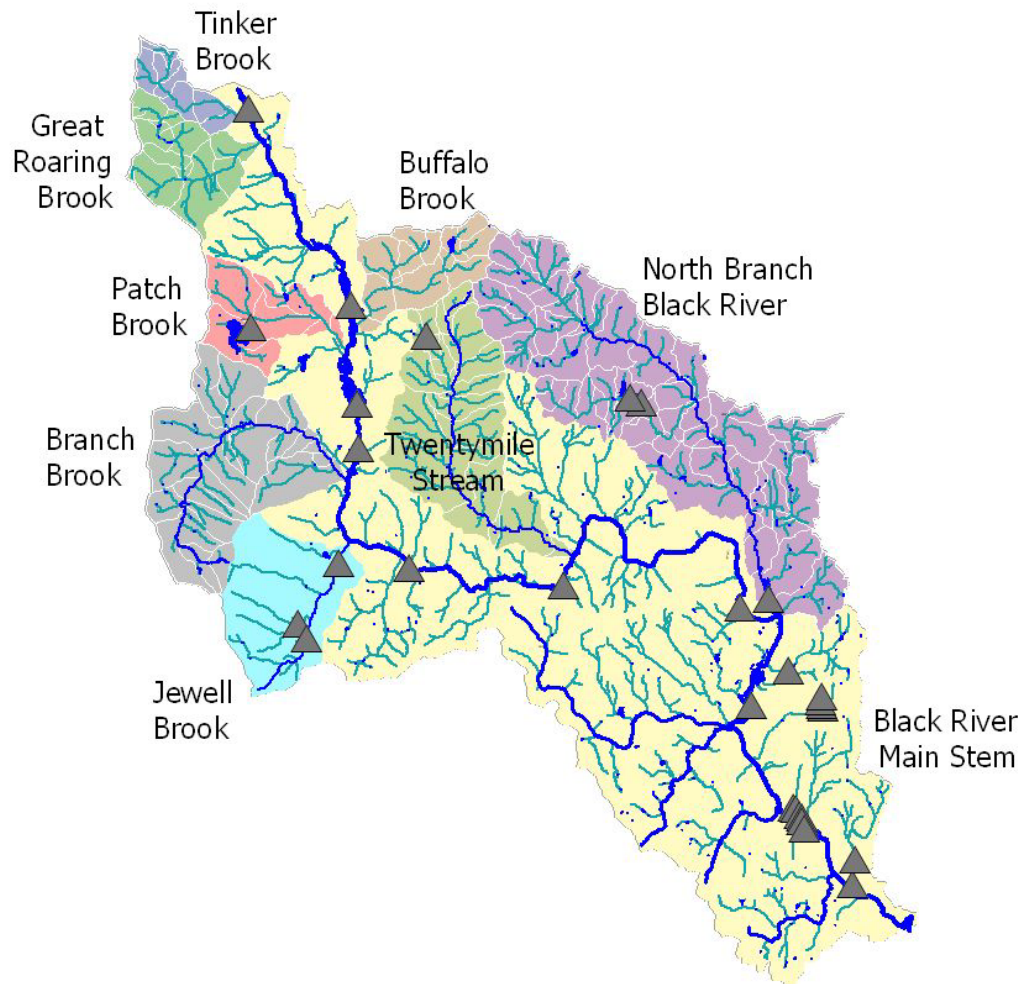
*Figure 7. Locations of Dams (either in use or breached) indexed as grade controls under Step 3.1 in the Black River Watershed (on 341 Phase 1 delineated reaches only).*

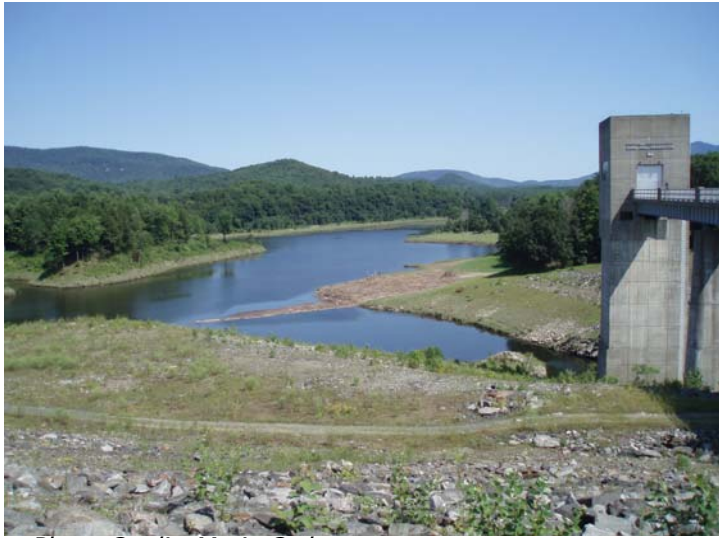
(a) North Springfield Lake, view to the north, July 2006.

Waters of the Black River are impounded behind a flood control dam constructed by the Army Corps of Engineers from 1957 to 1960 (a). The dam is 2,940 feet long and 120 feet high. At maximum capacity the reservoir can hold back 16.6 billion gallons of water. ACOE credits this dam with preventing \$57.3 million in potential flood damages over its more than 45 years in existence (ACOE, 2007).

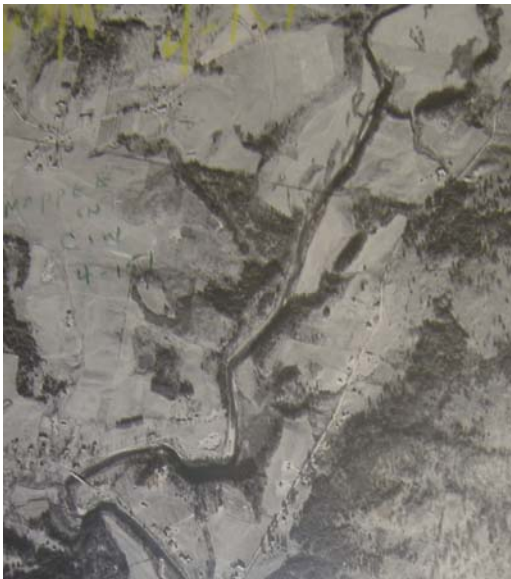
(b) Black River prior to construction of the dam, 1939 aerial photograph

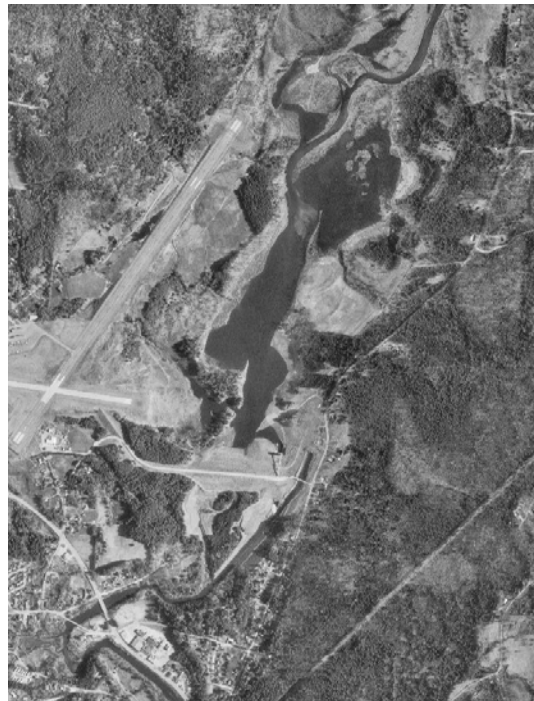
(c) Black River and North Springfield Lake and dam following construction, prior to construction of the dam, 1994 orthophotograph

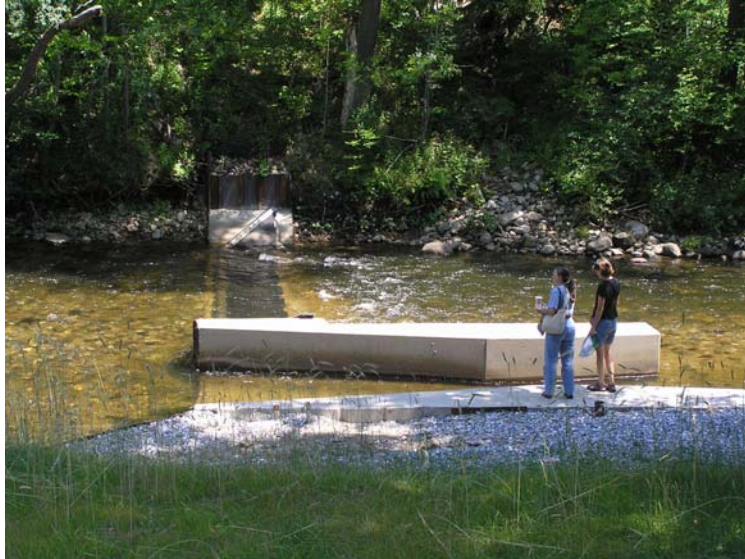
*Figure 12. Water withdrawal intake structure for Okemo Mountain snow making located on the Black River (reach M34) in Ludlow. 29 May 2006.*
