Browns River Phase I & II Geomorphic Assessment Project

Final Report Submitted by:
Winooski Natural Resources Conservation District

Browns River Stream Geomorphic Assessment

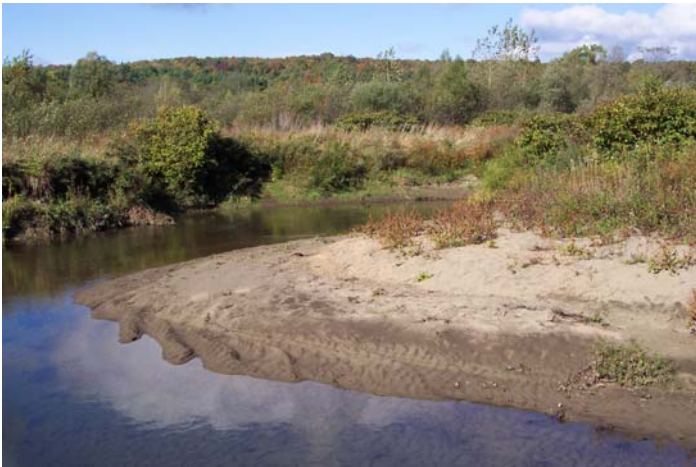
Depositional feature on the Browns River in Essex

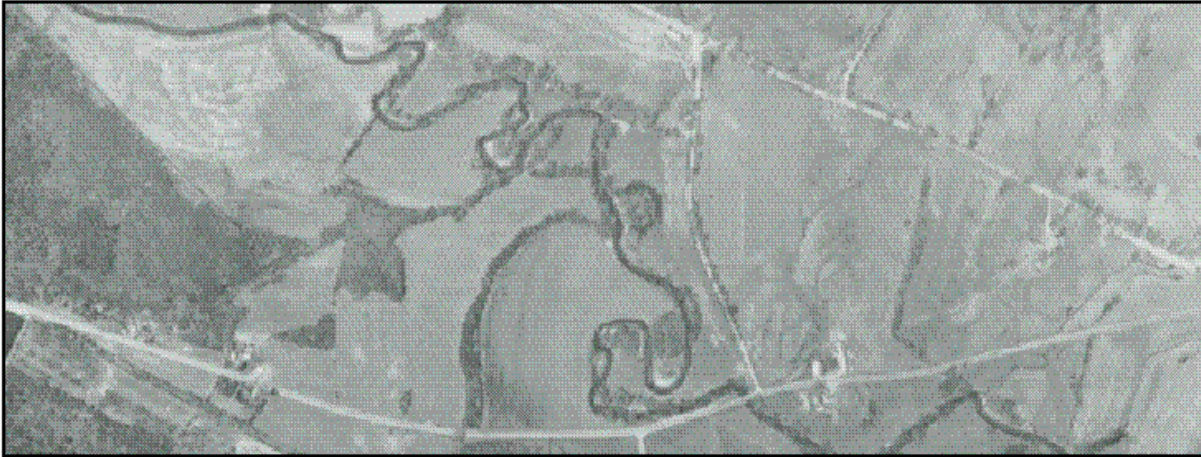
Figure 6A: Historic comparison depicting channel modification on Reach M11

1962 - Aerial Photo of Reach M11

Channelization is the process of changing the natural path of a river through activities such as windrowing and straightening. A channelized stream may degrade, or cut down vertically into its bed and cause the channel to lose access to its floodplain. The sediment resulting from the degradation process is re-deposited downstream of the channelized area. This results in aggradation, or building up, of the channel bed in this downstream area. Aggradation can result in channel widening, bank instability, and other channel responses, most of which are detrimental to both riverside land and aquatic habitat. Interviews with natural resource professionals, and review of orthophotos and topographic maps were used to examine this parameter. Figure 6A provides an historic comparison of a channel modification of the main stem under Route 15 in Essex.

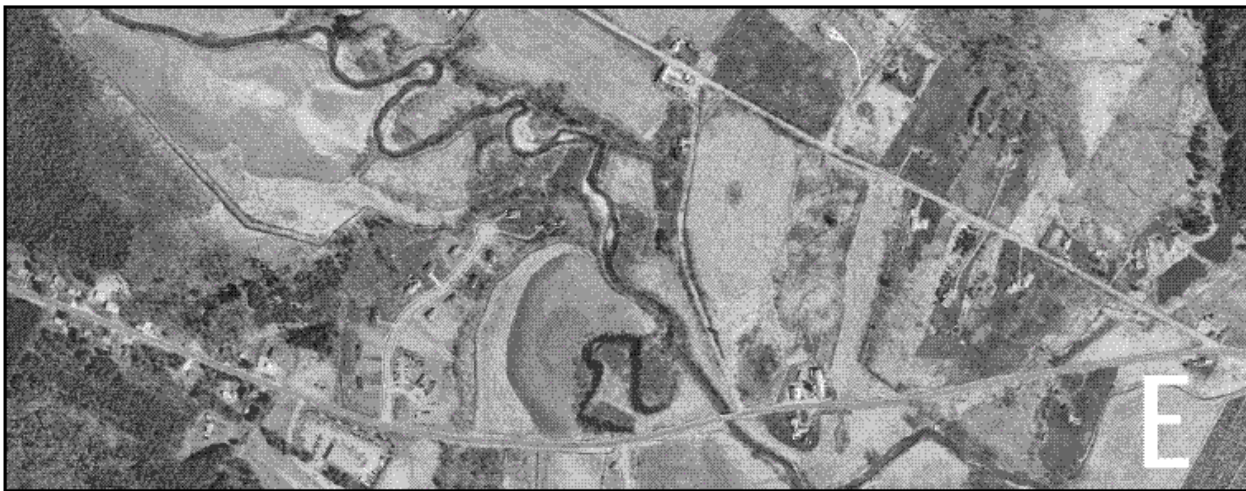
1999 - Digital Orthophoto of Reach M11
