# **PHASE I STREAM GEOMORPHIC ASSESSMENT**

**Conducted on Select Poultney Tributaries**

## **FINAL REPORT and DATA**

Study Completed between November, 2005 and March, 2007  
Report Completed May 2007

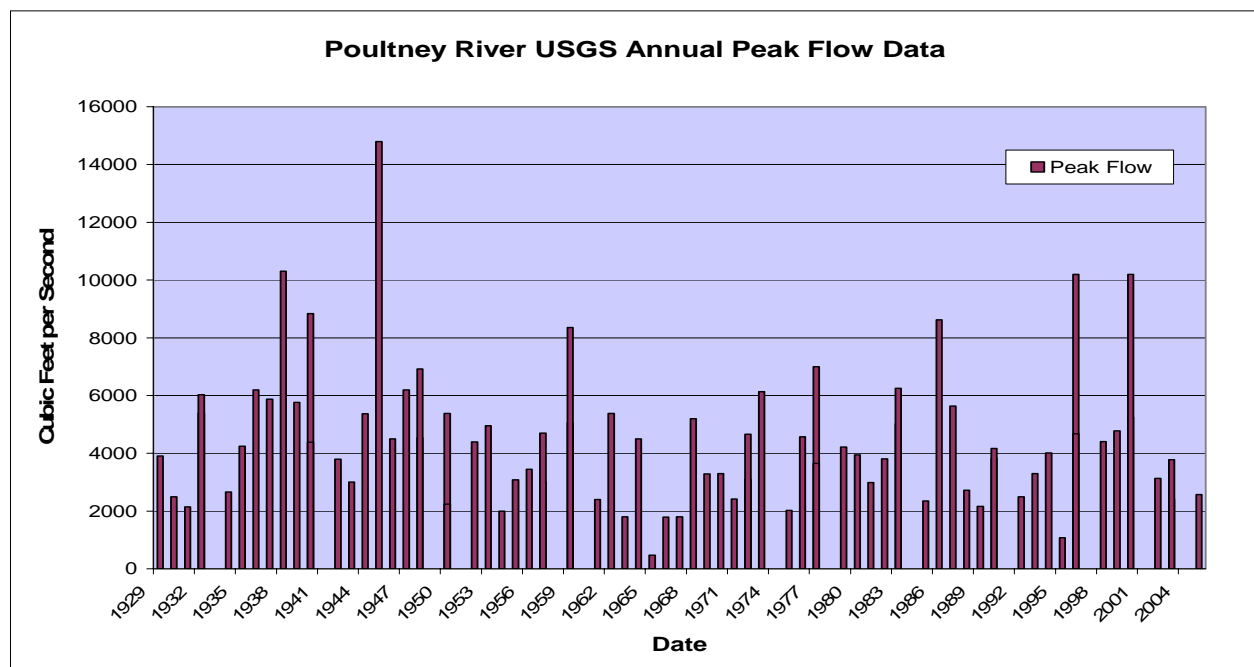
Graph 1: Poultney River Annual Peak Flow as measured at the USGS Gaging Station near Fair Haven, Vermont.

The highest peak flow measured at the Poultney River gauging station (near Fair Haven) between 1929 and 2005 (the period for which this data is available) was 14,800 ft<sup>3</sup> per second on July 20, 1945. Other flows over 8,000 ft<sup>3</sup> per second were measured in 1938, 1940, 1959, 1986, 1996, and 2000. (I don't know what return period this flow represents).

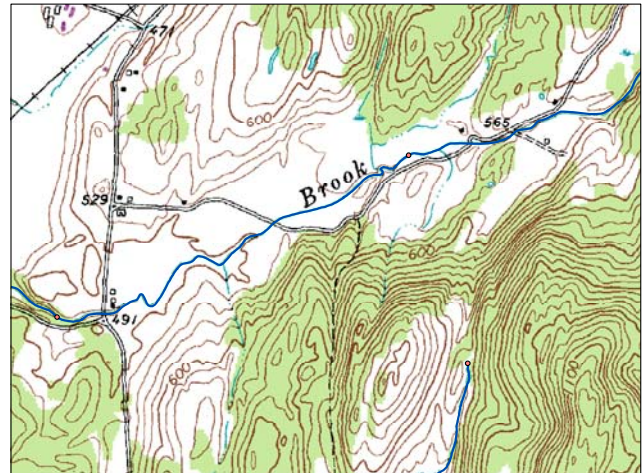
Reaches 1-4 have experienced significant amounts of straightening, some areas with berms to prevent future migration of the channel (reach 3 is pictured above and to the right). In these straightened areas, stream slope is increased (same elevation change over less distance) giving the stream more power to pick up and transport sediment. As a result, excess sediment is later deposited in locations along the length of the stream (especially areas downstream of the straightened areas, which exhibit lower slopes), leading to a buildup of sediment in the channel. Also contributing to the high levels of sediment deposition in this stream are tributaries that have degraded to form gullies in the headwaters (Godfrey, 2006). In many areas along Lewis Brook, roads create constraints and road runoff can additionally increase the sediment load.

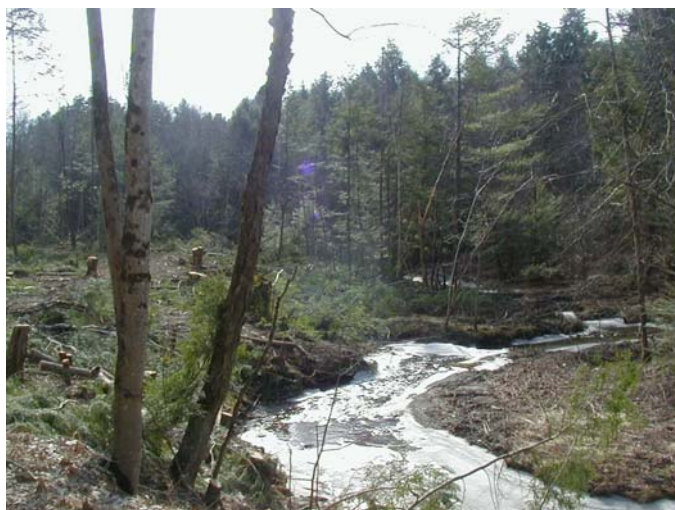
Barrett Brook originates in the Taconic Mountains to the north of Poultney. It flows south out of the hills and hugs the valley wall until flowing through Poultney, past the PMNRCD nature trail and education center at the Stonebridge, and into the Poultney River near the rail trail. In the photo to the right, it is flowing through a clear cut, possibly for a house site.

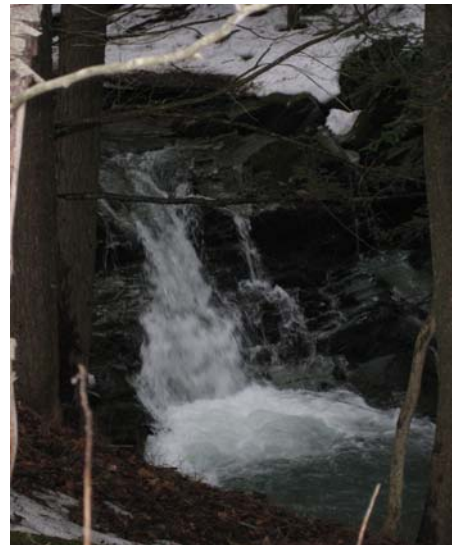
Hampshire Hollow and Clark Hollow Brooks are located entirely within the Taconic Mountains in the Poultney Township. They are a mix of confined, “C”, and semi-confined, “B”, stream types. Though the two streams are very close in proximity, they appear to have very different characteristics. Hampshire Hollow Brook (pictured at left and on the next page) flows through silty areas with wetland vegetation, while Clark Hollow Brook (grade control pictured below) flows through cobbled areas with mixed deciduous and coniferous forest.

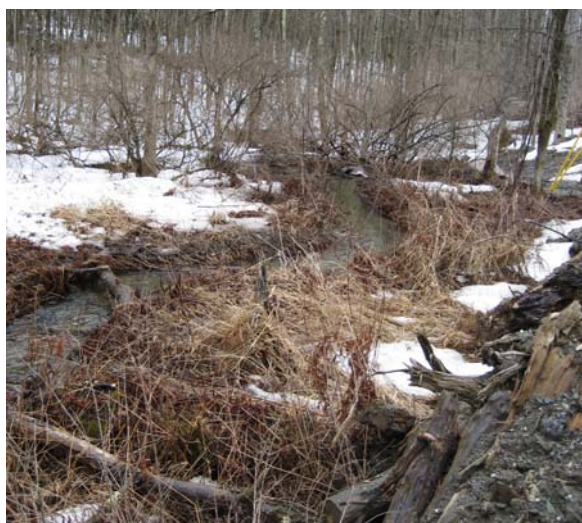
The picture to the left depicts a sandy stretch of stream in reach 4 that exhibits some wetland characteristics. The predominance of honeysuckle in the picture may indicate past clearing in this area. The debris in the lower-right corner is the edge of the road, which looks to have had recent work and may have been widened in this section.

**Potential projects** include increasing the buffer width along much of Hampshire Hollow Brook and allowing the brook to meander in the straightened areas. Pending further assessment, Better Backroads projects to decrease the amount of road sediment from entering reach 4 could also be explored.

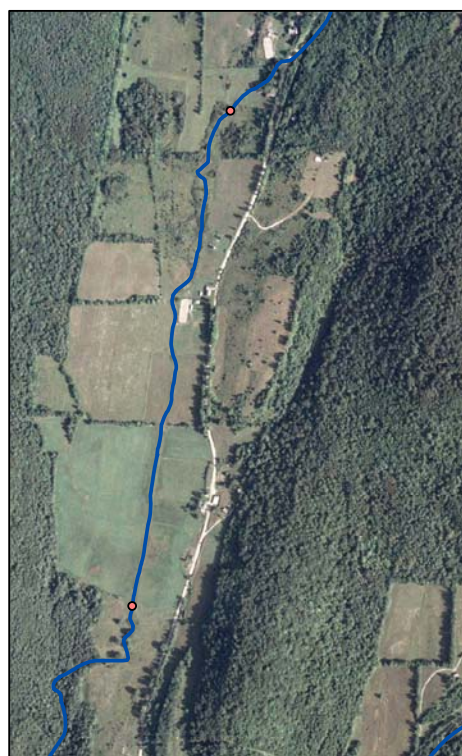
The photo at right shows the straightened section of reach 3. In addition to the straightened channel visible in the aerial photo, there are tributaries feeding into this reach that have been straightened as well.

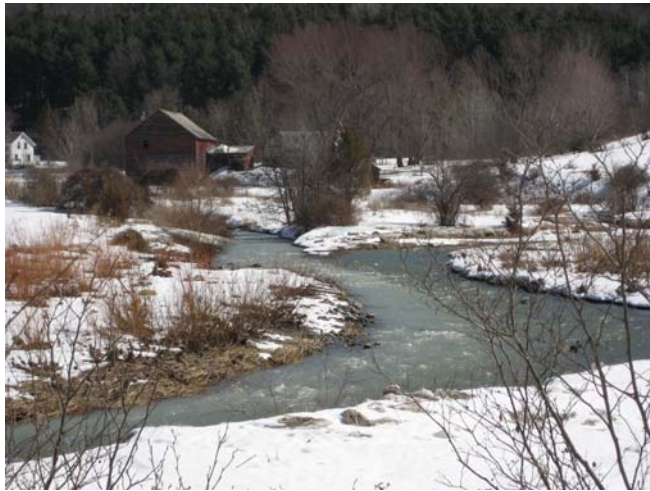
Much of the length of Lavery Brook is encroached by Morse Hollow Road (as seen in the graphic to the right). Development is also a potential stressor along most of the brook. During the windshield survey, high levels of sediment transport were noted in this brook. The photo above shows its confluence with the Poultney River. The waters flowing in from Lavery Brook (on the left) contain noticeably more sediment than the Poultney mainstem.

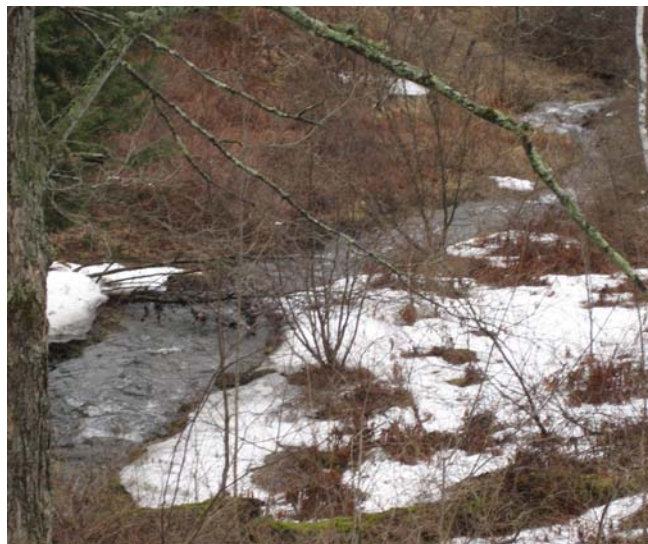
Significant lengths of reach 4 are encroached by Coy Hill and Mountain Road. Reach 1 appears affected by historic straightening. Deposition and meander migration were not noted during the windshield survey, though reach 1 was not accessible (reach 4 is pictured above).
