Stormwater Master Plan for the Town of Arlington, Vermont

FINAL REPORT

December 16, 2019

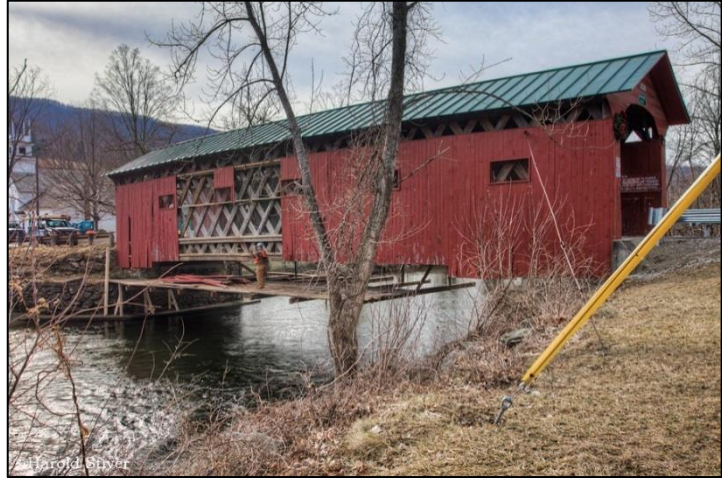
Figure 3.1: Post-Irene repairs in progress at the West Arlington covered bridge. Photo by Harold Stiver.

Tropical storm Irene (TSI) hit Vermont on August 28th, 2011 and dumped 3-5 inches of rain throughout the state with localized areas receiving totals from 7-11 inches. This rainfall coupled with high antecedent soil moisture conditions produced flooding that approached or exceeded the historic flood of 1927 in many large basins. In Arlington, damages resulting from Tropical Storm Irene were primarily due to erosion. Required repairs to the damages included rehabilitation of the West Arlington covered bridge (Figure 3.1).

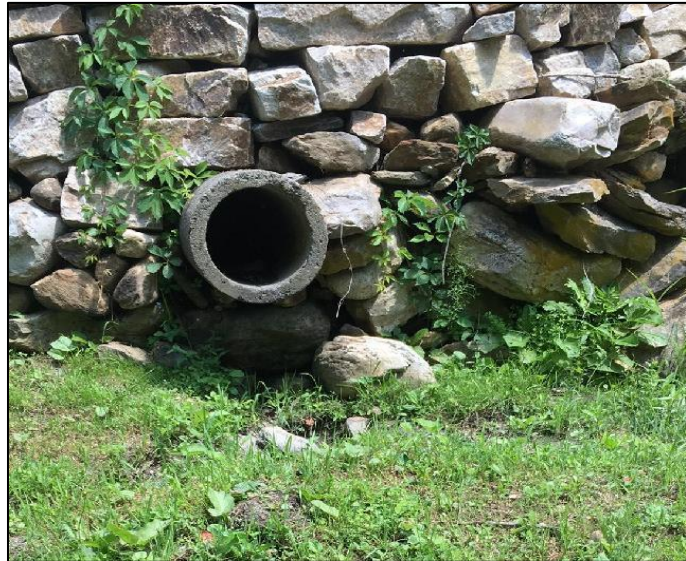
Figure 4.1: An outfall that “Partially Meets” the REI standards due to rill erosion at the outlet.

Of the 14 outfalls identified from stormwater infrastructure mapping completed in February 2018 by VTDEC, 13 outfalls were assessed for erosion because one of them could not be located. Only one outfall had erosion, which was present at the outlet (Figure 4.1).

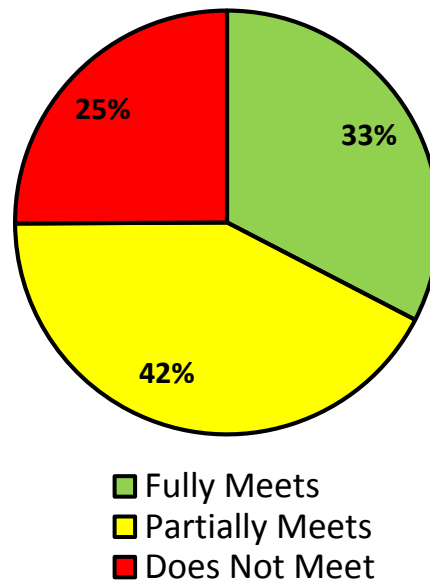
Figure 4.2: Standards compliance of HC road segments in Arlington based on the MRGP (VT ANR 2018).

An overview of the MRGP standards compliance of the hydrologically connected segments covered in the inventory is presented below. Any municipal road segment that scored a “Does Not Meet” or a “Partially Meets” will have to be upgraded to meet MRGP standards. Any road segment that scored a “Fully Meets” needs to be consistently maintained to continue to meet MRGP standards. Figure 4.2 summarizes the MRGP compliance of hydrologically connected road segments in Arlington. Examples photographs of segments that fully meet, partially meet, and do not meet are presented in Figure 4.4.

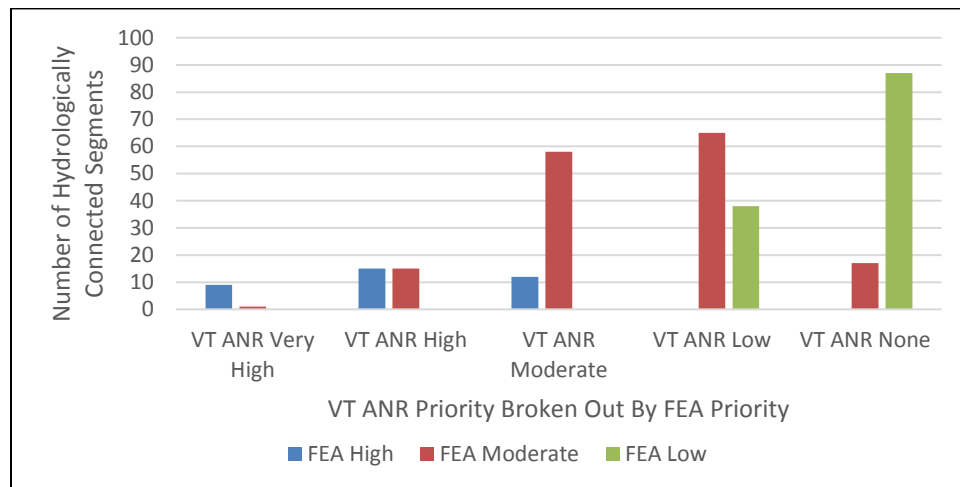
Figure 4.3: VT ANR Priority Broken out by FEA priority. Note that VT ANR does not prioritize segments that fully meet MRGP standards

Figure 4.3 shows the comparison between the VT ANR prioritization categories and the FEA water quality prioritization. Overall, the FEA prioritization may be viewed as a way to prioritize projects with the greatest potential to benefit water quality within the VT ANR categories. Other variables, such as anticipated costs, should be taken into consideration as the Town selects segments to address.

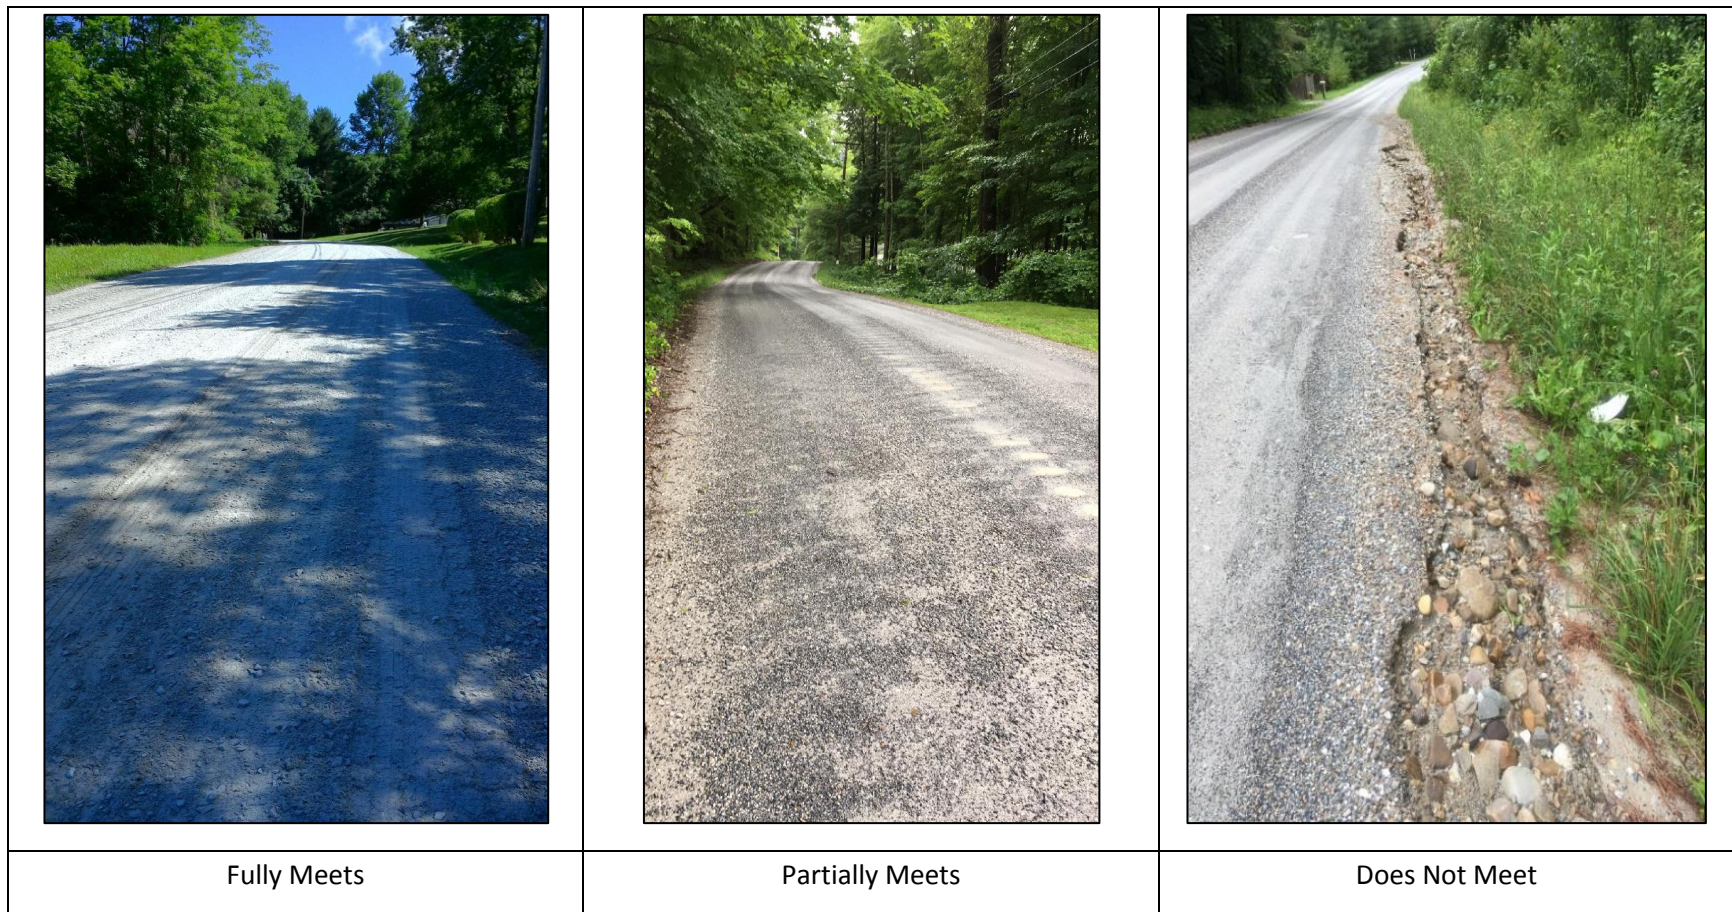
Figure 4.4: Examples of road segments with different levels of MRGP compliance.

Overall, 32% of the HC municipal road segments “Fully Meet”, 42% “Partially Meet”, and 25% “Do Not Meet” the MRGP REI standards. Road segments not meeting the standards most often lacked drainage ditches, had eroded drainage ditches, or had unstable and eroded conveyances. In some cases, as noted in the database, roadsides lacked the space for a drainage ditch (due to the presence trees, homes, stone walls, or ledge). These cases may require exemption from the MRGP standards by VTDEC. Common conditions for road segments partially meeting the standards include only one side of the road having adequate drainage (e.g. downslope side sheets off, but upslope side lacks ditch), eroded culvert headers, grader berms that resulted in drainage issues, and a lack of vegetation or stone at conveyances.

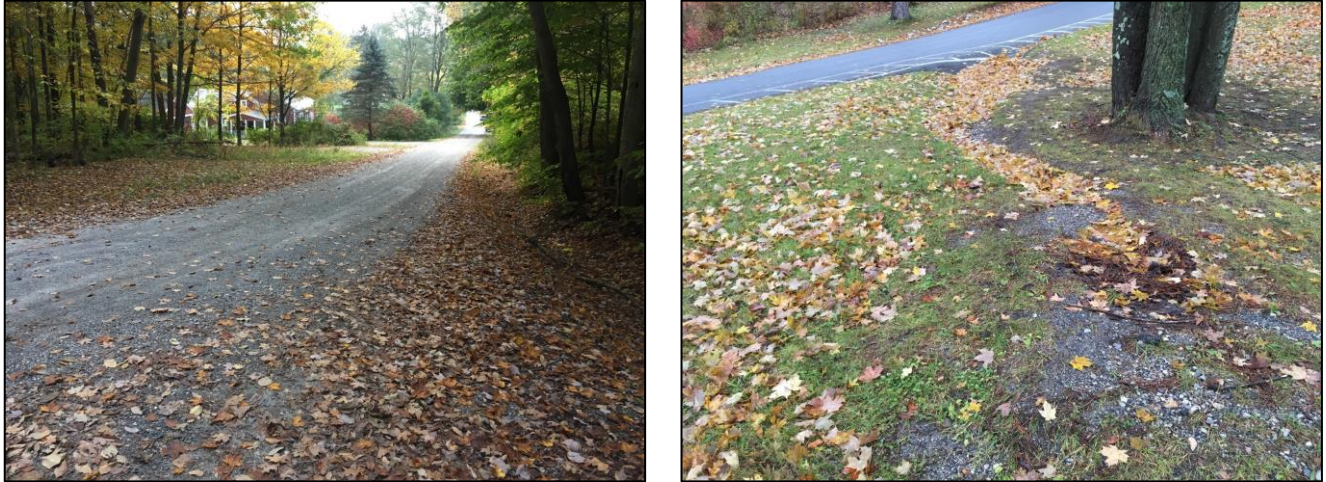
Figure 5.1: An unstable drainage ditch on the southern section of Tory Lane was tied for the lowest individual score (RD-15). An eroded flow path to a catch basin receiving runoff from impervious areas at Arlington Memorial High School (SW-12) was tied for the highest problem area score.

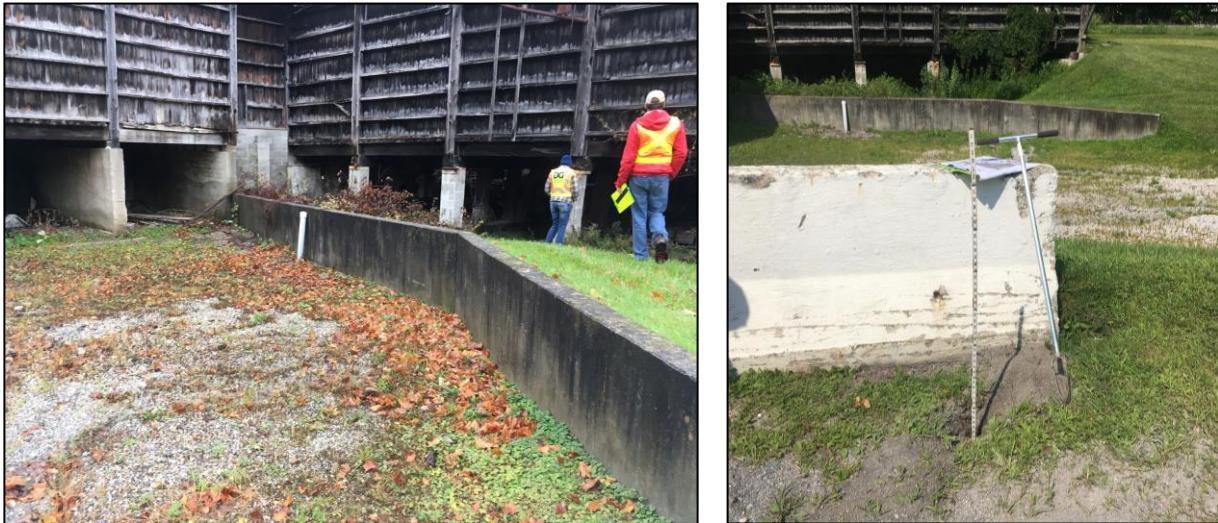
Figure 5.3: Exploring drainage patterns and discovering a buried catch basin during concept design development in the Chittenden Drive area (SW-7 & SW-8).

3. **Projects SW-7 & SW-8: Chittenden Drive Area Stormwater Improvements** – The area around Chittenden Drive is the headwaters for a large network of stormwater infrastructure that has been linked to flooding and erosion problems downstream. We evaluated the upslope drainages of the Chittenden Drive stormwater network, identified opportunities to mitigate the quantity of stormwater entering the network, and recommended practices to reduce stormwater sediment and nutrient loads.
4. **Project SW-9: American Legion Gravel Parking Infiltration** – The gravel parking lot drains to a catch basin located in the middle of the lot. This conveys stormwater and sediment to a nearby wetland.
