Gunner Brook, Barre City, Vermont

The lower reach of Gunner Brook in Barre City, Vermont has been found to be impaired for sediment in stormwater as measured by the biological community of the brook. There are at least 43 discharges to the brook from the developed lands of Barre City and Town between the mouth and Plainfield Brook Rd. The largest discharge to the river is drainage #149 Barre City which drains the Barre City Auditorium and Ice Arena. Under General Permit 3-9050 3 parcels including this one will have to implement or improve their existing stormwater discharges by 2028. It is estimated that if the 9050 retrofits were installed and the 3 parcels achieve compliance the net reduction for all modeled stormwater controls would be about 11% of the sediment load and 9% of the phosphorus load to the brook. A number of sites are outside the urbanized area and do not have pollutant load modeling but are suggested in the Stormwater Master Plans for Barre Town and Plainfield.

CENTRAL VERMONT
STORMWATER
MASTER PLAN

SHEET TITLE
**AUDITORIUM
AND ICE RINK
SITE PLAN**

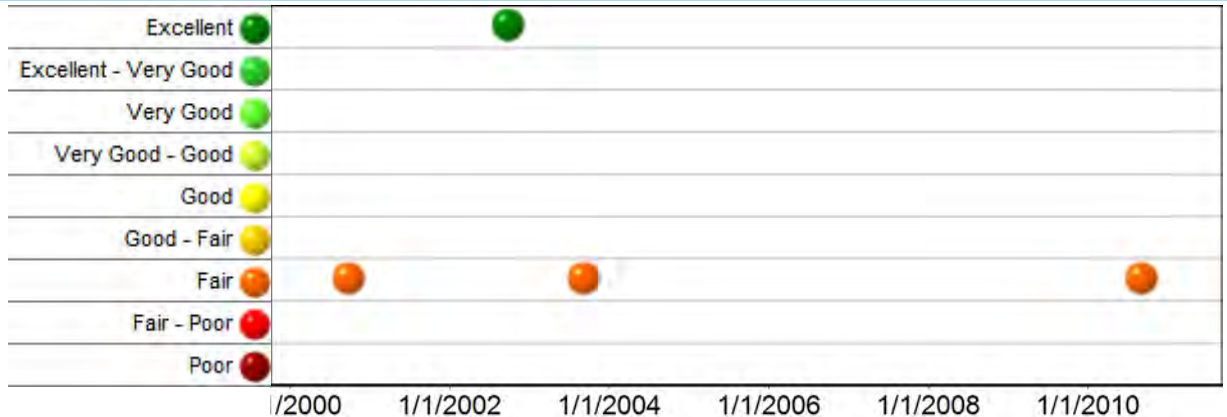
Macroinvertebrate Assessment

Macroinvertebrate population Assessments are a measure of the biological integrity of the macroinvertebrate community and an indicator of the health of the aquatic biota. (For More Details)

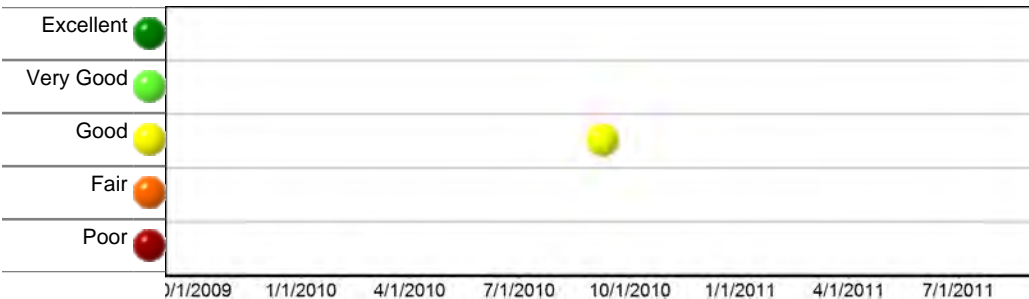
Fish Assessment

Fish populations provide a measurement of the general health of the aquatic biota. Since fish occupy the top of the food web their population integrates the conditions of lower community types. (For More Details)

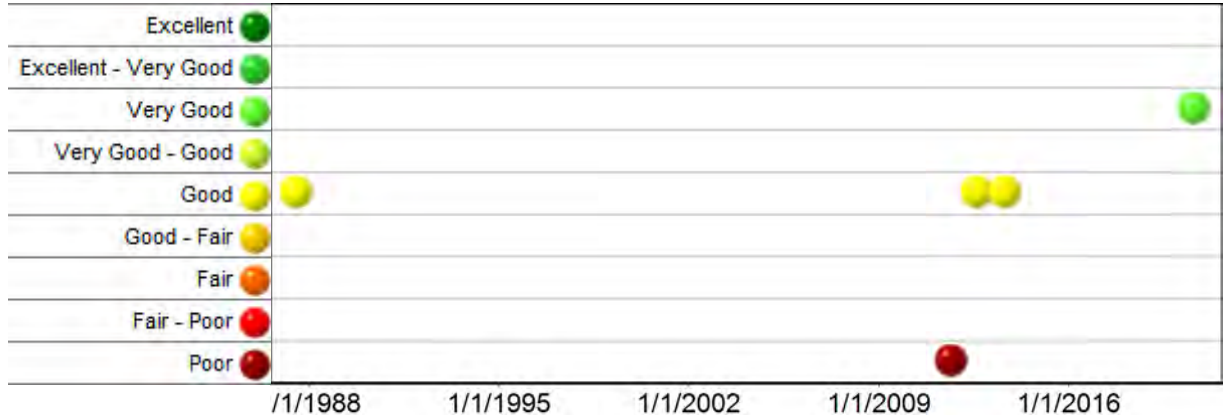
Macroinvertebrate Assessment

Macroinvertebrate population Assessments are a measure of the biological integrity of the macroinvertebrate community and an indicator of the health of the aquatic biota. (For More Details)

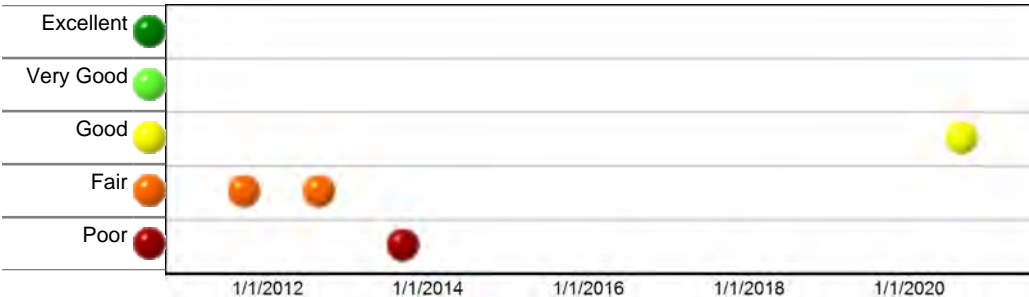
Fish Assessment

Fish populations provide a measurement of the general health of the aquatic biota. Since fish occupy the top of the food web their population integrates the conditions of lower community types. (For More Details)

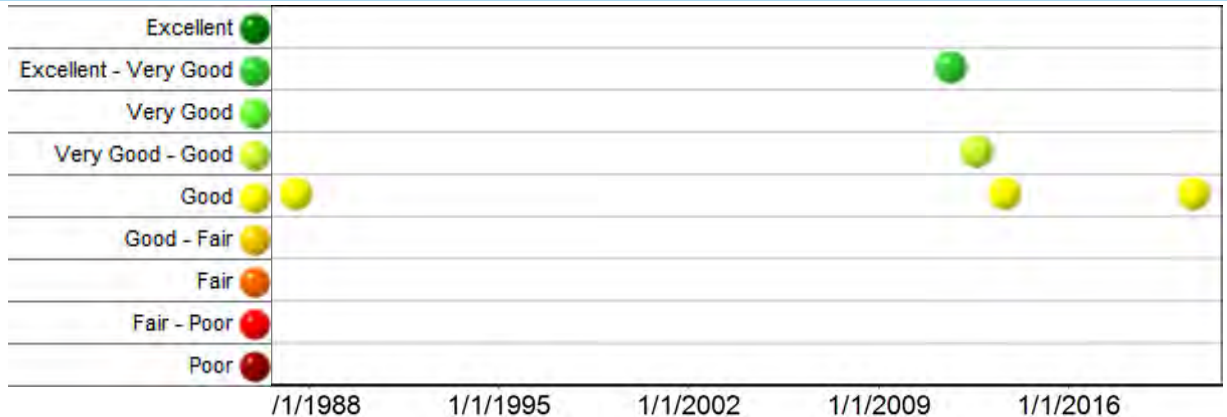
Macroinvertebrate Assessment

Macroinvertebrate population Assessments are a measure of the biological integrity of the macroinvertebrate community and an indicator of the health of the aquatic biota. (For More Details)

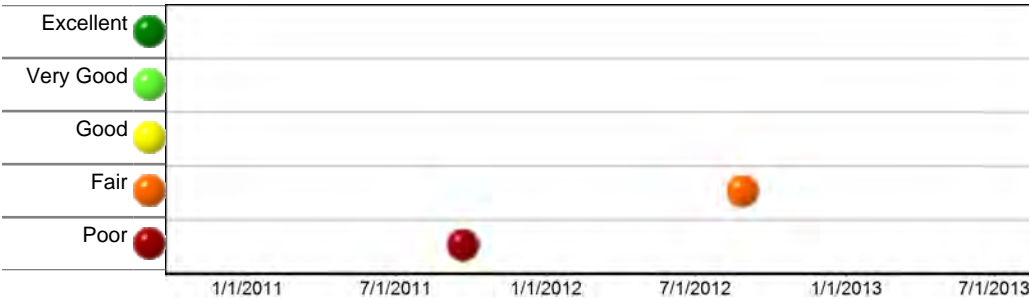
Fish Assessment

Fish populations provide a measurement of the general health of the aquatic biota. Since fish occupy the top of the food web their population integrates the conditions of lower community types. (For More Details)

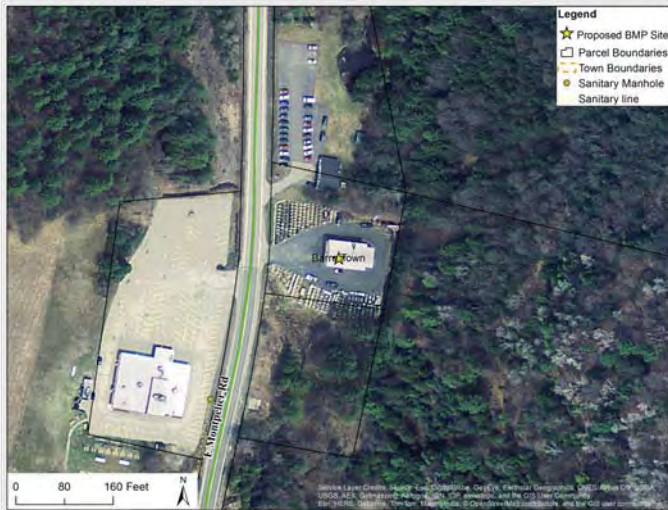
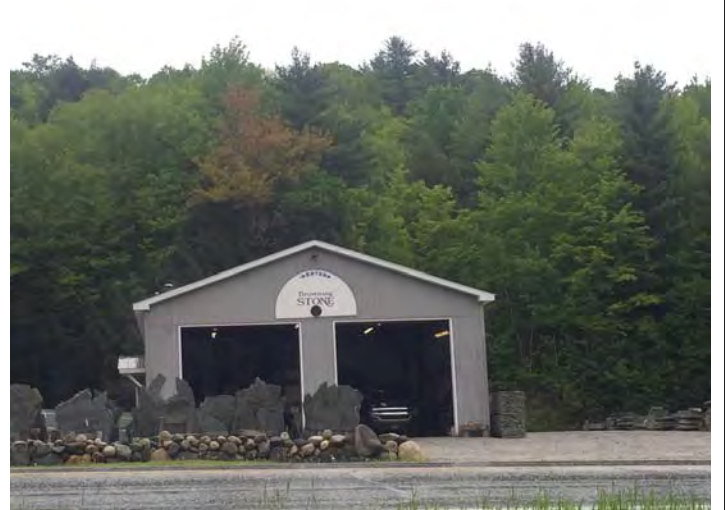
Site map	Site photo
----------	------------

BMP Summary Sheet		BMP ID #:	19
Site name: Browning Stone		Municipality:	Barre Town
Approximate address:	424 E Montpelier Rd		Assessment Date
Proposed BMP type:		Cistern	
Proposed BMP description:		Proposed BMP details	
Gutter roof and add cistern for water reuse.		Current site type	Commercial
		Relative drainage area	Small
		Impervious area (approx %)	High
		BMP pollutant reduction	Low
		BMP design required	Minimal
		Hydrologic soil group	C
		Proximity to water	Low
		Stormwater permit?	No
		Pollution visible	
		Land owner where BMP is located	Private
		If existing, BMP type	
		Relative project cost	Low
		Retrofit priority	Low
		Project score	94
		Project rank by municipality	41
Site Description			
private, not permitted, stone work			
Feasibility concerns:			
Ownership of Site

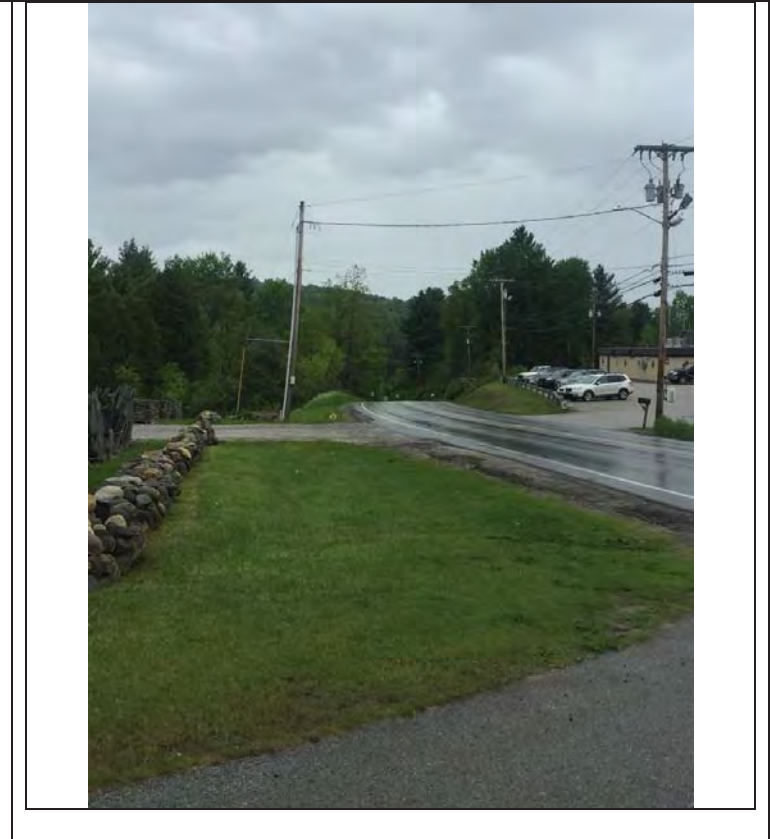
Site map	Site photo
----------	------------

BMP Summary Sheet		BMP ID #:	31
Site name: Eastman Auto		Municipality:	Barre Town
Approximate address:	431 E Montpelier Rd	Assessment Date	2017-06-02
Proposed BMP type:	Infiltration Trench, Cistern		
Proposed BMP description:	Construct infiltration trench along roadside in front of parking area and Browning Stone to capture runoff from Eastman's Auto. Gutter roof and direct to cistern. Rainwater can be used for car washing.		
Site Description	private, not permitted, car dealership		
Feasibility concerns:	Ownership of Site, Utilities		
		Proposed BMP details	
		Current site type	Commercial
		Relative drainage area	Small
		Impervious area (approx %)	Medium
		BMP pollutant reduction	Medium
		BMP design required	Minimal
		Hydrologic soil group	B
		Proximity to water	Low
		Stormwater permit?	No
		Pollution visible	
		Land owner where BMP is located	Private
		If existing, BMP type	
		Relative project cost	Low
		Retrofit priority	Low

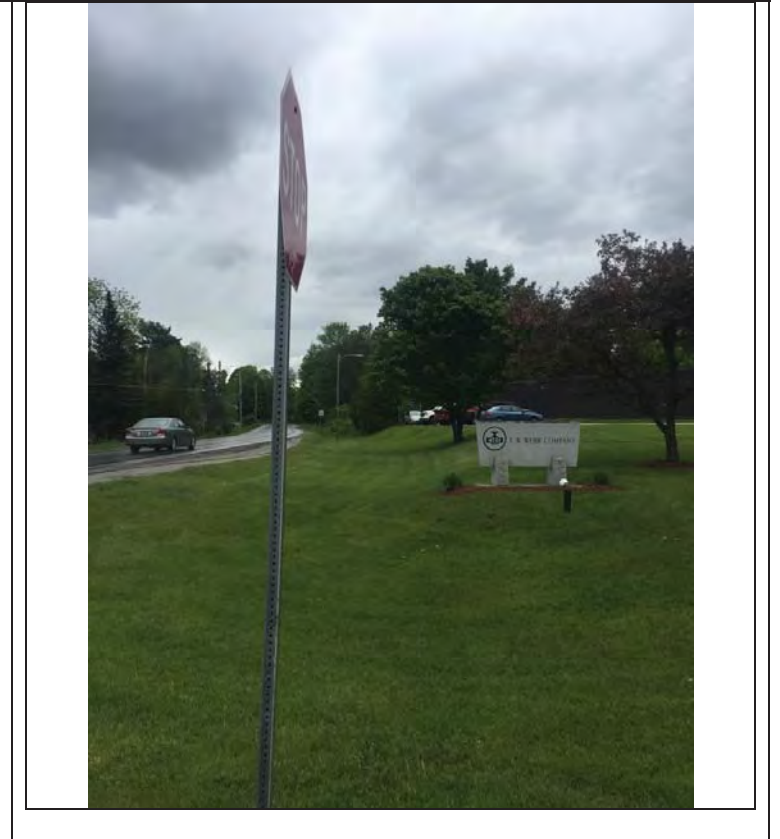
Site map	Site photo
----------	------------

BMP Summary Sheet		BMP ID #:	32
Site name:	F.W. Webb Co	Municipality:	Barre Town
Approximate address:	10 Clark Rd	Assessment Date	2017-06-02
Proposed BMP type:	Infiltration Basin		
Proposed BMP description:	Construct linear grass infiltration basin with overflow to existing culvert.		
Site Description	private, not permitted, pretty well vegetated, not a large volume		
Feasibility concerns:	Ownership of Site, Wetlands Across Street		
	Proposed BMP details		
	Current site type	Commercial	
	Relative drainage area	Small	
	Impervious area (approx %)	Medium	
	BMP pollutant reduction	Medium	
	BMP design required	Minimal	
	Hydrologic soil group	B	
	Proximity to water	Low	
	Stormwater permit?	No	
	Pollution visible		
	Land owner where BMP is located	Private	
	If existing, BMP type		
	Relative project cost	Low	
	Retrofit priority	Low	
	Project score	83	
	Project rank by municipality	53

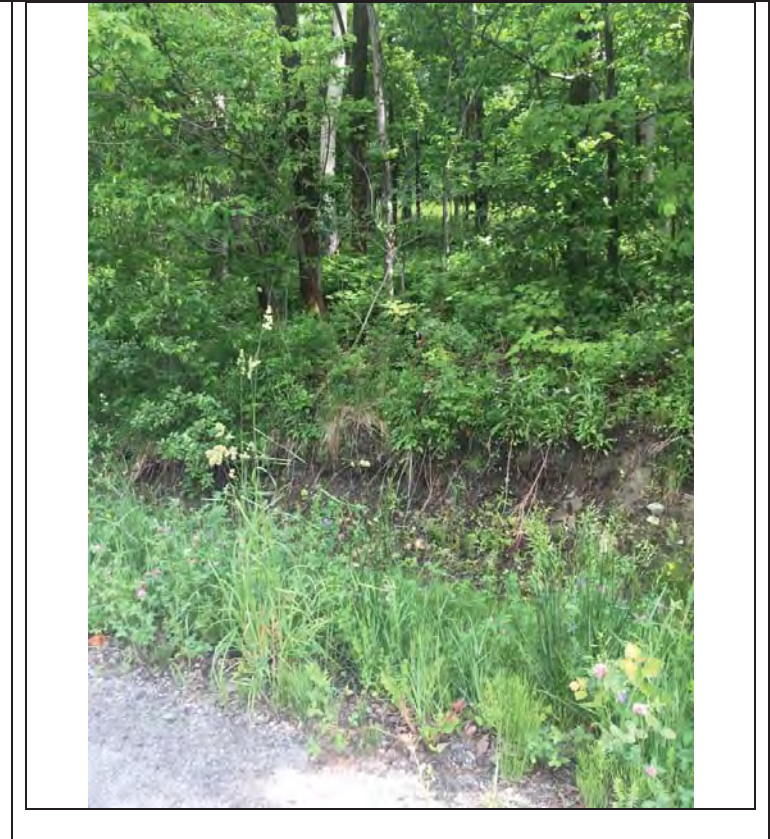
Site map	Site photo
----------	------------

BMP Summary Sheet		BMP ID #:	22																														
Site name:	Gonyeau Rd near Upper Rd	Municipality:	Plainfield																														
Approximate address:	Gonyeau Rd and Upper Rd	Assessment Date	2017-06-20																														
Proposed BMP type:	Swale Improvements																																
Proposed BMP description:	<p>Stone line roadside ditch and add check dams. Stone line ditch and add check dams along Gonyeau Rd (both sides around intersection).</p>																																
Proposed BMP details

Current site type	Road / ROW	Relative drainage area	Medium	Impervious area (approx %)	Low	BMP pollutant reduction	Low	BMP design required	Medium	Hydrologic soil group	D	Proximity to water	High	Stormwater permit?	No	Pollution visible		Land owner where BMP is located	Town /City	If existing, BMP type		Relative project cost	Medium	Retrofit priority	Medium	Project score	81	Project rank by municipality	38
Current site type	Road / ROW																																
Relative drainage area	Medium																																
Impervious area (approx %)	Low																																
BMP pollutant reduction	Low																																
BMP design required	Medium																																
Hydrologic soil group	D																																
Proximity to water	High																																
Stormwater permit?	No																																
Pollution visible																																	
Land owner where BMP is located	Town /City																																
If existing, BMP type																																	
Relative project cost	Medium																																
Retrofit priority	Medium																																
Project score	81																																
Project rank by municipality	38																																
Site Description	<p>D soils, ROW, moderate steepness, no permit, noted by town: Town noted newly replaced culvert is too small, assess contributing stormwater impacts.</p>																																
Feasibility concerns:	<p>Proximity to Stream, Poor Soils, Space, Utilities</p>

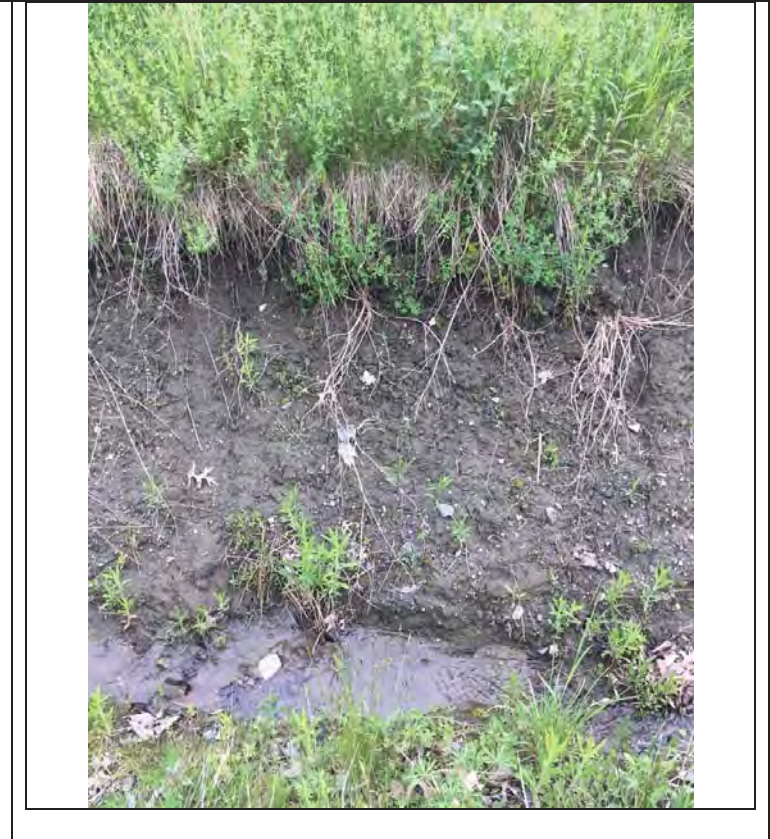
Site map	Site photo
----------	------------

BMP Summary Sheet		BMP ID #:	16
Site name:	Flood Rd Swale	Municipality:	Plainfield
Approximate address:	Flood Rd, east of intersection with Lower Rd	Assessment Date	2017-06-09
Proposed BMP type:	Swale enhancements		
Proposed BMP description:	<p>Stone armor existing swale and add check dams to reduce stormwater velocity, prevent erosion, and allow for settling of materials. Road is steep and swale is currently eroding.</p>		
Site Description	<p>Roadside swale</p>		
Feasibility concerns:	<p></p>		
		Proposed BMP details	
		Current site type	Road / ROW
		Relative drainage area	Small
		Impervious area (approx %)	Medium
		BMP pollutant reduction	Low
		BMP design required	Minimal
		Hydrologic soil group	D
		Proximity to water	Low
		Stormwater permit?	No
		Pollution visible	Excessive Erosion
		Land owner where BMP is located	Town /City
		If existing, BMP type	
		Relative project cost	Low
		Retrofit priority	Low
		Project score	90

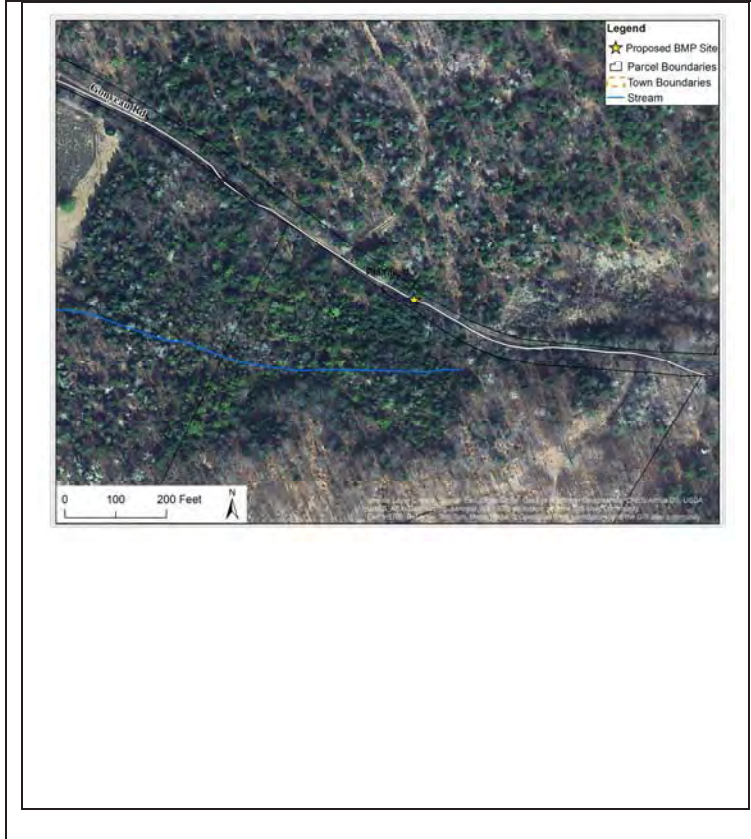
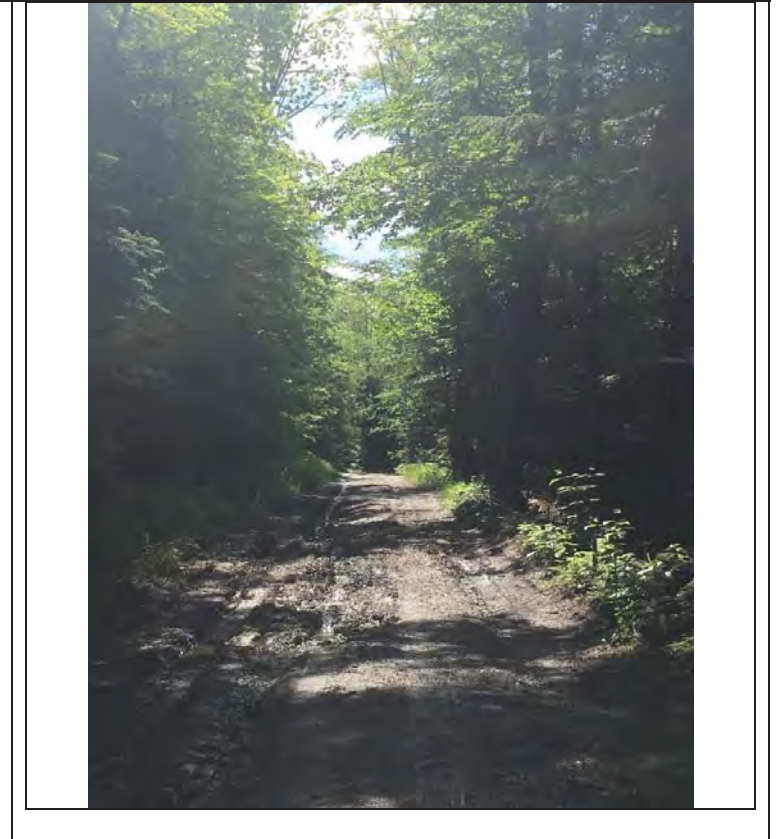
Site map	Site photo
----------	------------

BMP Summary Sheet		BMP ID #:	21
Site name: Gonyeau Rd		Municipality:	Plainfield
Approximate address:	Gonyeau Rd	Assessment Date	2017-06-20
Proposed BMP type:	Road Resurfacing, Vegetated Swale, Swale Improvements		
Proposed BMP description:		Proposed BMP details	
Town noted class 4 road is eroding. There is a spring running down middle of unimproved road. Redirect water off road into stone lined or vegetated channel. Regrade road. Consider resurfacing road with appropriate material (i.e., stay mat).		Current site type	Road / ROW
Site Description		Relative drainage area	Medium
public ROW, relatively steep, no permit, noted by town		Impervious area (approx %)	Low
Feasibility concerns:		BMP pollutant reduction	Medium
Poor Soils		BMP design required	Medium
		Hydrologic soil group	C
		Proximity to water	Medium
		Stormwater permit?	No
		Pollution visible	Excessive Erosion
		Land owner where BMP is located	Town /City

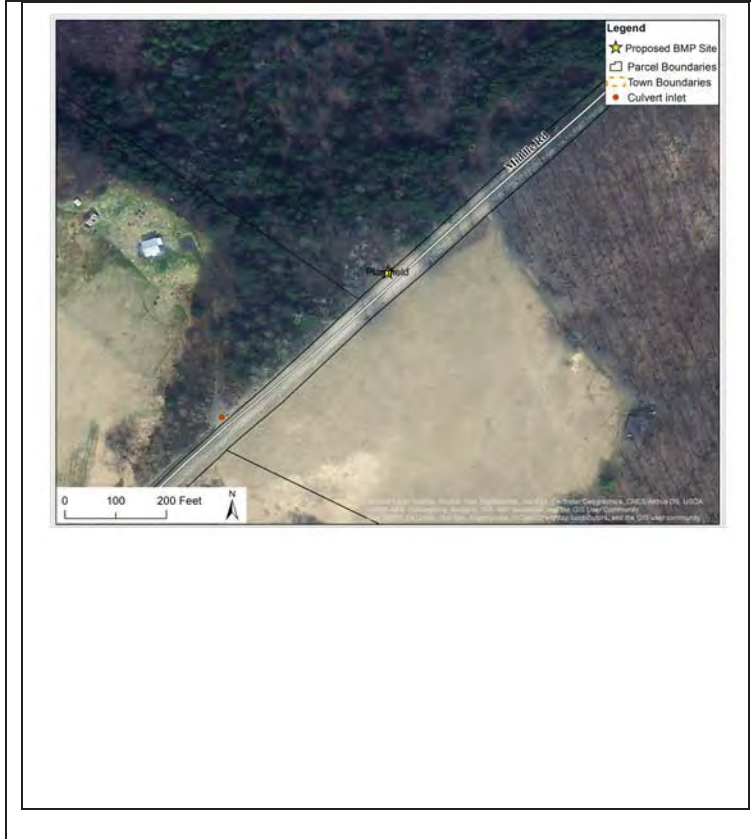
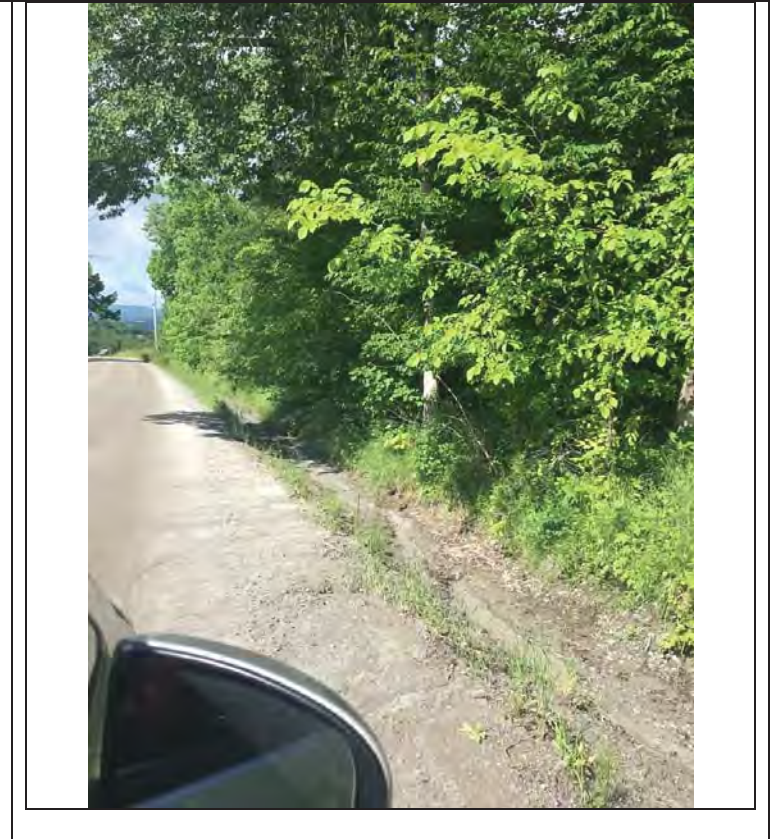
Site map	Site photo
----------	------------

BMP Summary Sheet		BMP ID #:	28
Site name: Middle Rd Ditch		Municipality:	Plainfield
Approximate address:	Middle Rd	Assessment Date	2017-06-20
Proposed BMP type: Swale Improvements, Cross Culvert			
Proposed BMP description:		Proposed BMP details	
Formalize roadside ditch. Add cross culverts to distribute road runoff to vegetated areas. Stone line ditch and add check dams.		Current site type	Road / ROW
		Relative drainage area	Small
		Impervious area (approx %)	Low
		BMP pollutant reduction	Low
		BMP design required	Minimal
		Hydrologic soil group	C
		Proximity to water	Low
		Stormwater permit?	No
		Pollution visible	
		Land owner where BMP is located	Town /City
		If existing, BMP type	
		Relative project cost	Low
		Retrofit priority	Low
		Project score	84
		Project rank by municipality	32
Site Description			
Ditches along Middle Rd, road runoff			
Feasibility concerns:			
Space

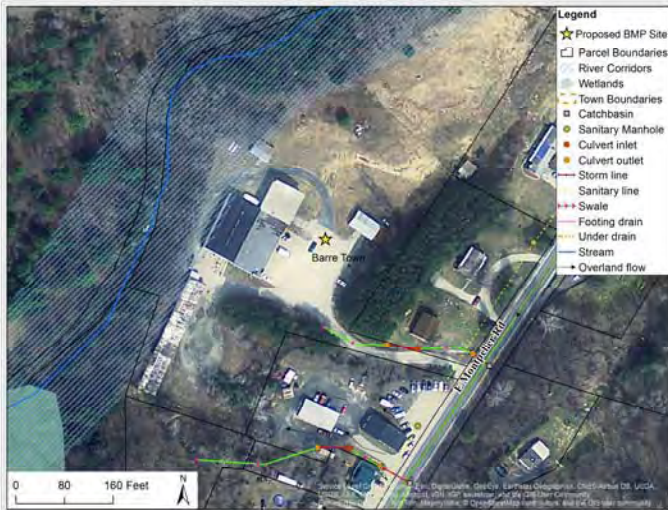
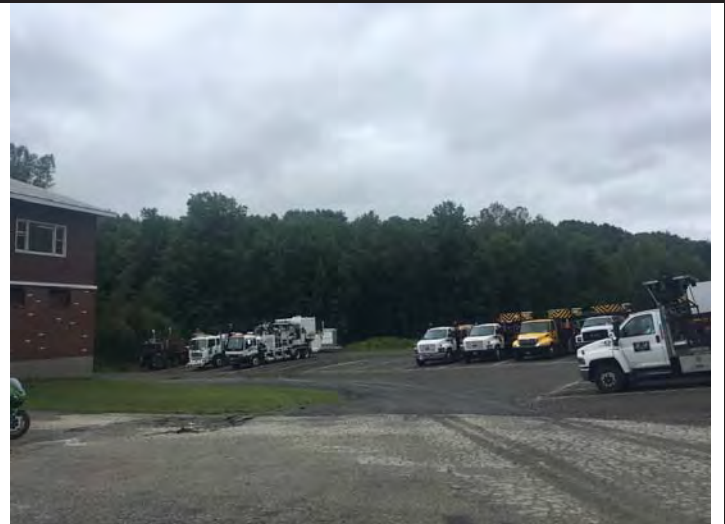
Site map	Site photo
----------	------------

BMP Summary Sheet		BMP ID #:	40
Site name:	L&D Safety Marking Corporation	Municipality:	Barre Town
Approximate address:	304 E Montpelier Rd	Assessment Date	2017-06-02
Proposed BMP type:	Infiltration Trench, Vegetated Swale, Cistern / Rain Barrel, Dry Well		
Proposed BMP description:	<p>Direct roof runoff to cistern or dry well for lower building. Construct infiltration trench and swale along parking lot to the left of the driveway.</p>		
Site Description	A soils, private, not permitted		
Feasibility concerns:	Ownership of Site		
		Proposed BMP details	
		Current site type	Commercial
		Relative drainage area	Small
		Impervious area (approx %)	Medium
		BMP pollutant reduction	Medium
		BMP design required	Medium
		Hydrologic soil group	A
		Proximity to water	High
		Stormwater permit?	No
		Pollution visible	
		Land owner where BMP is located	Private
		If existing, BMP type	
		Relative project cost	Low
		Retrofit priority	Low

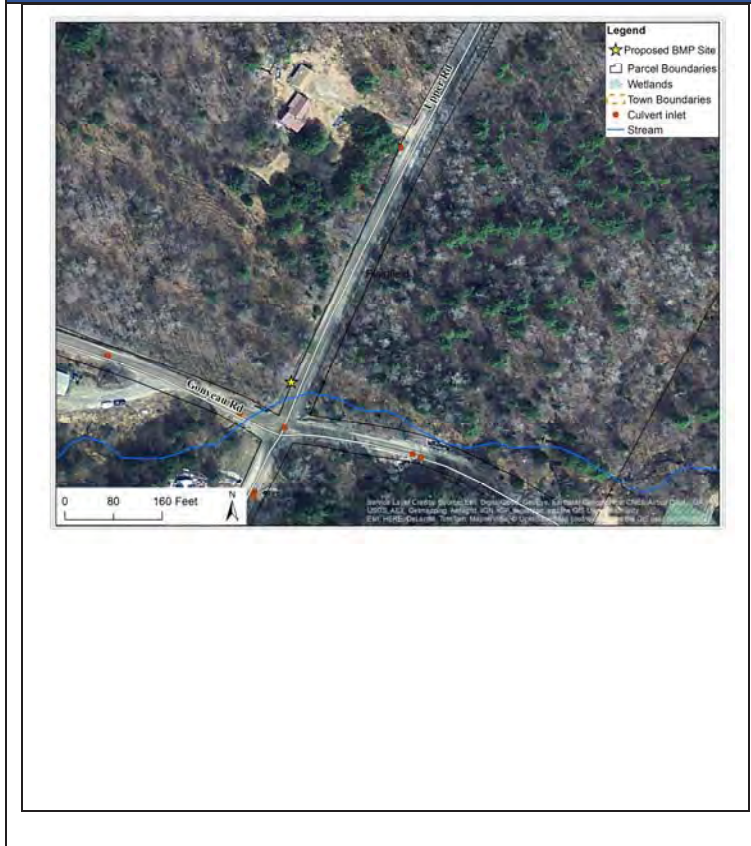
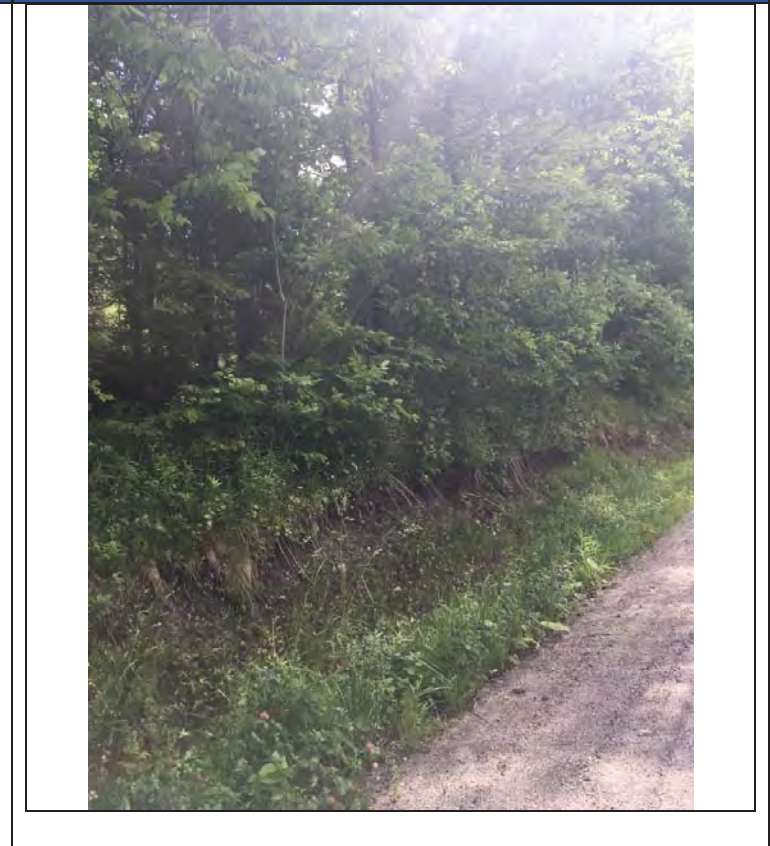
Site map	Site photo
----------	------------

BMP Summary Sheet		BMP ID #:	47
Site name: Upper Rd near Gonyeau Rd		Municipality:	Plainfield
Approximate address:	Gonyeau Rd and Upper Rd		Assessment Date
		2017-06-20	
Proposed BMP type:	Swale Improvements		
Proposed BMP description:		Proposed BMP details	
Stone line roadside ditch and add check dams. Along Upper Rd, add stone lined stormwater turnouts to vegetated areas prior to stream spaced along road dependent on grade.		Current site type	Road / ROW
		Relative drainage area	Medium
		Impervious area (approx %)	Low
		BMP pollutant reduction	Medium
		BMP design required	Medium
		Hydrologic soil group	D
		Proximity to water	High
		Stormwater permit?	No
		Pollution visible	
		Land owner where BMP is located	Town /City
		If existing, BMP type	
		Relative project cost	Low
		Retrofit priority	Medium
		Project score	101
		Project rank by municipality	13
Site Description			
D soils, ROW, moderate steepness, no permit, noted by town: Town noted newly replaced culvert is too small, assess contributing stormwater impacts.

Feasibility concerns:			
Proximity to Stream, Poor Soils, Space, Utilities
