CENTRAL VERMONT – STORMWATER MASTER PLAN

DUXBURY, FAYSTON,
MORETOWN, WAITSFIELD,
AND WARREN,
VERMONT

FINAL REPORT

April 30, 2019

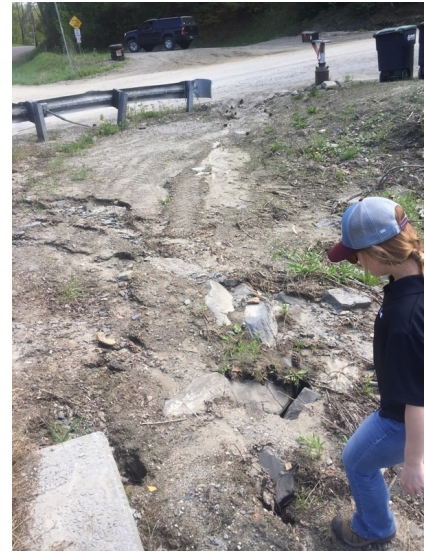
Figure A9. General road and ditch improvements are proposed for the Ward Hill Rd and Route 100 site.

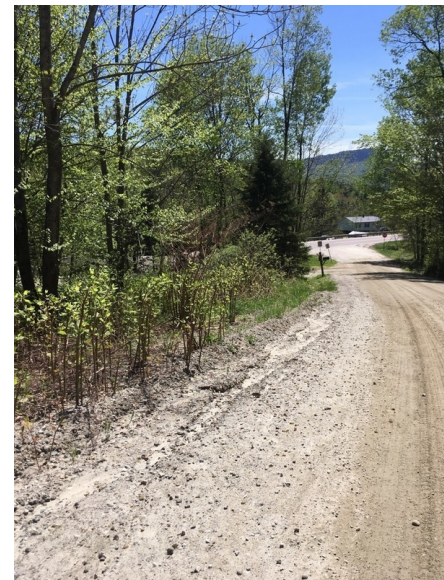
Figure A11. General road and ditch improvements are proposed for the Turner Hill Rd South site.

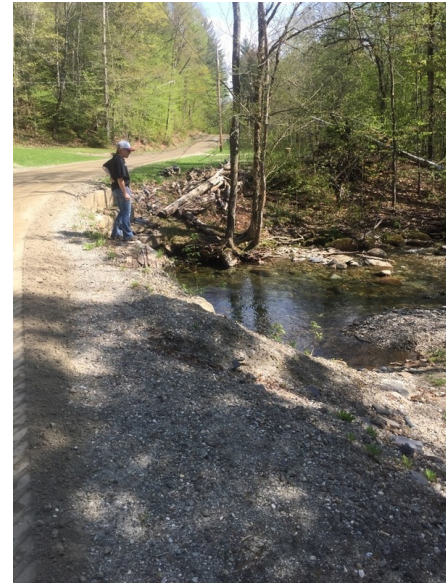
Figure A12. A sediment trap is proposed for the Dowsville Rd and Vigilante Rd site.

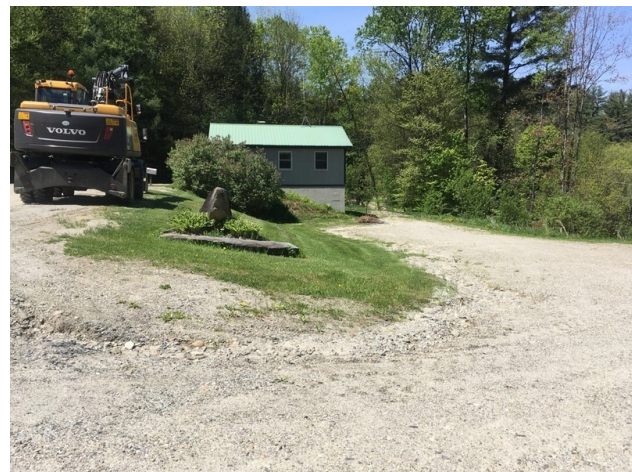
Figure A13. A bioretention feature is proposed for the Duxbury Town Garage site.

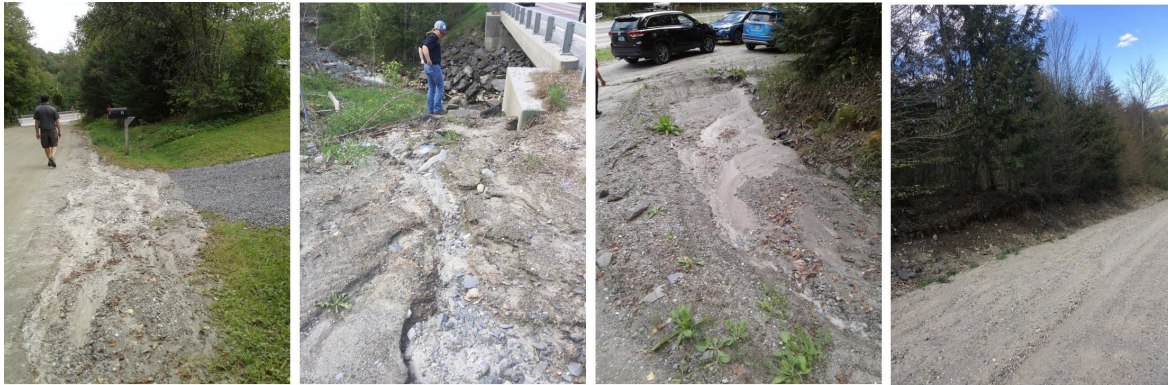
Stormwater is running over the road and depositing sediment where a driveway culvert is not present.

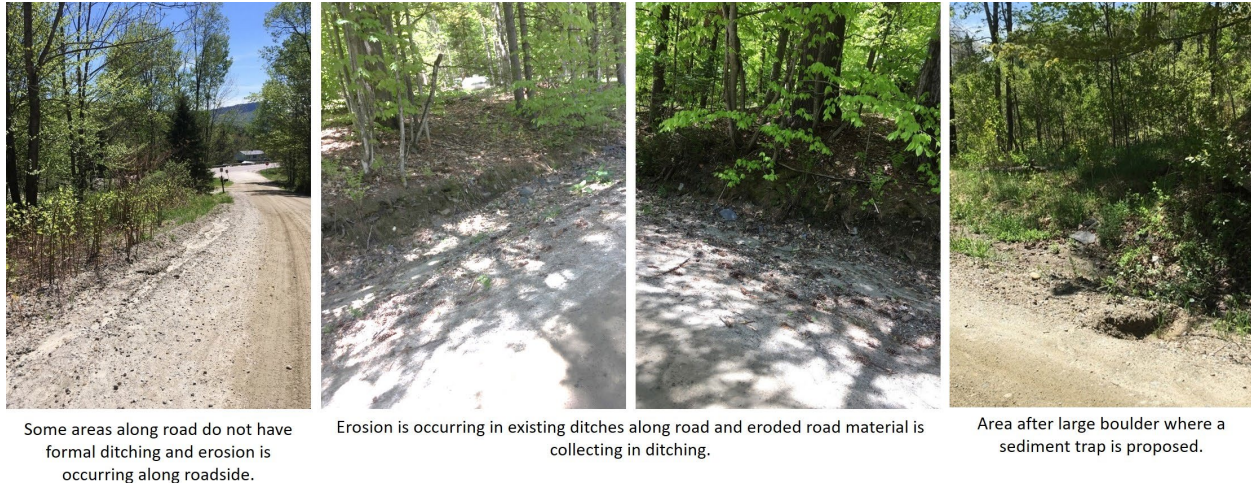
Figure A23. The proposed retrofits are described in the above photos

The proposed retrofit includes regrading and recrowning the road to better direct water off the road, ensuring that no grader berms remain, and stabilizing existing ditching and formalizing ditching where lacking (southern section of road). Also, adding timber check dams and cutting back slope in lower steep section is recommended. A sediment trap is proposed that will overflow to a turnout to the wooded area before large boulder (see starred location in Figure A22). See the photos and associated descriptions in Figure A23.

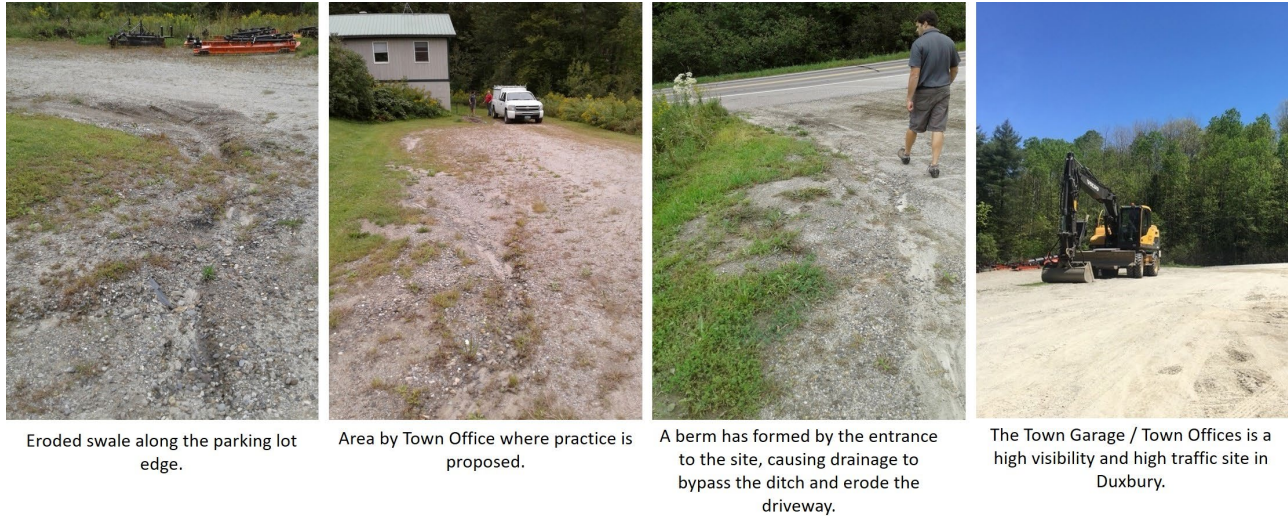
Figure A27. The proposed retrofits are described in the above photos.

The proposed stormwater improvements for this site include stabilizing the existing erosional channel into a vegetated or stone lined swale. This water should be directed around the existing greenspace to the lower Town Offices parking area (see starred location in Figure A26). It is proposed that drainage is directed to a sand filter and a bioretention feature. Additionally, the accumulated berm by the road should be removed to allow water to access the existing ditch. See the photos and associated descriptions in Figure A27. It is recommended that an educational sign be installed at this site. This cost is not reflected in the estimated project cost itemized below. Approximately \$500 should be budgeted for this sign.

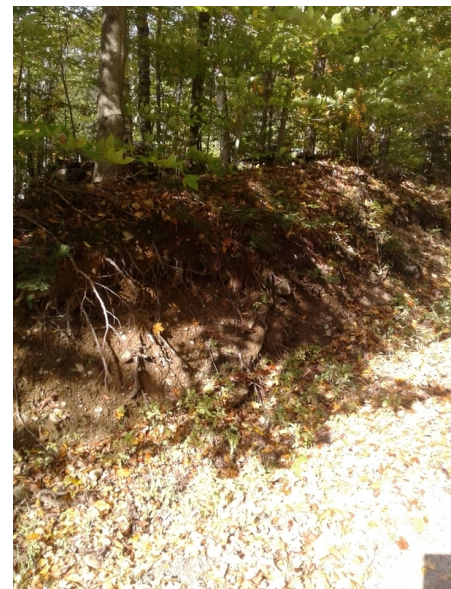
Figure B11. Erosion was noted within roadside ditch and at culvert outlet.

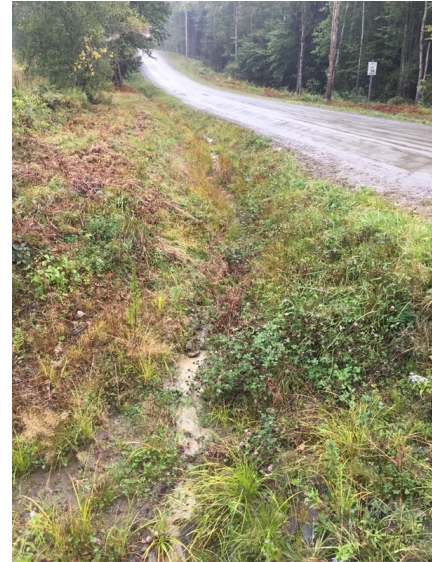
Figure B12. Stormwater within roadside ditch is actively transporting sediment to stream.

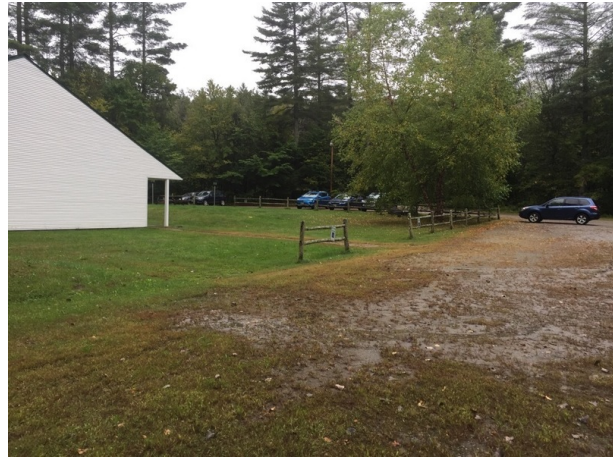
Figure B13. Drainage from the Town Office parking lot is currently unmanaged.

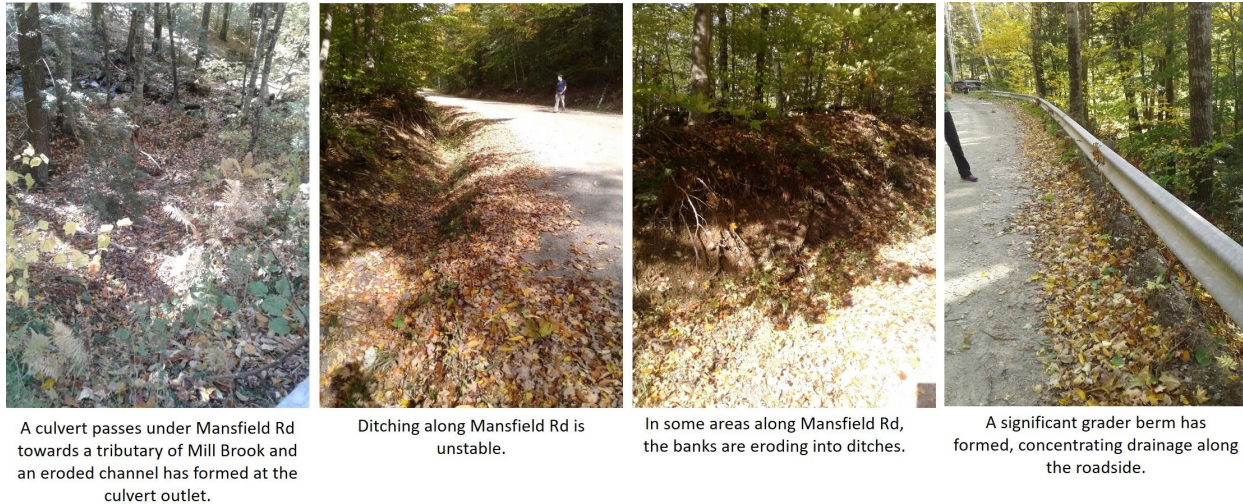
Figure B21. The proposed retrofits are described in the above photos.

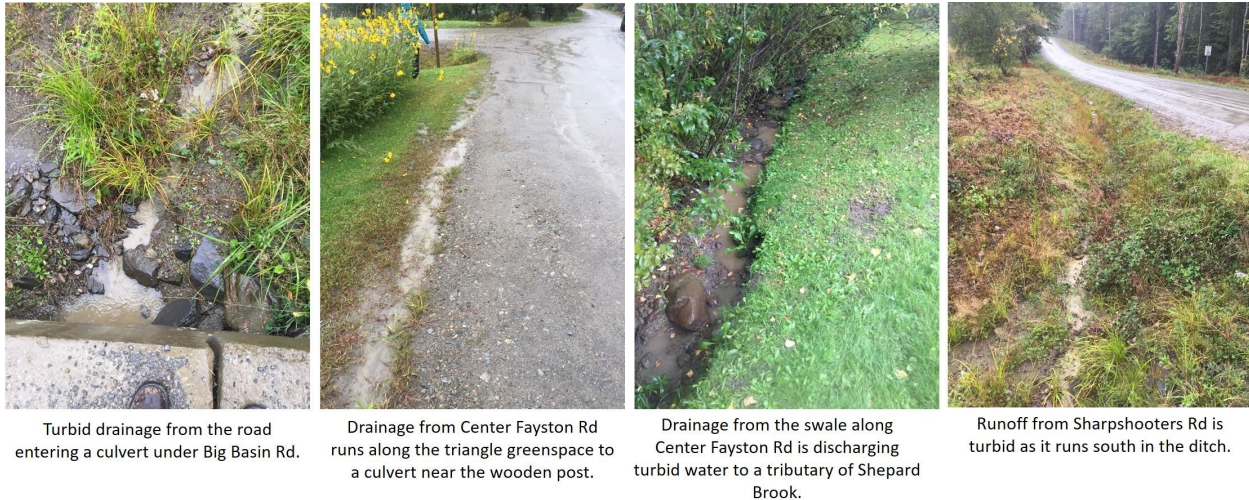
Figure B23. The proposed retrofits are described in the above photos.

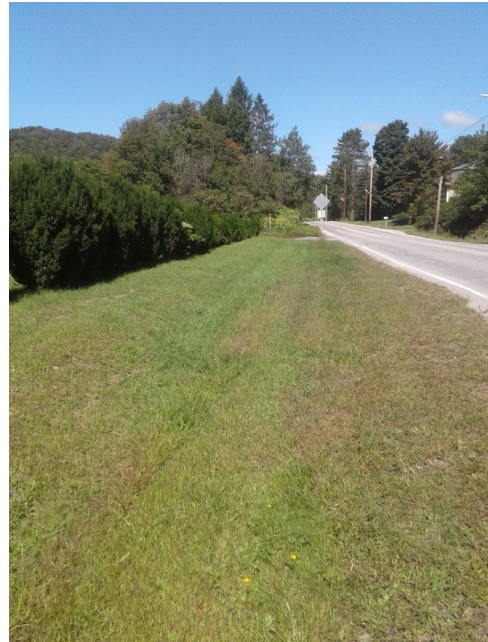
Figure C9. A subsurface infiltration practice is proposed in the greenspace pictured above along Route 100B.

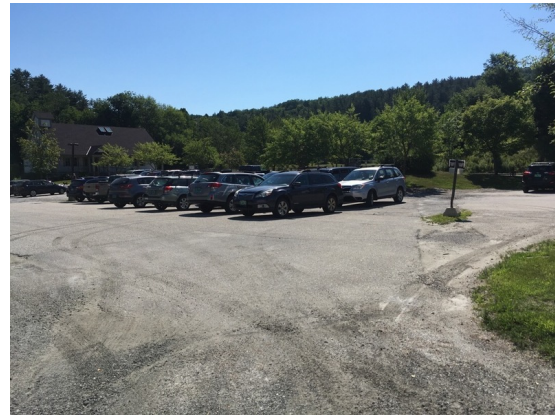
Figure C10. It is proposed that the drainage from the Moretown Elementary parking lot be managed in a gravel wetland.

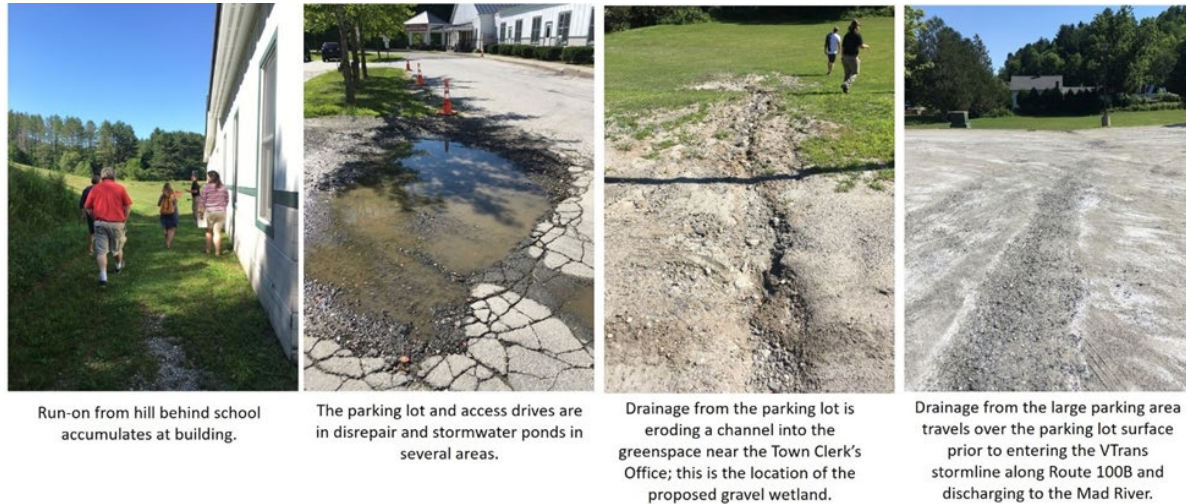
Figure C19. The proposed retrofits are described in the above photos.

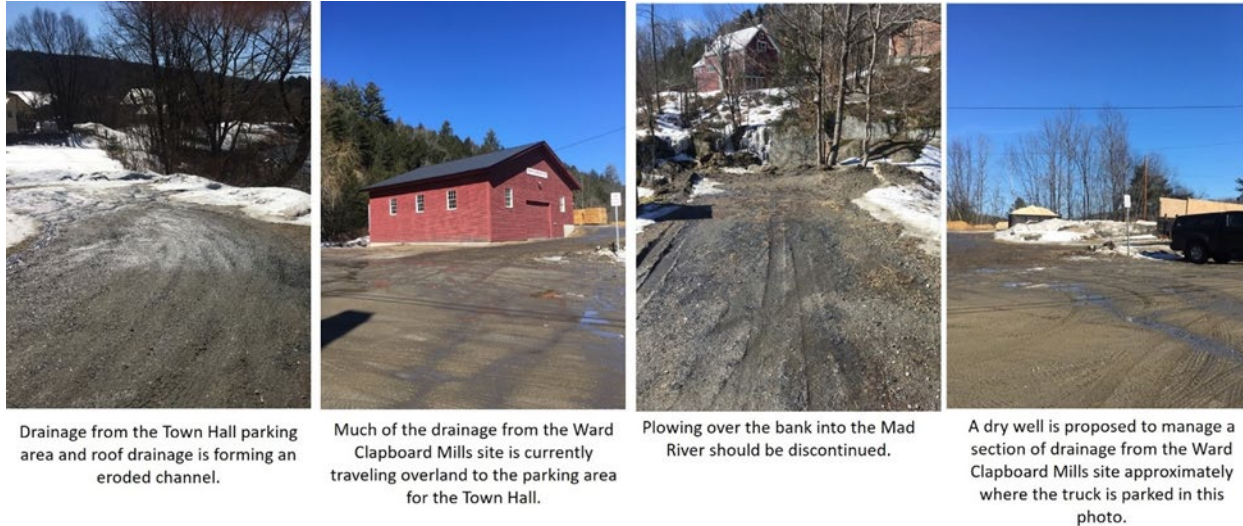
Figure C23. The proposed retrofits are described in the above photos.

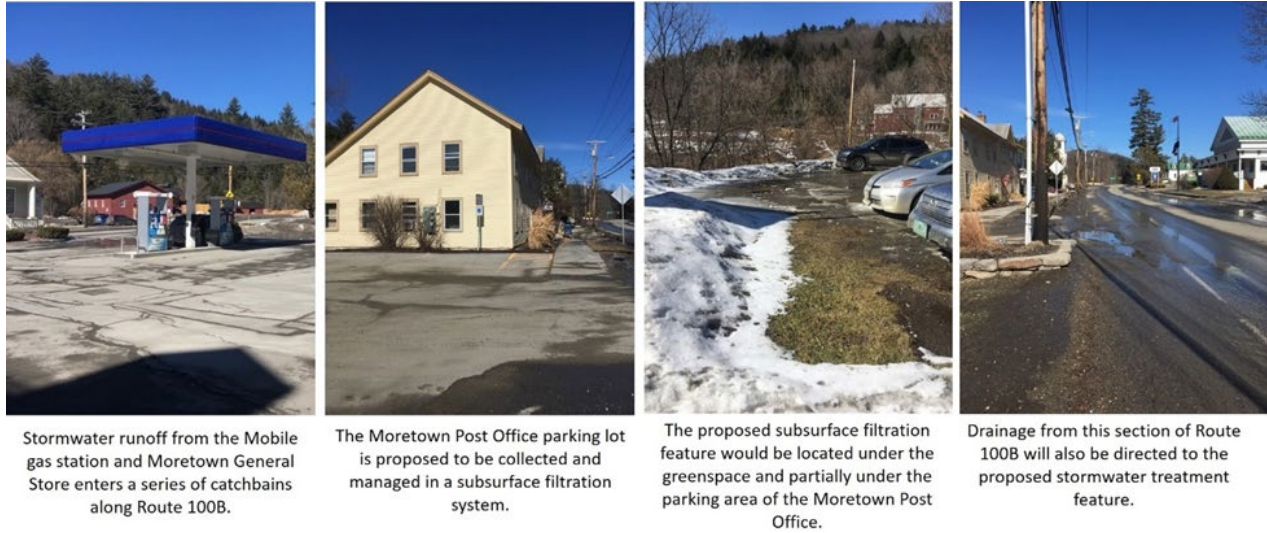
Figure C25. The proposed retrofits are described in the above photos.

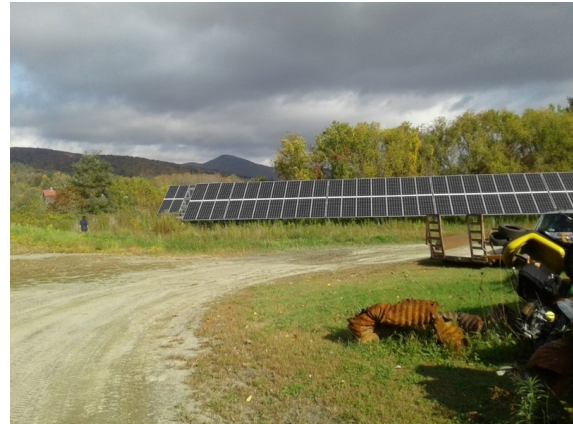
Figure D9. The proposed infiltration basin is located to the left of photo.

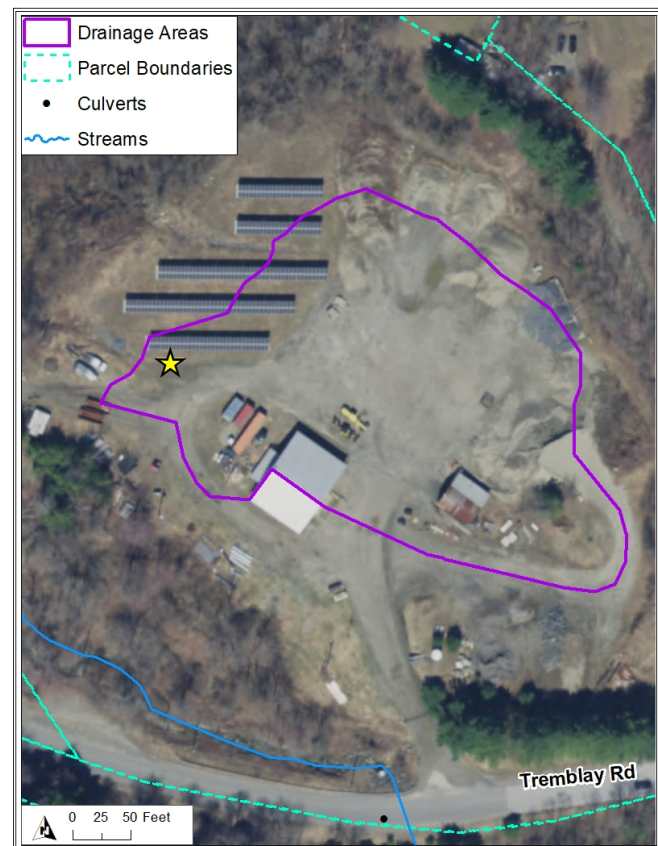
Figure D14. The proposed BMP drainage area is shown in purple. The recommended BMP locations are shown with stars.

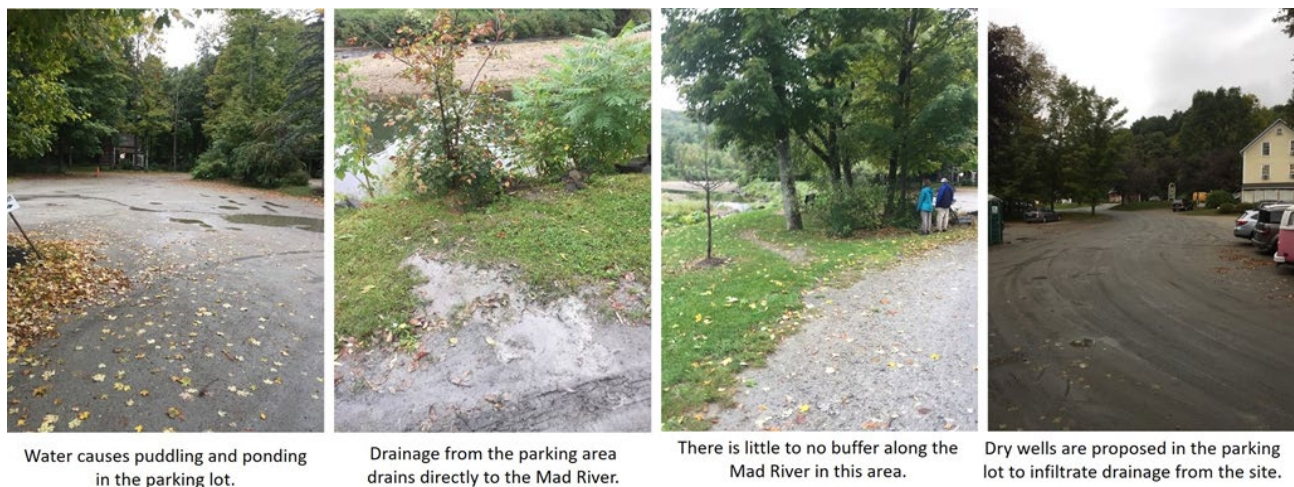
Water causes puddling and ponding in the parking lot.

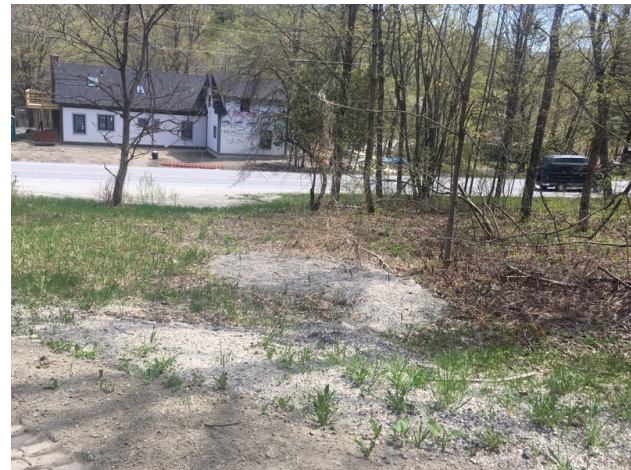
Figure E13. An infiltration basin is proposed in the area pictured above.
