**INDIAN BROOK STORMWATER
MANAGEMENT EVALUATION**

Prepared For:
Lake Champlain Basin Program
54 West Shore Rd
Grand Isle, Vermont 05458

December 1997

Prepared By:
James Pease
Vermont Department of Environmental Conservation
Water Quality Division
10 North Building
103 S. Main Street
Waterbury, VT 05676

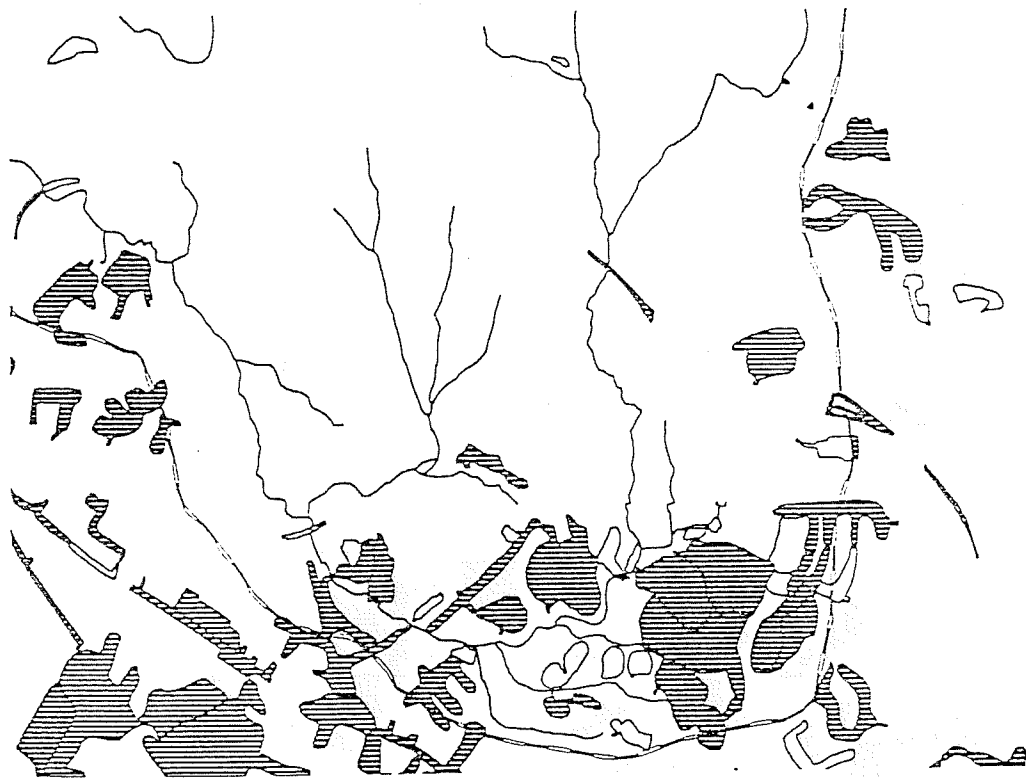
Figure 5.13: Estimated total suspended solids loading from sewersheds in the Indian Brook watershed.

Recwater	Storm sewershed	Treatment (Appendix 4)	EIA%	Loading kg/yr
Highest Total Suspended Solids (Figure 5.13)				
Indian	Five Corners-North	CB	56.9	5,687
<i>Indian</i>	<i>Laing Farm Shopping Center</i>	<i>CB/SB/WL</i>	55.2	5,029
Indian	Countryside Drive 1-4	CB	13.8	4,919
Highest Total Phosphorus (Figure 5.14)				
<i>Indian</i>	<i>Laing Farm Shopping Center</i>			11
Indian	Countryside Drive 1-4			11
Indian	Five Corners-North			9
Highest Total PAH (Commercial Landuses Only)				
<i>Indian</i>	<i>Laing Farm Shopping Center</i>			83
Indian	Five Corners-North			61
Indian	Essex Junction H.S. 1		70.6	38
Highest Total Metals (Figure 5.15)				
Indian	Five Corners-North			7
<i>Indian</i>	<i>Laing Farm Shopping Center</i>			5
Indian	Countryside Drive 1-4			5

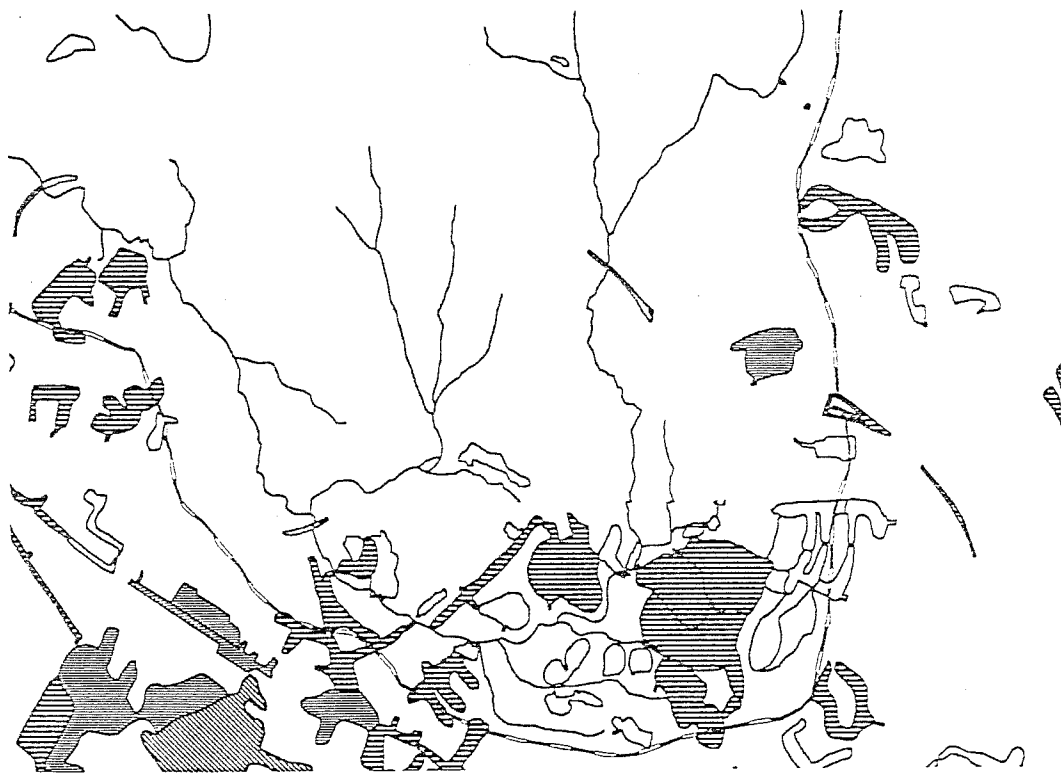
Figure 5.14: Estimated total phosphorus loading from sewersheds in the Indian Brook watershed.

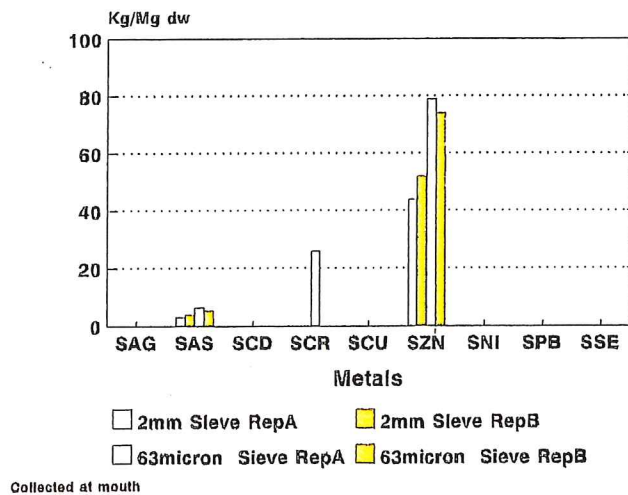
Figure 5.15: Estimated total metals loading from sewersheds in the Indian Brook watershed. Graph at bottom shows concentrations of metals in whole (2mm) and fine fraction (63u) sediments at the mouth of the Indian watershed. Samples collected in 1995.

The brook has two targeted storm sewersheds: the Five Corners-North sewer and the Essex Junctional Educational Center storm drains (Table 5-2, Figures 5.12-5.15).
