JERICHO, VT – STORMWATER MASTER PLAN

JERICHO, VERMONT

FINAL REPORT
April 19, 2017

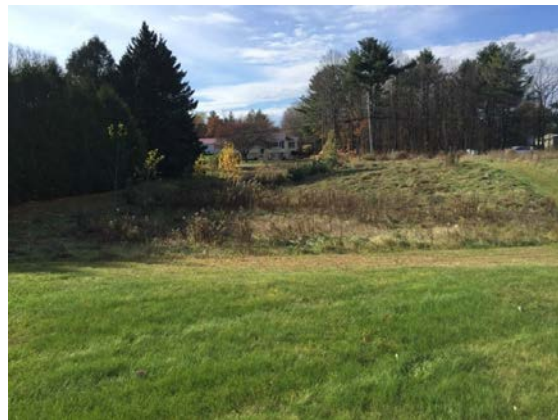
Figure 7. Town Parcel

Project Name: Town Parcel Infiltration Basin

Description: Large infiltration basin in Town-owned parcel located on the corner of Packard Road and VT-15. The parcel consists of low-lying vegetation and is open and undeveloped. A large area drains to this location and contributes to annual, seasonal flooding. During times of high flow, stormwater is piped to the Browns River. The proposed feature would help to mitigate flooding and decrease stormwater flow to the river by detaining runoff and promoting infiltration.

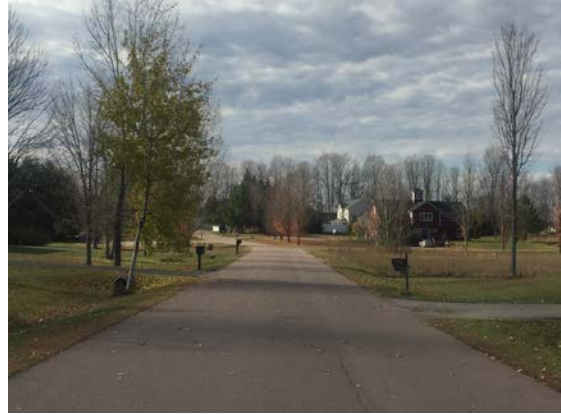
Figure 8. South Main Street

Project Name: South Main Street Underground Storage and Infiltration Chambers

Description: Underground chambers located in the Town’s ROW along South Main Street, parallel to VT-15. Chambers would be implemented under the road surface and into the Town’s ROW. This is a designated chronic problem area with annual, seasonal flooding. Neighborhood-wide flooding is prompted by poor soils in upper-extent slopes within the drainage area. Furthermore, there are many residential developments with large amounts of impervious surfaces and little existing stormwater infrastructure. The proposed feature would mitigate flooding by capturing and infiltrating a large volume of stormwater runoff from the drainage area.

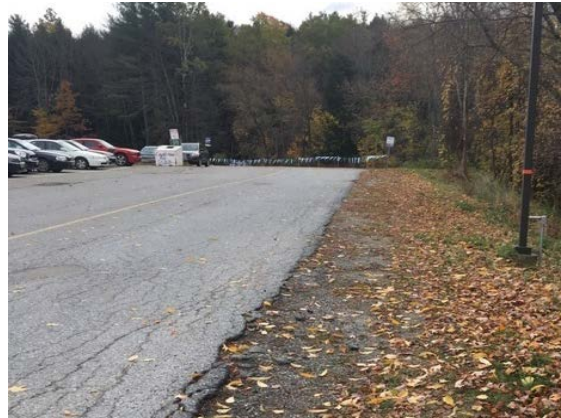
Figure 9. MMU Parking Lot

Project Name: MMU Underground Storage and Infiltration Chambers

Description: Underground chambers at MMU located on Browns Trace Road. Chambers would be implemented beneath the school’s lower parking lot, adjacent to a Lee River tributary. There is a large amount of impervious cover on this property, from which stormwater runoff is collected and piped to the stream. The proposed feature would improve water quality, decrease streambank erosion and the occurrence of poor pavement quality due to stormwater ponding, and capture and infiltrate runoff from the property.

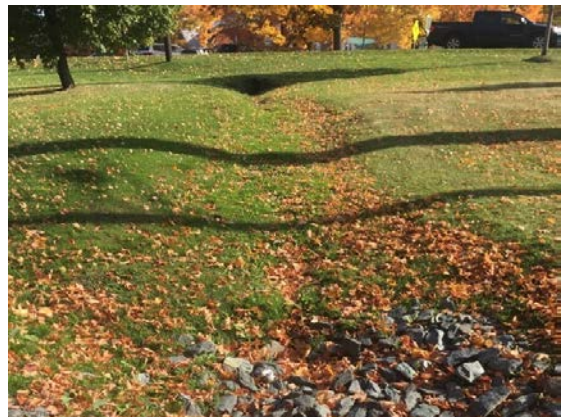
Figure 10. Across from Jericho Center's Town green

Project Name: Jericho Center Circle Infiltration Basin

Description: Infiltration basin located in the island across from the Town green in Jericho Center. This is a designated problem area consisting of poorly drained soils and little existing stormwater infrastructure in the upper-extent slopes. Stormwater runoff is currently piped to the wetland at the end of Wilder Road. The proposed feature will accept and infiltrate drainage from Bolger Hill Road, the Town green, and Browns Trace Road.

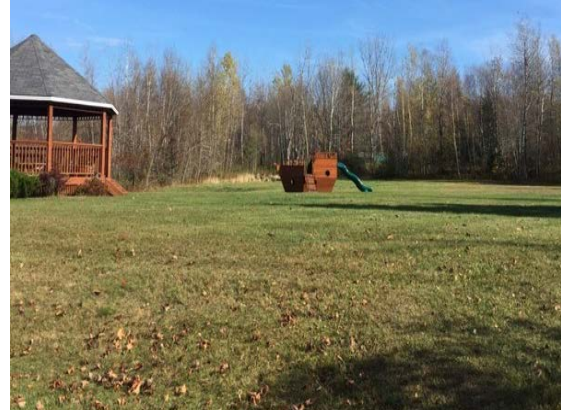
Figure 11. Park in Jericho East Subdivision

Project Name: Jericho East Park Underground Storage and Infiltration Chambers

Description: Underground chambers located in the parcel on the corner of Kriste Lane and South Main Street. This is an undeveloped parcel of common land within the Jericho East Subdivision. Drainage from this area contributes to the flooding experienced along lower South Main Street. The proposed feature would accept and infiltrate drainage from upper-extents of the subdivision, and decrease stormwater flowing to South Main Street.

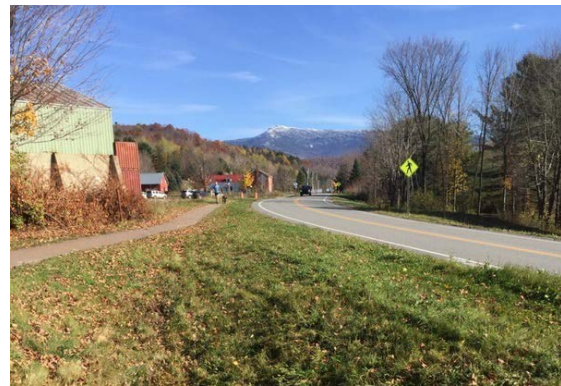
Figure 12. Intersection of Dickensen Street and River Road

Project Name: Dickensen Street Gravel Wetland

Description: Gravel wetland located across from Dickensen Street, in front of the Browns River Middle School on River Road. This area drains commercial and residential land uses and includes the Town’s Riverside future growth area. All stormwater is currently piped to a swale running directly to the Browns River.

Substantial redevelopments are planned for this parcel, and there are limited possibilities to manage stormwater onsite. Managing this runoff could benefit the Town by providing an opportunity to collaborate with private developers to improve water quality and potentially meet permit requirements.
