Stormwater Master Plan for the Town of Ludlow Vermont

FINAL REPORT

June 24, 2021

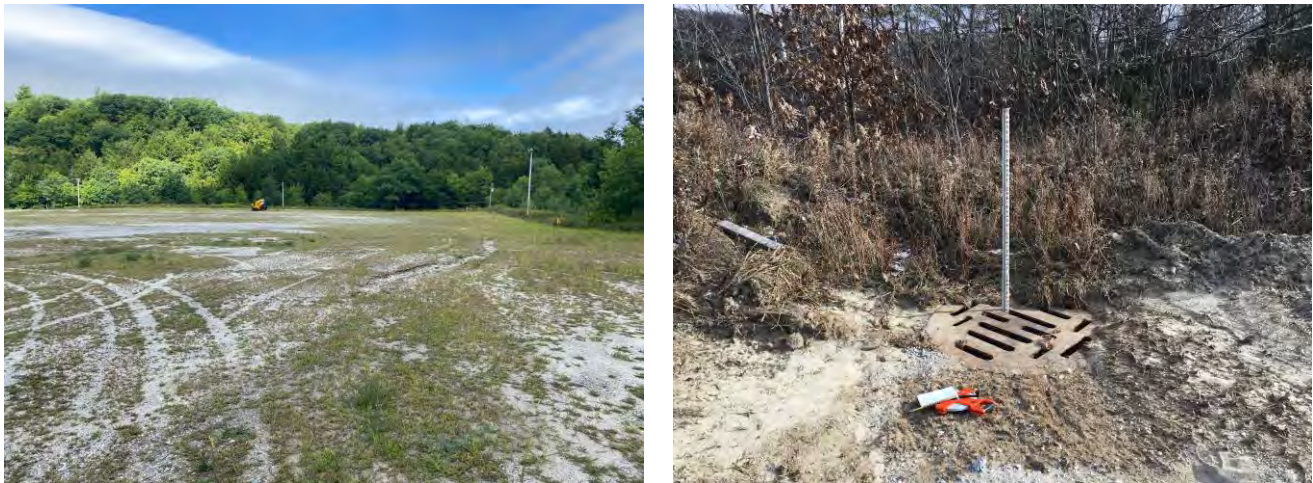
Figure 4: Project LT-04 had the highest score (42 out of 50). The project is located on a Town owned parking lot that is leased by Okemo Mountain Resort (blue lot). A large portion of the gravel parking lot drains to a deep catch basin structure which is directly connected to a stream to the north. Large gully and rill erosion features were observed along concentrated flow paths across the parking area. The opportunity to treat a large volume of water and a very high sediment/nutrient load while on Town property produced the highest score for any of our stormwater master planning projects to date.

The 55 projects described in the master project table (Appendix B) were prioritized based on the potential for each project to improve water quality, reduce environmental impact, project feasibility, and co-benefits. Estimated project cost and the phosphorus removal efficiency (\$/lb of P) were included. We followed the Unified Scoring Prioritization for Stormwater Master Plans document developed by VTDEC (VTDEC, 2018a), with an adjustment to the phosphorus loading and phosphorus reduction criteria. This method includes a total of 19 criteria divided into 3 categories. The final score is expressed as a percent of the total score, with slightly different criteria applied to road drainage projects. Total scores were out of a maximum of 50 points (Table 5). Two scoring categories are not applicable to road erosion/road drainage projects, which had a maximum score of 44 points. The projects in Appendix B ranged from a low score of 15 to 42 points (Figure 4).

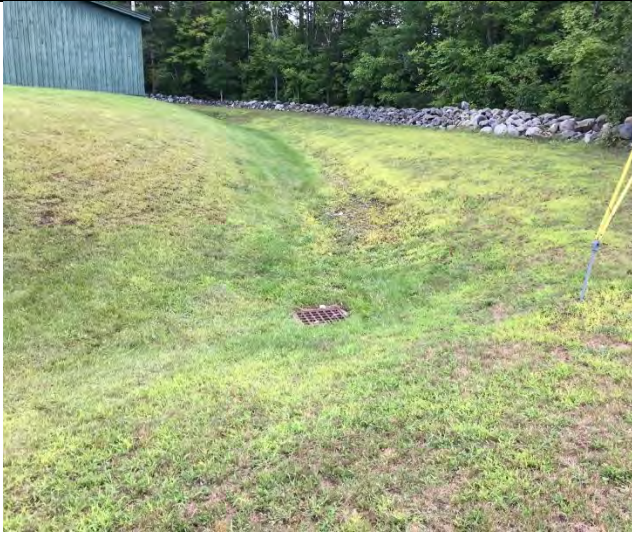
<p>Photo 1: Swale from the north entering the catch basin.</p>		<p>Photo 2: Large depression where a feature could be installed.</p>				
<p>BMP Description: Install a large infiltration feature in the grassy depression south of the parking lot (photo 2) with an overflow into the existing catch basin. Enhance the existing swale (photo 1) to infiltrate runoff.</p>

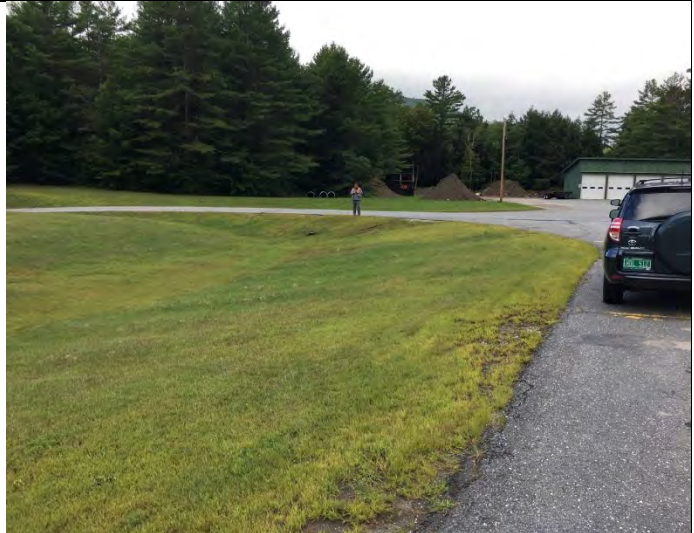
Land Ownership	VT Highway Dept.					
BMP Type	Surface Infiltration, Swale Enhancement					
Drainage Area/Impervious	4.68/1.61 acres					
% Impervious	34%					
Estimated Project Cost	\$ 52,400					
P Efficiency (\$/lb removed)	\$ 10,019					
Project Priority	High					
<p>Site Description: Large grass swale/depression draining to a single catch basin that is directly connected to receiving water. Large drainage area including garage rooftop area and paved/gravel parking lot. North side of property drains to existing swale to catch basin. Steep slopes adjacent to swale.</p>

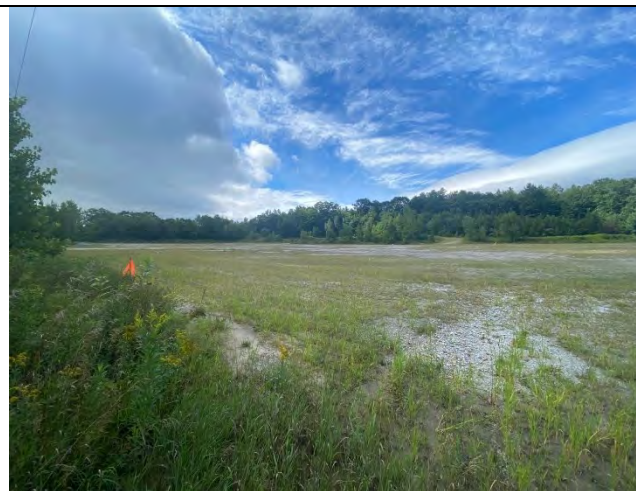
Site Description: Catch basin directly connected to perennial stream drains a very large gravel parking lot (Town owned). Numerous gully and rill erosion features along concentrated flow paths through parking lot.

Photo 1: The large parking lot as seen from the location of the catch basin.

BMP Description: Adjust grading and stabilize flow paths to direct runoff to a new infiltration feature near the existing catch basin. Surface or subsurface infiltration are feasible.

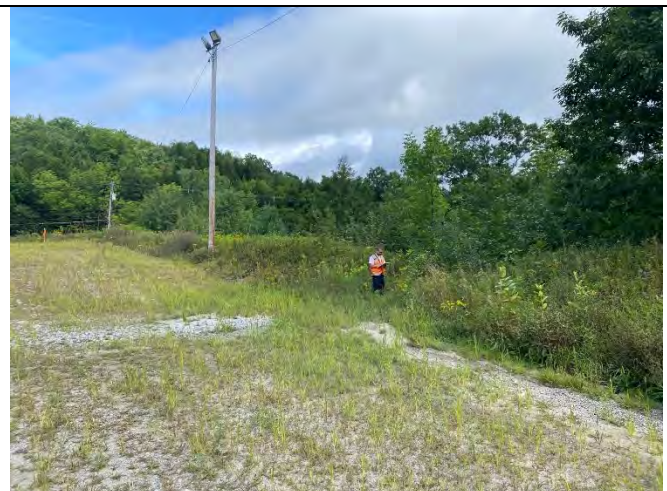
Photo 2: Rill and gully erosion into the catch basin (location marked by FEA personnel)

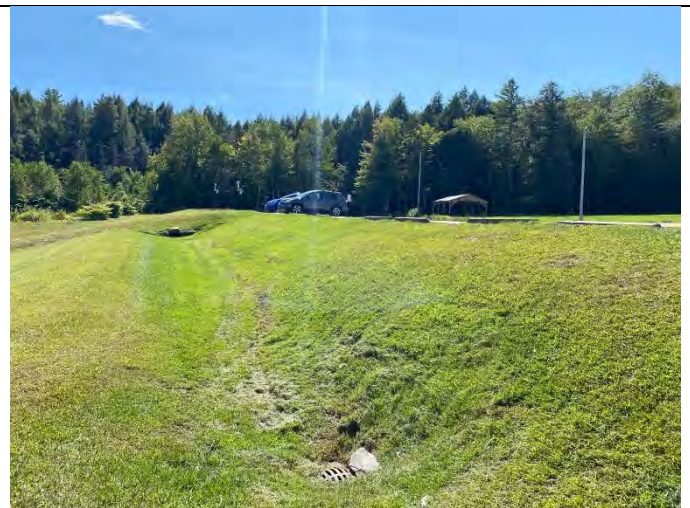
Photo 2: Swale along east side of parking lot that does not receive runoff due to poor site grading

BMP Description: Direct drainage into a rain garden or bioretention swale

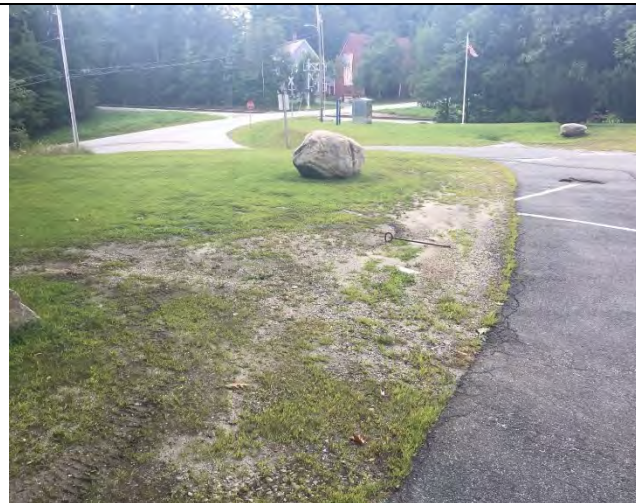
Site Description: Sheet Erosion off of portion of parking lot flows to grassed area. Some erosion along edge of steep driveway from concentrated flow of parking lot. Buried electric nearby. Border of A/Unrated soils

Photo 1: Sediment deposition at low point of the parking lot where water runs off. Ineffective catch basin in the top right corner.

BMP Description: Install a collection swale and infiltration basin

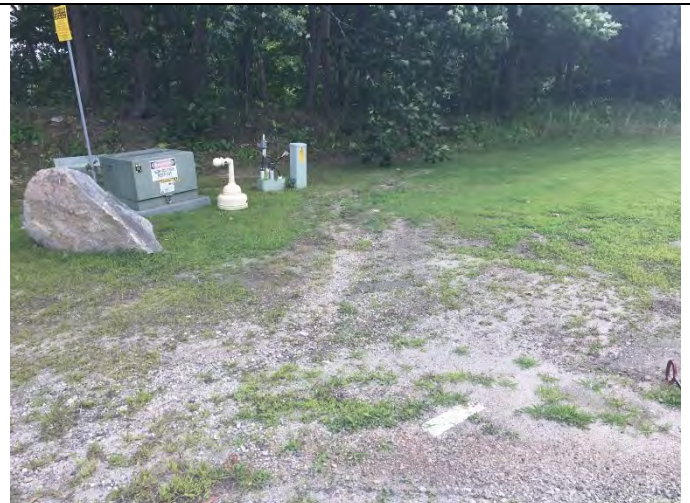
Photo 2: Minor rill erosion alongside buried utilities.

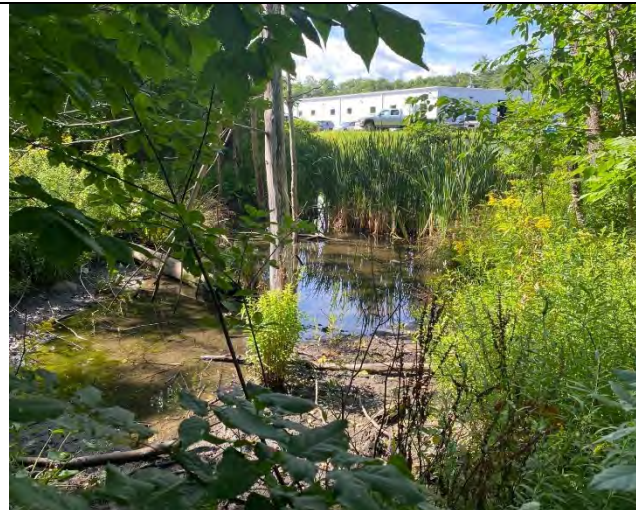
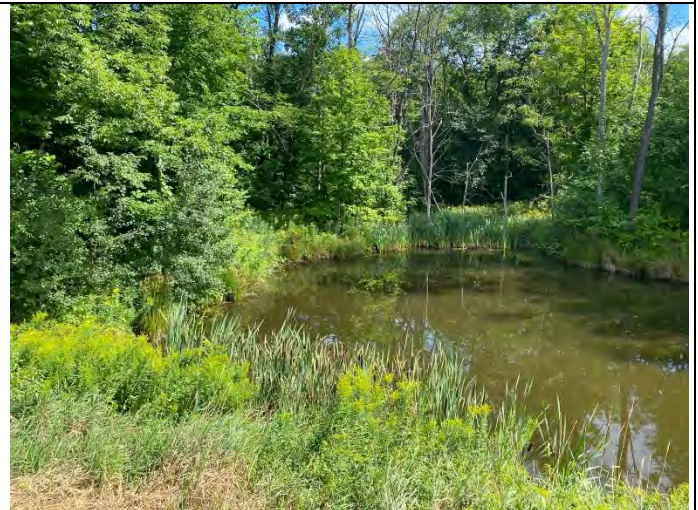
Site Description: Existing wet pond with no outlet infrastructure. Drains all of subwatershed 46, gully erosion where water overflows pond

Photo 1: Low point of the existing wet pond's rim where water spills over. **Photo 2:** Existing wet pond from above.

BMP Description: Use existing wet pond as a forebay and make a new wet pond or gravel wetland, could also take portion of runoff from LT-16 (1 acre).

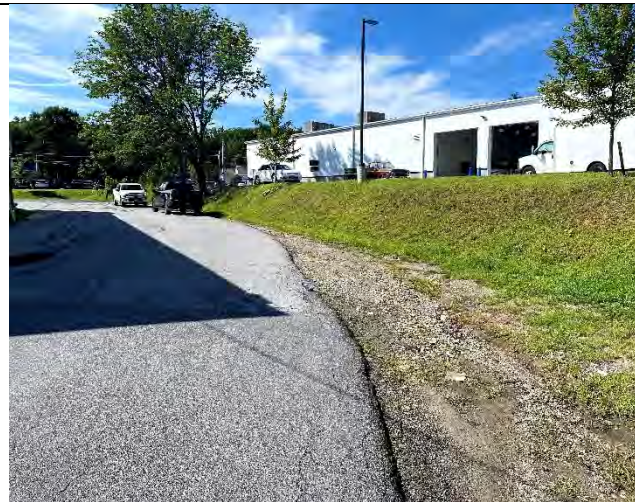
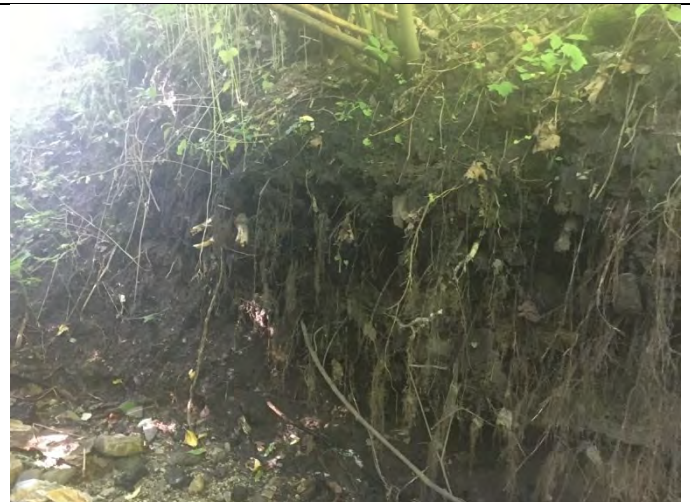
Site Description: The Shaws parking lot and rooftop drain to the corner of the lot through swales and overland flow and into a large gully that leads directly into the Black River.

Photo 1: Rill erosion in swale along the side of the parking lot. **Photo 2:** Severe erosion near gully head

BMP Description: Stabilize gully, some flow along edge of parking lot could be directed to LT-15

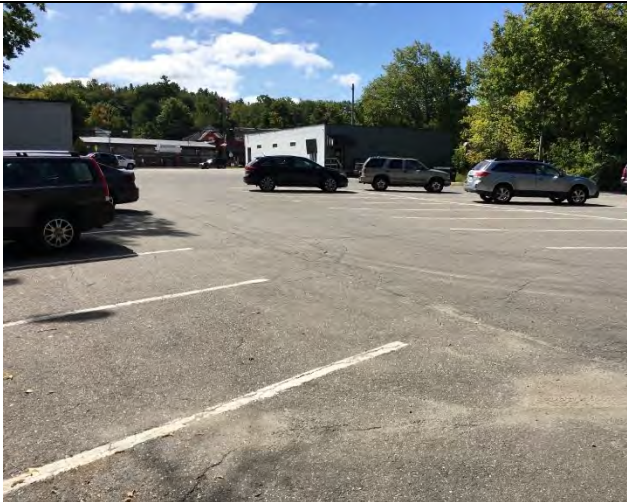
Site Description: The low point of the municipal parking lot drains directly into the river.

Photo 1: Municipal parking lot with minor sediment deposition.

BMP Description: Stabilize and enhance the swales along the sides of the parking lot. Install a rain garden in the corner to treat the water before it enters the river.

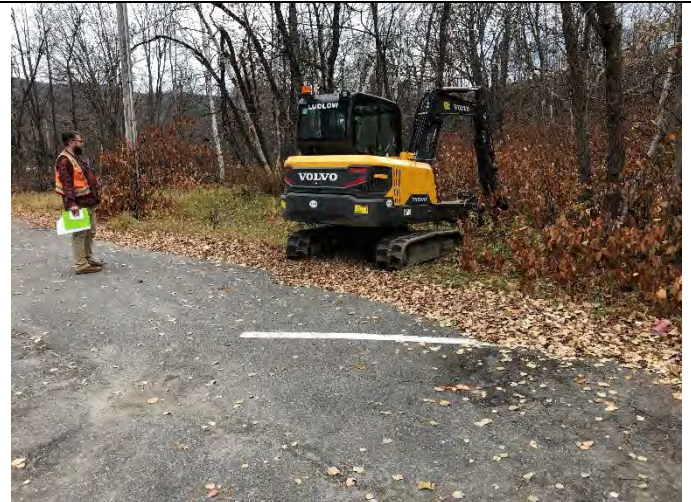
Photo 2: The low point in the corner of the lot. All drainage from the lot drains over this area.

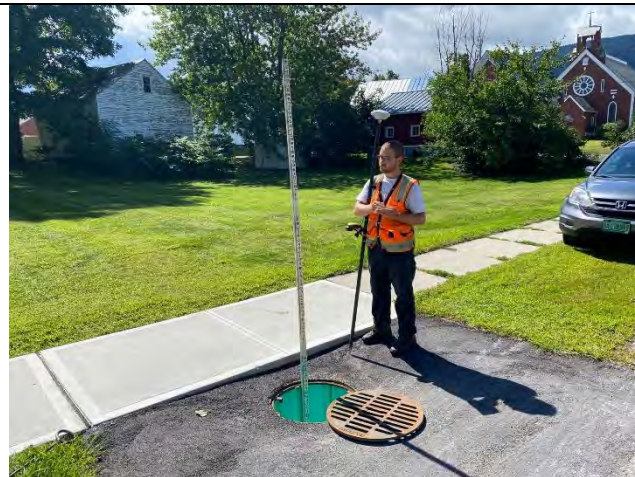
Site Description: Stormline with a large drainage area passes through an empty private lot. High Street has recent catch basin and stormline upgrades, but no treatment.

Photo 1: Catch basin next to empty lot.

BMP Description: Opportunity for a large underground infiltration feature. Flow split would be required at the final catch basin, or new catch basin. Would likely require an inline pre-treatment device (swirl separator). Pipe elevations surveyed and water elevation can't be raised in drainage network. Soils are unrated but neighbor says well drained.

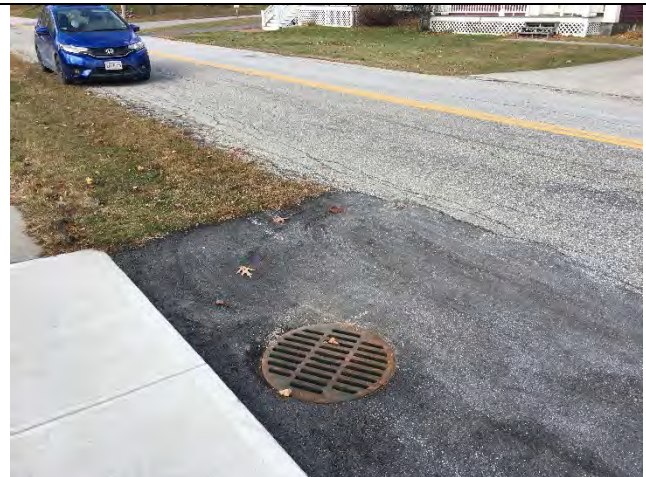
Photo 2: Road draining to catch basin

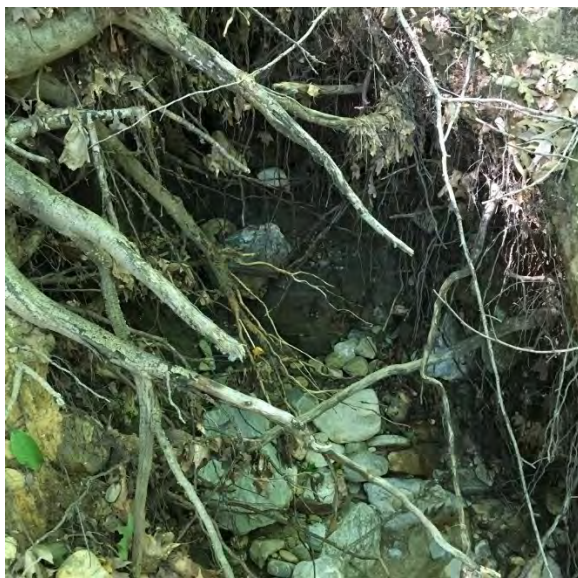
Site Description: Outfall from stormline draining a portion of the retirement complex is causing severe gully erosion down a steep slope to a stream.

Photo 1: Erosion at the head of the gully.

BMP Description: Treat runoff with subsurface infiltration feature, stabilize outlet erosion. Gully is likely too steep to access with equipment.

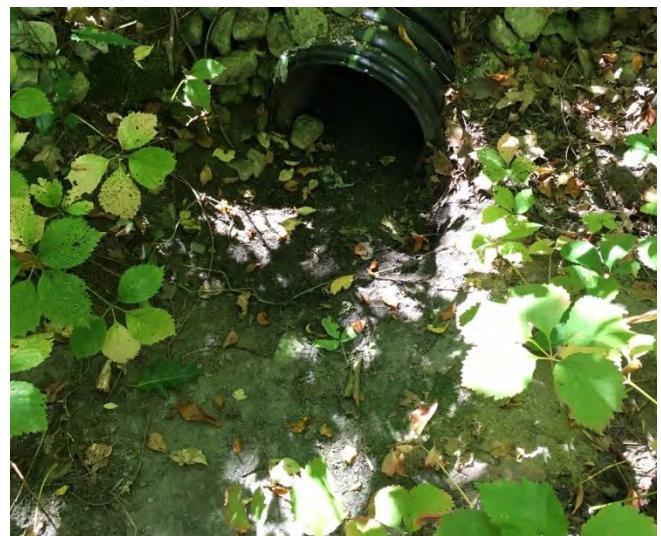
Photo 2: Sediment deposition at the outlet of the culvert.

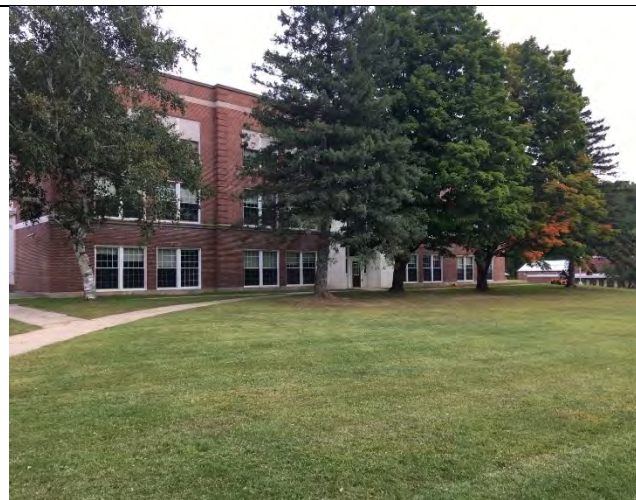
Site Description: High school roof drains into combined sewer. This is the only remaining combined sewer connection in the Town.

Photo 1: Open space in front of school suitable for subsurface infiltration

BMP Description: Redirect roof drains to back or east side of building to new underground infiltration. Overflow could be connected to existing storm line

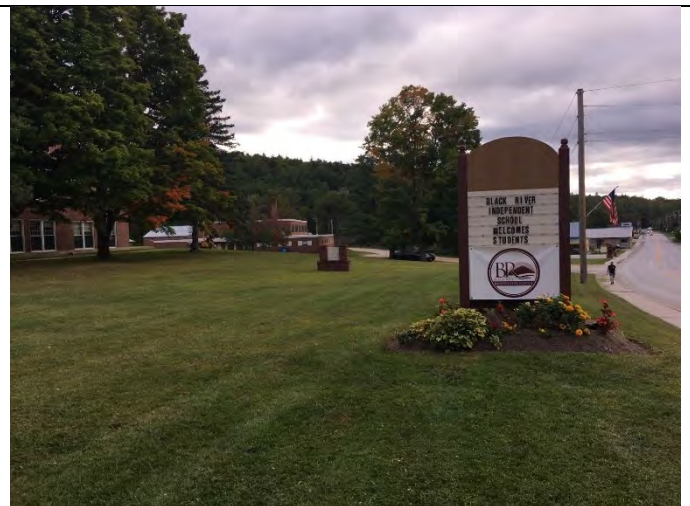
Photo 2: Open space in front of school suitable for subsurface infiltration

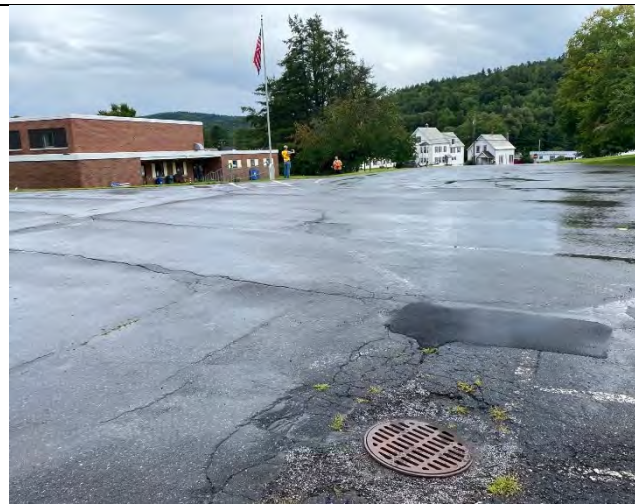
Site Description: Large portion of school complex drains to storm line with adjacent green spaces.

Photo 1: Catch basin tied into the system.

BMP Description: Install an underground infiltration system. Several potential areas, likely not room for full WQv. Unrated soils.

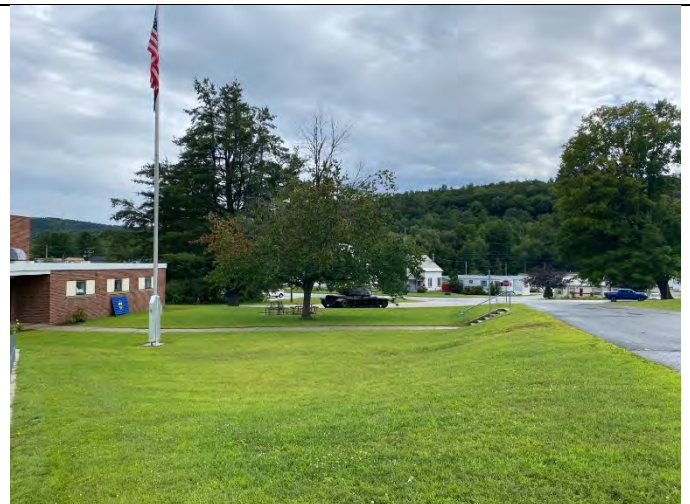
Photo 2: Green space above pipe where underground infiltration could be installed.

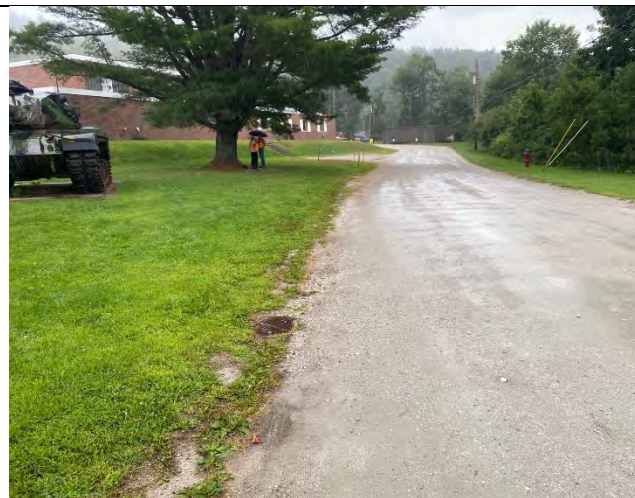
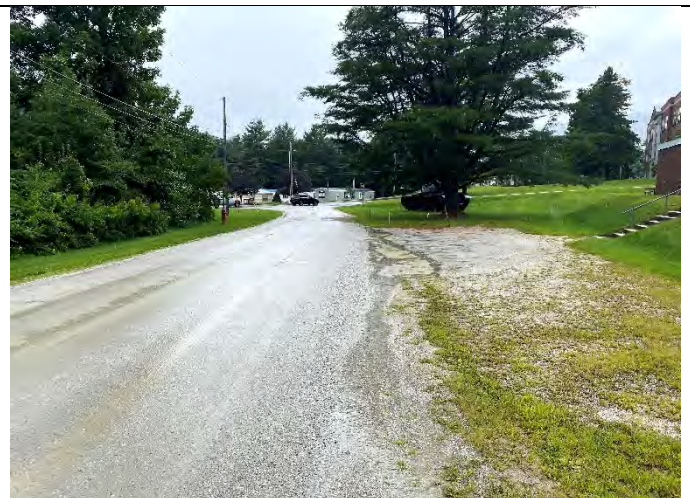
Site Description: Two catch basins on either side of gravel road leading up to community center and thrift store. Erosion along both sides of road.

Photo 1: Open space adjacent to tank for larger bioretention feature with overflow to catch basin

Photo 2: Erosion and sediment deposition along road in front of community center

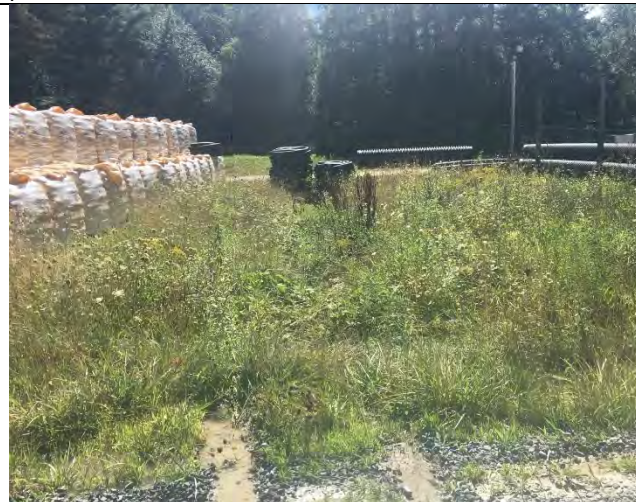
Site Description: Very large drainage area to a channel through the LaValley Building Supply parking lot. Room for wetland treatment benches along channel in 3 areas. large sediment load from parking area. Stream is mapped as perennial

Photo 1: Swale in the middle of the large gravel parking lot. Rill erosion visible in the bottom of the photo.

BMP Description: Install floodplain benches and potentially an outlet control structure to create a wetland treatment system. Three separate areas along channel could be modified.

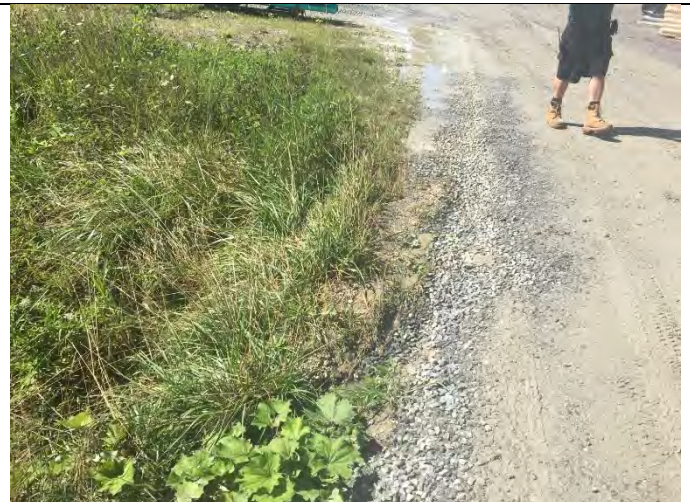
Photo 2: Sheet erosion off gravel parking lot into one of the swales.

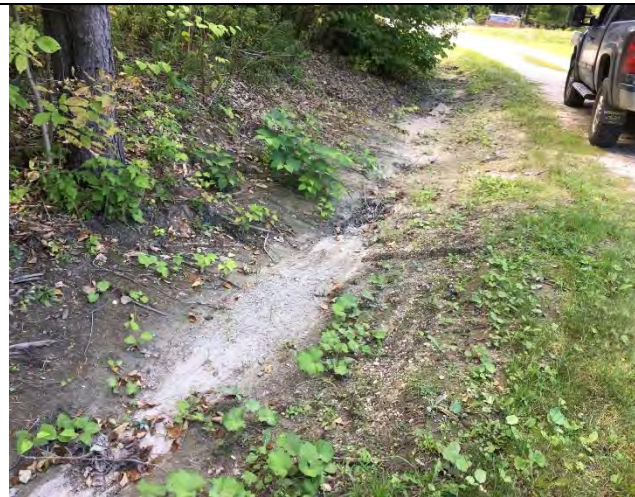
Site Description: Swale is partially filled in and has reduced function. Fills with water and overflows into river. Erosion from gravel lot above is adding a significant sediment load. Dry hydrant and industrial water withdrawal are next to swale.

Photo 1: Sediment deposition in the swale.

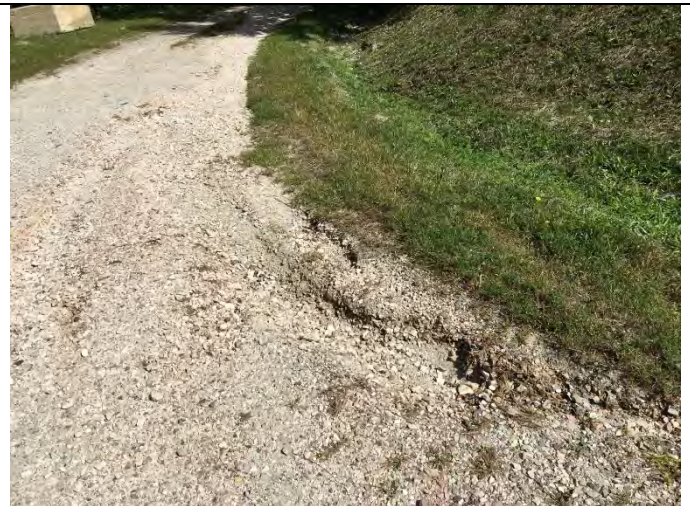
Photo 2: Eroding corner of the gravel road.

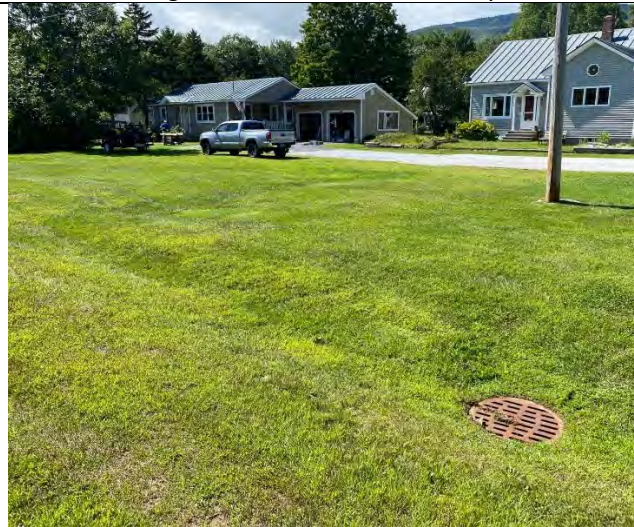
Site Description: Runoff from the steep driveway into the cemetery crosses High St and flows to a drop inlet that is mostly filled, discharging to a grassed swale. The swale drains to another drop inlet that is the top of a long stormline to the river. A neighbor said that soils were very well drained.

Photo 1: Drop inlet and grass swale where project will be installed.

BMP Description: Install a new catch basin and cross-culvert at the east side of the cemetery driveway, replace the shallow DI with a catch basin, install an infiltrating bioretention feature along the grassed swale with overflow to the existing drop inlet.

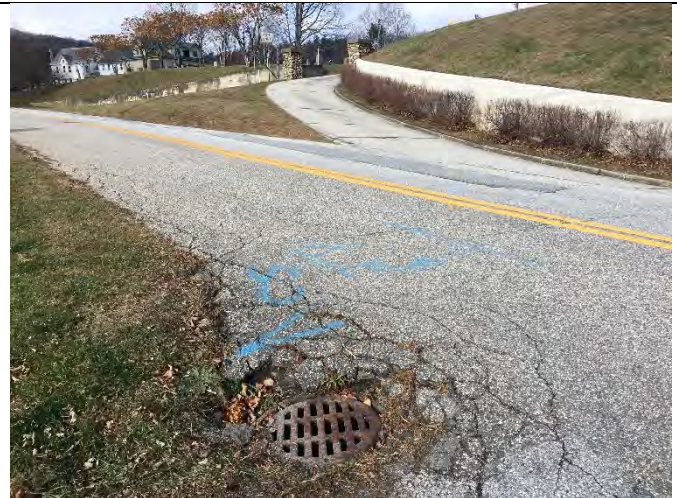
Photo 2: Existing drop inlet, some runoff likely bypasses the DI due to poor grading.

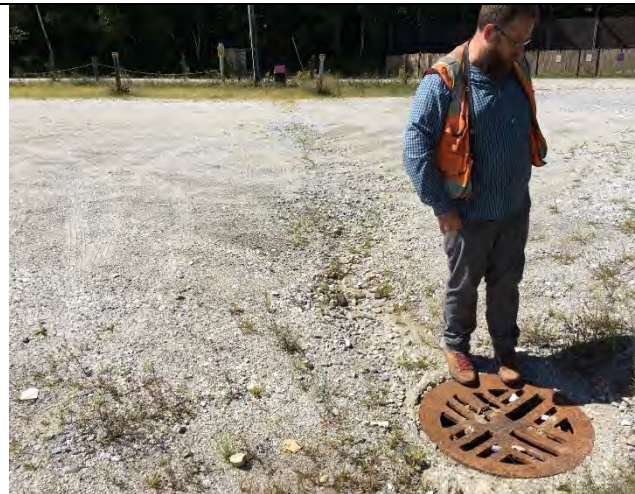
Site Description: Large, 2-tier parking lot with gravel. Could use multiple projects. Catch basin draining upper lot leads to gully (5x4x25ft) into stream. May be included in planned updates under 3125-9015.1

Photo 1: Catch basin in upper lot where treatment feature will be located.

BMP Description: Install a large underground infiltration in upper lot area, need to verify water table on steep slope. Unrated soils

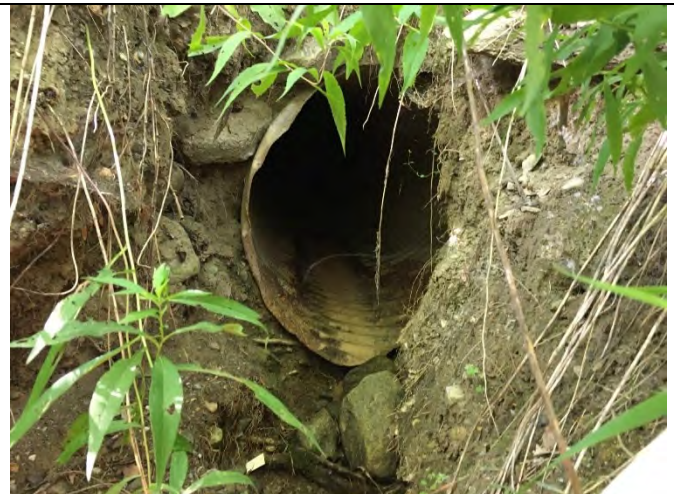
Photo 2: Outfall from the system with gully erosion into stream.

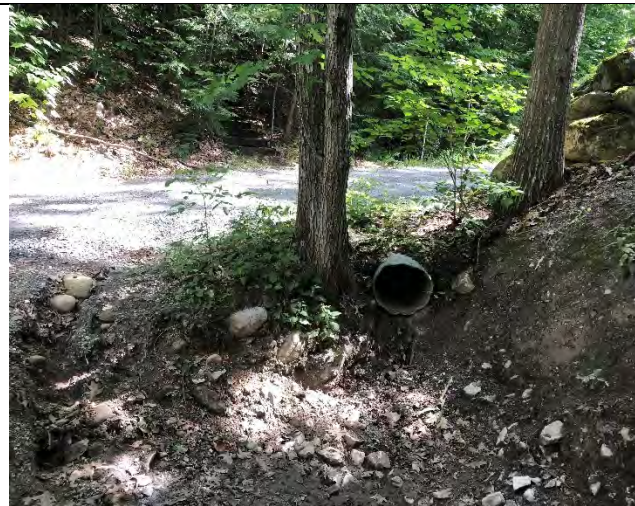
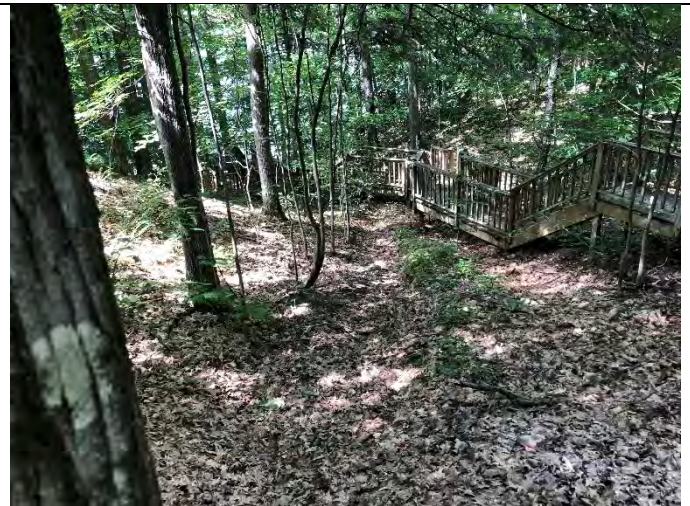
Site Description: Steep private roads lack ditches and carry sediment into town-maintained ditch before flowing through a cross-culvert and discharging to Lake. Estimated 50cf of sediment per year from road and ditch erosion.

Photo 1: Outfall into eroding gully that leads to lake. **Photo 2:** Existing gully/flow path into lake.

BMP Description: Upgrade ditches, cross culverts and turnouts. Install small sediment basin near outlet into lake.

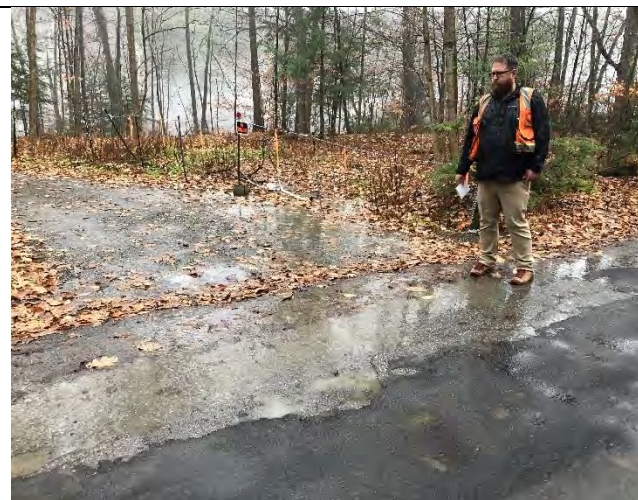
Site Description: Ditch along north/east side of Red Bridge Road spills across road at bend with moderate erosion, runoff continues along road to lake with moderate erosion down foot path to canoe/kayak access. Private landowner (Sperzel) is supportive of water quality projects.

Photo 1: Open space along runoff flow path suitable for rain garden installation.

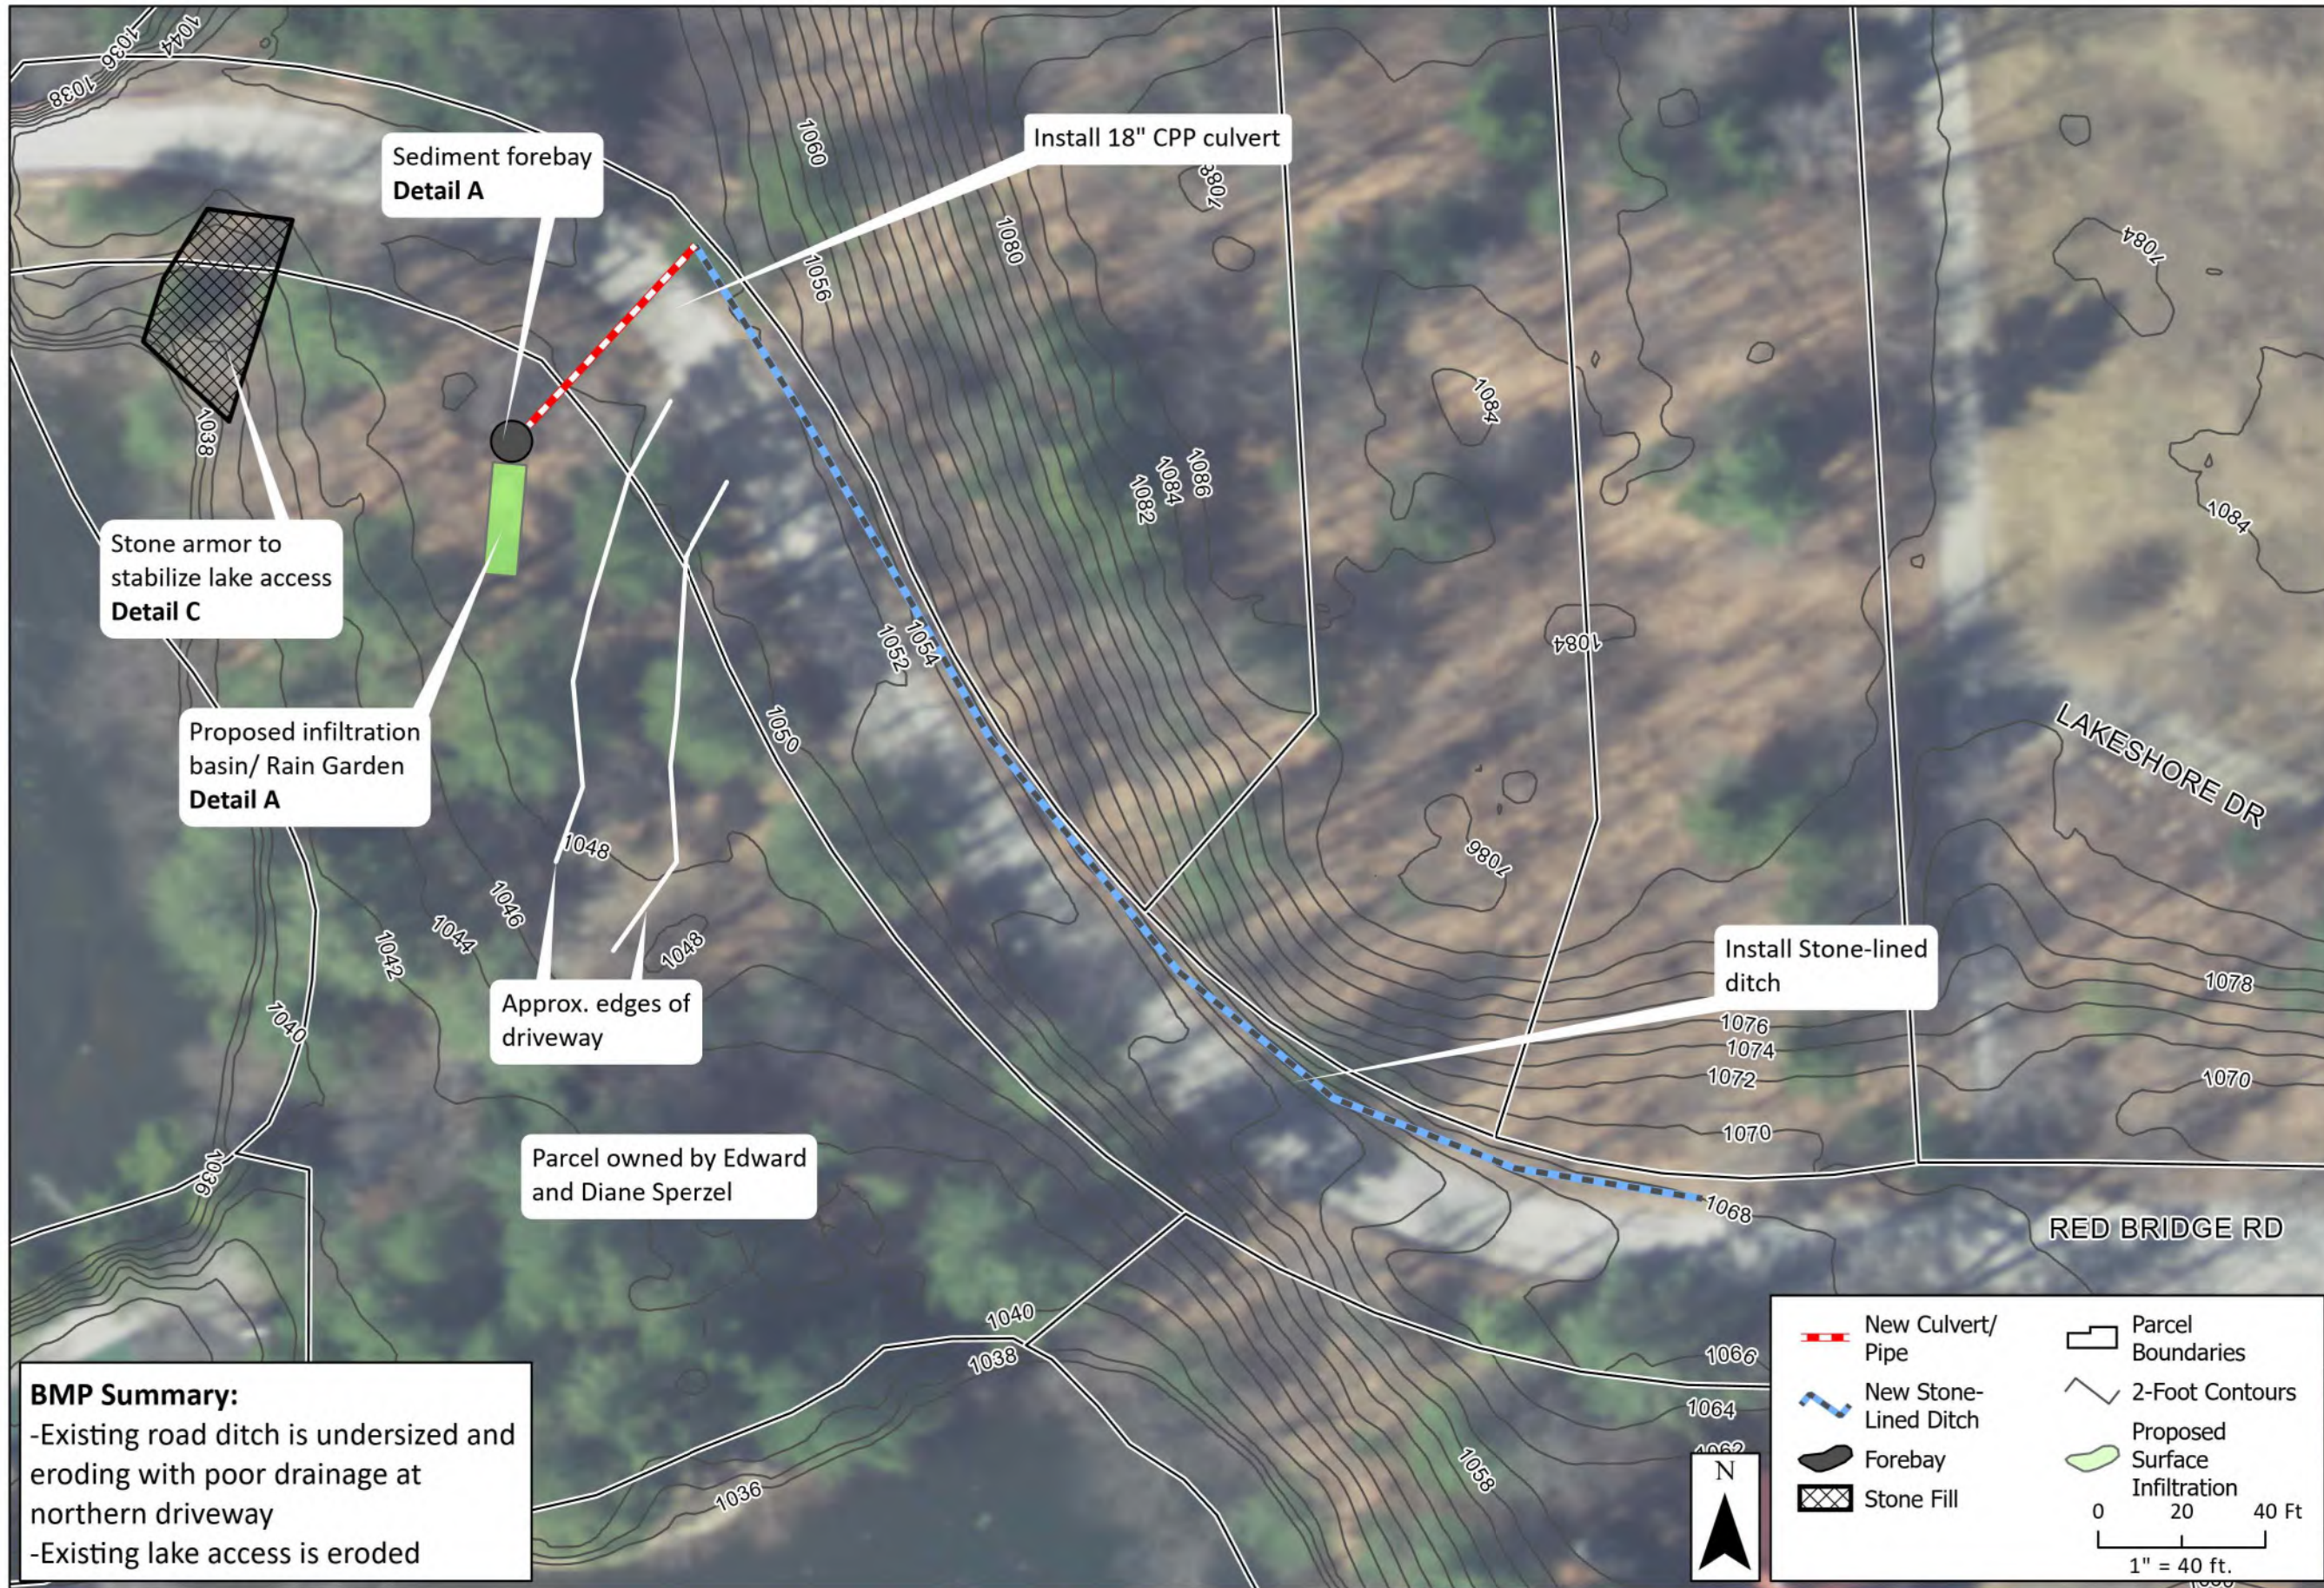
BMP Summary:
 -Existing road ditch is undersized and eroding with poor drainage at northern driveway
 -Existing lake access is eroded

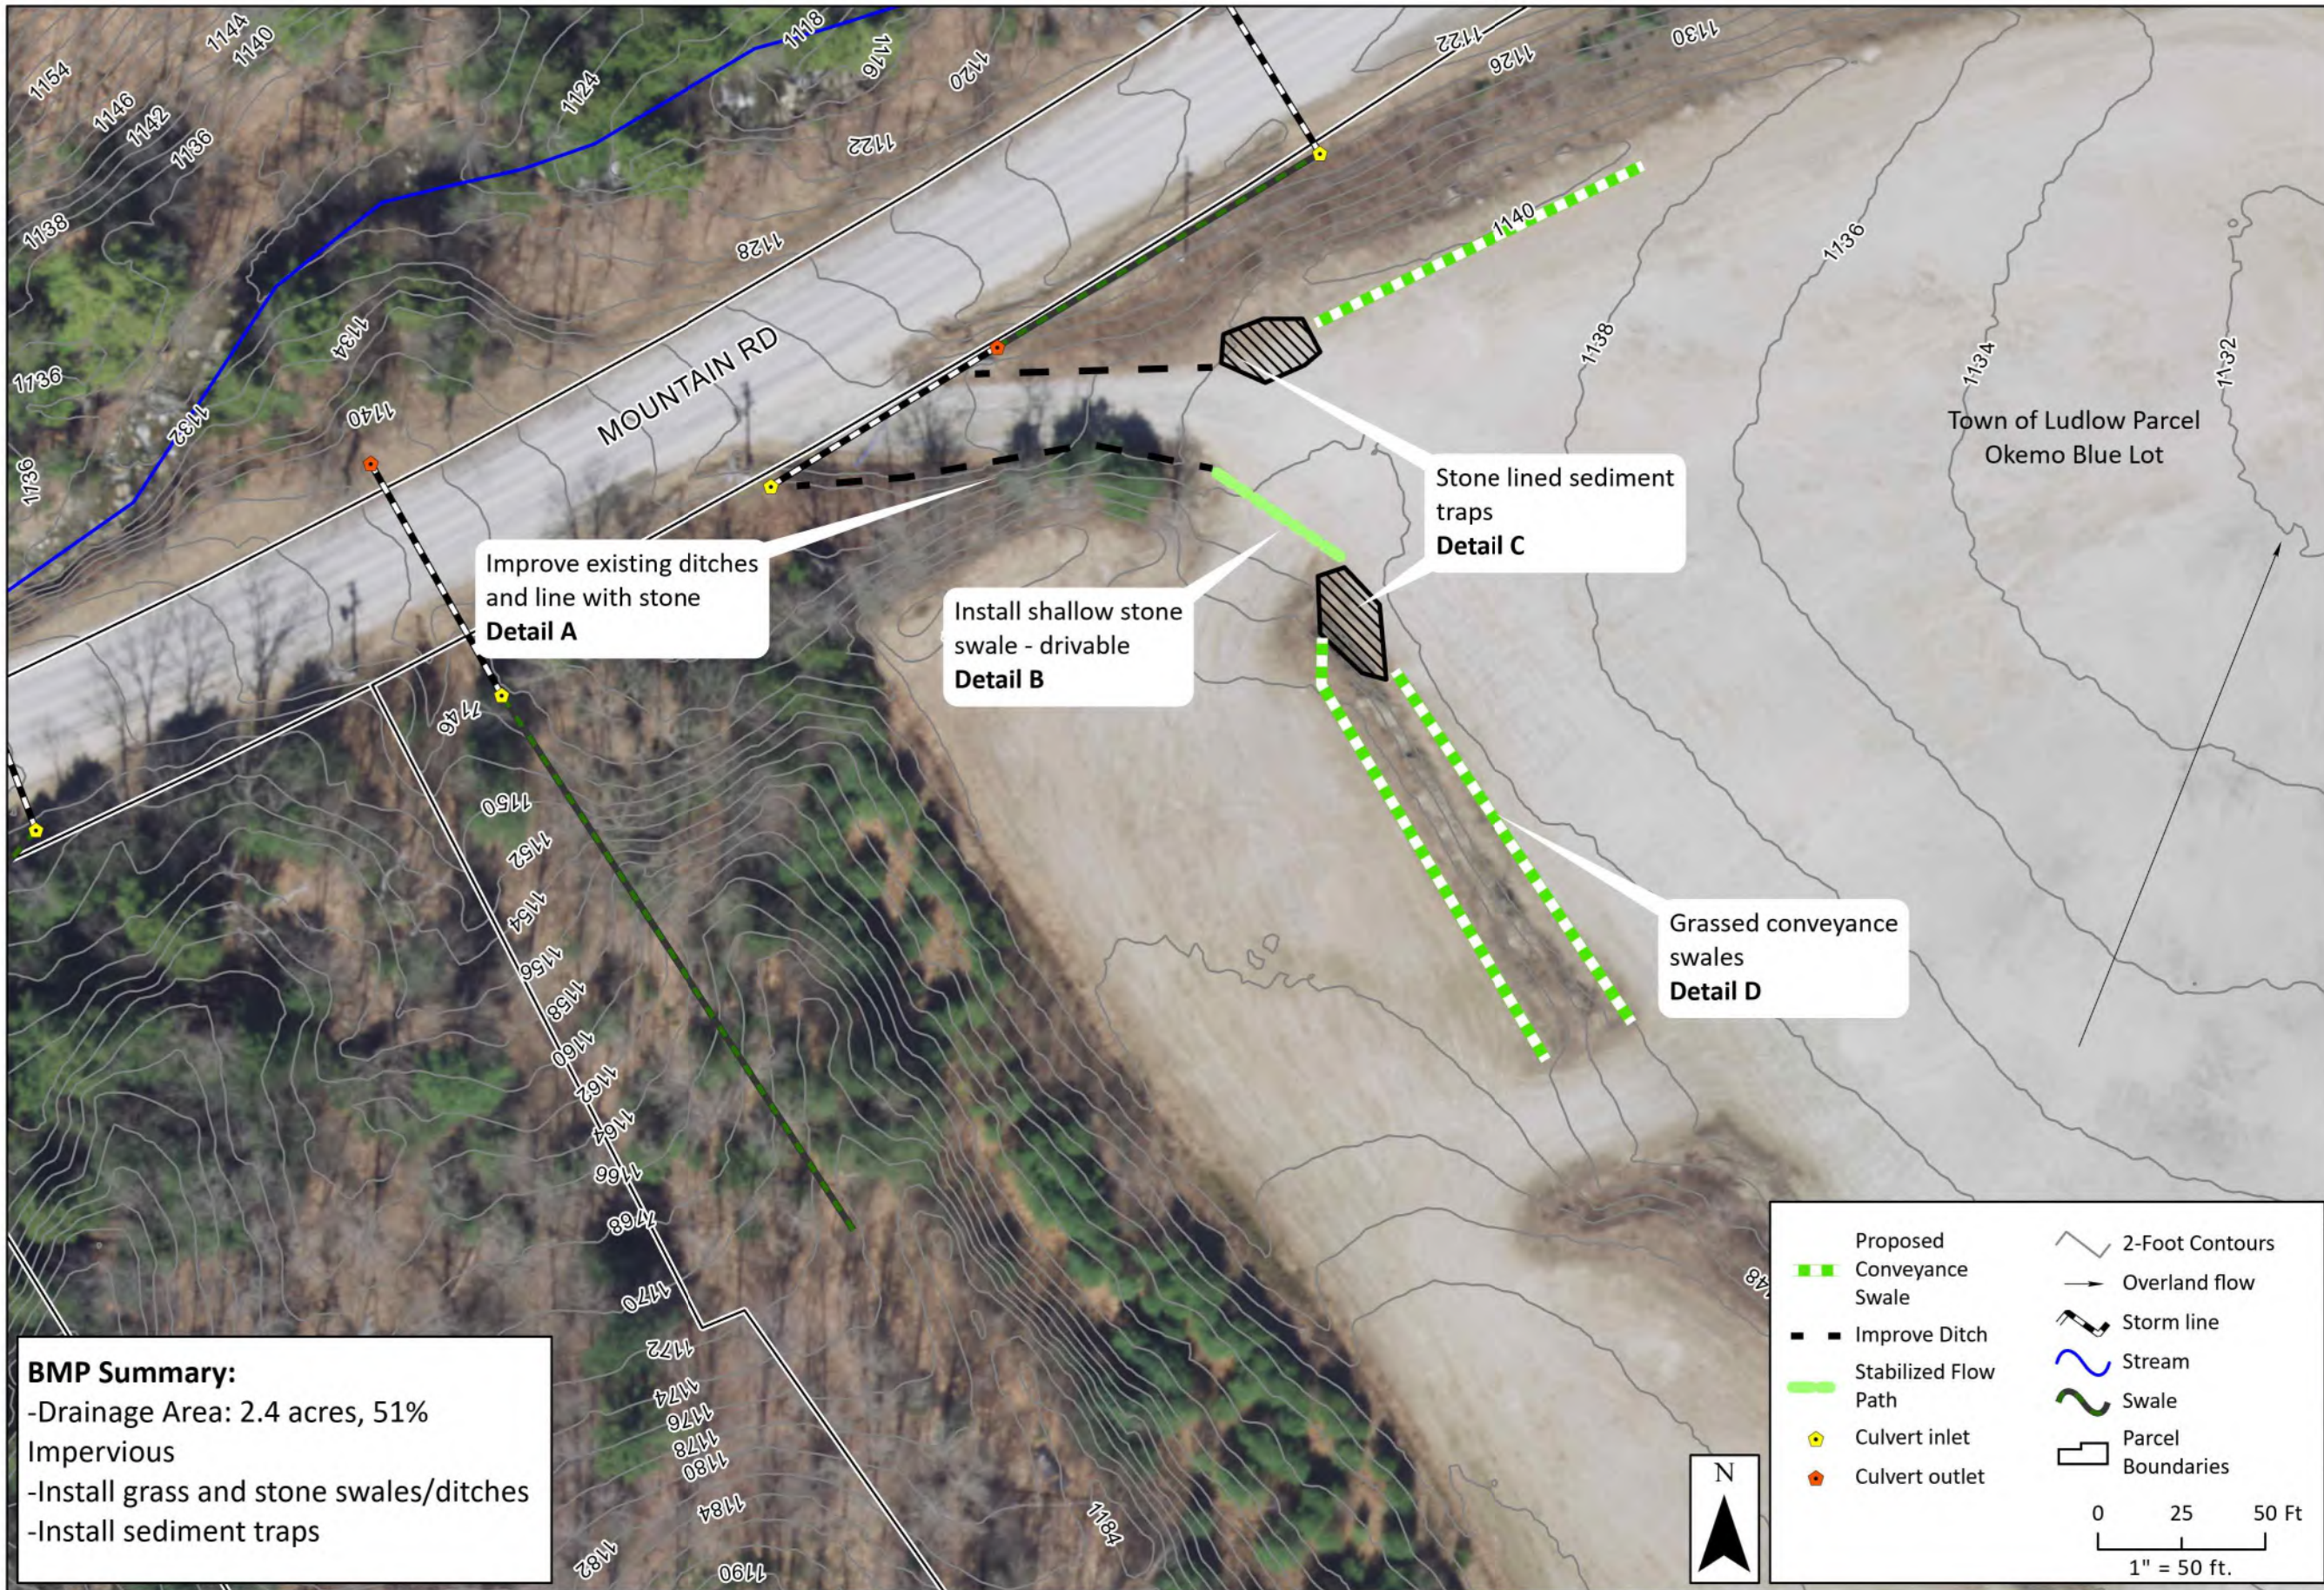
BMP Summary:
 -Drainage Area: 2.4 acres, 51% Impervious
 -Install grass and stone swales/ditches
 -Install sediment traps

Improve existing ditches and line with stone
Detail A
