Stormwater Master Plan Town of Richford, Vermont

PROJECT NO. 17-079-B PREPARED FOR:

Stormwater Master Plan

Town of Richford, Vermont

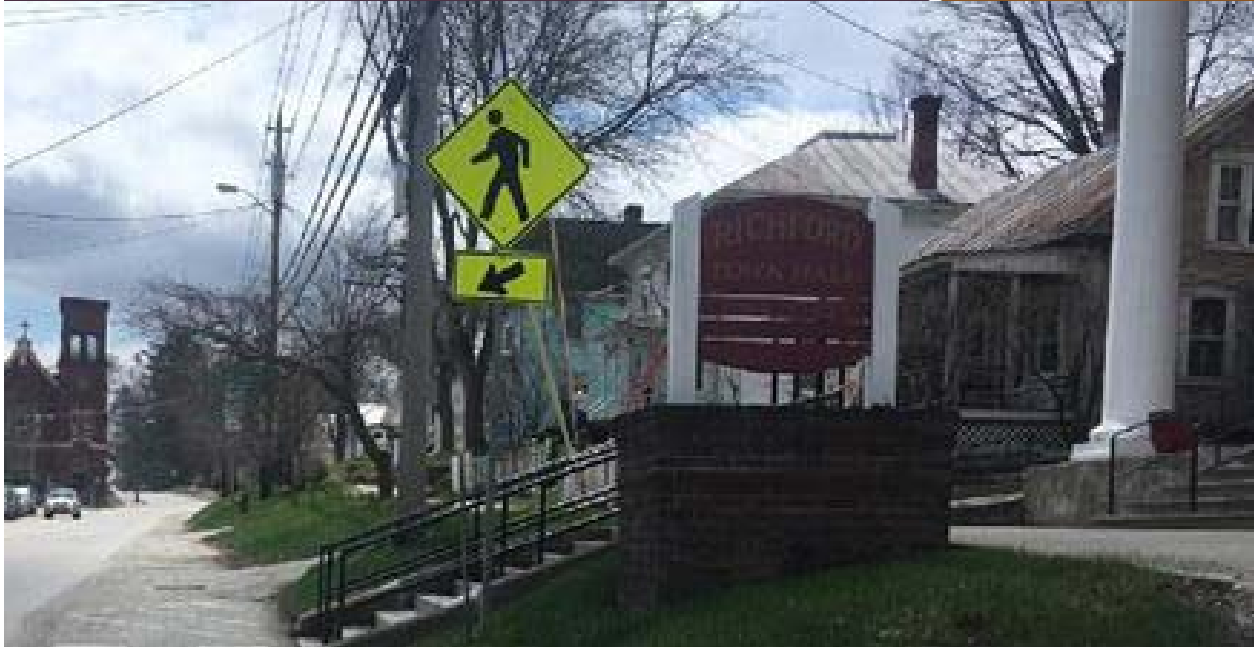
Cover: On-street parking spaces adjacent to Town Hall along Main Street in Richford; and concept design for a curb extension bioretention (i.e. ‘bump out’) retrofit to provide water quality treatment for runoff from Main Street and steeply sloped roads adjacent to Main Street.

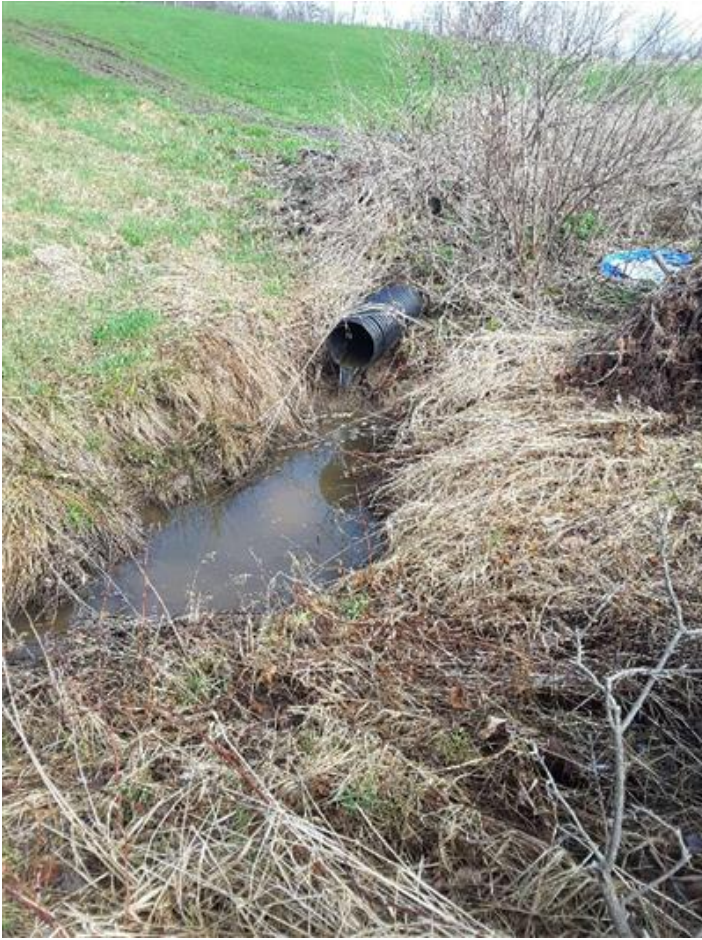
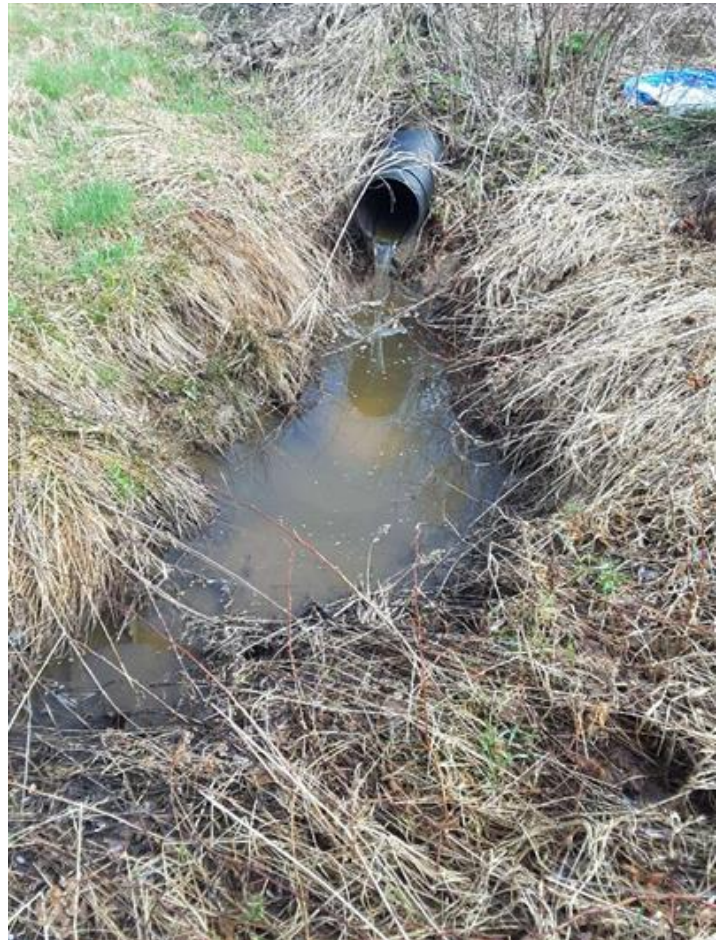
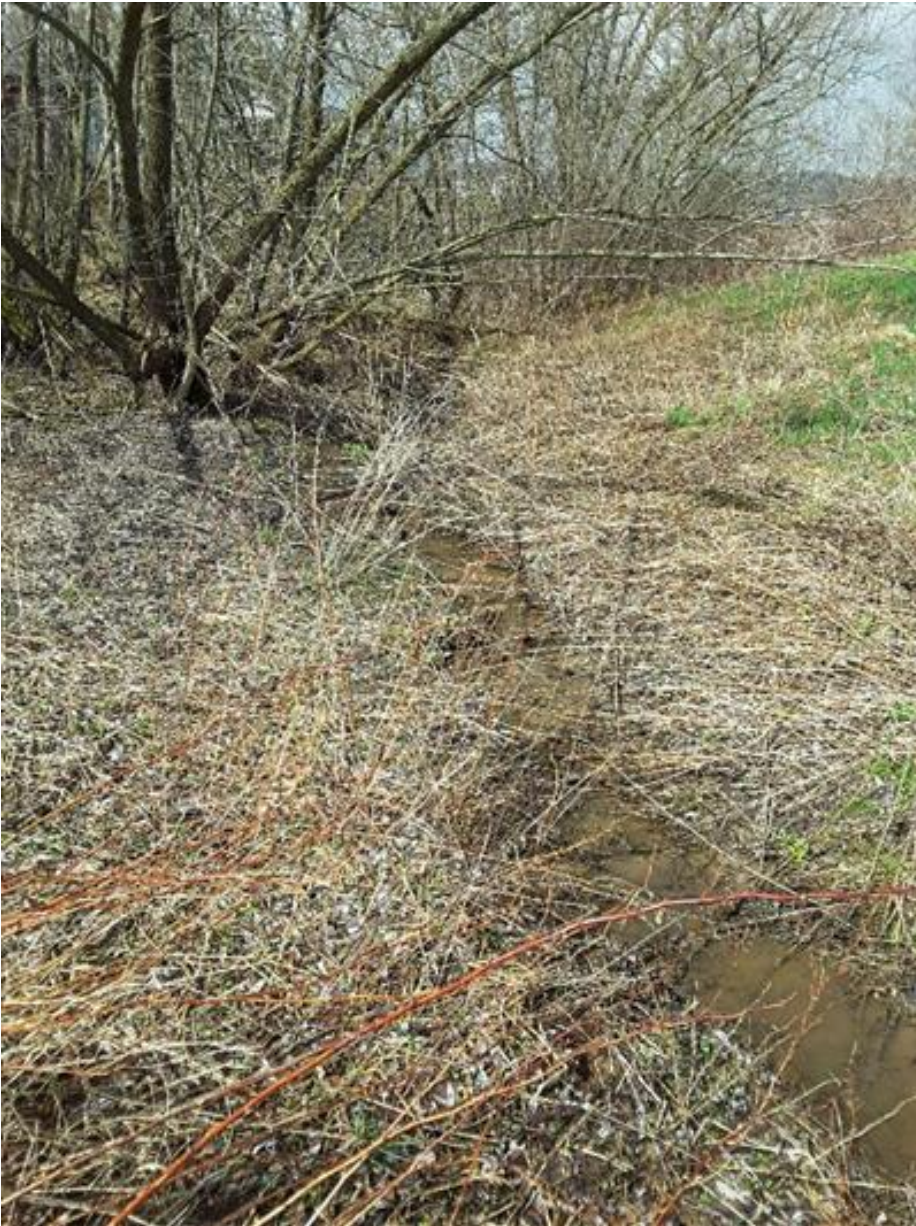
ID#: 3																			
Name: Private farm culvert on Hamilton Place Ext.																			
Concept Description: Install stone splash pad, check dams to slow flow and reduce erosion. Potentially include plantings to increase channel roughness, slow down flow and promote storage and infiltration, where feasible.																			
Notes/Feasibility Private property. Met owner, talks were positive and at this point, he's on board with the project. Project most appropriate for NRCS funding if owner qualifies, MRGP if doesn't qualify. Property may not qualify as a farm – it is our understanding owner is a landscaper, not a farmer.																			
GENERAL SITE INFORMATION																			
Site Contact Info: Town of Richford	RETROFIT DETAILS																		
Ownership: Private	Project Candidate: Yes																		
Land Use Type: Single family residential, agriculture (?)	New BMP / Retrofit Existing: New BMP																		
Land Use Detail:	Proposed Retrofit Practice(s): Ditch stabilized with stone lining (>5-8% slope), Culvert headwall repair, Check Dam																		
Existing BMP on Site? No	Non-Structural Controls:																		
Is site a hotspot? No	Non-Structural Other:																		
Sources/pollutants: Sediment, potential fertilizer inputs (e.g., athletic fields, golf courses, farms)	Maintenance Burden: Low																		
Soils: Buxton, (BxE) D; WT 1.5 - 2'

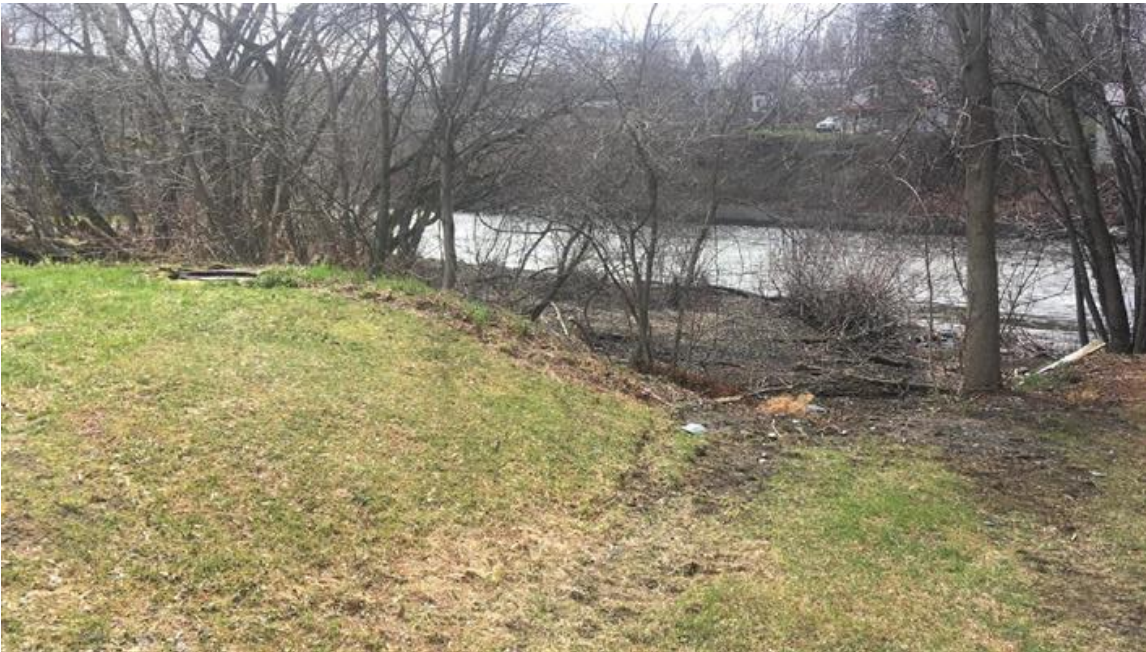
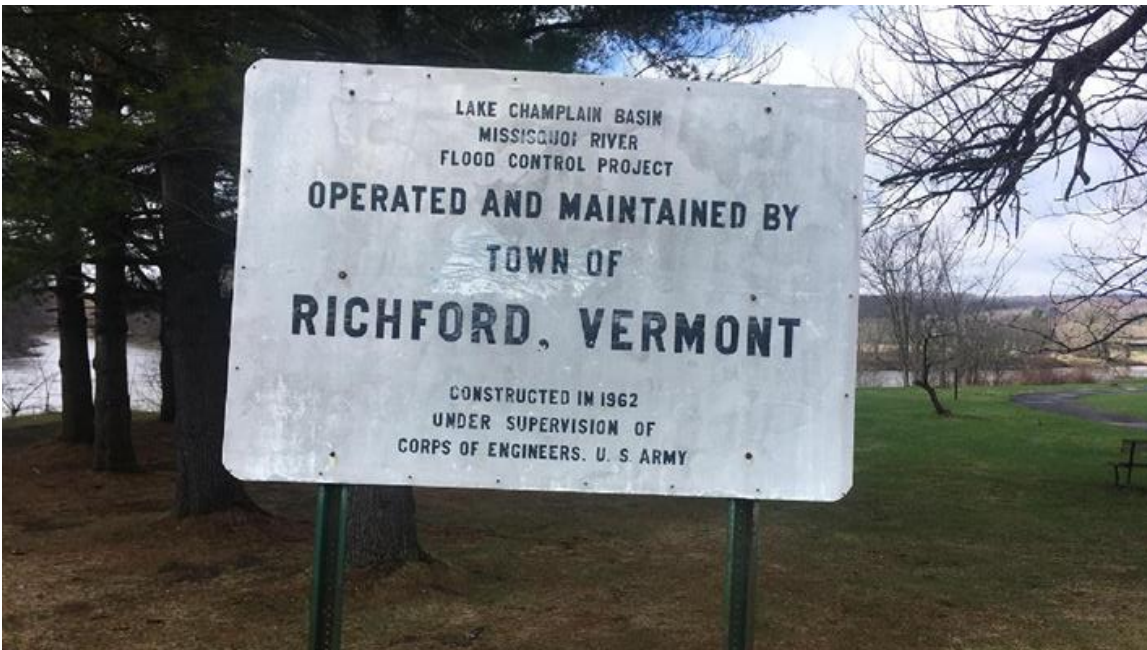
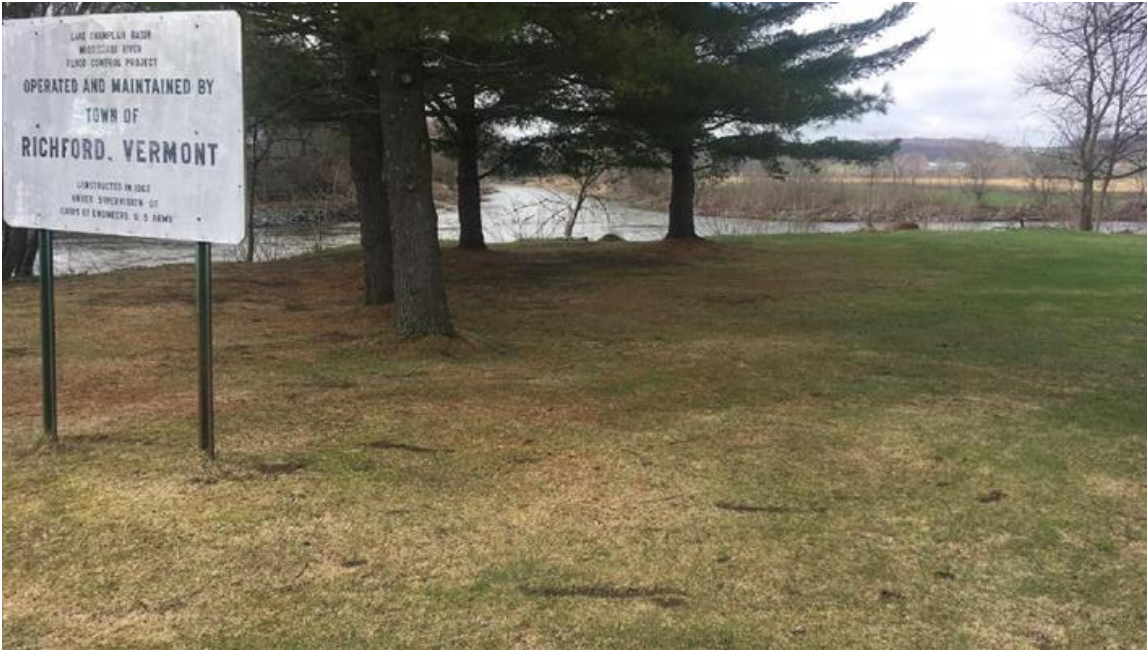
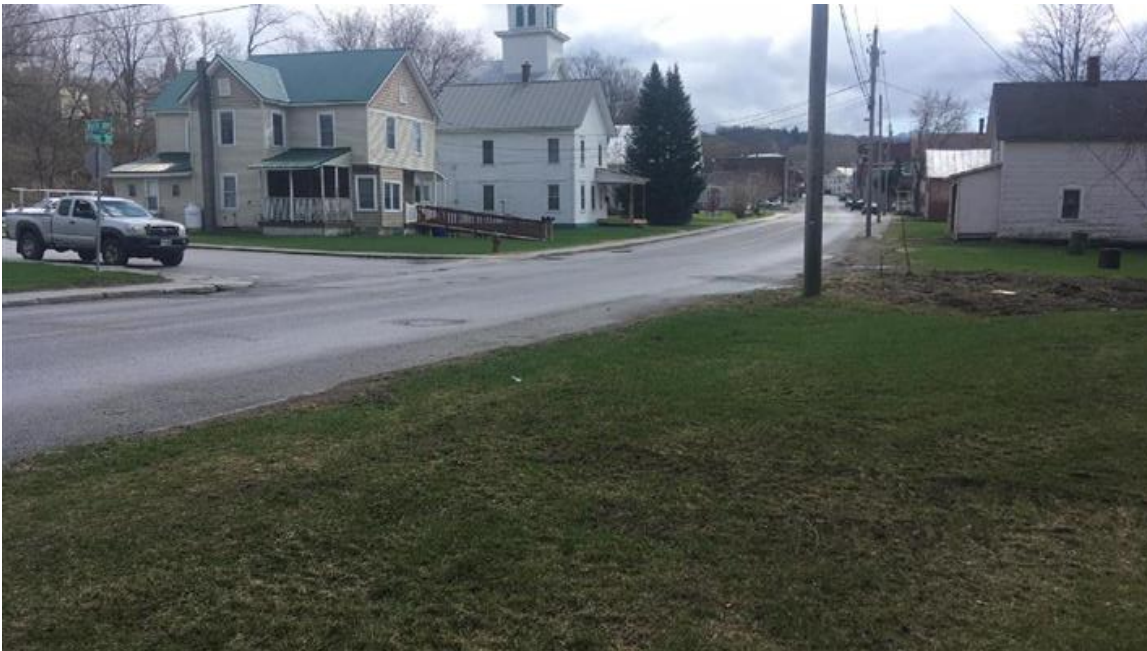
ID#: 4																			
Name: North Ave and River St. @ Missisquoi River																			
Concept Description: Open space in line with North Avenue at river shows evidence of rill erosion. Install gravel wetland in adjacent town owned land (park to the west) to accept flow from existing SW piping system. Also consider swirl separator in place of catch basin directly upstream. Restore bank and riparian area along river; include armoring at outfall pipe.																			
Notes/Feasibility: Area constrained by River Corridor and existing Flood Control Project by USACOE. Follow-up needed with DEC Rivers Program and Stream Alteration engineer. If project in floodplain not possible, consider only a swirl separator in River Street or North Ave to remove sediment.																			
GENERAL SITE INFORMATION																			
Site Contact Info: Town of Richford	RETROFIT DETAILS																		
Ownership: Public	Project Candidate: Yes																		
Land Use Type: Single family residential, open space	New BMP / Retrofit Existing: New BMP																		
Land Use Detail:	Proposed Retrofit Practice(s): Rill erosion repair (1"-11" erosion depth), Outfall stabilization, Bioretention, stormceptor, gravel wetland																		
Existing BMP on Site? No	Non-Structural Controls: Educational signage																		
Is site a hotspot? No	Non-Structural Other:																		
Sources/pollutants: Sediment	Maintenance Burden: Low																		
Soils: Munson, (MuB) C/D; WT 0.5 - 2'

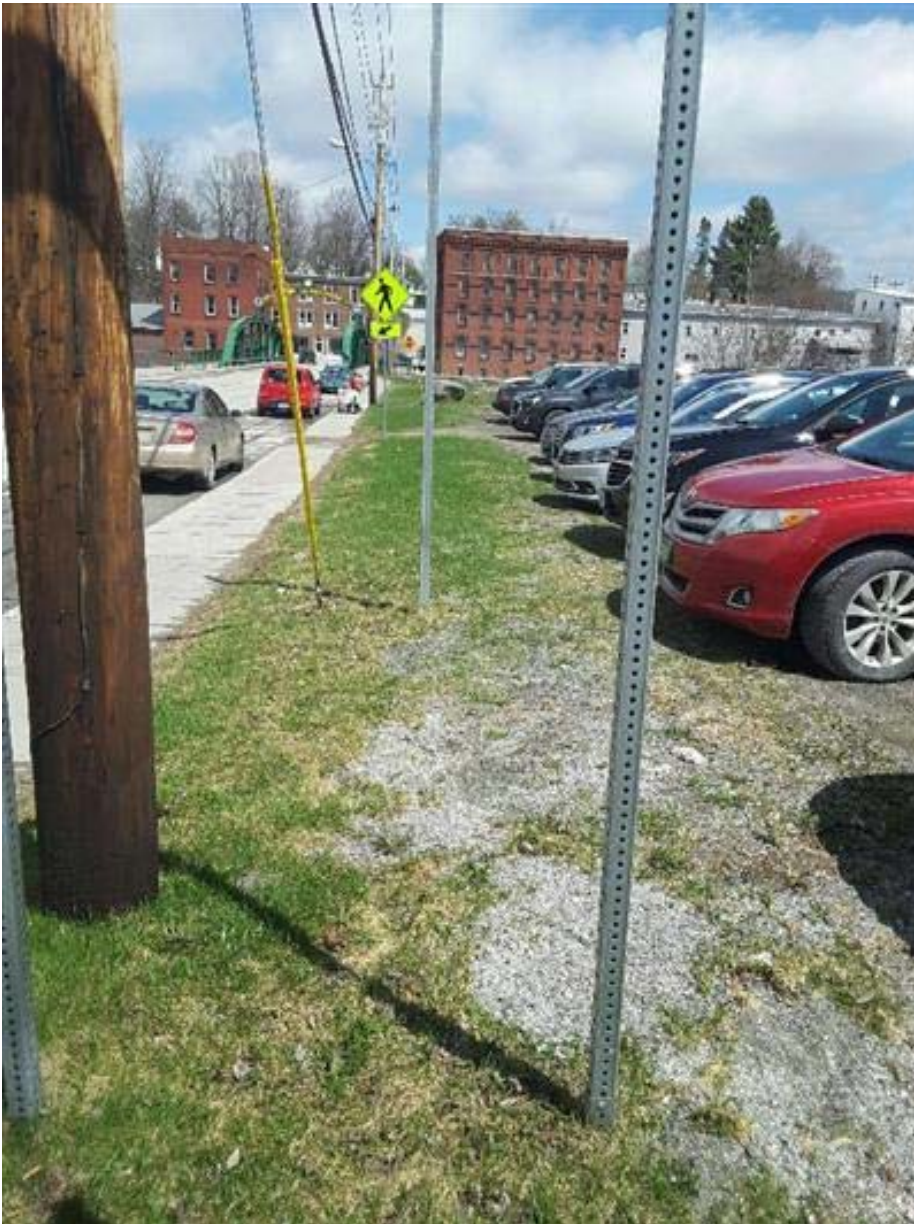
ID# 6, Image 1

ID#: 6																			
Name: Bioswale Across From Vista Supermarket																			
Concept Description: Install a bioswale between the parking lot and sidewalk across the road from Vista Supermarket. Grade the parking lot to drain to swale.																			
Notes/Feasibility: Consider installing multiple stages to make maintenance easier. Also consider underdrain. On 7/5 the Town informed us that there may be a tunnel under the road at this location, and that the parking lot is owned by the Peoples Trust Bank.																			
GENERAL SITE INFORMATION																			
Site Contact Info: Town of Richford	RETROFIT DETAILS																		
Ownership: Public/private	Project Candidate: Yes																		
Land Use Type: Transport-Related (roadway or ROW), Multi-family Residential	New BMP / Retrofit Existing: New BMP																		
Land Use Detail:	Proposed Retrofit Practice(s): Bioretention, Basin, Dry Swale, Rain Garden																		
Existing BMP on Site? No	Non-Structural Controls: Educational signage																		
Is site a hotspot? No	Non-Structural Other:																		
Sources/pollutants: Sediment	Maintenance Burden: Moderate																		
Soils: Ondawa, (Od) B; WT '1'

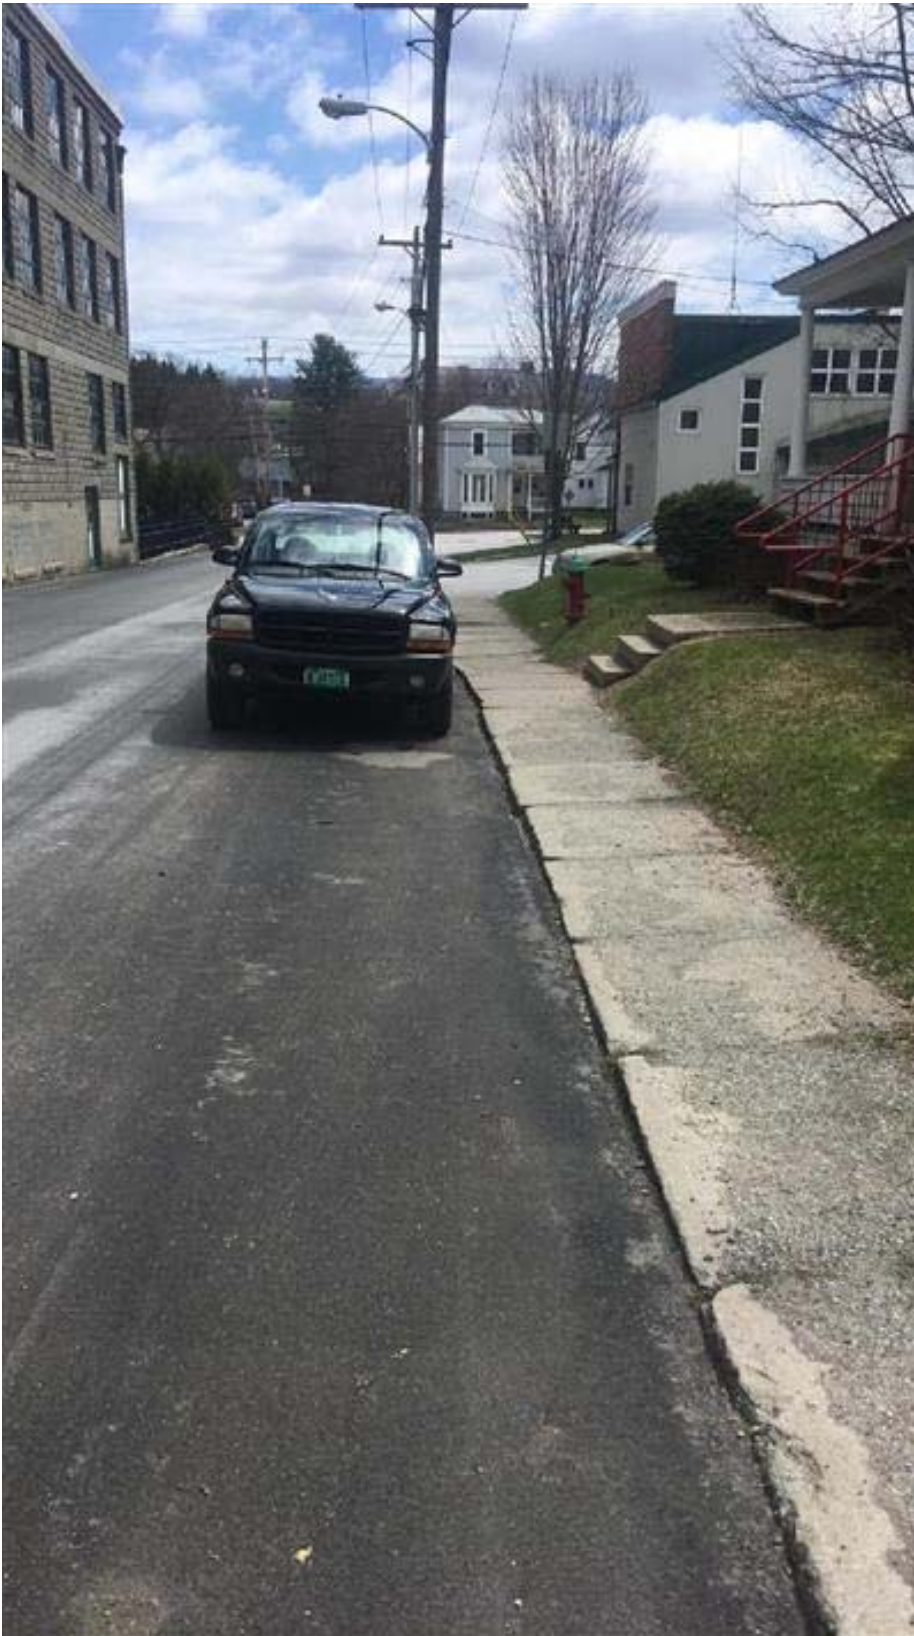
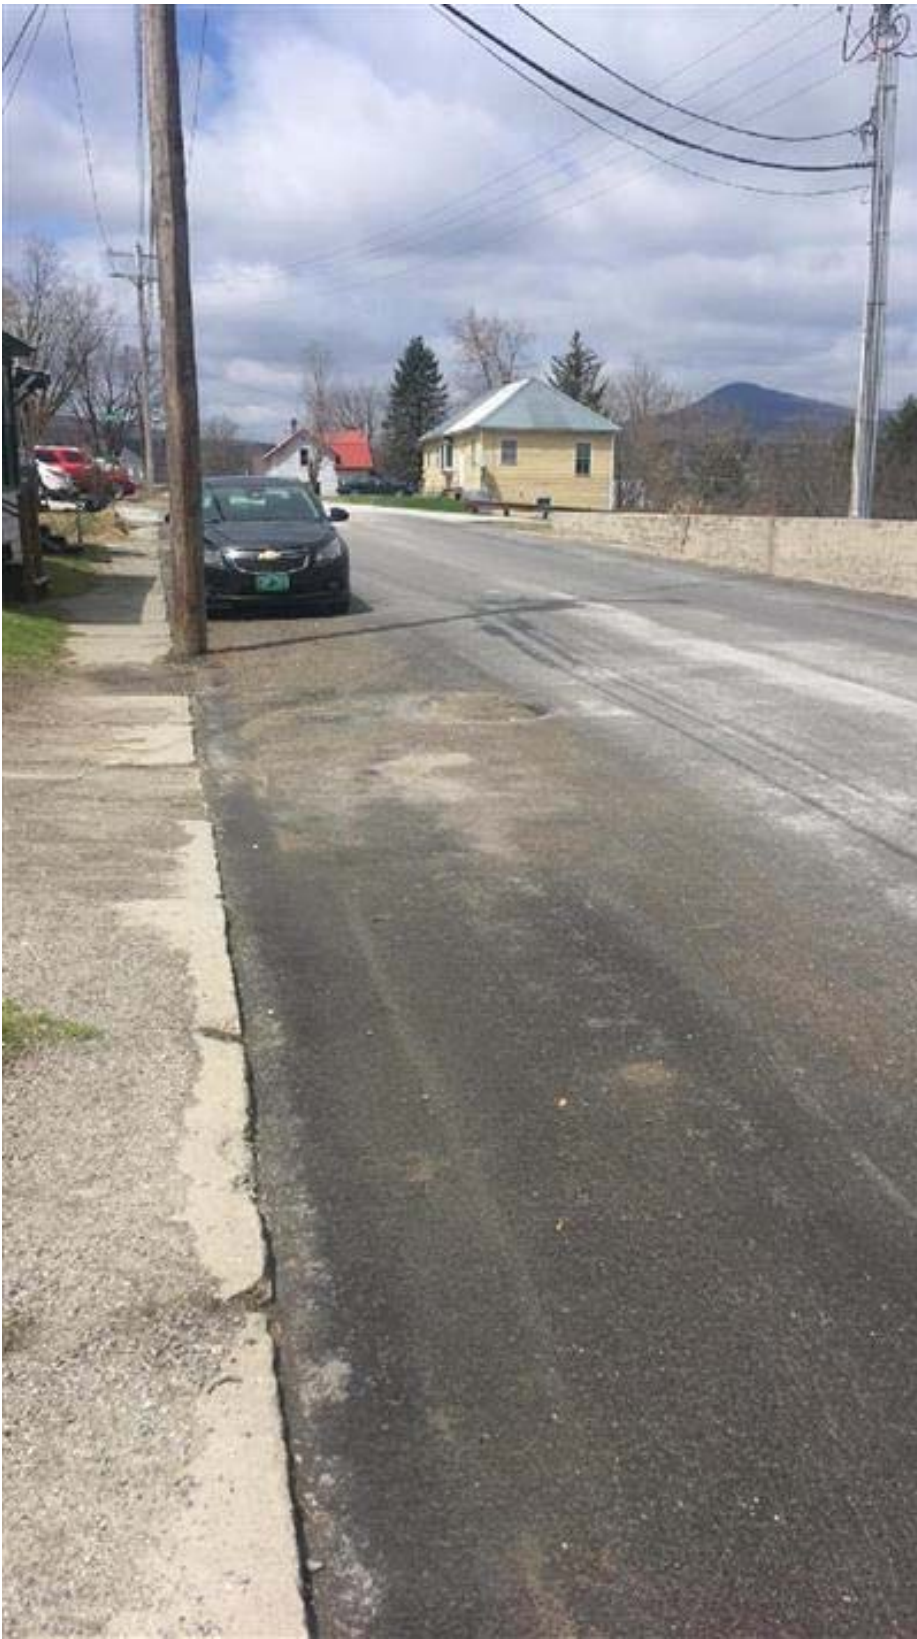
ID# 7, Image 1

ID#: 7																			
Name: Powell St. bump out																			
Concept Description: Small bump out proposed in front of Richford Community Housing (10 to 12 Powell St.), to collect sediment running down road.																			
Notes/Feasibility: Proposed BMP does not include infiltration due to contaminated building on other side of street.																			
GENERAL SITE INFORMATION	RETROFIT DETAILS																		
Site Contact Info: Town of Richford	Project Candidate: Yes																		
Ownership: Public	New BMP / Retrofit Existing: New BMP																		
Land Use Type: Transport-Related (roadway or ROW), single family residential, commercial	Proposed Retrofit Practice(s): Bioretention, Bump-Out																		
Land Use Detail:	Non-Structural Controls: Educational signage																		
Existing BMP on Site? No	Non-Structural Other:																		
Is site a hotspot? No	Maintenance Burden: Medium																		
Sources/pollutants: Sediment

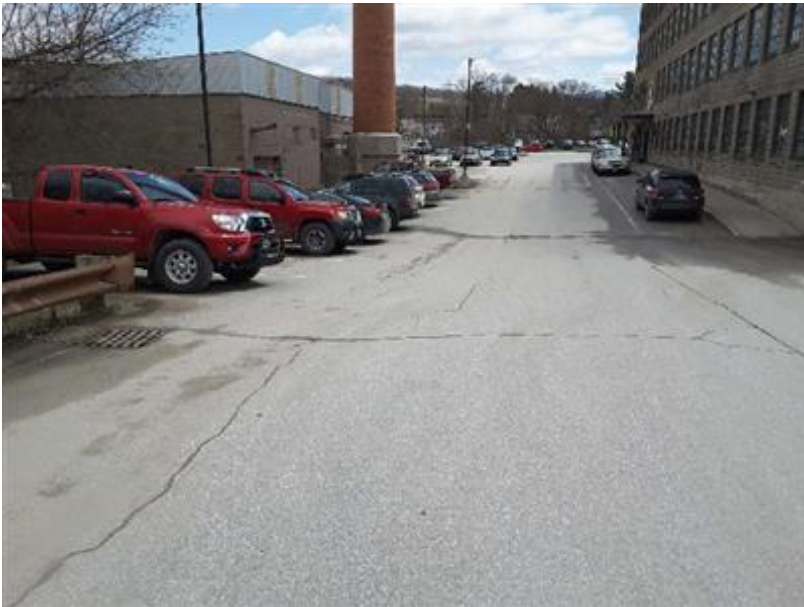
ID# 8, Image 1

ID#: 8																			
Name: Vista Supermarket back parking lot																			
Concept Description: Install sediment basin at low point in parking lot to capture and manage sediment load being delivered to river. Potentially disconnect existing catch basin to capture more sediment. Act 250 documentation indicates a detention pond was proposed west of this area ~2005. The feature was not observed during site visit, due to the basin being completely filled with sediment.																			
Notes/Feasibility: Enlarging the existing basin would require removal of parking spaces. Do not infiltrate due to potential subsurface contamination; consider swirl separator to remove sediment. Act 250 permit 6F0538 and associated letter to VTDEC (2005) indicates entire site included 1.1 ac impervious but no permit required.																			
GENERAL SITE INFORMATION																			
Site Contact Info: Town of Richford	RETROFIT DETAILS																		
Ownership: Private	Project Candidate: Yes																		
Land Use Type: Commercial	New BMP / Retrofit Existing: Retrofit Existing BMP																		
Land Use Detail:	Proposed Retrofit Practice(s): Pre-treatment Forebay, Dry Detention Pond, Bioretention Basin, Swirl Separator																		
Existing BMP on Site? No	Non-Structural Controls:																		
Is site a hotspot? No	Non-Structural Other:																		
Sources/pollutants: Sediment	Maintenance Burden: Moderate																		
Soils: Ondawa, (Od) B; WT '1'

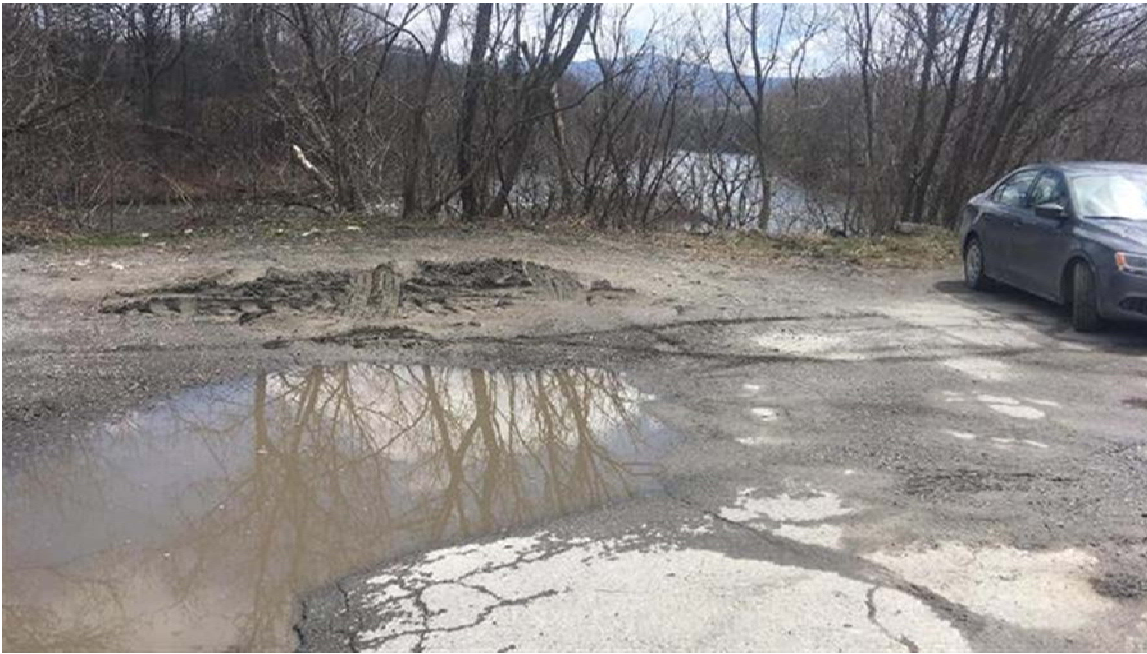
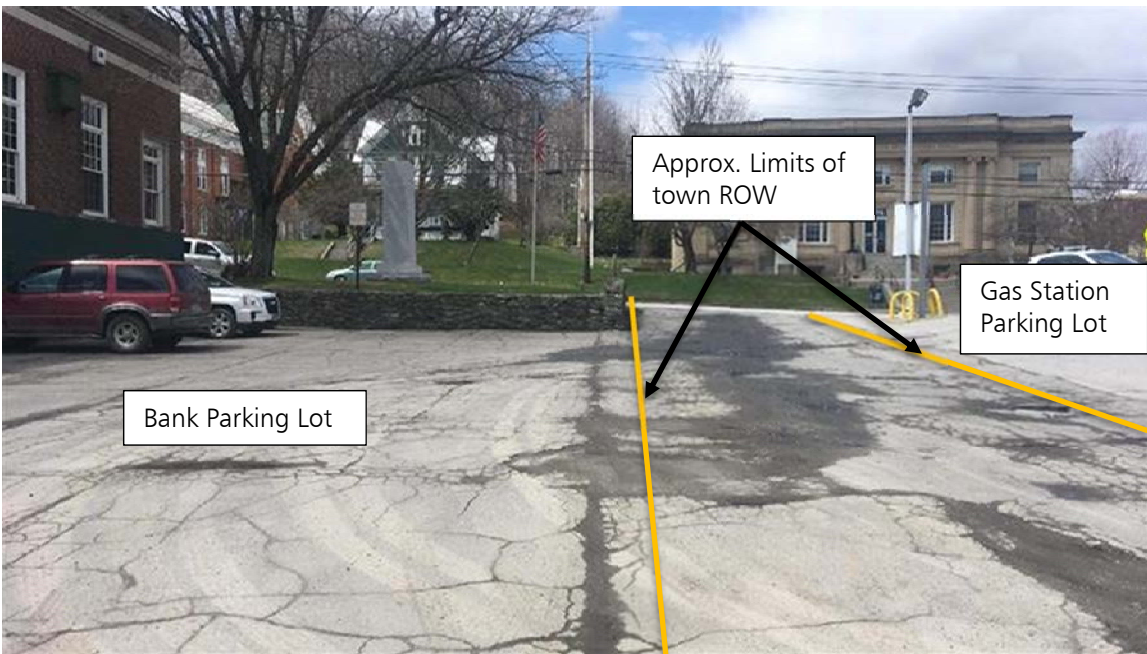
ID#: 9																			
Name: TD Bank Bioretention																			
Concept Description: Bioretention practice to capture flow and sediment off Main St. and bank parking lot. Restore bank where rill erosion has occurred, via appropriate methods (plantings or armoring).																			
Notes/Feasibility: Design to prevent infiltration due to adjacent gas station. Be aware of soft bank soils when designing discharge. On 7/5 the Town provided limits of their approximate ROW. See Image 2 below.																			
GENERAL SITE INFORMATION																			
Site Contact Info: Town of Richford	RETROFIT DETAILS																		
Ownership: Private and public, see Image 2 below	Project Candidate: Yes																		
Land Use Type: Commercial	New BMP / Retrofit Existing: New BMP																		
Land Use Detail:	Proposed Retrofit Practice(s): Rill erosion repair (1"-11" erosion depth), Bioretention, Basin																		
Existing BMP on Site? No	Non-Structural Controls:																		
Is site a hotspot? No	Non-Structural Other:																		
Sources/pollutants: Sediment	Maintenance Burden: Medium																		
Soils: Windsor, (WsB) A; WT '1'

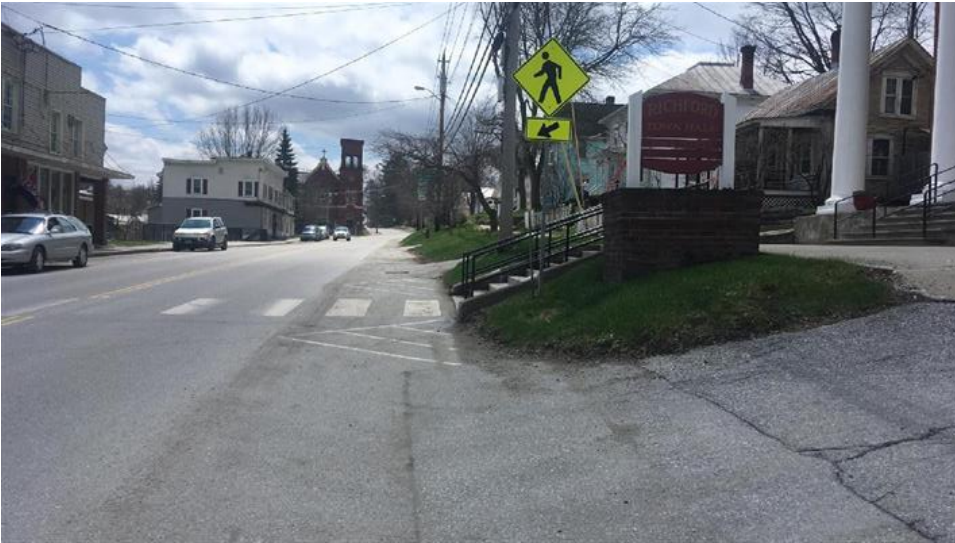
ID# 10, Image 1

ID#: 10																			
Name: Town Hall Bump Out																			
Concept Description: Install up to 4 bump outs in front of town hall entrance. Install over existing storm system to increase infiltration.																			
Notes/Feasibility: Consider capping or removing existing grate inlet at Town Hall entrance.																			
GENERAL SITE INFORMATION	RETROFIT DETAILS																		
Site Contact Info: Town of Richford	Project Candidate: Yes																		
Ownership: Public	New BMP / Retrofit Existing: New BMP																		
Land Use Type: Transport-Related (roadway or ROW), commercial	Proposed Retrofit Practice(s): Bioretention, Bump-Out																		
Land Use Detail:	Non-Structural Controls: Educational signage																		
Existing BMP on Site? No	Non-Structural Other:																		
Is site a hotspot? No	Maintenance Burden: Medium																		
Sources/pollutants: Sediment

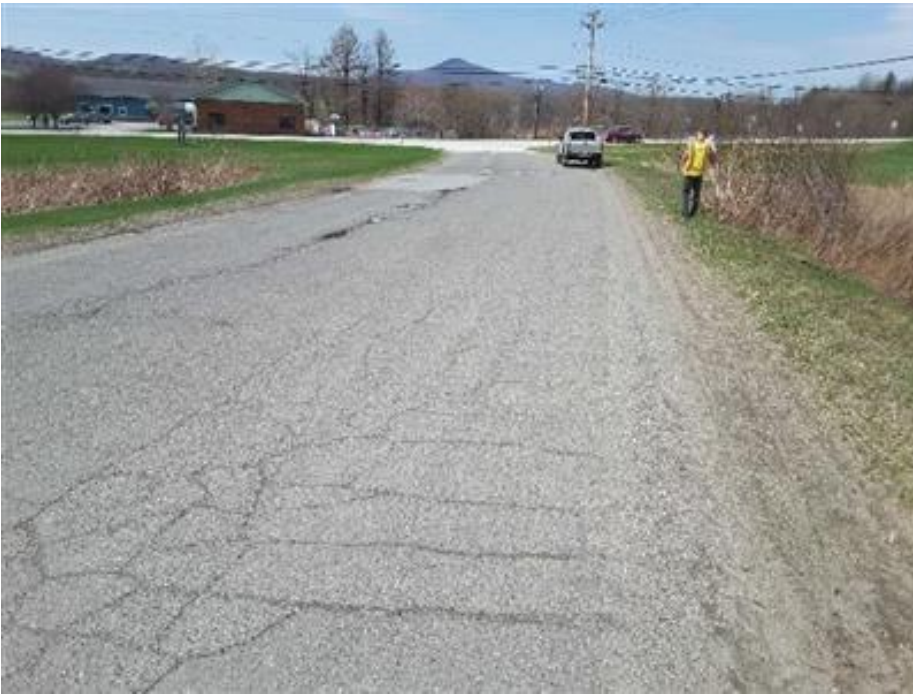
ID# 11, Image 1

Concept Description: Install bioswale along school access road to capture and treat runoff. Upsize culvert under the access road - it's significantly rusted out and under sized.																			
Notes/Feasibility: Bank full width at this channel is 4-5'. Is the school subject to a 3-acre permit? What are they required to treat? Could be addressed by 1 project.																			
GENERAL SITE INFORMATION																			
Site Contact Info: Town of Richford	RETROFIT DETAILS																		
Ownership: Public	Project Candidate: Yes																		
Land Use Type: Educational, Transport-Related (roadway or ROW)	New BMP / Retrofit Existing: New BMP																		
Land Use Detail:	Proposed Retrofit Practice(s): Bioretention, Dry Swale																		
Existing BMP on Site? No	Non-Structural Controls: Educational signage																		
Is site a hotspot? No	Non-Structural Other:																		
Sources/pollutants: Sediments	Maintenance Burden: Medium																		
Soils: Rumney (Ru), B/D; WT 0-1.5'

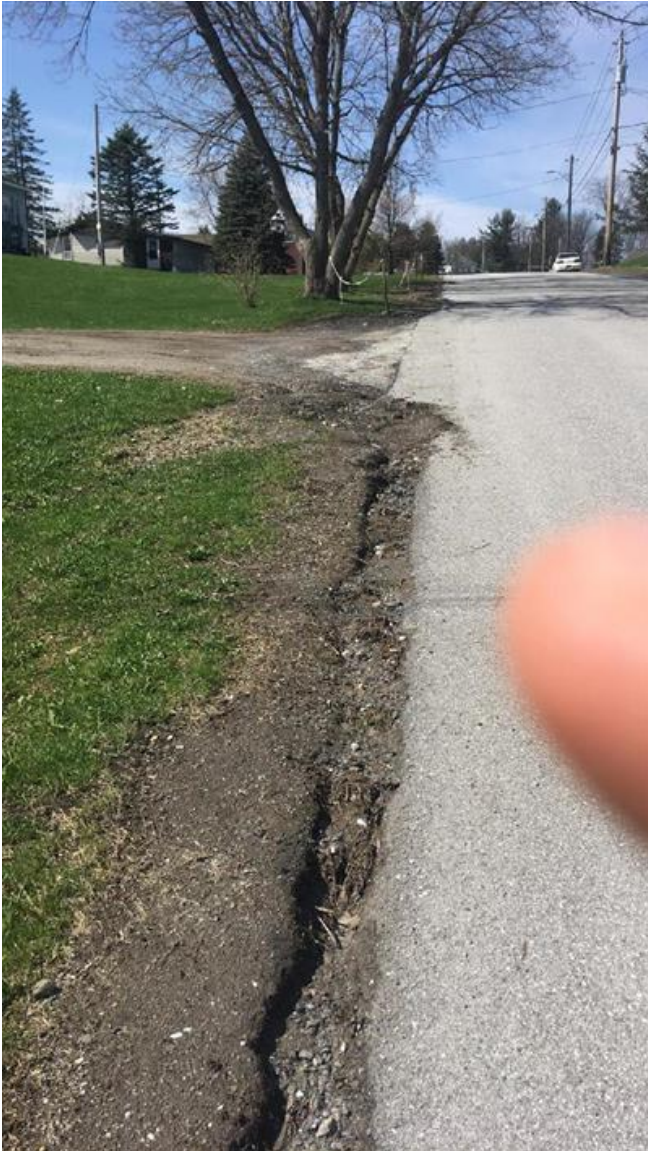
ID# 12, Image 1

ID#: 12																			
Name: Noyes Street Swale																			
Concept Description: Just upstream of Larry's Auto. Install swale along road, include vegetation and check dams. Possibly also replace culvert at drive just up road from swale.																			
Notes/Feasibility: Currently there is ~160' of erosion along edge of road up from swale, 2-5" wide. Town wants to place stone along this ditch but there is resistance from landowners.																			
GENERAL SITE INFORMATION																			
Site Contact Info: Town of Richford	RETROFIT DETAILS																		
Ownership: Public and private	Project Candidate: Yes																		
Land Use Type: Single Family Residential (< 1 ac. lots), Commercial, Transport-Related (roadway or ROW)	New BMP / Retrofit Existing: New BMP																		
Land Use Detail:	Proposed Retrofit Practice(s): Rill erosion repair (1"-11" erosion depth), Check Dam, Bioretention, Dry Swale																		
Existing BMP on Site? No	Non-Structural Controls:																		
Is site a hotspot? No	Non-Structural Other:																		
Sources/pollutants: Sediment	Maintenance Burden: Medium																		
Soils: Missisquoi (MsD), A; WT 'L'

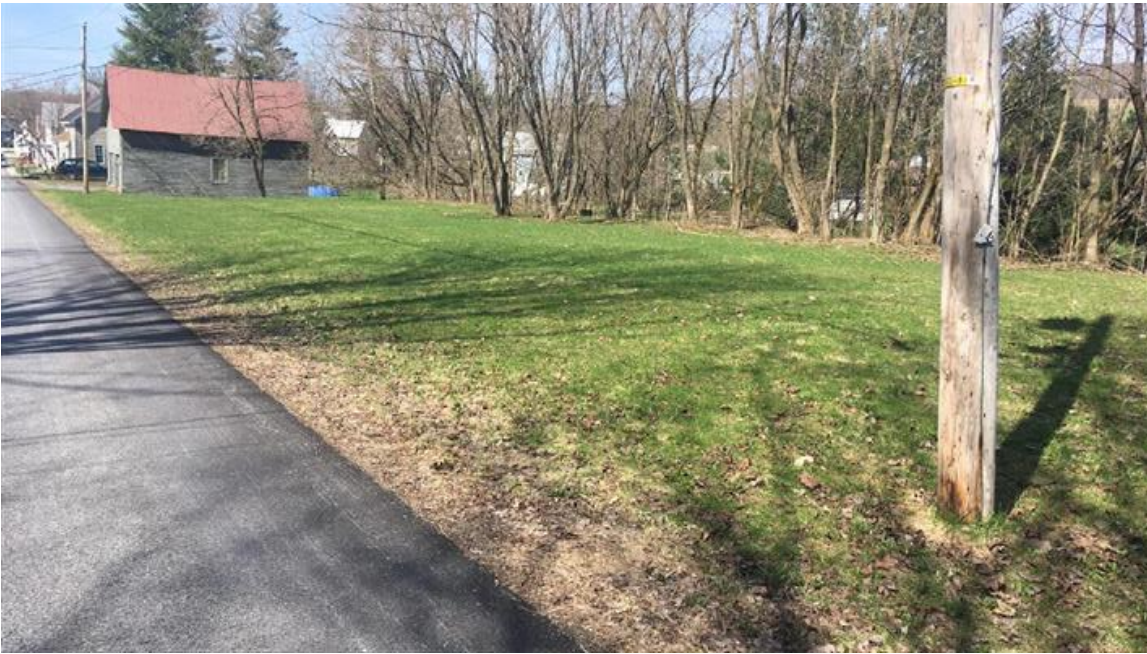
ID# 13, Image 1

ID#: 13																																					
Name: Center Street bioretention																																					
Concept Description: Capture road and driveway runoff and send to a 20' x 30' bioretention, if soils don't conflict. If infeasible, create water features for water quality and incorporate park elements.																																					
Notes/Feasibility: Determine ownership of the field – Town informed us on 7/5 that this is privately owned land. Also stated that soils may have low infiltration capacity, despite what was provided in the soil survey.																																					
GENERAL SITE INFORMATION																																					
Site Contact Info: Town of Richford	Project Candidate: Yes																																				
Ownership: Private	New BMP / Retrofit Existing: New BMP																																				
Land Use Type: Single Family Residential (< 1 ac. lots), Transport-Related (roadway or ROW)	Proposed Retrofit Practice(s): Bioretention																																				
Land Use Detail:	Non-Structural Controls: Educational signage																																				
Existing BMP on Site? No	Non-Structural Other:																																				
Is site a hotspot? No	Maintenance Burden: Medium																																				
Sources/pollutants: Sediment																																					
Soils: Missisquoi (MsD), A; WT 'L'

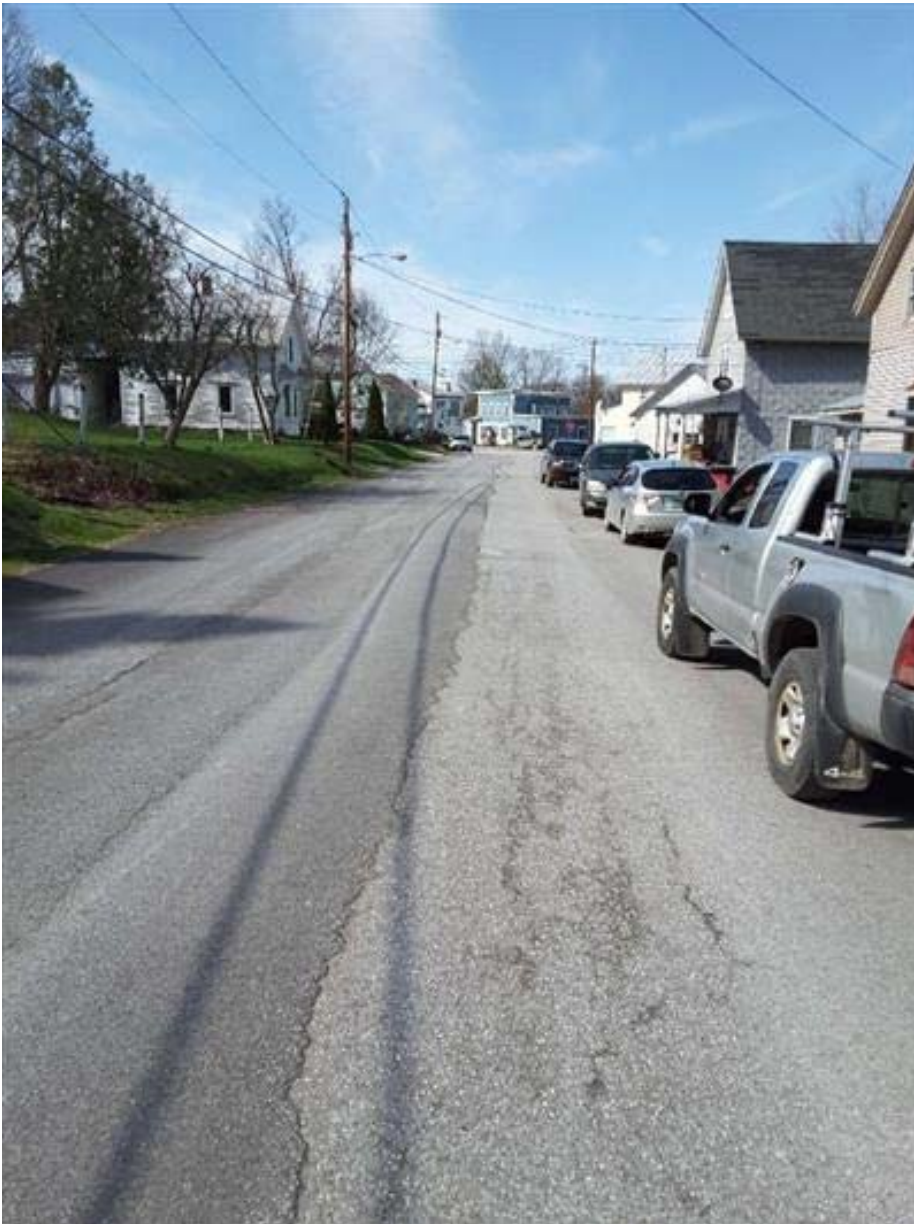
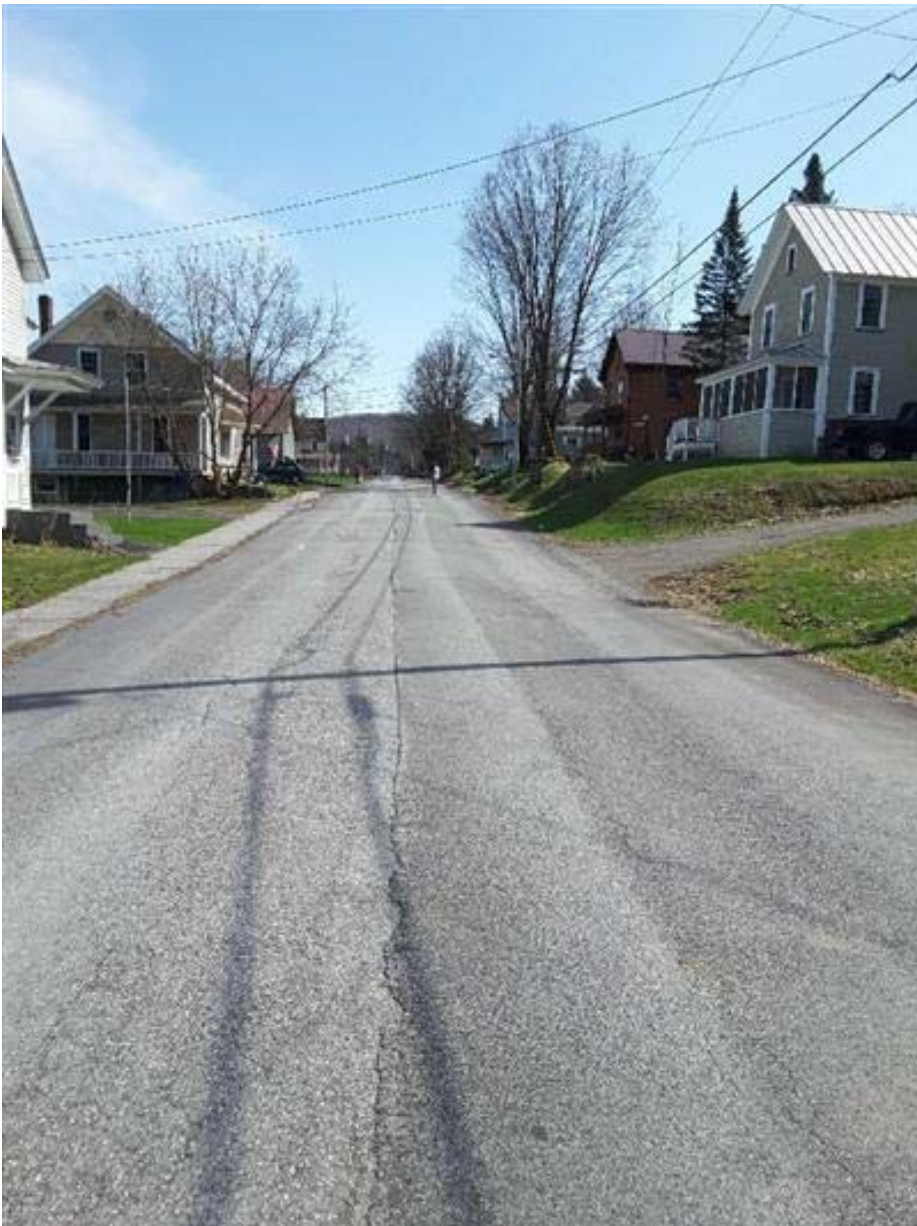
ID# 14, Image 1

ID#: 14																			
Name: Center Street bump outs																			
Concept Description: Install traffic calming bump outs to infiltrate and remove runoff from the existing closed drainage network.																			
Notes/Feasibility: Confirm elevation of water table.																			
GENERAL SITE INFORMATION																			
Site Contact Info: Town of Richford	RETROFIT DETAILS																		
Ownership: Public	Project Candidate: Yes																		
Land Use Type: Single Family Residential (<1 ac. lots), Transport-Related (roadway or ROW)	New BMP / Retrofit Existing: New BMP																		
Land Use Detail:	Proposed Retrofit Practice(s): Bioretention, Bump-Out																		
Existing BMP on Site? No	Non-Structural Controls:																		
Is site a hotspot? No	Non-Structural Other:																		
Sources/pollutants: Sediment	Maintenance Burden: Low																		
Soils: Missisquoi (MsD), A; WT '1'

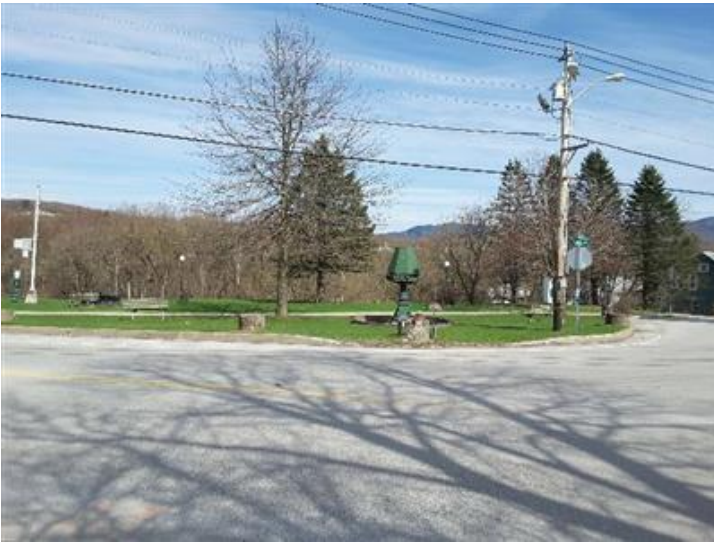
ID# 15, Image 1

ID#: 15																			
Name: Troy St. and Main St.																			
Concept Description: Install bump out or curb cut bioretention at the park located near the intersection of Troy and Main Streets.																			
Notes/Feasibility: Utility conflicts. Electric and water utilities visible. Town informed us on 7/5 that these utilities serve only the adjacent park and should be easy to move/relocate.																			
GENERAL SITE INFORMATION	RETROFIT DETAILS																		
Site Contact Info: Town of Richford	Project Candidate: Yes																		
Ownership: Public	New BMP / Retrofit Existing: New BMP																		
Land Use Type: Park, Transport-Related (roadway or ROW)	Proposed Retrofit Practice(s): Bioretention, Curb Cut, Bump-Out																		
Land Use Detail:	Non-Structural Controls: Educational signage																		
Existing BMP on Site? No	Non-Structural Other:																		
Is site a hotspot? No	Maintenance Burden: Medium																		
Sources/pollutants: Sediment

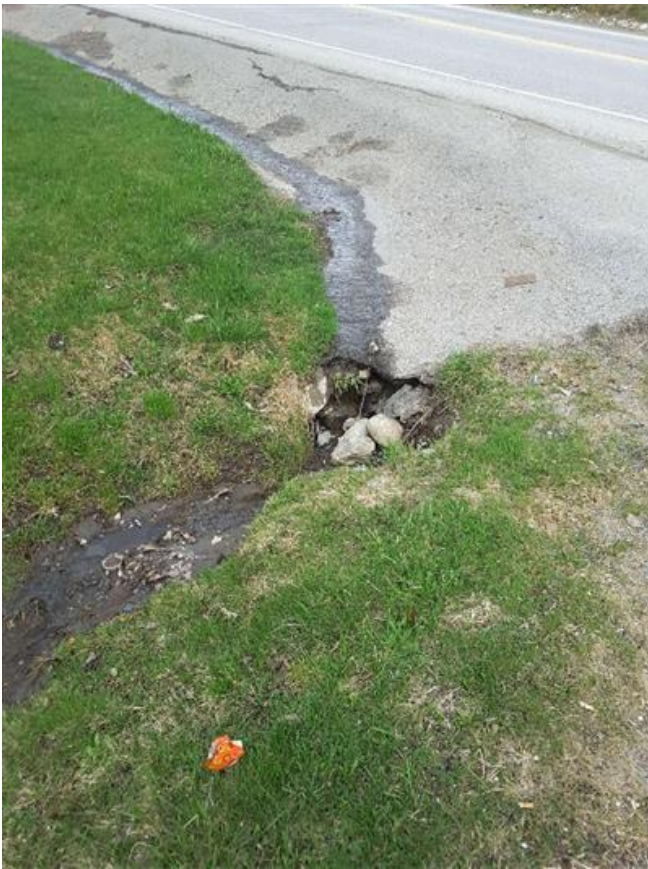
ID# 17, Image 3

- **Site ID – 17, Rt. 105 Paved Swale (Score 16)** – not pursued since the town intends to address this project in the future. Town agrees with practice and noted the municipality could install the practice.
