Stormwater Master Plan Town of Richford, Vermont

PROJECT NO. 17-079-B PREPARED FOR:

Stormwater Master Plan

Town of Richford, Vermont

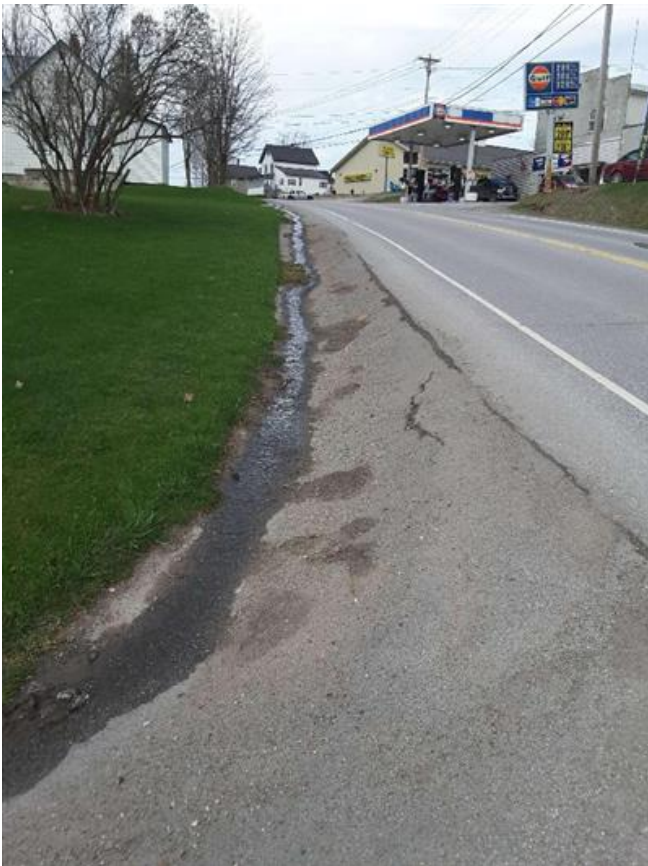
ID# 17, Image 4

- **Site ID – 17, Rt. 105 Paved Swale (Score 16)** – not pursued since the town intends to address this project in the future. Town agrees with practice and noted the municipality could install the practice.

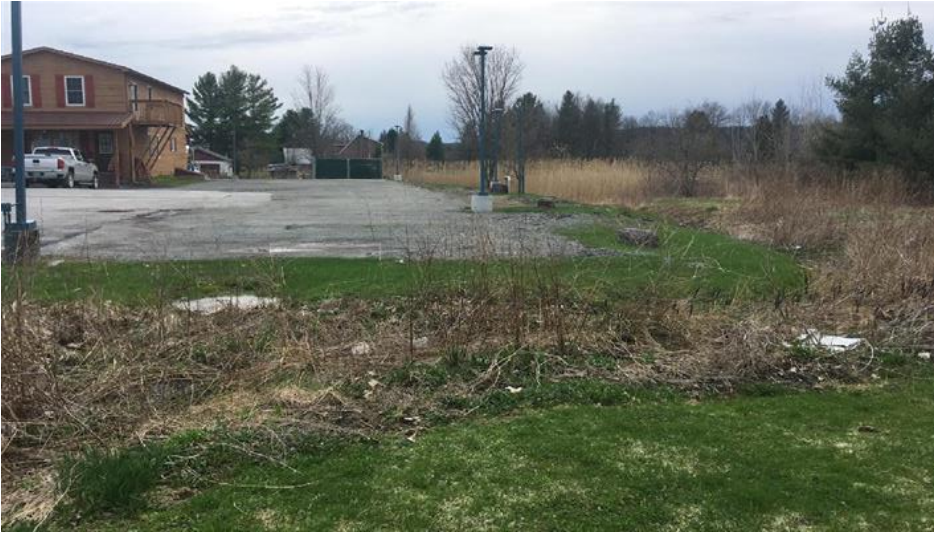
ID# 18, Image 1

ID#: 18																			
Name: Maple Street Swale																			
Concept Description: Homeowner saying swale floods both adjacent properties often. Enlarge swale, stabilize with stone and vegetation. Improve channel geometry at outlet (around Mobil parking lot) to promote better flow through system.																			
Notes/Feasibility: Swale is ~130' straight shot to Mobil property boundary, then curves around parking lot to wetlands, another ~100'.																			
GENERAL SITE INFORMATION																			
Site Contact Info: Town of Richford	RETROFIT DETAILS																		
Ownership: Private	Project Candidate: Yes																		
Land Use Type: Single Family Residential (< 1 ac. lots), Transport-Related (roadway or ROW), Commercial	New BMP / Retrofit Existing: New BMP																		
Land Use Detail:	Proposed Retrofit Practice(s): Ditch stabilized with vegetation (< 5% slope)																		
Existing BMP on Site? No	Non-Structural Controls:																		
Is site a hotspot? No	Non-Structural Other:																		
Sources/pollutants: Sediment	Maintenance Burden: Low																		
Soils: Munson (MuB), C/D; WT 0.5-2'

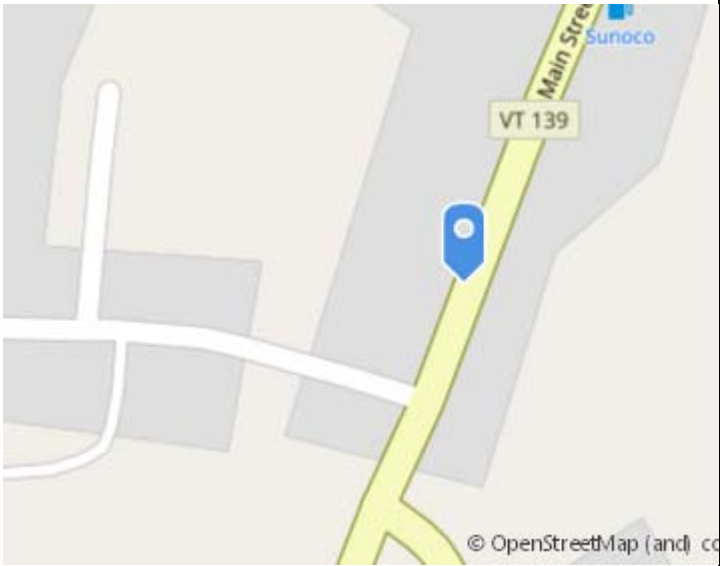
ID#: 32																			
Name: Main Street Bumpout #3

Concept Description: Additional Main St. bump outs.																			
Notes/Feasibility: This project is south of both ID# 10 (Town Hall Bumpout) and ID# 31.																			
GENERAL SITE INFORMATION	RETROFIT DETAILS																		
Site Contact Info: Town of Richford	Project Candidate: Yes																		
Ownership: Public	New BMP / Retrofit Existing: New BMP																		
Land Use Type: Transport-Related (roadway or ROW), commercial	Proposed Retrofit Practice(s): Bioretention, Bump-Out																		
Land Use Detail:	Non-Structural Controls: Educational signage																		
Existing BMP on Site? No	Non-Structural Other:																		
Is site a hotspot? No	Maintenance Burden: Medium																		
Sources/pollutants: Sediment

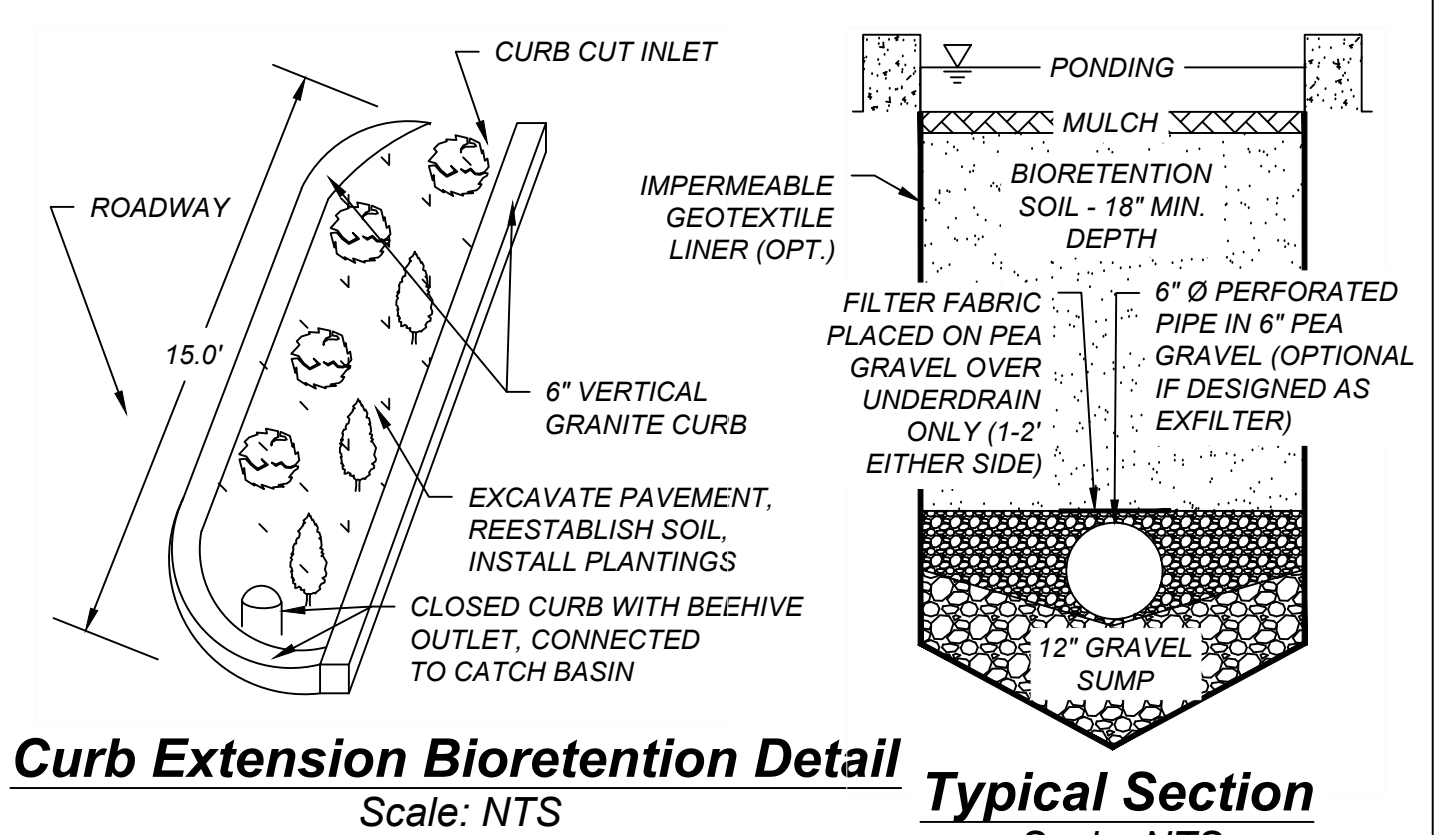
- Notes:**
- The purpose of these practices is to collect and treat runoff from the roadway using filtering or infiltration based bioretention practices.
