**BARTLETT BROOK STORMWATER  
MANAGEMENT EVALUATION**

Prepared For:  
Lake Champlain Basin Program  
54 West Shore Rd  
Grand Isle, Vermont 05458

December 1997

Prepared By:  
James Pease  
Vermont Department of Environmental Conservation  
Water Quality Division  
10 North Building  
103 S. Main Street  
Waterbury, VT 05676

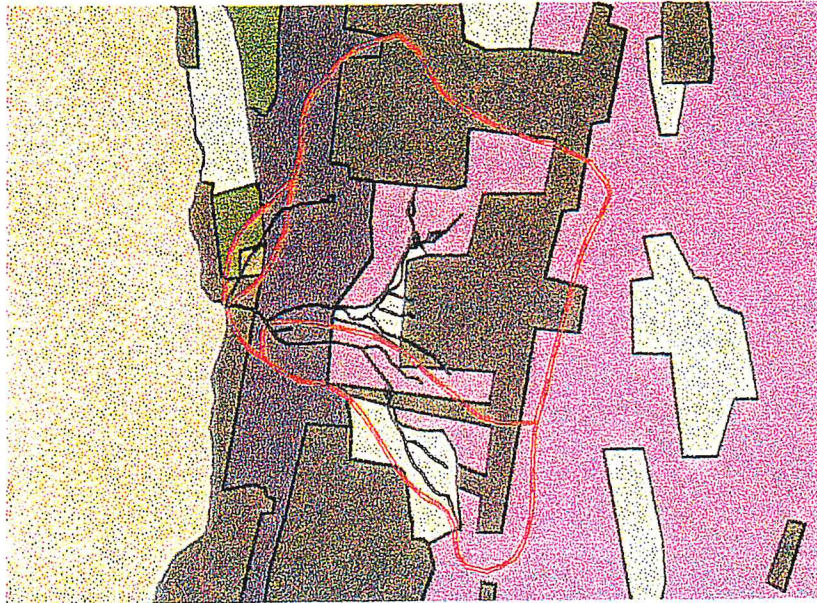
Figure 2.2: Bartlett Brook watershed 1995 actual land use; and future landuse as defined by zoning designation.

In 1995 the watershed land use was approximately 40% residential, 20% commercial, 30% agricultural/cropland and 10% forest. Regional planners predict the watershed to become approximately 50% subregional growth center and 50% mixed urban use. Impervious surface area in the watershed is approximately 17% (Figure 2.2, Table 2-1).

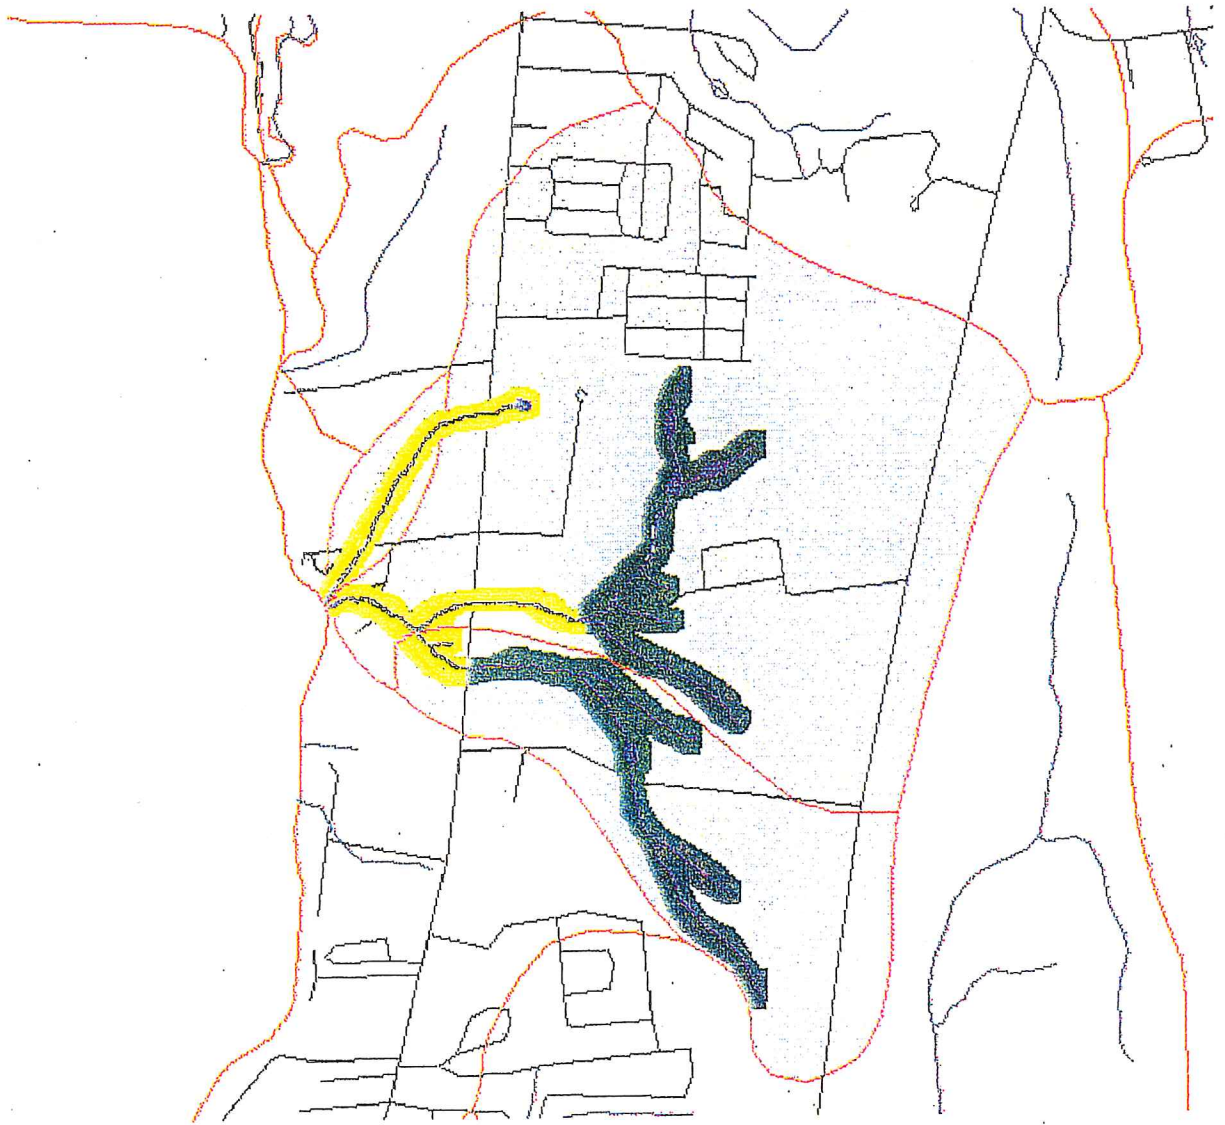
Riparian Corridor Evaluation (RCE)  
Red=Poor, habitat structure gone  
Brown=Fair, major habitat alteration  
Yellow=Good, minor habitat alteration  
Green=Very Good, monitor for changes  
Blue=Excellent, protect existing status

**Figure 2.6: Bartlett Brook Riparian Corridor Evaluation.** Evaluation was conducted using the Riparian Corridor Evaluation methodology (Petersen, 1992). A series of measurements and observations are recording while walking the stream channel.

Riparian habitat and stream channel integrity have been protected in part by municipal zoning. However, current stormwater discharges and future discharges following Shelburne Rd.-Rte.7 reconstruction may drastically alter stream riparian conditions. Habitat alteration is close to severe in the lower watershed. The stream corridor upstream of Rte. 7 on the main fork is managed for agricultural uses but the corridor is for the most part intact and healthy (Figure 2.6). Sediment embeddedness in the brook is extremely high (silt fraction is 54% of total channel sediment sample) below Shelburne Road (Figure 2.7).

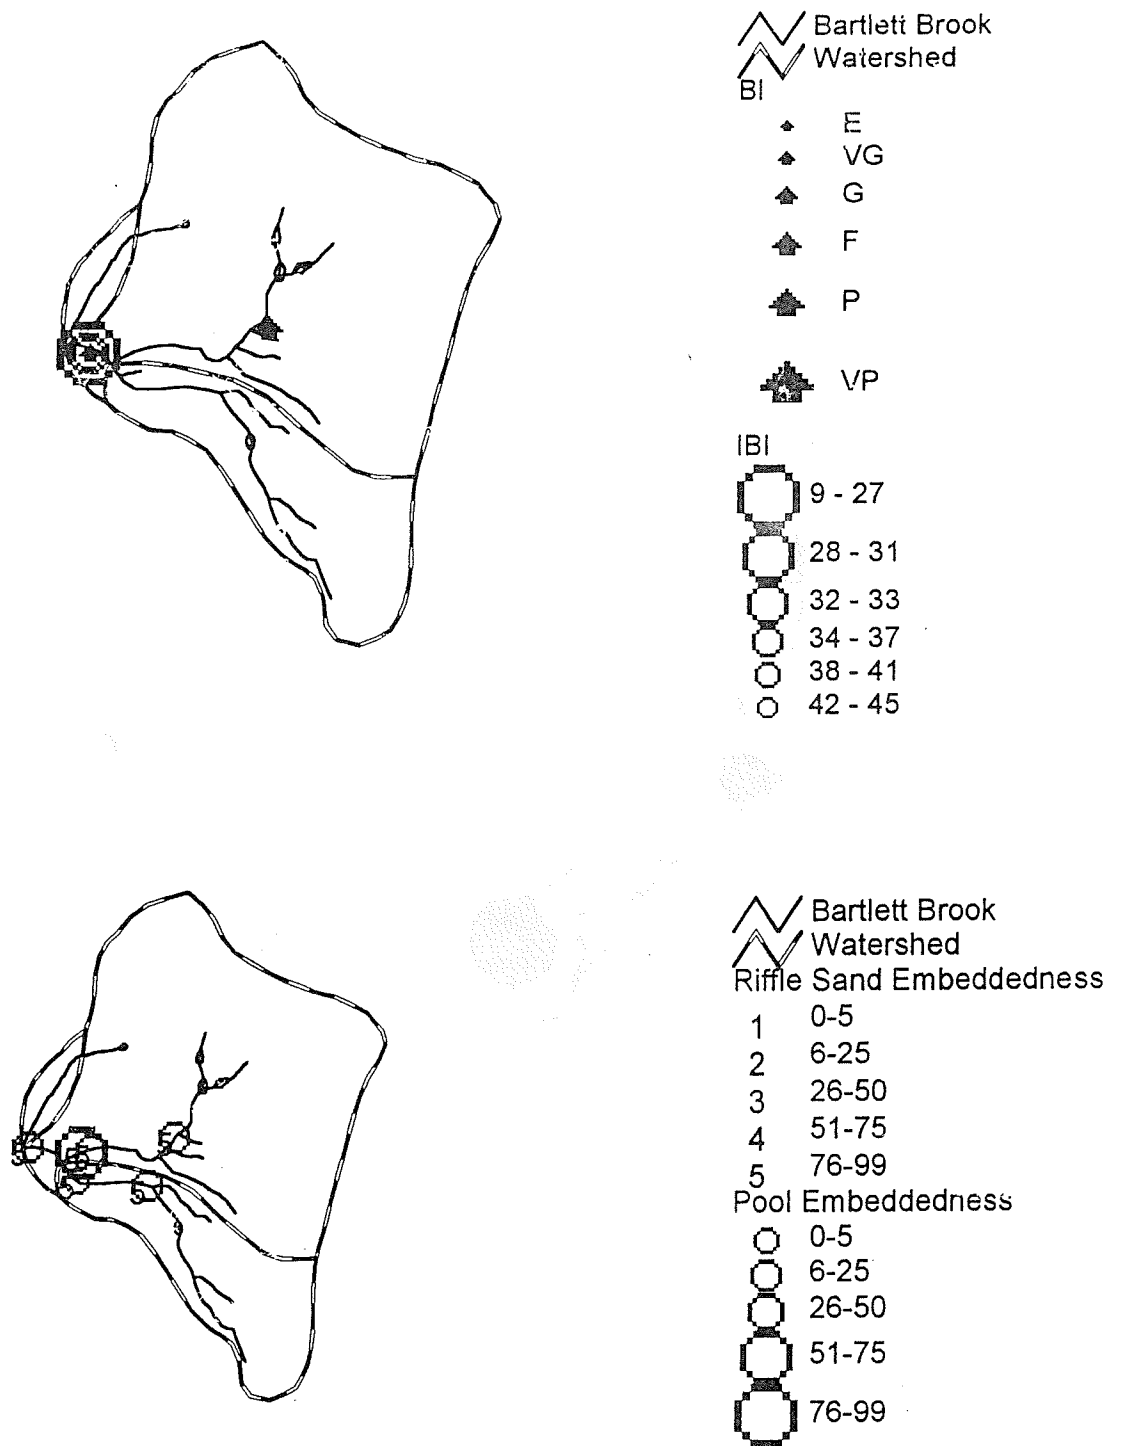
**Figure 2.7: Bartlett Brook watershed - biological condition. Fish and macroinvertebrate community measures of integrity. A macroinvertebrate biotic index (BI) rating of less than good is indicative of sub-Class B condition. A fish Index of Biotic Integrity (IBI) rating of less than 31 is indicative of sub-Class B condition.**

**Watershed measure of pool and riffle sedimentation. A high degree of sand embeddedness indicates excessive erosion and impairs aquatic habitat and the biological communities that are supported by that habitat.**

indicates the effect of severe sedimentation and enrichment impacts in the upper watershed adjacent to the UVM farm. The stream does not meet the Class B water quality standard for biological condition at any of the biological assessment sites (Figure 2.7).

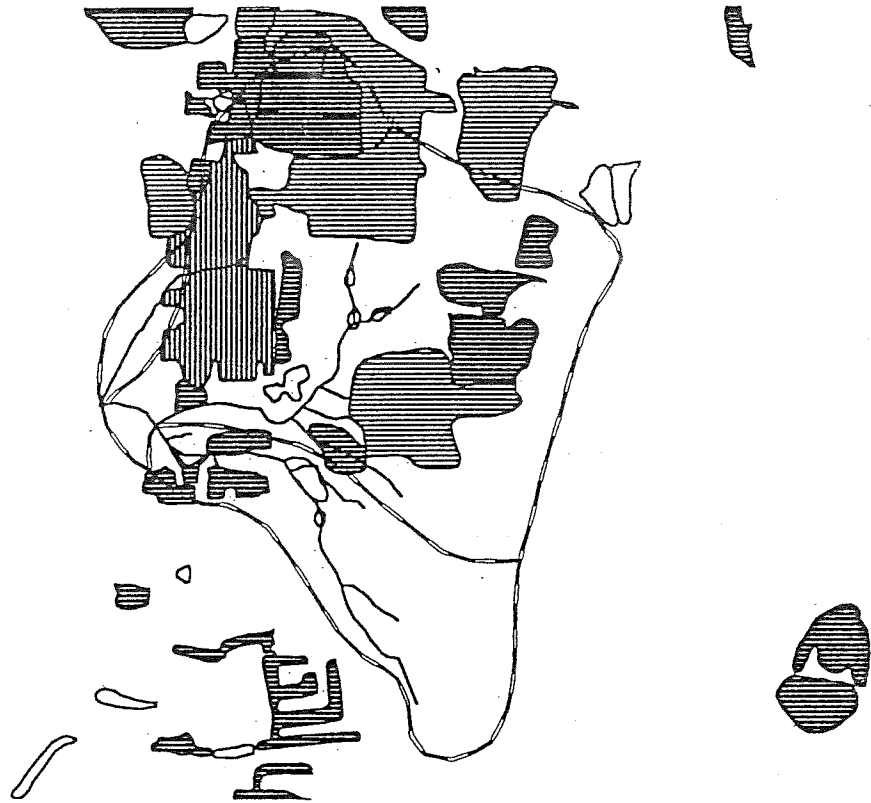
Figure 2.10: Estimated total suspended solids loading from sewersheds in the Bartlett Brook Watershed.

Recwater	Storm sewershed	Treatment (Appendix 4)	EIA%	Loading kg/yr
Highest Total Suspended Solids (Figure 2.10)				
Bartlett	Shelburne Road 1	DP/OS/CB/GS	47.5	35,701
Bartlett	Bay Court	SF	14.7	9185
Highest Total Phosphorus (Figure 2.11)				
Bartlett	Shelburne Road 1			56
Bartlett	Bay Court			14
Highest Total PAH (Figure 2.12) (Commercial Landuses Only)				
Bartlett	Shelburne Road 1			382
Highest Total Metals (Figure 2.13)				
Bartlett	Shelburne Road 1			43
Bartlett	Bay Court			11

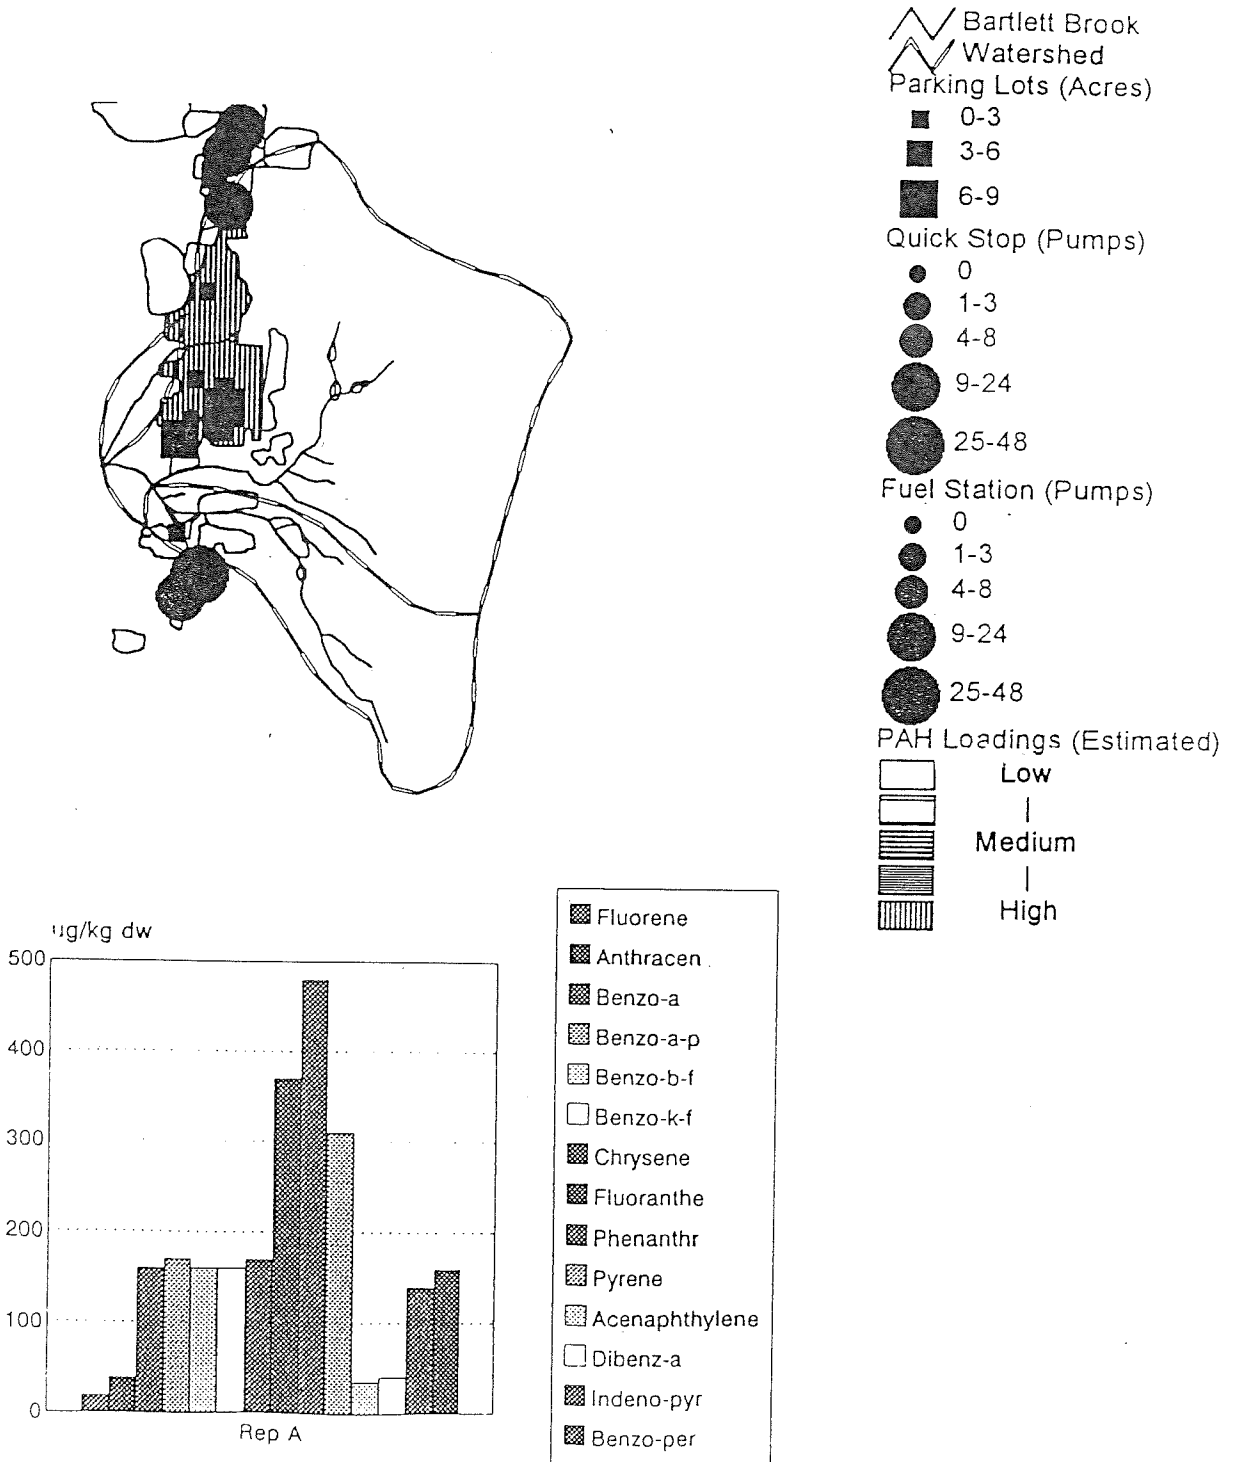
**Figure 2.12: Estimated total PAH loading from sewersheds in the Bartlett Brook watershed.** Graph at bottom shows concentrations of PAHs in sediments at the mouth of the Bartlett watershed. Samples collected in 1995. Potential sources of PAHs are identified as EPA hot spots - parking lots and gasoline service areas.

An investigation by the Aquatic Biomonitoring Section of polynuclear aromatic hydrocarbon levels in the Shelburne Bay drainages found that, of all the tributaries assessed, Bartlett Brook's North and Middle Forks contained the highest levels of these compounds in the sediments of the tributaries assessed. This contamination is most likely a result of vehicular emissions and storage-repair-service of vehicles in the watershed drainage.

6. Relatively high densities of land uses related to the potential discharge of polynuclear aromatic hydrocarbons (PAH's) are reflected in elevated levels of PAH's in sediments at the mouth of Bartlett Brook, particularly in the north tributary. While there is no specific evidence that the levels found represent a significant environmental risk, some site control feasibility studies should be initiated for public drinking water supply protection purposes. The Champlain Water District may wish to include such studies while developing a source area protection plan.
