**POTASH BROOK STORMWATER  
MANAGEMENT EVALUATION**

Prepared For:  
Lake Champlain Basin Program  
54 West Shore Rd  
Grand Isle, Vermont 05458

December 1997

Prepared By:  
James Pease  
Vermont Department of Environmental Conservation  
Water Quality Division  
10 North Building  
103 S. Main Street  
Waterbury, VT 05676

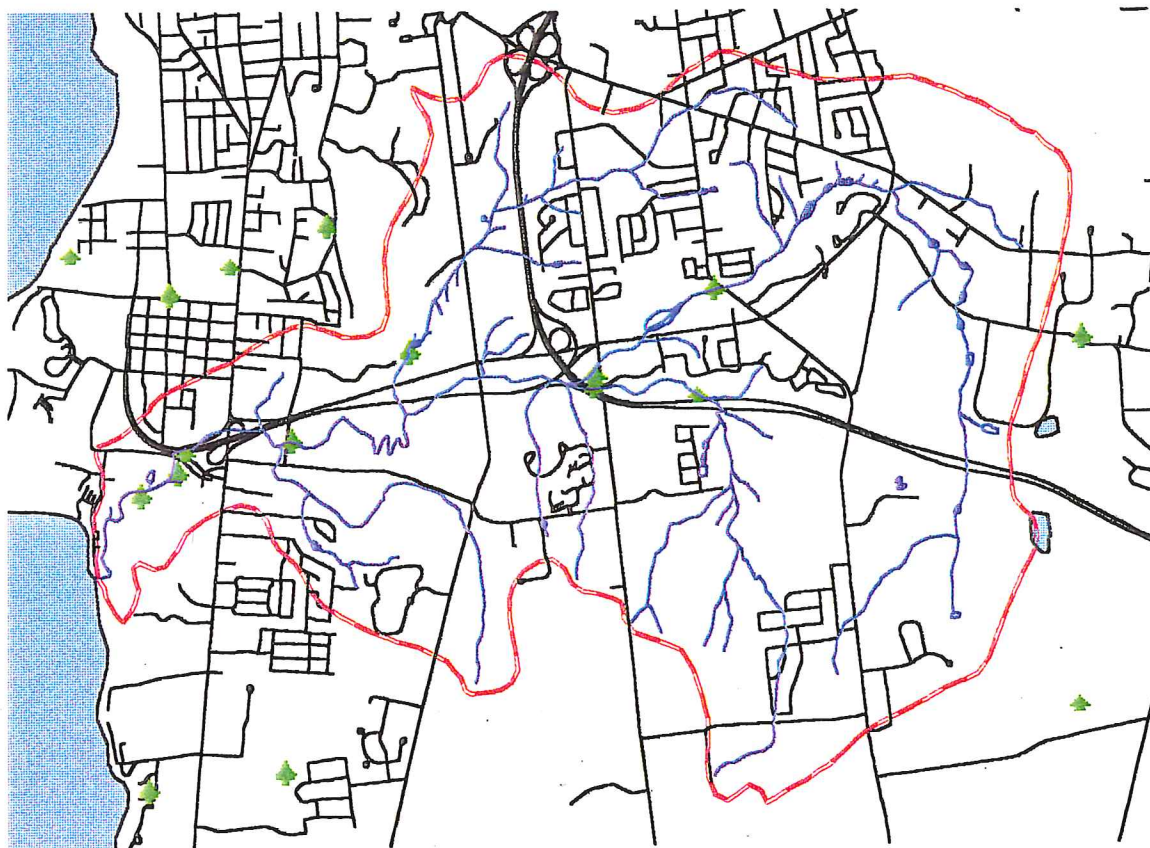
Figure 7.1: Potash Brook watershed showing roads and biological monitoring sites.

Potash Brook watershed is located in the city of South Burlington and encompasses an area of approximately 5300 acres (21 km<sup>2</sup>) (Figure 7.1). The stream rises in the city's growing southeast quadrant between Dorset and Spear Streets. It flows north and west through a series of wetlands and natural areas to Lake Champlain near Red Rocks beach. A northern tributary drains UVM agricultural lands and the Williston Road area of South Burlington.

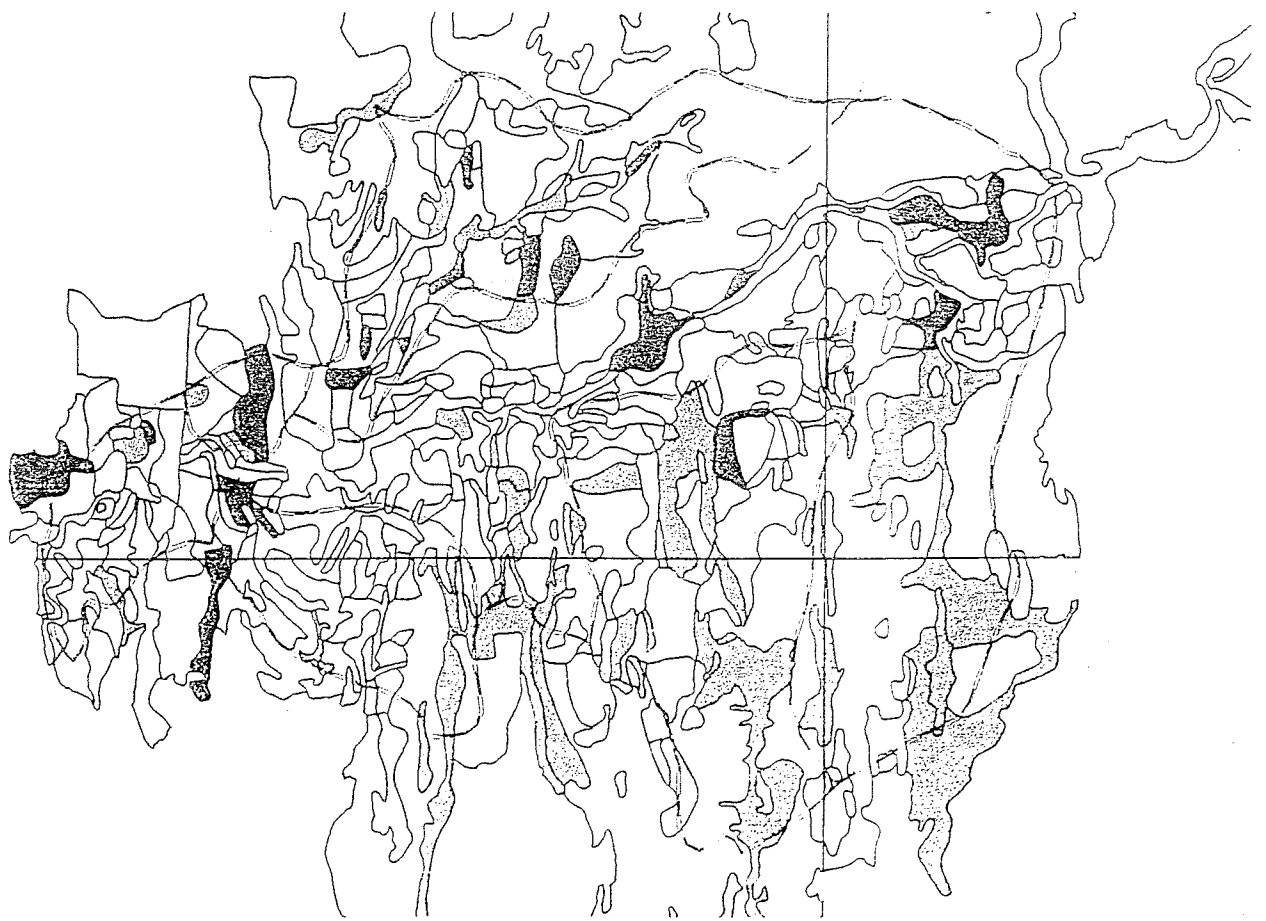
*Potash Brook - Wetpond/Wetland Soils*

**Figure 7.5: Potash Brook watershed - wetpond/wetland soils.**

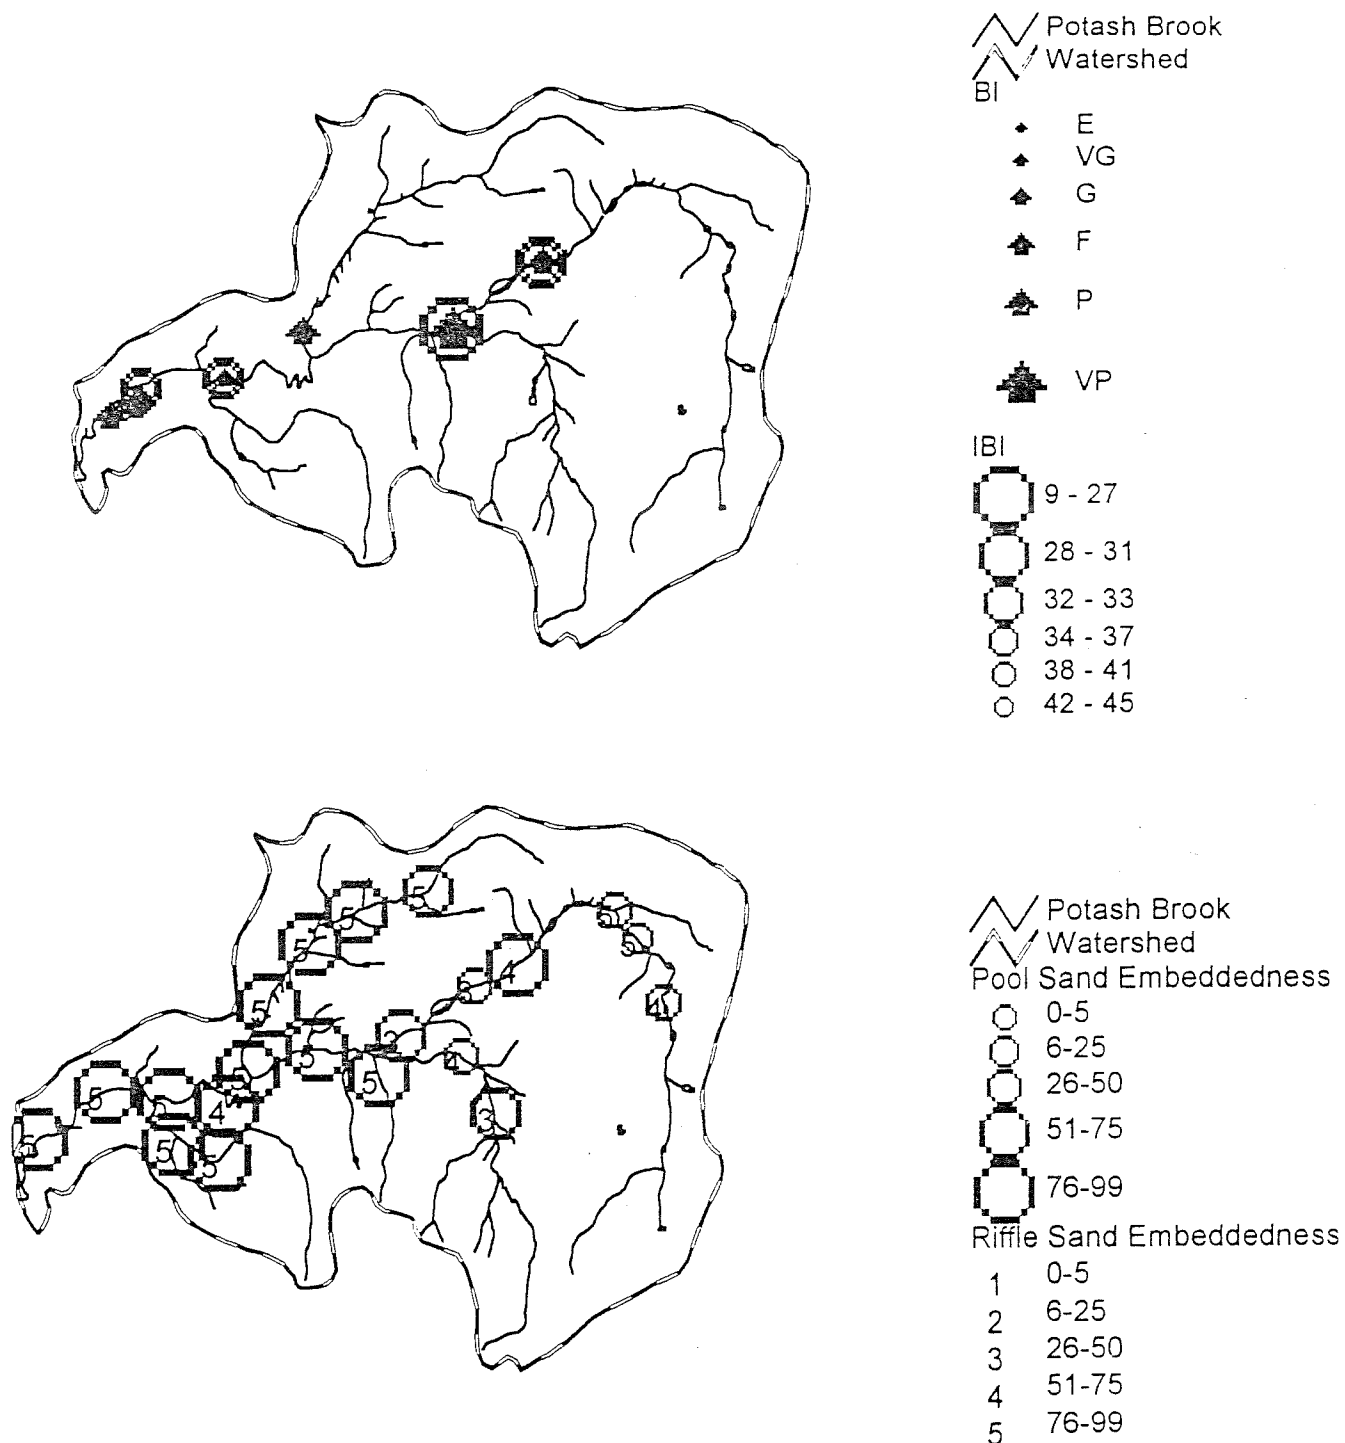
Figure 7.8: Potash Brook watershed - biological condition. Fish and macroinvertebrate community measures of integrity. A macroinvertebrate biotic index (BI) rating of less than good is indicative of sub-Class B condition. A fish Index of Biotic Integrity (IBI) rating of less than 31 is indicative of sub-Class B condition.

Watershed measure of pool and riffle sedimentation. A high degree of sand embeddedness indicates excessive erosion and impairs aquatic habitat and the biological communities that are supported by that habitat.

Good pool habitat and healthy riparian habitat is reflected in the relatively strong fish populations in the brook. A project by the VT Fish and Wildlife Department to enhance fish habitat adjacent to I-189 appears to be successful (Langdon, personal communication). Macroinvertebrate sampling at 6 sites in the watershed indicates moderate sediment impacts and poor aquatic health with the exception of the reach between milepost 1-3. This reach is the only part of the stream which meets the Class B water quality standard for biological integrity (Figure 7.8).

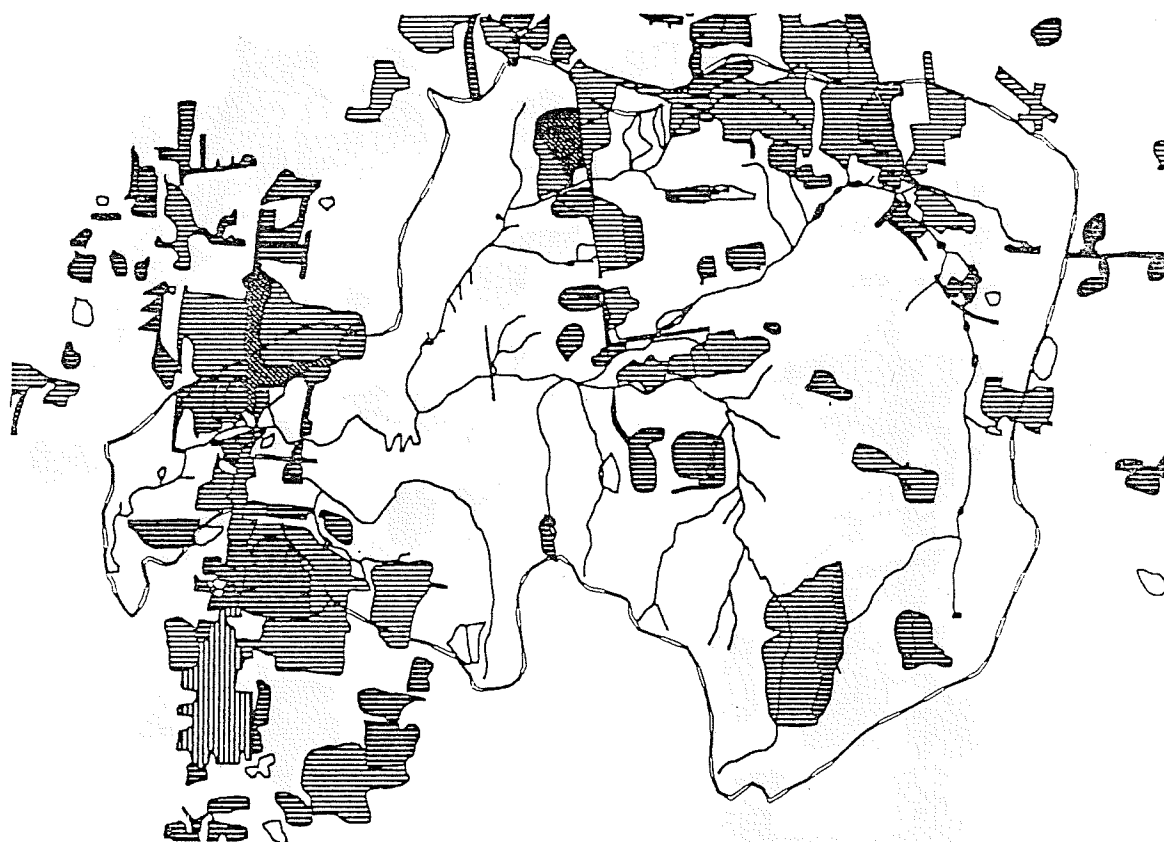
Figure 7.13: Estimated total suspended solids loading from sewersheds in the Potash Brook watershed.

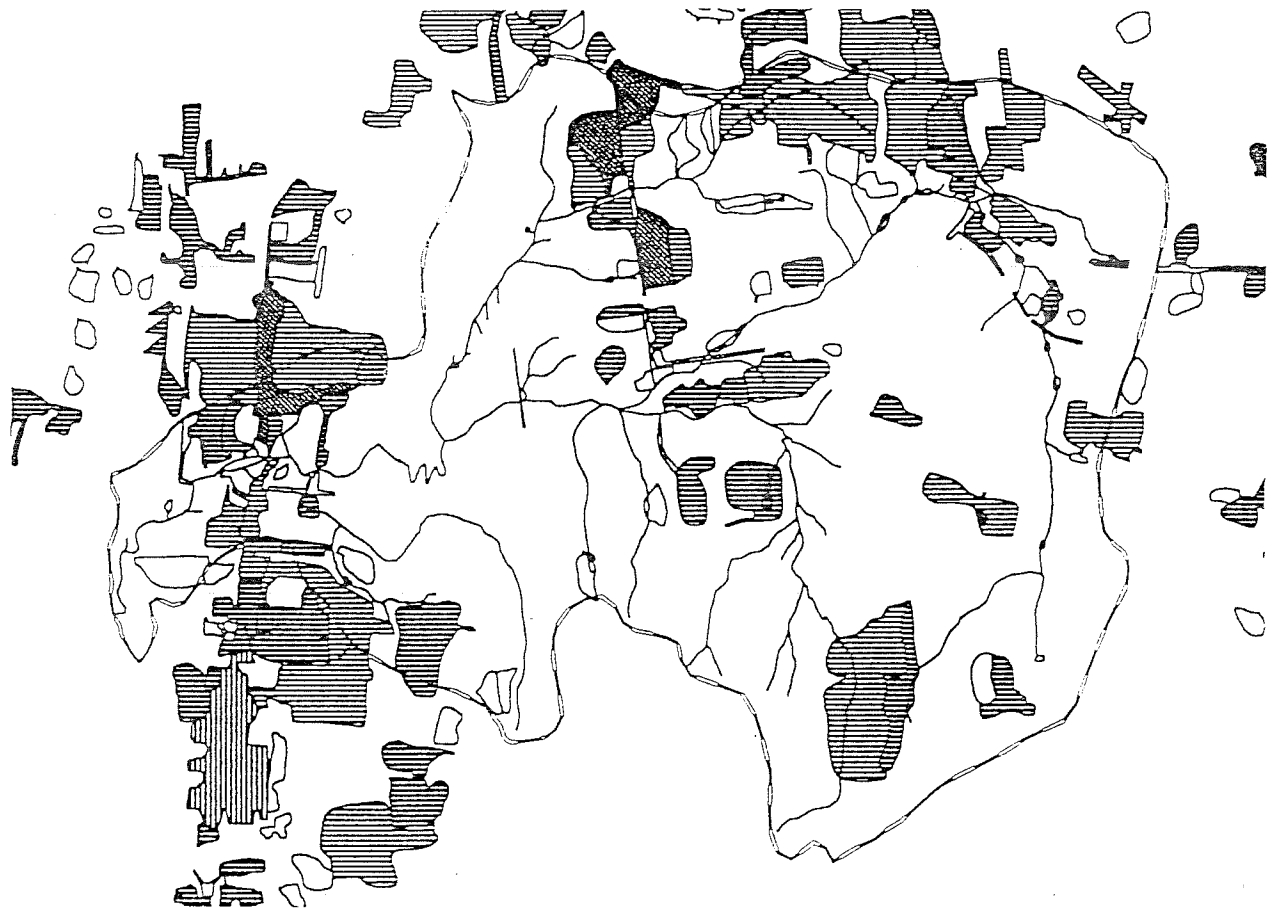
Figure 7.14: Estimated total phosphorus loading from sewersheds in the Potash Brook watershed.

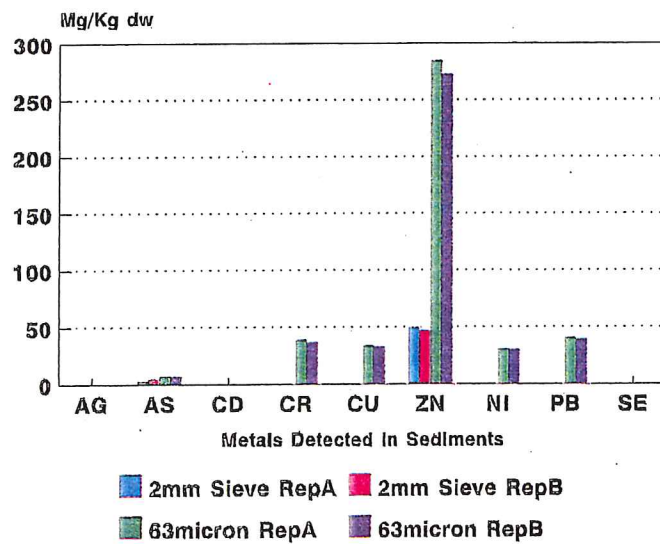
**Figure 7.15: Estimated total metals loading from sewersheds in the Potash Brook watershed.** Graph at bottom shows concentrations of metals in whole (2mm) and fine fraction (63u) sediments at the mouth of the Potash watershed. Samples collected in 1995.
