Roberts Brook, St. Johnsbury, Vermont

Roberts Brook in St. Johnsbury Vermont has been found to be stressed by stormwater runoff as measured by the biology and chemistry of the stream. There are a number of significant discharges to the stream from the developed lands of St Johnsbury Center. The largest discharge to the stream is the Drainage Area 95 which drains the upper watershed between the Town gravel yard and upper Spaulding Rd. In addition there is combined sewer basin connected to the Town sanitary sewer which should be removed and replaced with a dry well or infiltration gallery. The recommended course of action for rural stormwater and sediment impacted streams is to install road best management practices and provide treatment for surface runoff if possible. A map showing the location of the discharges and possible retrofit locations is provided. A cost estimate (excluding land costs) for one of the controls is provided.

Problem Area Data Sheet

SAINT JOHNSBURY SWMP
PR-06 LACKEY HILL ROAD
 STORMWATER IMPROVEMENTS LAYOUT
 SAINT JOHNSBURY VERMONT

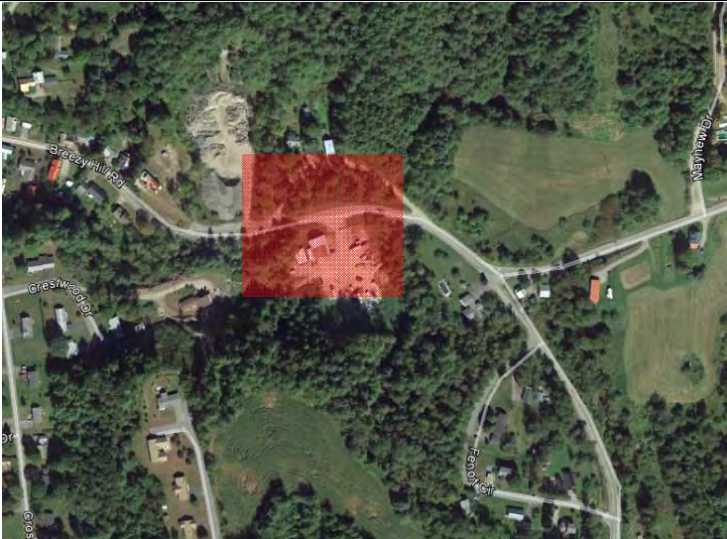
Photo 1: Series of small gullies caused by road runoff

Description of Observed Conditions:
 Unmanaged stormwater runoff from roadway concentrates where Breezy Hill Rd crosses Roberts Brook (Passumpsic River tributary) and is causing gully erosion and general embankment instability.

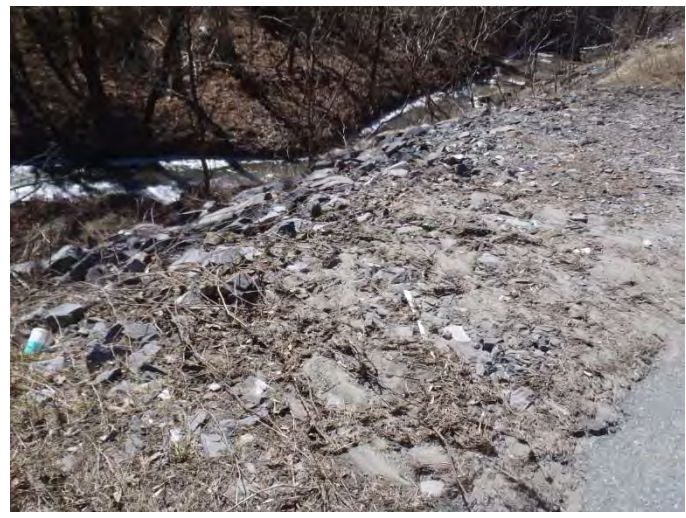
Photo 2: Area of overbank flow and previous stabilization efforts

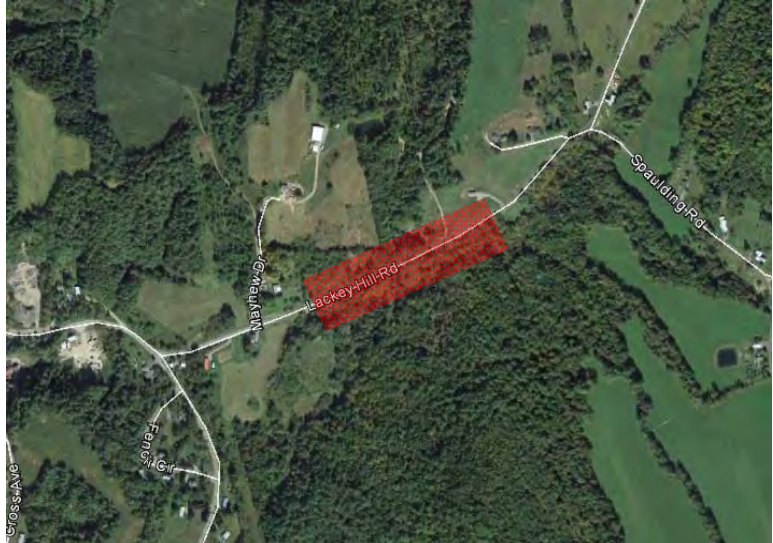
Description of Observed Conditions:
 Unstable ditches, turnouts and cross-culverts are resulting in significant erosion and visibly more turbid water in Roberts Brook between Spaulding Rd and Breezey Hill Rd. Opportunity to bring overly-wide section of road back to standard width and establish properly shaped ditches, with stone-lining and check dams as needed.

Photo 1: Erosion at driveway culvert outlet	Photo 2. Unstable turn-out along southside of Lackey Hill

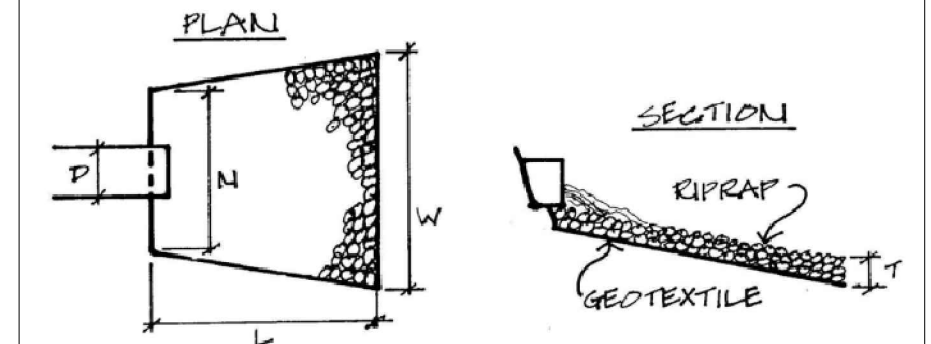
STONE APRON DETAIL

Rock Apron Specifications					
Culvert Diameter (D)	Riprap Size	T (in.)	N (ft.)	W (ft.)	L (ft.)
18 inches	(3-12 inch)	18	4.5	14.5	10.0
24 inches	(3-12 inch)	18	6.0	20.0	14.0

D= diameter of culvert
 T= depth of stone in apron
 N= width of apron near culvert
 W= width at downhill end of apron
 L= length of apron
