TOWN OF WALLINGFORD— STORMWATER MASTER PLAN

**WALLINGFORD,
VERMONT**

FINAL REPORT

February 22, 2019

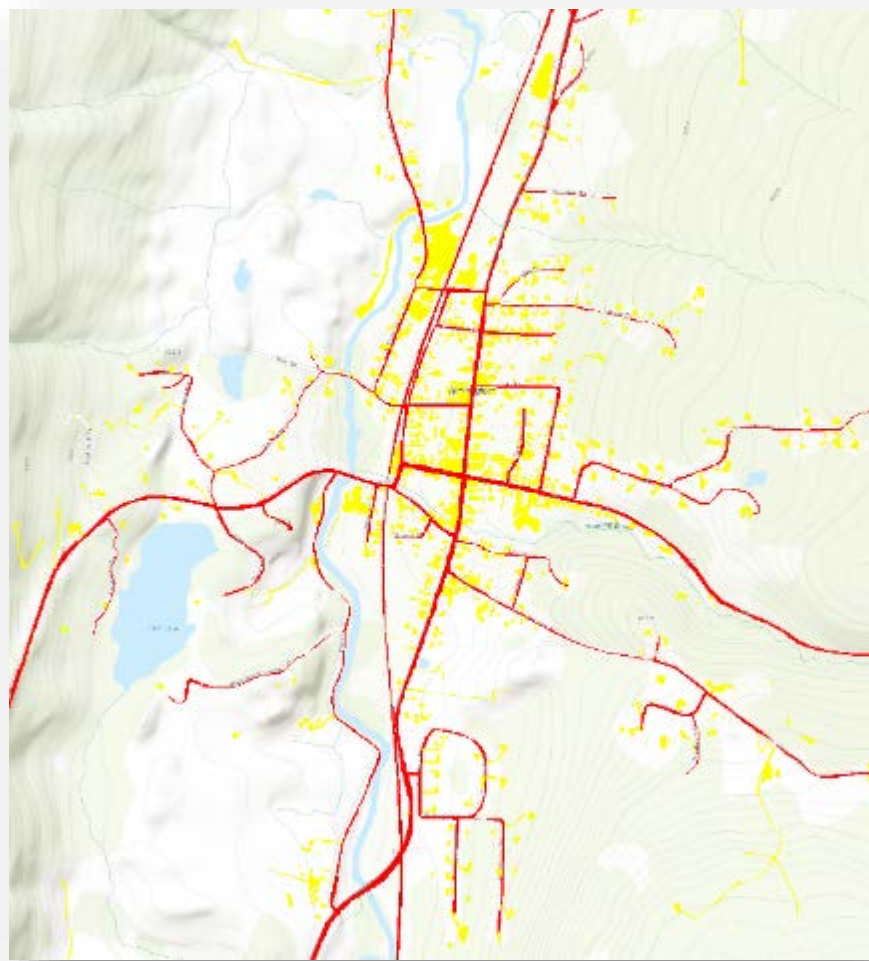
Figure 1: Downtown Wallingford showing road-related impervious cover in red and all other impervious cover in yellow. Approximately half the impervious cover in Wallingford is road-related.

Impervious Coverage remotely-sensed GIS layer) – paved roads and parking lots, roof tops, gravel road and parking lots, and other impervious coverage areas. These areas make up 1.4% of the total town area. Of these 403 acres of impervious coverage, 210 acres or 0.07% are public roads. The remainder is split between public and private parcels of development.

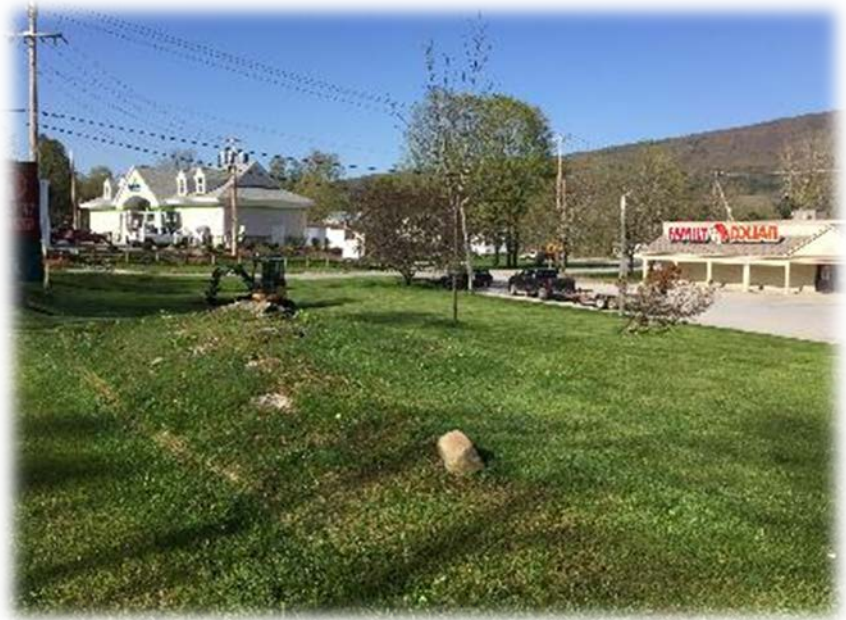
Figure 2: The potential site where sub-surface chambers could be installed as a filtration practice is show in this photo. Only the green space in front of the parking area would be developed for stormwater management.

A system of sub-surface chambers will be installed in the front yard of the Wallingford Family Dollar. The property is owned by James Mulkin, who has expressed his support of the project to the concept design phase. The Family Dollar Corporation has also expressed their support, as long as the chamber system does not interfere with their daily operations. The chambers will have to be installed so as to avoid the ledge outcrop on the site. The

concept calls for laying the chambers out in such a way as to stagger each of the rows. The system will be sized to treat the full Water Quality volume (WQv) from the majority of Wallingford’s developed downtown area. During geotechnical assessment, groundwater was found at a depth of approximately 6.0-6.5’. The chambers will be located above that elevation and will be underdrained using an 8” perforated underdrain pipe, located below a 2’ layer of sand that will act as a filter for pollutants. No runoff will be infiltrated. Runoff events larger than the WQv storm will bypass the system via an overflow and be routed to the same ditch they currently flow to. No change will be made to runoff routing for storms larger than the WQv storm.

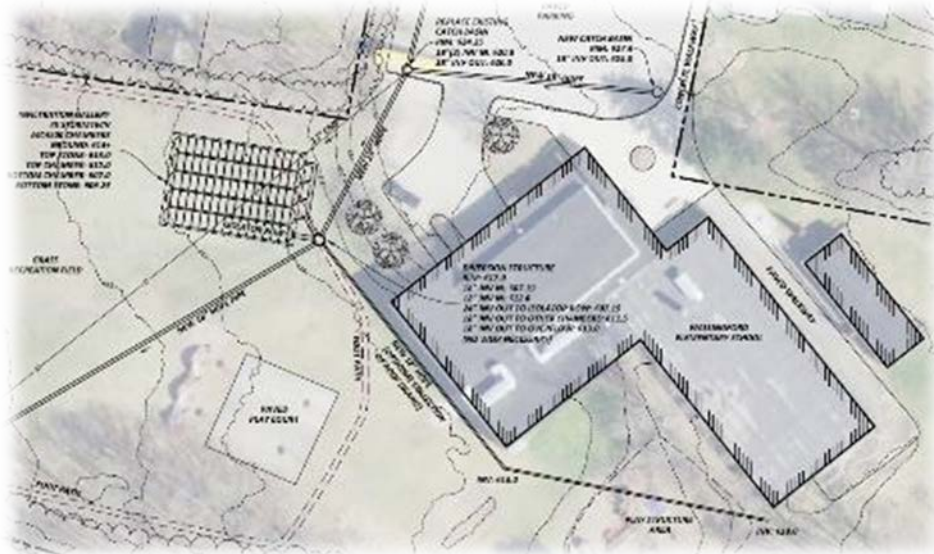
Figure 3: Vignette from the 30% concept design for the Wallingford School infiltration chamber system. The system would take drainage from the entire school area, including some of the road and residential neighborhood adjacent to the school.

Figure 4: Vignette from the 30% concept design for the Wallingford School infiltration chamber system. The system would take drainage from the entire school area, including some of the road and residential neighborhood adjacent to the school.

The system will consist of a series of 5x15 Storm Tech MC-4500 sub-surface infiltration chambers designed to fully infiltrate the Water Quality volume (WQv) from a 22.75 acre drainage area, 20.04% of which (or 4.55 acres) is impervious. This drainage area includes the school's main parking lot and rooftop (provided

the roof drain pipes can be tied to the system – plans are inconclusive on this matter). Larger storms will bypass the system via an overflow pipe to the Roaring Brook. Geotechnical assessment at the site found a favorable infiltration rate of approximately 1.3” per hour. Conversations with the Town Road Foreman, who has extensive knowledge of this particular site, indicates that there may be some buried debris on the site below the ball field (old concrete tanks or other debris from the high school demolition). This may complicate excavation for the chambers to some degree.

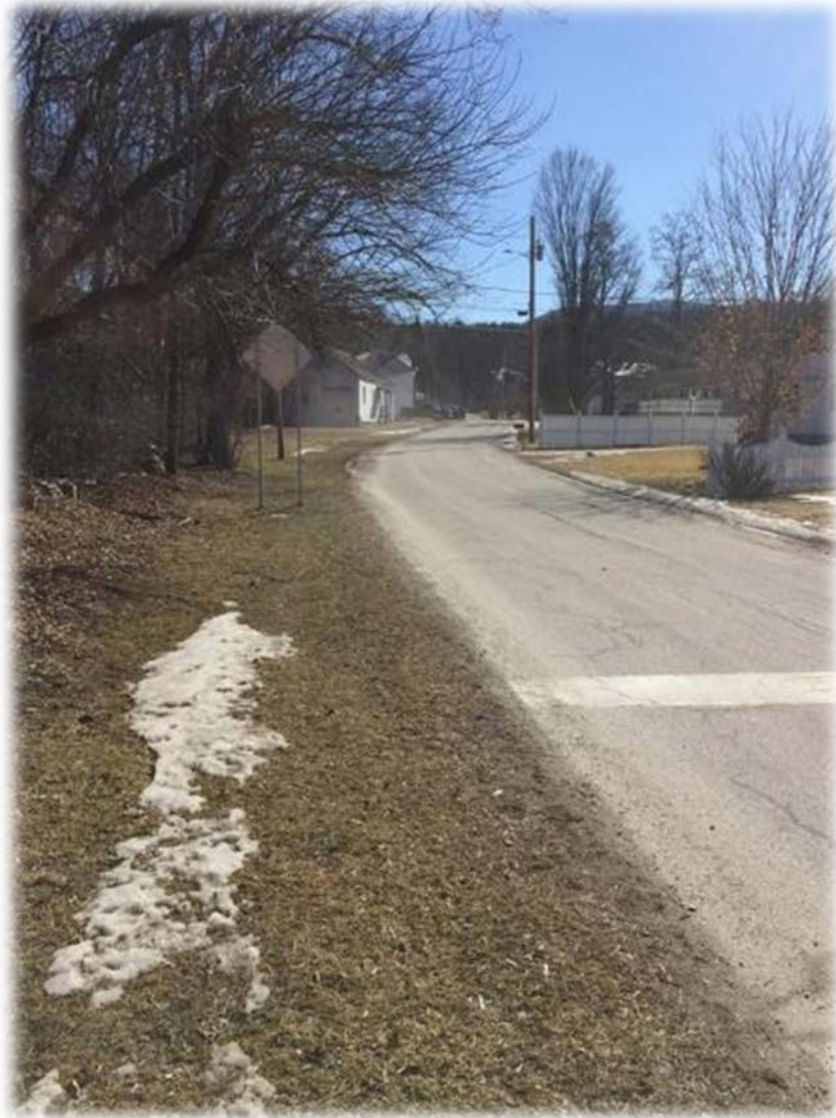
Figure 5: Florence Avenue right-of-way greenspace where the infiltration swale would be installed. The swale would essentially formalize and improve the existing ROW.

Figure 6: Florence Avenue right-of-way greenspace where the infiltration swale would be installed. The swale would essentially formalize and improve the existing ROW.

Between the road edge and the berm separating the road right-of-way from Roaring Brook, an infiltration swale could be dug to allow for runoff from Florence Avenue and several surrounding residences to drain and infiltrate into soil. The right-of-way is publicly owned. The improvement would consist of excavating the ROW to specifications, amending 18-24" of soil with bioretention media, and replanting with grass seed. The swale would be sloped such that the bottom would allow for up to 1.75' of ponding prior to overflow. An overflow pipe would be installed through the existing berm to allow for runoff bypass to the Brook.

This would allow the berm to continue to provide some measure of local flood control, though it should be noted that the primary reason that localized flooding occurs in this location is the undersized stream crossing bridge located downstream of Florence Avenue.

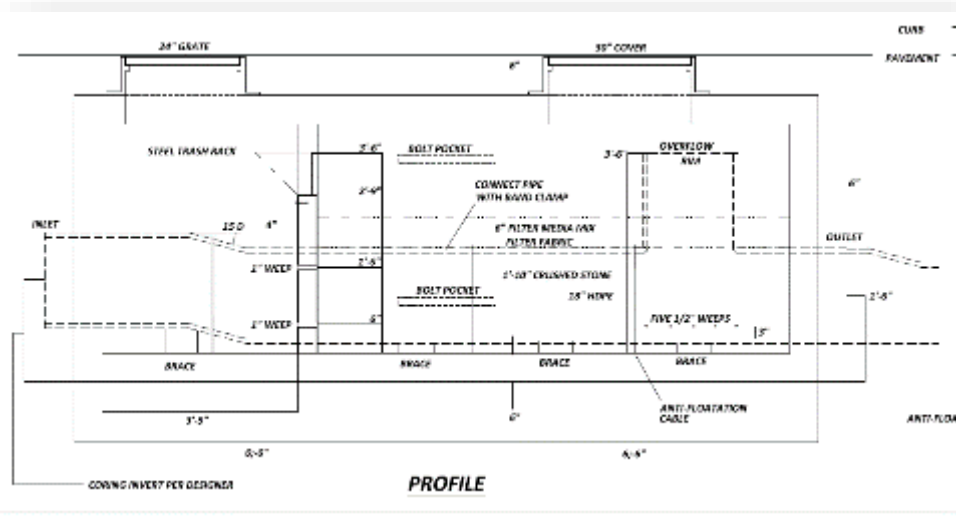
Figure 7: Vignette of the modified media box filter originally developed by the University of New Hampshire Stormwater Center and modified for installation in an ‘online’ configuration by Watershed Consulting Associates, LLC and Lakeside Environmental Group.

Figure 8: Vignette of the modified media box filter originally developed by the University of New Hampshire Stormwater Center and modified for installation in an ‘online’ configuration by Watershed Consulting Associates, LLC and Lakeside Environmental Group.

overflow pipe. Each three-piece unit (as originally designed) is designed to treat up to 0.5 acres of impervious cover. An additional segment can be added for each additional 0.25 acres of impervious cover. This practice was chosen as it non-proprietary, is easily serviced, has easily replaceable filter media, and can be installed in the road right of way without impacting traffic, plowing, parking, or adding infiltrated runoff to the road subbase, which was a particular concern expressed by VTrans for this location. VTrans has been appraised of this design and is generally favorable of the concept, though they noted that they aren't necessarily in favor of the increased operation and maintenance that will come with these practices.

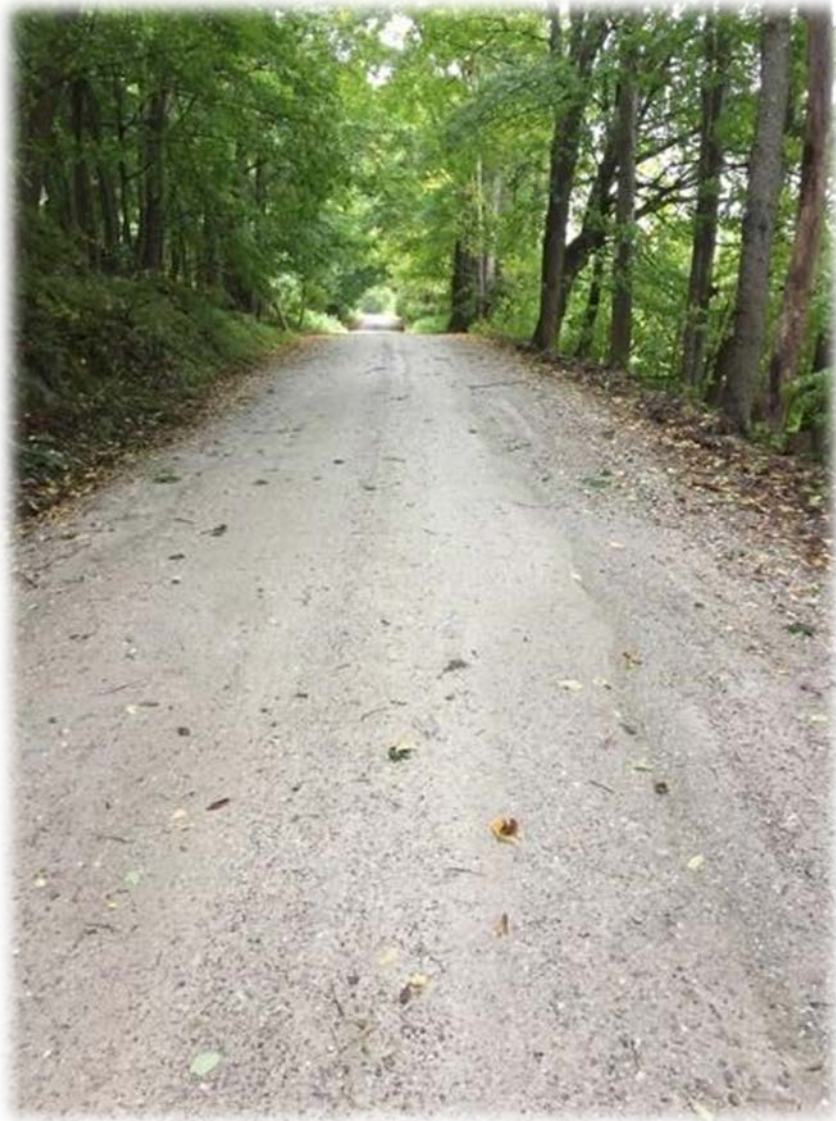
Figure 9: West Hill Road 4. This road segment needs to be re-crowned.

This segment near 1799 West Hill Road is 1,115’ long and has long sections of eroded ditches flowing to a small tributary. Nearly 50% of this overall segment needs to be re-crowned (though it is important to note that the assessment occurred in the fall of the year), and around 50% of the ditching needs to be stabilized in some fashion. In addition, there are undersized culverts along this road segment. In order to bring the segment into compliance with MRGP requirements there are a number of best management practices (BMPs) that should be installed. See the Attachment 6.2 – Road Erosion Solutions for a description of the specific

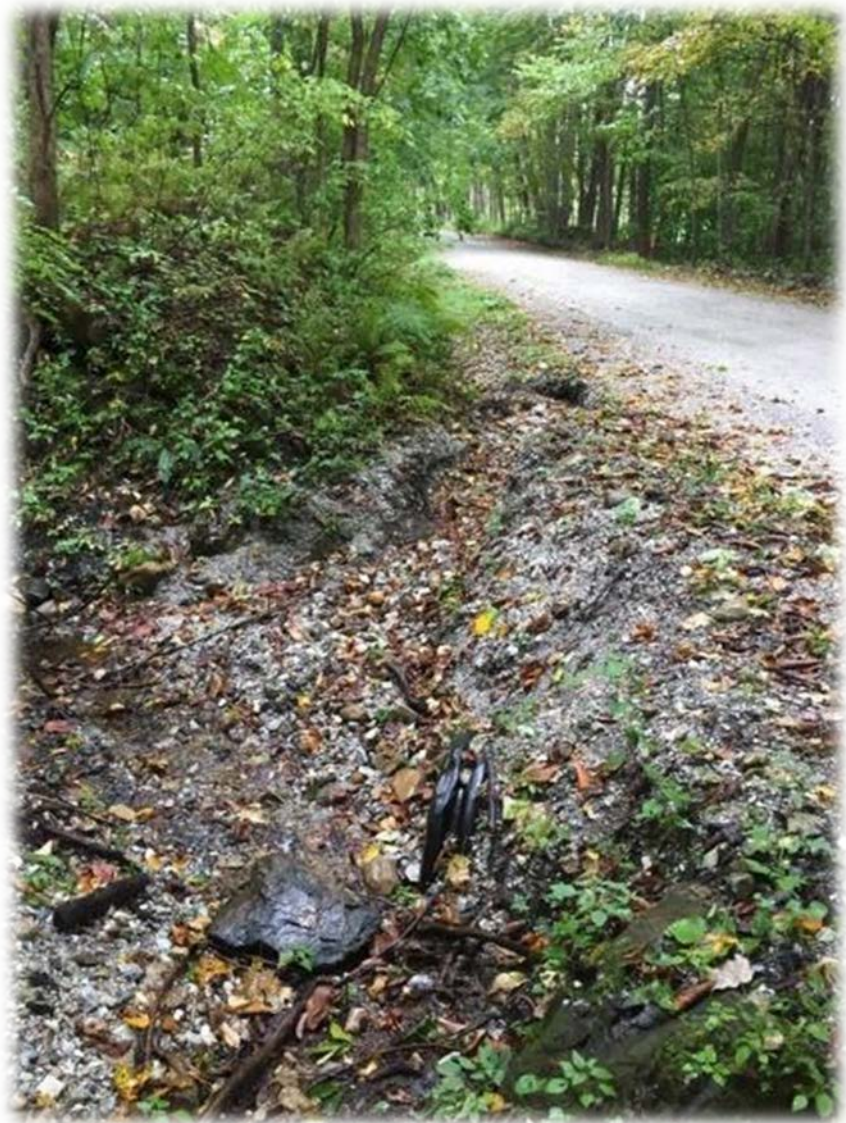
Figure 10: West Hill Road 5. The turnout at the bottom of the road is eroding directly into the tributary.

This segment, which is just downhill of 2048 West Hill Road, is approximately 415' long and has an eroded, steep ditch on the uphill side of the road that flows directly to a small tributary. The ditch needs re-shaping and armoring with stone. Additionally, a section of grader berm needs to be removed and a new road crossing culvert could be installed to take water from the uphill ditch into an open field area on the opposite side of the road before the ditch meets the tributary. Some re-crowning of the road is necessary. See the Attachment 6.2 – Road Erosion Solutions for a description of the specific practices and materials estimate.

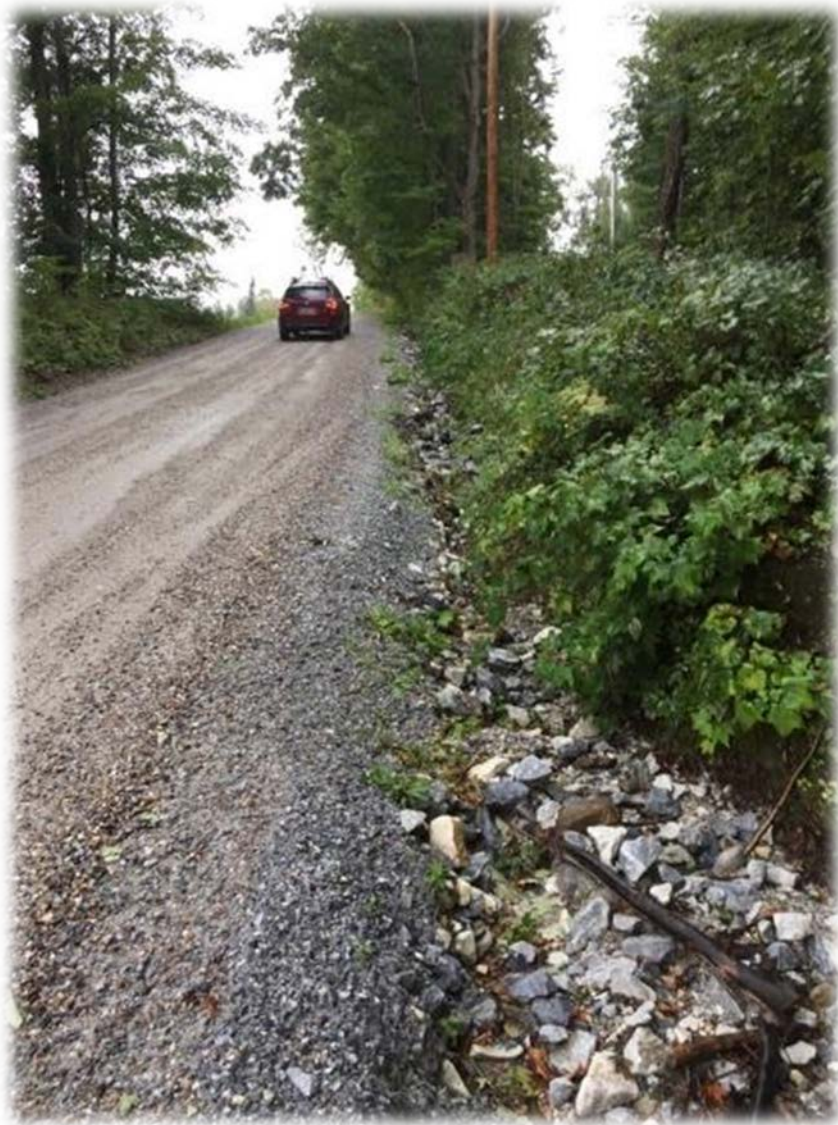
Figure 11: West Hill Road 3. Grader berm needs removing and the ditch is eroding.

This segment of road, downhill from 1348 West Hill Road, is approximately 545’ long with a 450’ long section of ditch on the uphill side of the road that is eroded and needs to be re-shaped and armored. One existing culvert may need to be replaced, or at least dug out of the sediment that is blocking the inlet and outlet, and there is an opportunity to install three road crossing culverts to rock aprons to divert runoff and sediment away from the tributary at the bottom of the hill. There is a 320’ section of the road that has a grader berm that should be removed. The road segment also needs to be re-crowned. See the Attachment 6.2 – Road Erosion Solutions for a description of the specific practices and materials estimate.

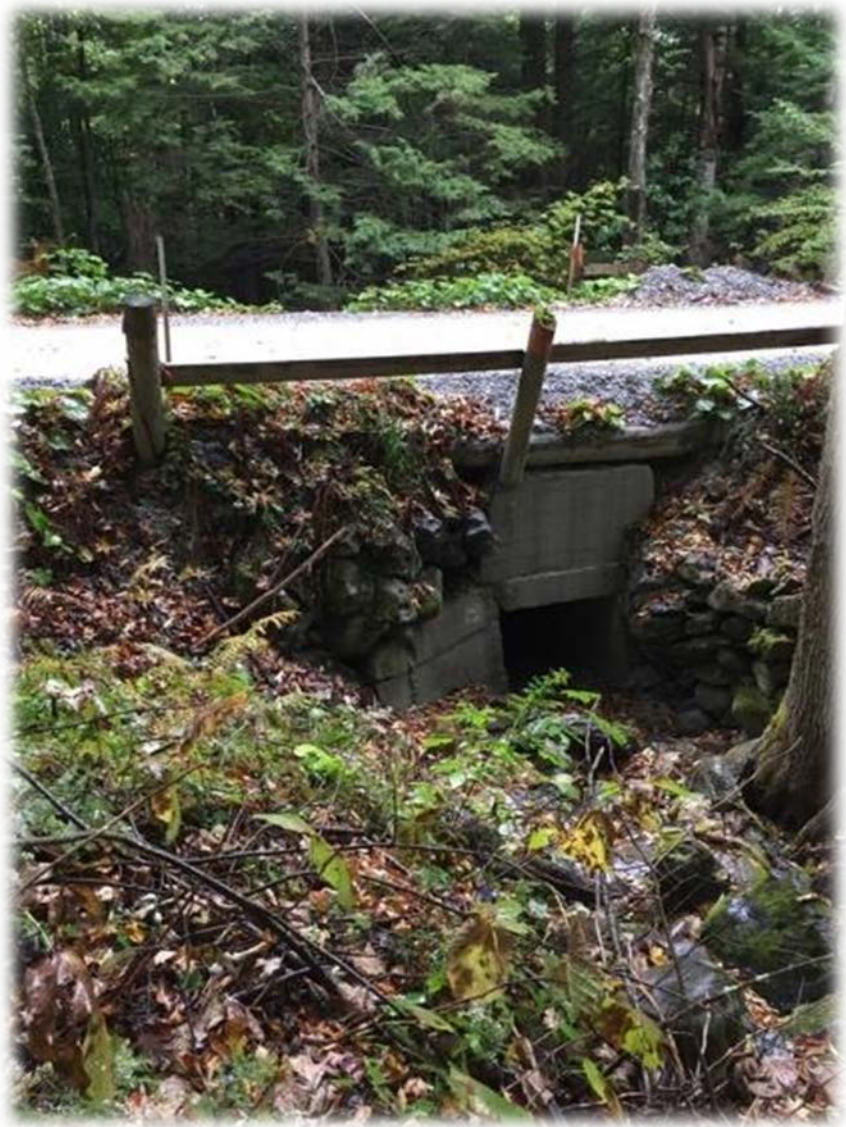
Figure 12: West Hill Road 1. Misaligned and undersized culvert at bottom of road segment.

This road segment, located downhill of 518 West Hill road, is approximately 580’ long and has ditches on both sides of the road that are steep and eroded that lead directly to a small tributary. The road segment should be re-crowned, though there was no evidence of a grader berm. There are two opportunities to install a road crossing culvert to a rock apron, though driveways on the receiving side of the road will be a complicating factor. Additionally, the stream crossing culvert at the bottom of the road segment appears to be undersized and in poor condition. At minimum a culvert that matches the

hydraulic or bankfull width
