**CENTENNIAL BROOK STORMWATER  
MANAGEMENT EVALUATION**

December 1997

Prepared By:  
James Pease  
Vermont Department of Environmental Conservation  
Water Quality Division  
10 North Building  
103 S. Main Street  
Waterbury, VT 05676

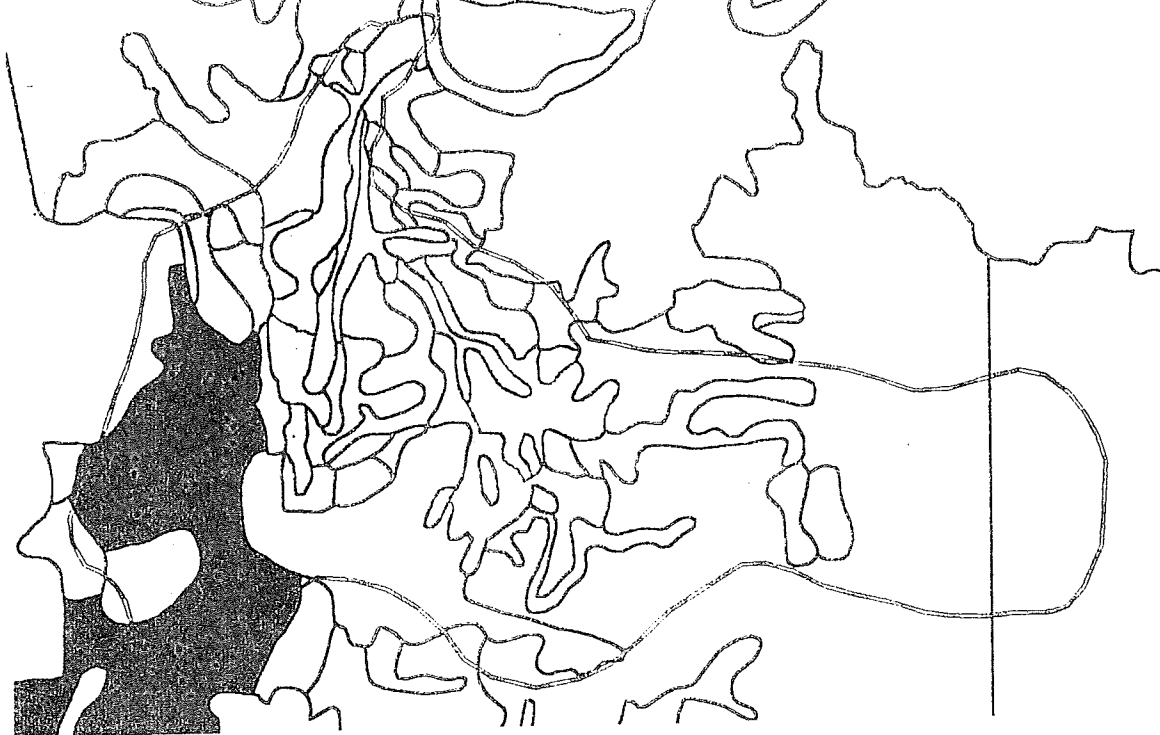
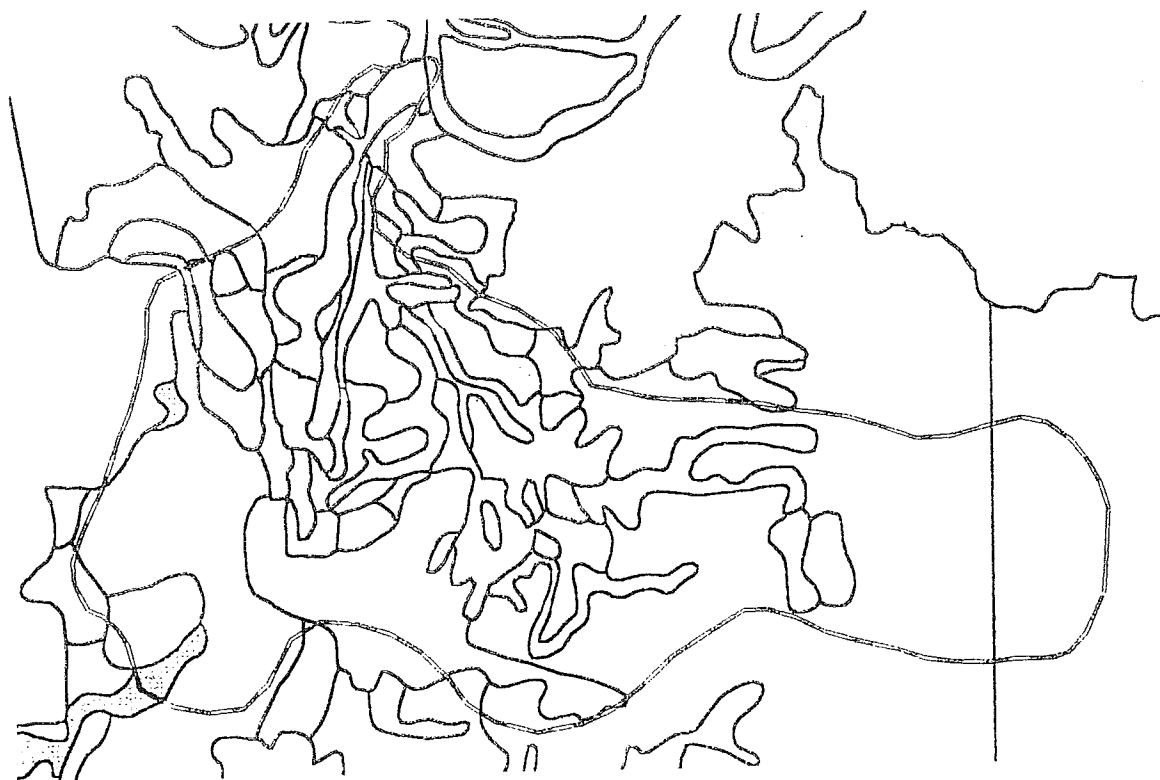
**Figure 3.4: Centennial Brook watershed - areas of highly erodible soils. These soils are easily displaced.**

Adams-Windsor sandy loams are abundant in the developed residential regions and could provide excellent sites for municipal storm drain retrofits utilizing infiltration best management practices. Few soil sites for wetpond/wetland treatment exist. The current abundance of natural ponds/wetlands provides treatment of stormwater prior to discharge to the Winooski River. Existing stormwater sediment basins also provide sites for stormwater wetpond retrofits. Highly erodible soils are common in the lower stream channel and are frequently released during storm events due to the large volume of water discharged to the stream. Stream channel enlargement is evident in the lower main channel (Figures 3.3-5).

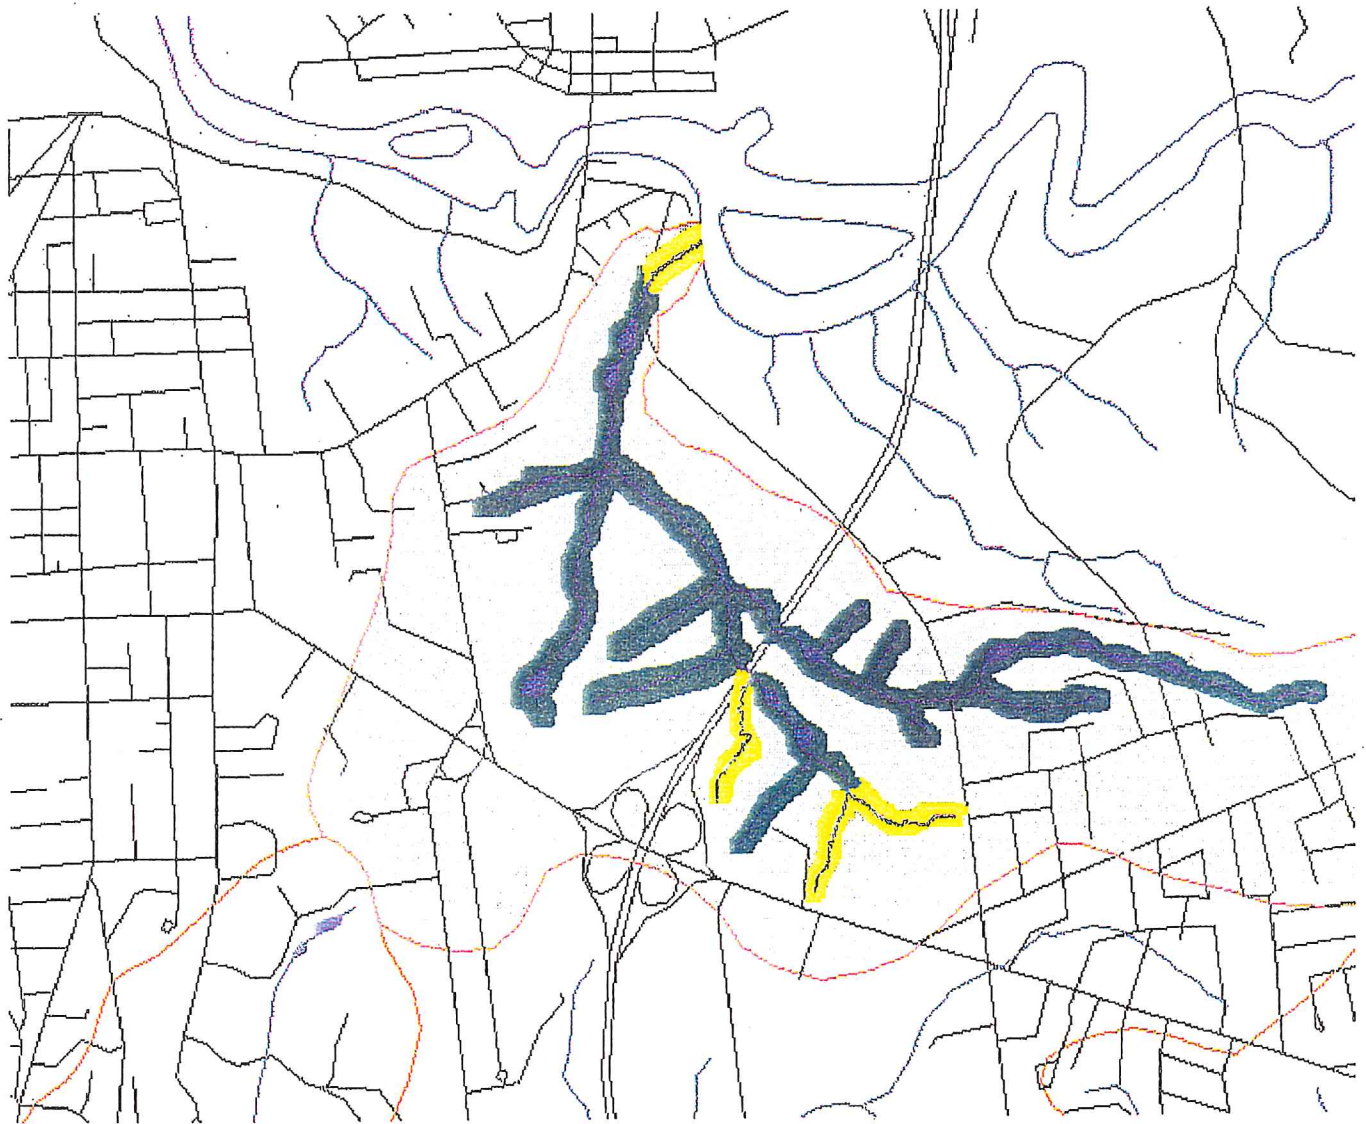
**Figure 3.5: Centennial Brook watershed - wetpond/wetland soils.**

Riparian Corridor Evaluation (RCE)  
Red=Poor, habitat structure gone  
Brown=Fair, major habitat alteration  
Yellow=Good, minor habitat alteration  
Green=Very Good, monitor for changes  
Blue=Excellent, protect existing status

**Figure 3.6: Centennial Brook Riparian Corridor Evaluation.** Evaluation was conducted using the Riparian Corridor Evaluation methodology (Petersen, 1992). A series of measurements and observations are recording while walking the stream channel.

The riparian corridor from the mouth to the headwaters is in very good shape with the exception of the southeastern tributaries adjacent to Williston Road (Figure 3.6). This good riparian habitat quality is not reflected by the macroinvertebrate biological community largely due to the scouring effects of stormwater flows. Sedimentation in this sand plain brook is severe. Stormwater scouring moves large amounts of sediment downstream. Silt deposits appear to be low probably due to the large number of manmade and natural ponds in the watershed. Fish populations appear to be in satisfactory health which is reflective of the high quality corridor habitat. Significant decreases in insect density and richness below stormwater inputs

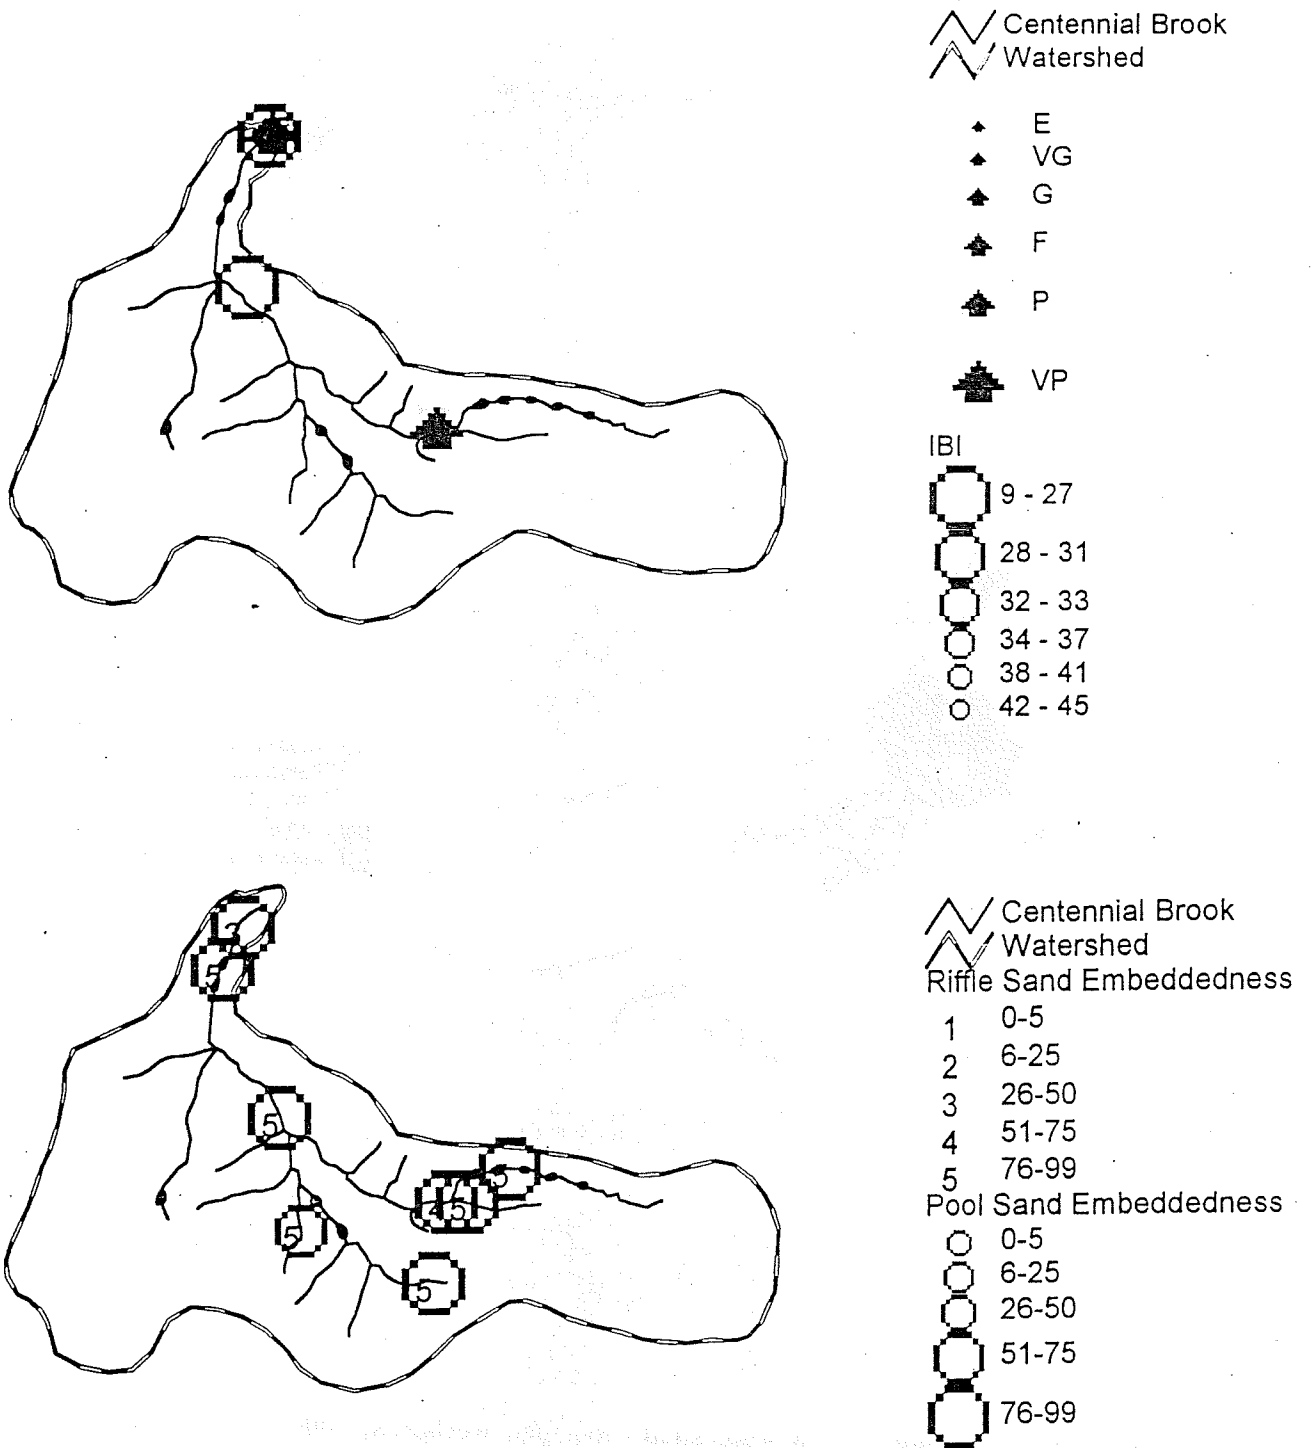
Figure 3.7: Centennial Brook watershed - biological condition. Fish and macroinvertebrate community measures of integrity. A macroinvertebrate biotic index (BD) rating of less than good is indicative of sub-Class B condition. A fish Index of Biotic Integrity (IBI) rating of less than 31 is indicative of sub-Class B condition.

Watershed measure of pool and riffle sedimentation. A high degree of sand embeddedness indicates excessive erosion and impairs aquatic habitat and the biological communities that are supported by that habitat.

indicates the degrading effects of high flows, scouring and sediment. The stream does not currently meet the Class B standard for biological integrity at the assessed sites (Figure 3.7).

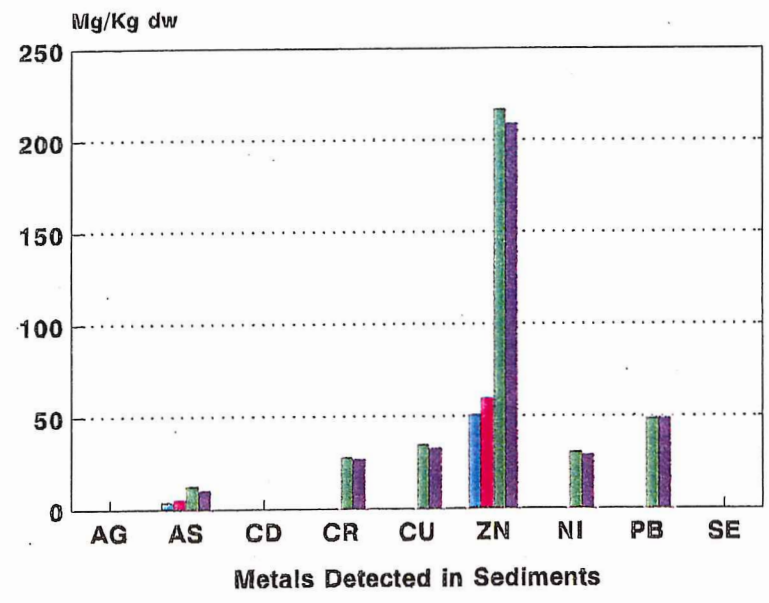
**Figure 3.13: Estimated total metals loading from sewersheds in the Centennial Brook watershed.** Graph at bottom shows concentrations of metals in whole (2mm) and fine fraction (63u) sediments at the mouth of the Centennial watershed. Samples collected in 1995.
