**Using FEMA's HAZUS-MH to Estimate the Number and Potential Location  
of  
Unreinforced Masonry Buildings (URM)  
in  
Chittenden County Vermont**

**Prepared by**

**The Northeast States Emergency Consortium  
1 West Water Street  
Suite 205  
Wakefield, MA 01880  
[www.nesec.org](http://www.nesec.org)**

**May 2018**

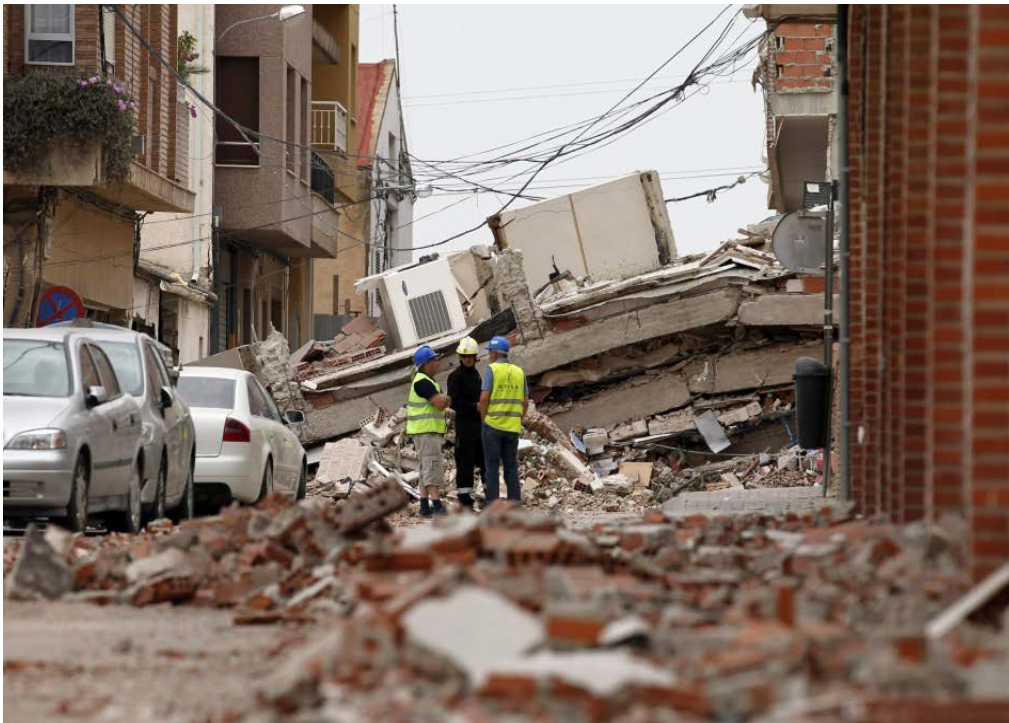
For example, the May 12, 2011 earthquakes in Lorca Spain were only magnitude 4.4 and 5.1, yet there was incredible damage to URM buildings, significant injuries, and 10 deaths (See Figure 1).

**Figure 1. Damage to URM buildings Following the 2011 Lorca Earthquake in Spain**

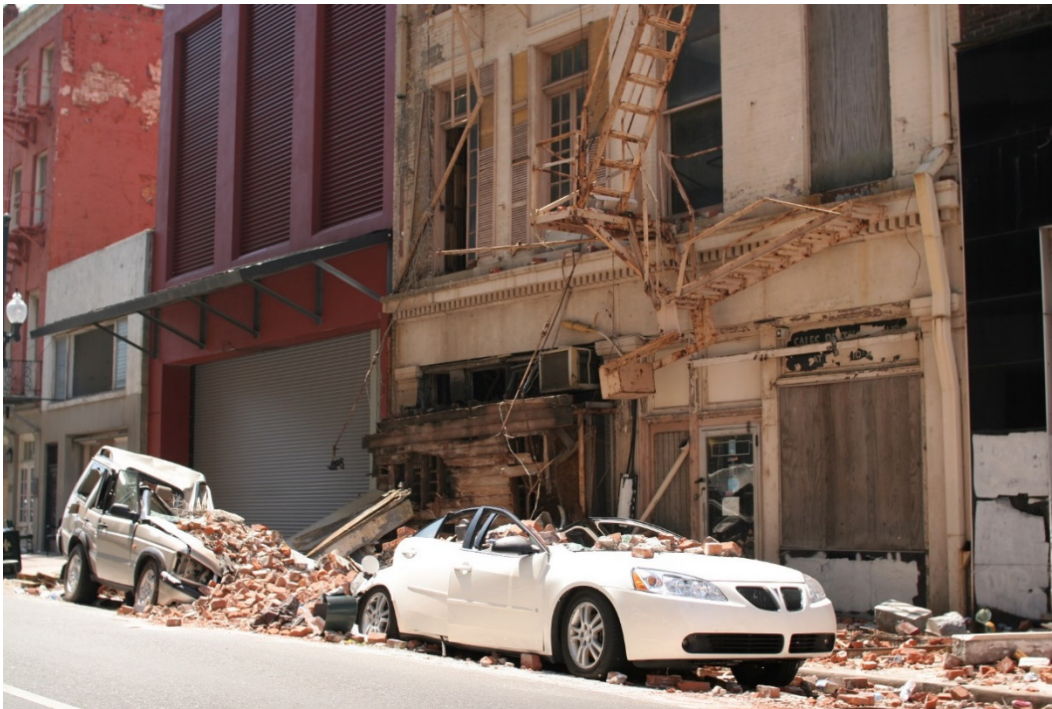
For example, in New Orleans, winds from Hurricane Katrina caused significant damage and destruction to URM buildings (See Figure 2).

**Figure 2. URM Building Damage New Orleans, LA Hurricane Katrina 2005**

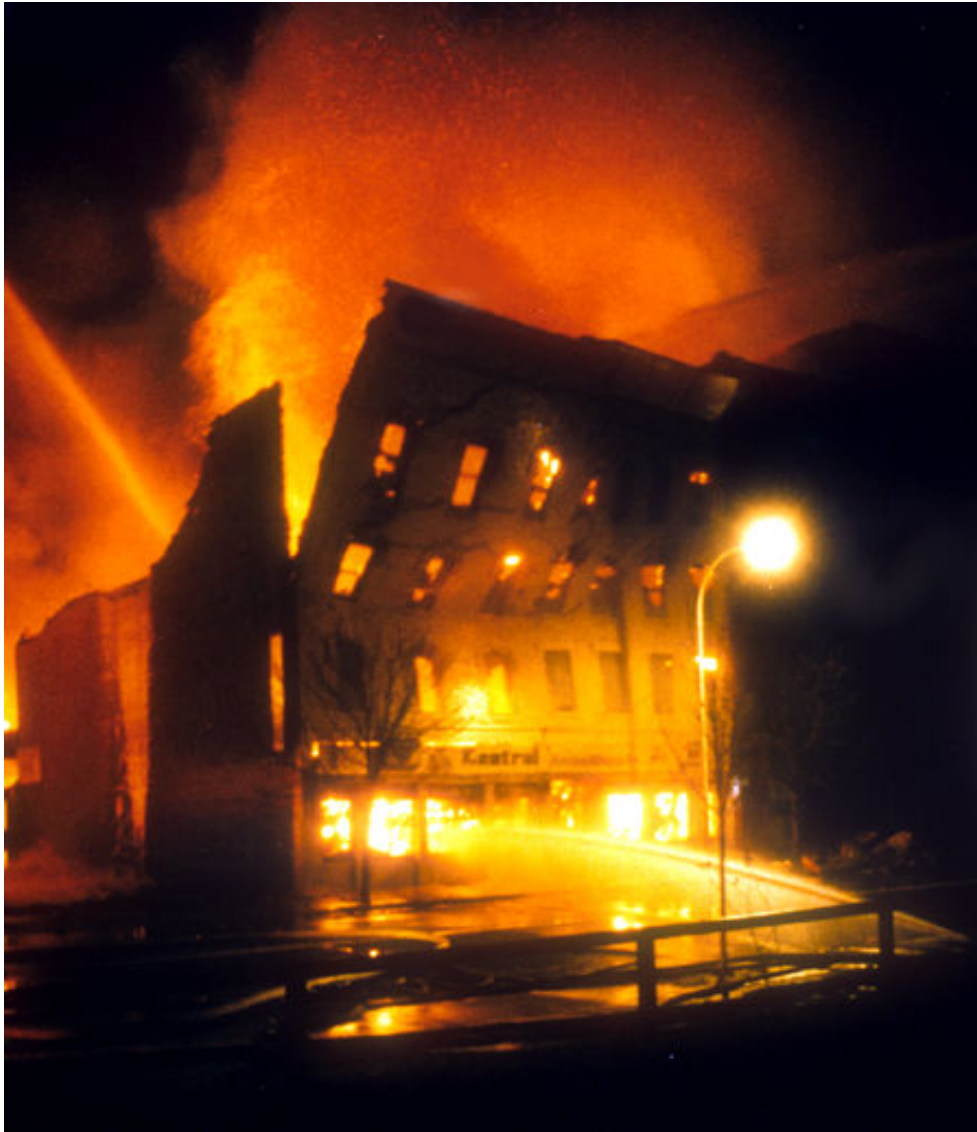
Fires following earthquakes are quite common and can also significantly affect URM buildings. Collapse of URM buildings is more likely during a fire and is normally outward at a distance greater than the height of the exterior wall.<sup>4</sup> (See Figure 3)

**Figure 3. Fire Causing Collapse of a URM Building**

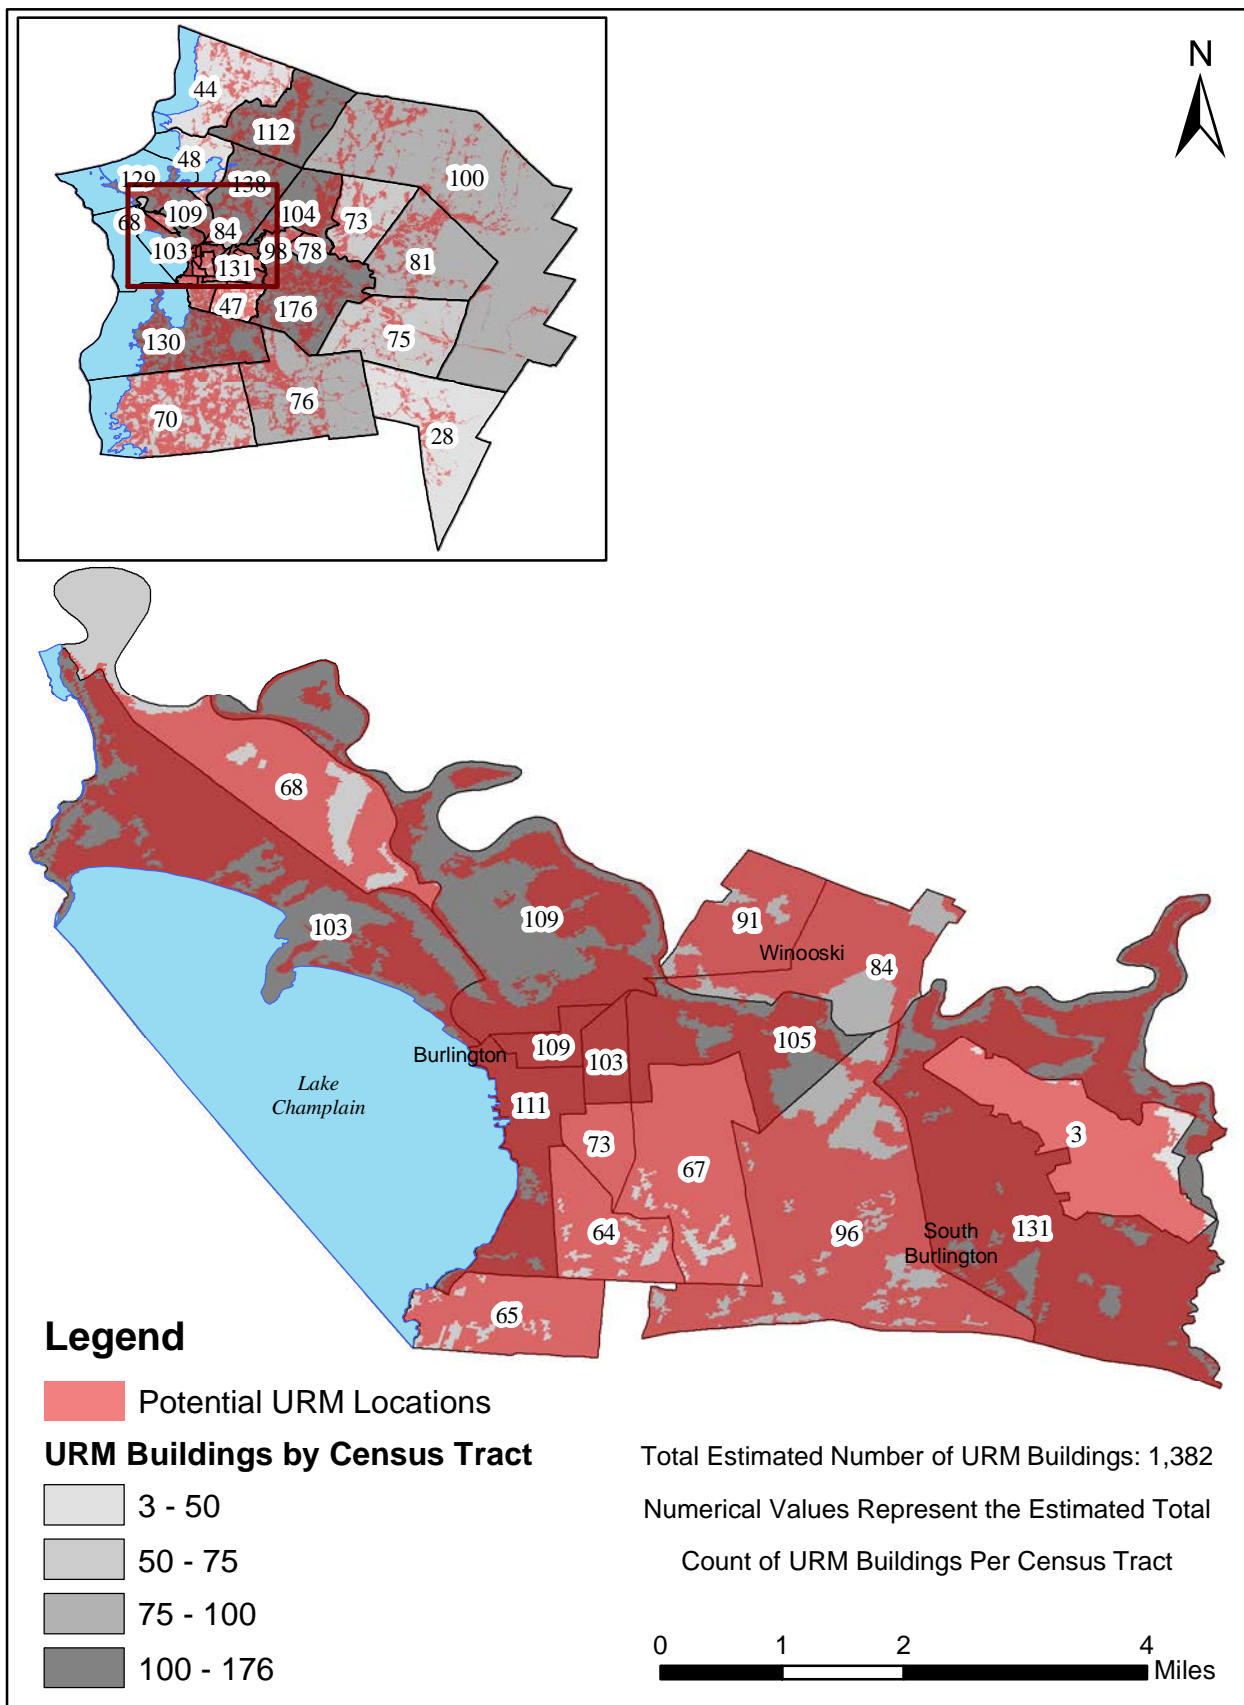
# Estimated Number of Unreinforced Masonry Buildings (URM) by Census Tract and Potential Locations by Most Densely Populated Areas in Chittenden County, Vermont

Map 3 overlays potential URM locations in red on the estimated number of URM buildings by the census tract layer and city/town. Shades of gray are used to estimate the total number of URM buildings. The red overlay indicates the likely areas where URM buildings are located. The size of the census tract does not directly influence the number and location of URM buildings because census tracts are defined by total population and are intended to be roughly the same size based on population, not land area. While not true in all cases, small census tract are typically part of a more densely populated area. This is important to note for this project because more urbanized areas hold the greatest chance for containing multiple URM buildings. For this reason, an inset map of the most densely populated areas is included as Map 4.
