Smugglers Notch Slope Instability Report

Vermont Geological Survey Technical Report VGTR2009-1

June 4, 2009

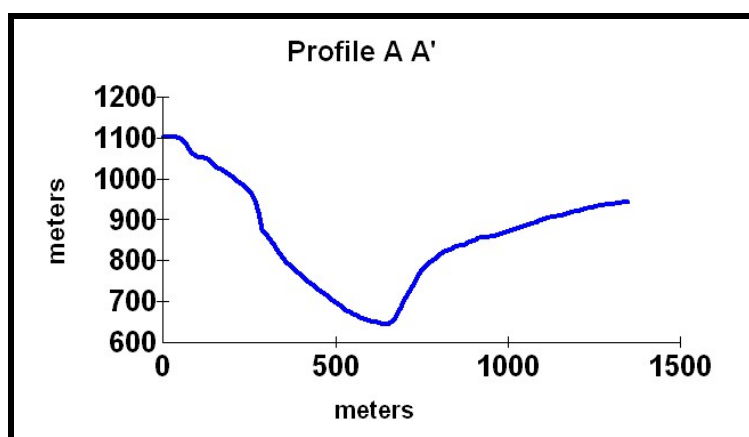
Figure 4.2. Topographic profile A-A' across the Notch. See Figure 4.1 for location. Note that the west side is substantially higher than the east side.

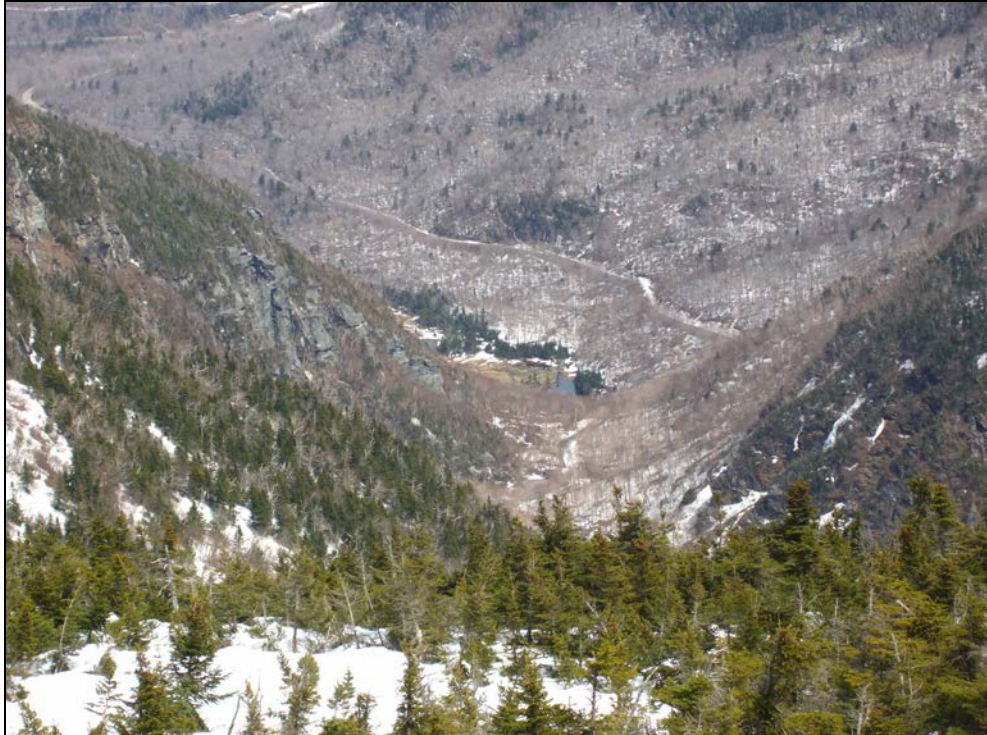
Figure 4.5. The Notch as seen looking north from Mount Mansfield, from north of The Nose.

Looking northeastward from The Nose on Mount Mansfield, Figure 4.5 clearly shows the rugged character of the Notch. Rocky cliffs rise abruptly several hundred feet above a valley bottom of talus. This view shows the northern “arm” of the Notch, which trends northeasterly from near the height of land in the Notch.

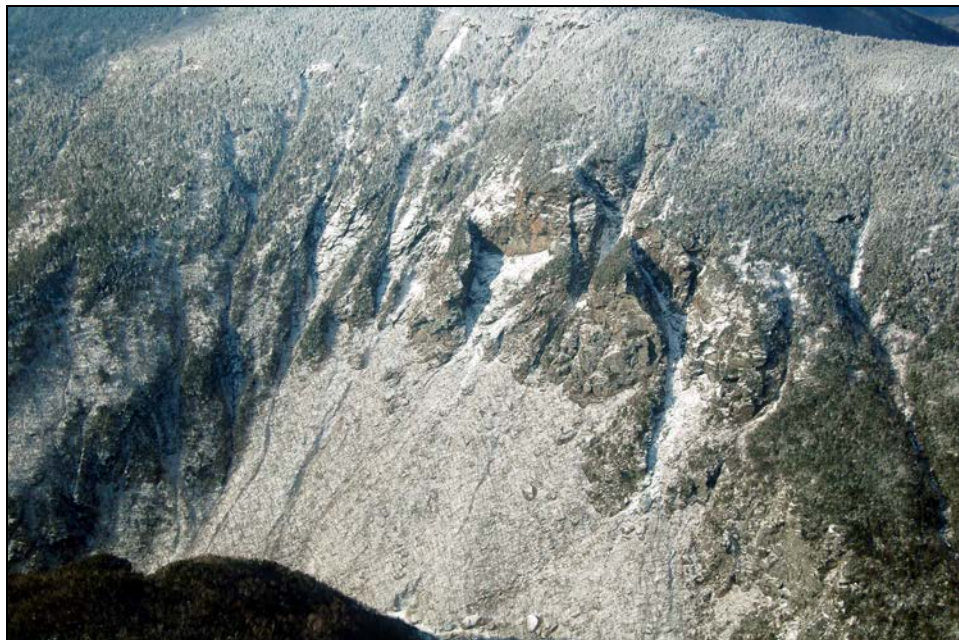
Figure 4.6. Aerial view of the west cliffs showing talus apron and debris flow tracks. Figure 4.10 shows the left (southern) portion in greater detail. Photograph taken on November 9, 2007 by Tom Eliassen, Vermont Agency of Transportation.

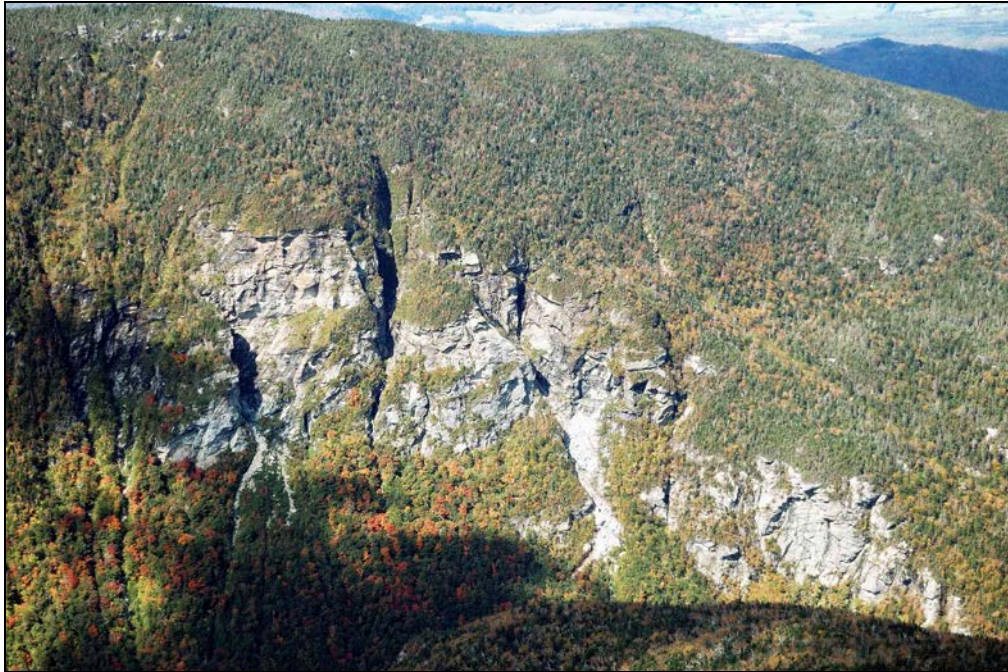
Figure 4.7. Aerial view of west cliffs. From left to right: Cass's Gully, Hidden Gully, Easy Gully (with prominent slide scar) and cliffs above main parking lot. Photograph taken in November, 2006 by Tom Eliassen, Vermont Agency of Transportation.

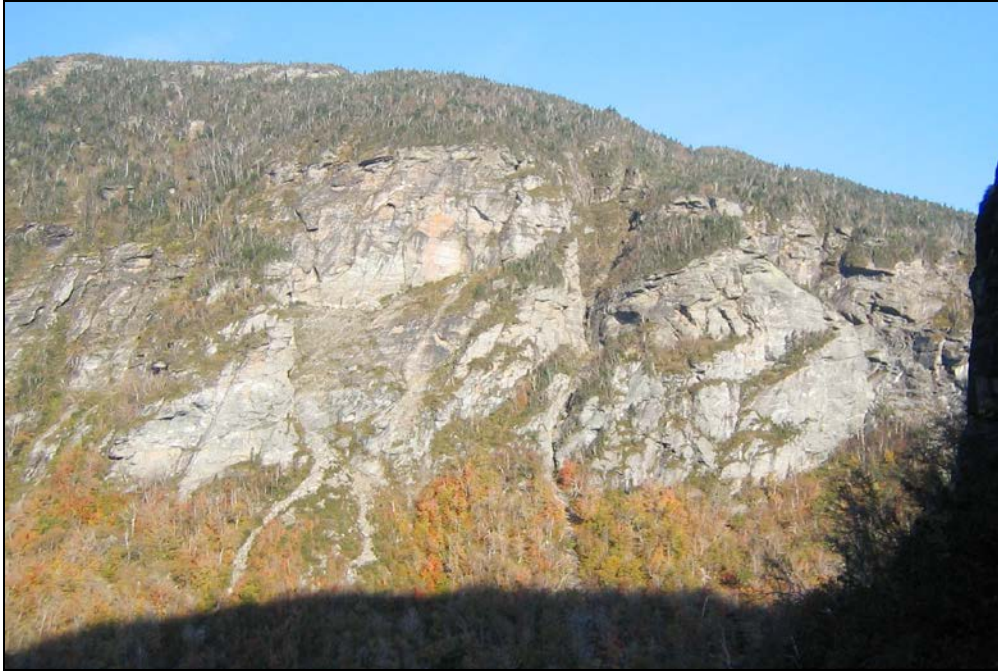
Figure 4.8. Cass's Gully and Hidden Gully sections of west cliffs. Photo from Elephant's Head Gully on September 15, 2006. Photo courtesy of Marc Couper, Stowe Mountain Rescue Service.

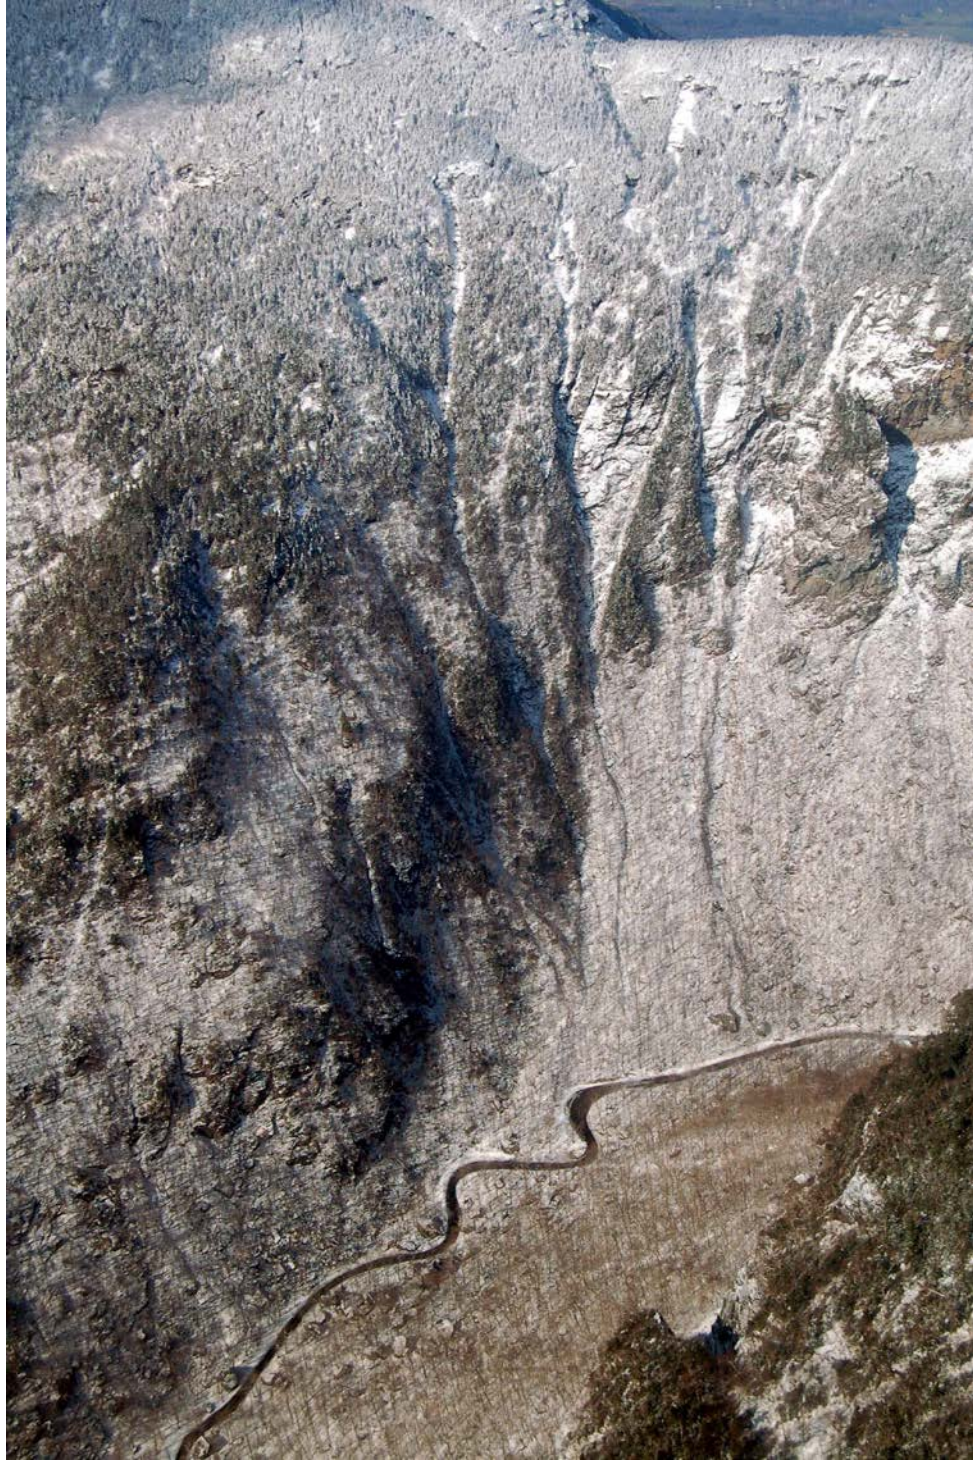
Figure 4.9. Aerial view of the western cliffs and debris flow tracks south of Cass's Gully. Note that the rock chutes that feed some of the tracks extend up above the main cliffs almost up to the ridgeline. Photograph taken on November 9, 2007 by Tom Eliassen, Vermont Agency of Transportation.

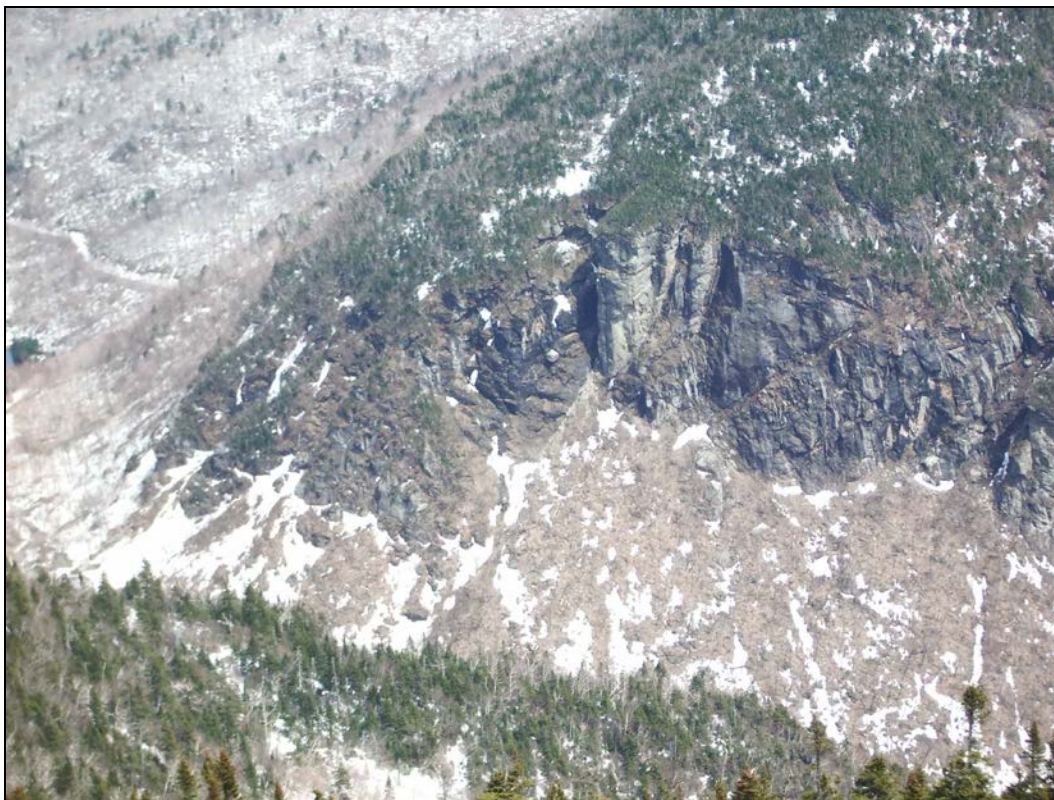
The cliffs of the eastern side of the Notch are shown in Figure 4.11, which was taken from The Nose. At left are the broken cliffs southeast of the parking area. In the center is the dark gash of the Elephants Head Gully and the Head itself to the right of the Gully. High cliffs continue to the right edge of the frame. As on the west side, note the apron of talus at the base of the high cliffs. Field work and aerial photo interpretation indicate that debris flow activity is more limited on the east side than on the west, although a large cone of debris flow material emanates from the Elephants Head Gully area. Although debris flows may be more limited on the east side, the largest single debris flow event at the Notch came down from the eastern cliffs on May 22, 1986, blocking Rt. 108 and the West Branch of the Little River near the Stowe-Cambridge town line. This was part of a set of 12 or more events that occurred following heavy rains. See Chapter 7 and Table 7.1.

Figure 4.11. The Elephant's Head butte and the eastern cliffs as viewed from Mount Mansfield, north of The Nose, April 26, 2007.

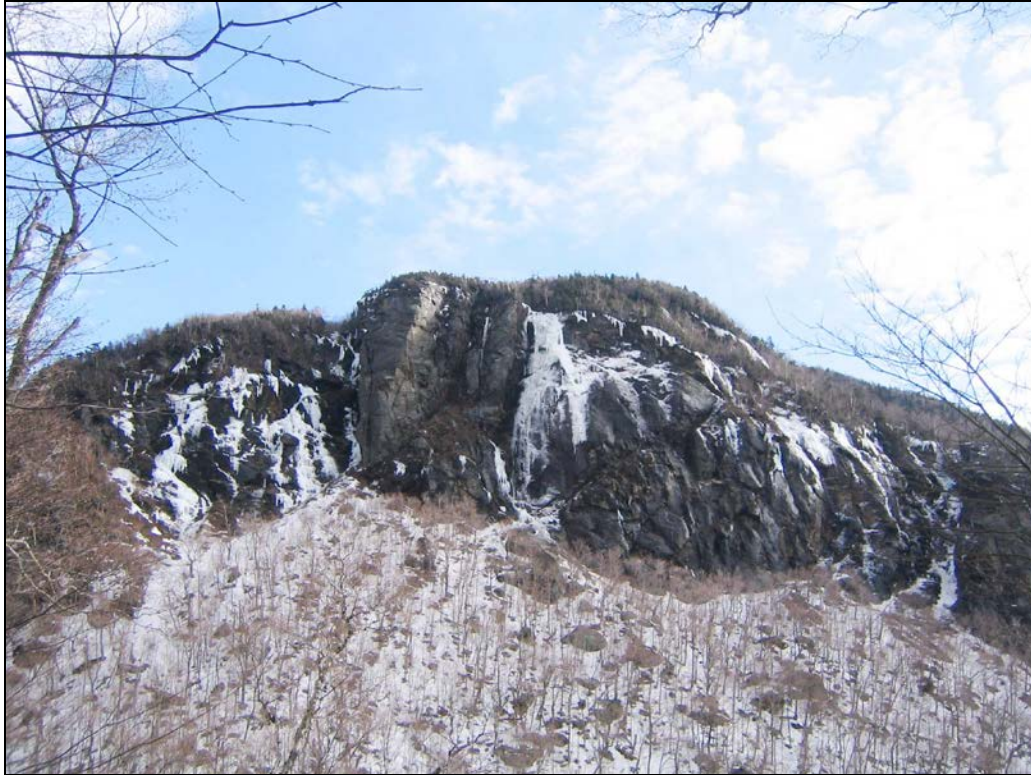
Figure 4.12. Elephant's Head buttress to left of center with talus apron below. January 20, 2006. Photo courtesy of Marc Couper, Stowe Mountain Rescue Service.

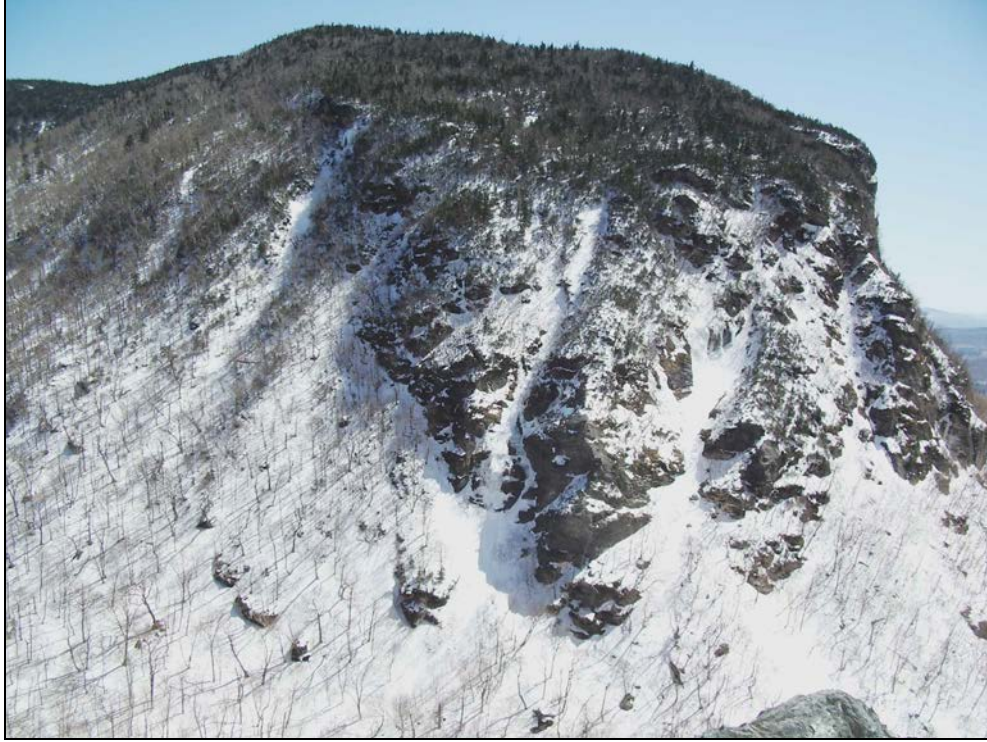
Figure 4.13 shows the northern parts of the eastern cliffs, above and south of the main parking lot. This was taken from Easy Gully at the base of the cliffs. Note the prominent rock chutes trending down and to the left. These, like chutes throughout the Notch, are formed by erosion along fractures in the bedrock. The chutes shown in the figure appear to concentrate together any rocks falling from the cliffs above them. Tim Wilson of the Agency of Transportation reports that a boulder originating on the north part of these cliffs reached the road south of the main parking lot (personal communication, January, 2008.) The rock chutes in the foreground also serve to concentrate snow avalanches.

Figure 4.13. Northern end of the cliffs on the east side of the Notch. Photo taken from Easy Gully photo point in April, 2007.

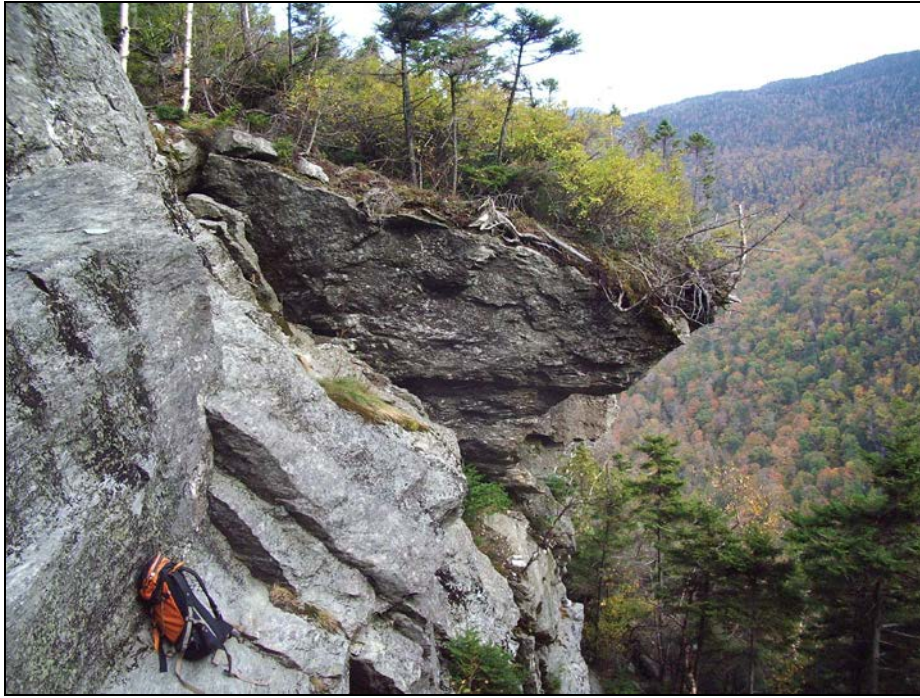
Figure 5.2. Overhang on cliffs on west side. Knapsack for scale. Overhangs are common on both sides of the Notch. This particular one may eventually fail by sliding or toppling due to an open joint in the left-hand side. Other overhangs serve as source areas for falls. Photo 3534a, 10/2/2007.

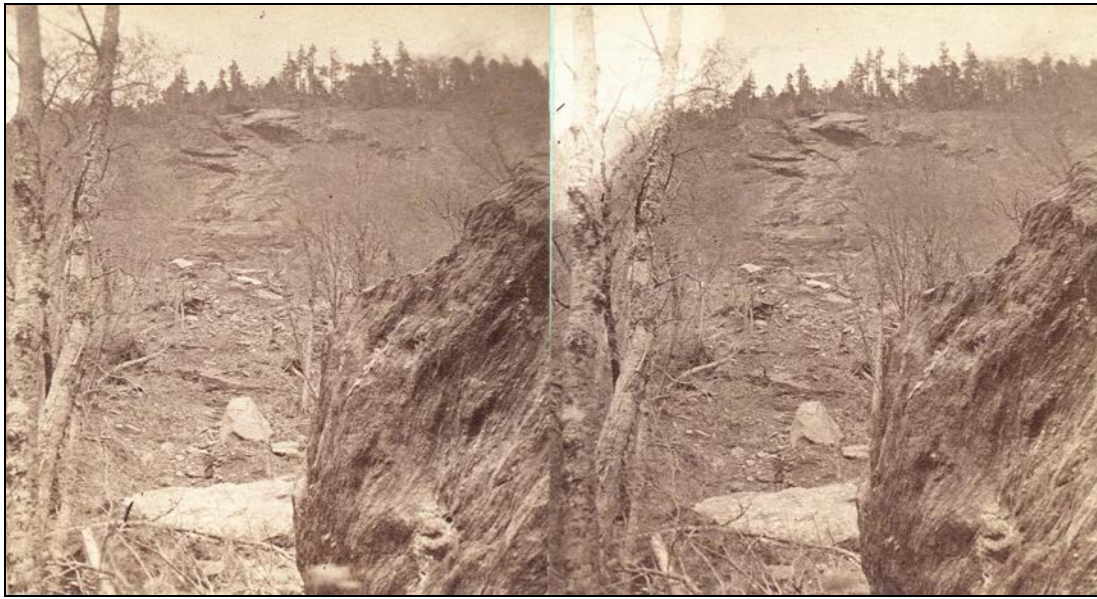
Figure 7.2. Stereoview of a rock fall path in Smugglers Notch taken in 1873. This is probably the path taken by the October, 1868 rock fall, although the author was unable to match this view with any of the Smugglers Notch cliffs. Note the figure of a man visible just above the light-colored boulder in the middle-distance. Image courtesy of Vermont Historical Society.

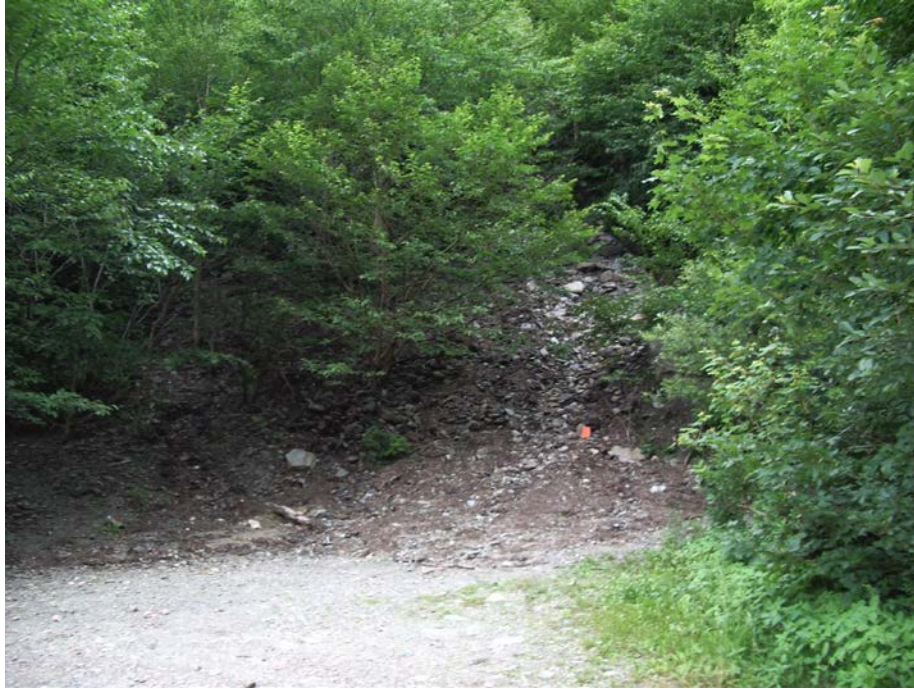
Figure 7.7. Looking west at base of Hidden Gully on the west side of Rt. 108 at the debris fan formed by the recent debris flow. Orange field book on fan for scale. Debris is removed by VAOT after each flow. July, 2006.

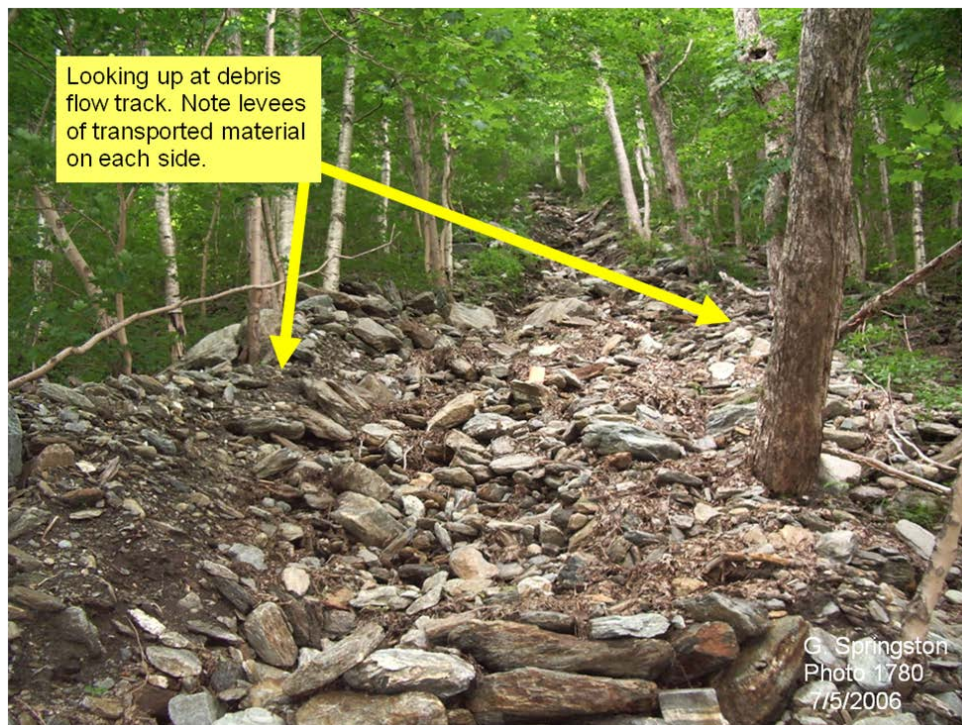
Figure 7.8. Looking up the recently active Hidden Gully debris flow path. Note levees of coarse debris on both sides. July, 2006.

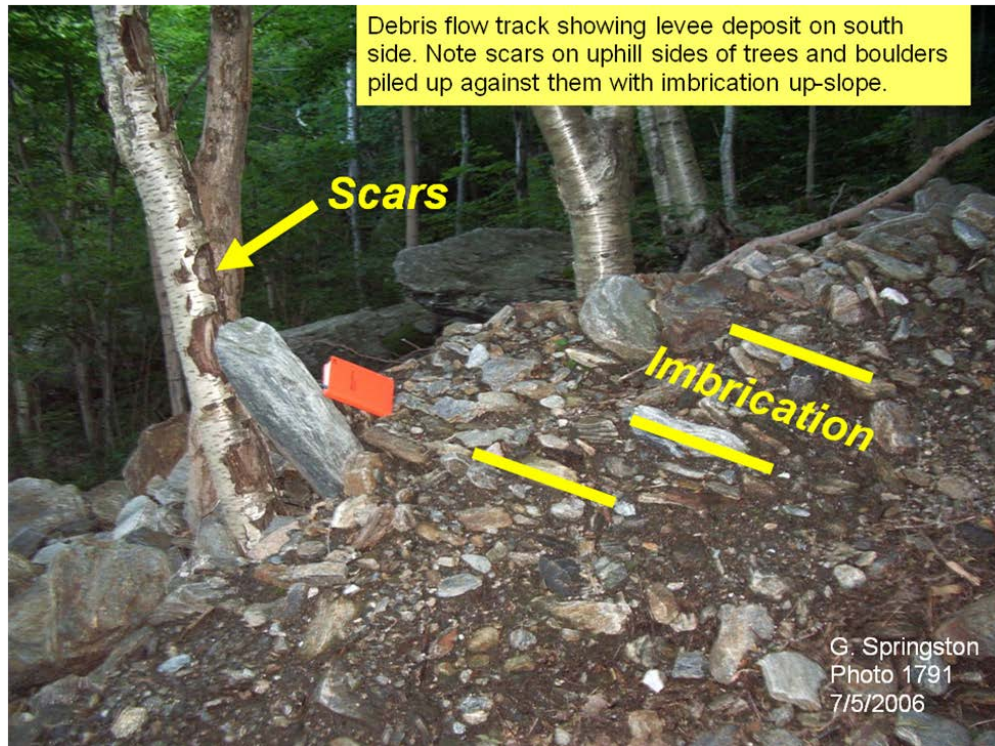
Figure 7.9. Debris flow track showing levee deposit on south side. Orange field book for scale. Note scars on uphill sides of trees and boulders piled up against them with imbrication up-slope.

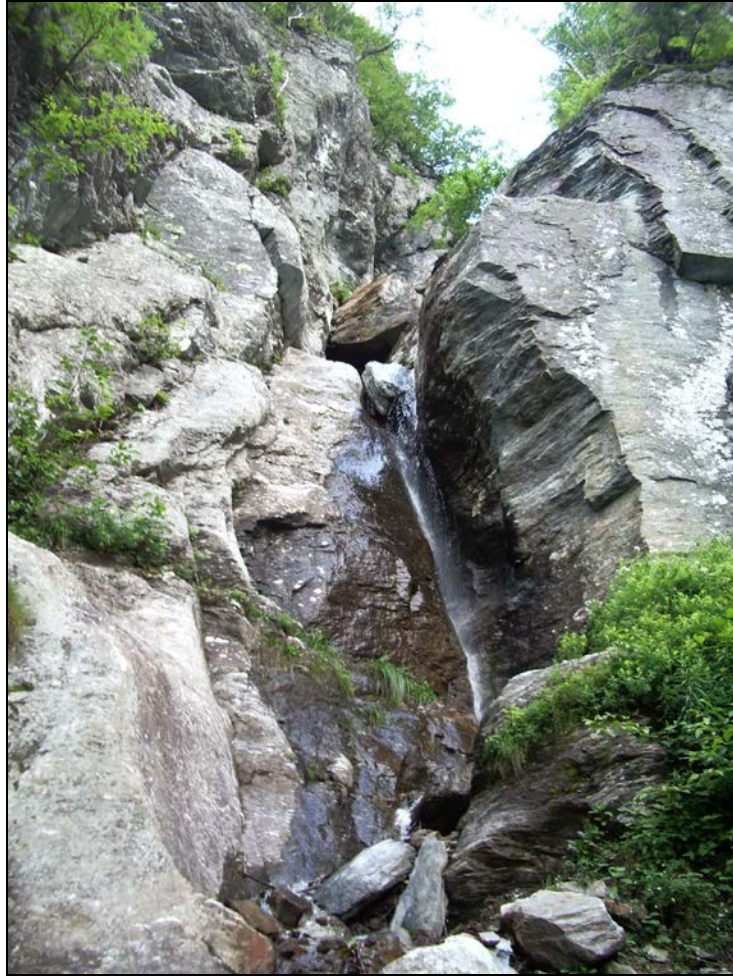
Figure 7.10. Bedrock cascade above talus/debris flow deposits. Lower end of rock chute that feeds the Hidden Gully debris flow. There was no indication that debris had originated up on this bedrock section. Instead, it appears to have been remobilized from the talus and debris flow deposits below this section. July, 2006.

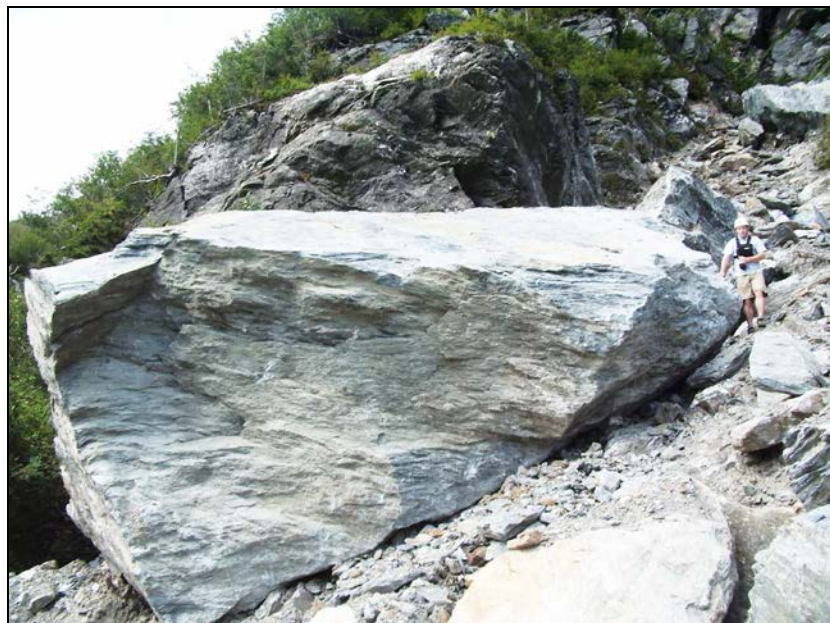
Figure 7.11. Block that fell from cliff in early August, 2006. Climber at right for scale. Photo taken August 18, 2006.

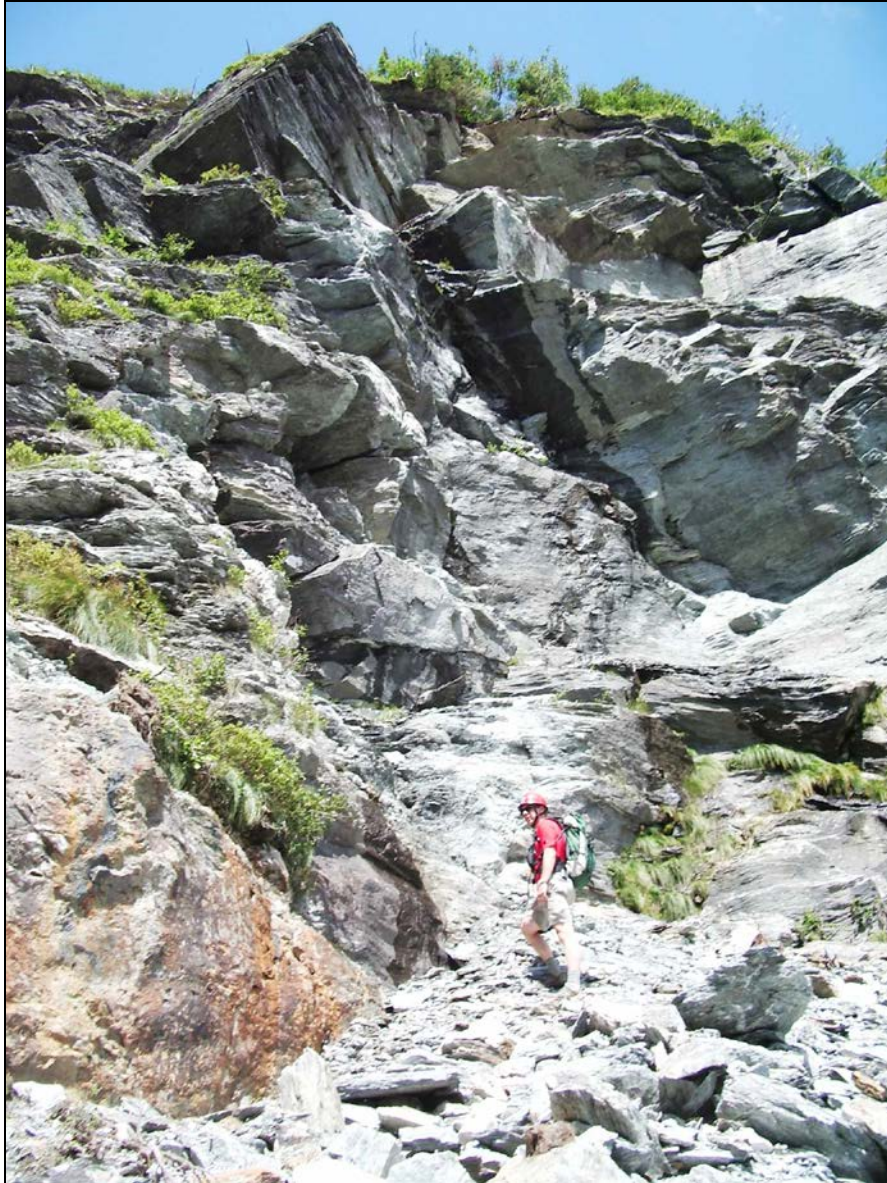
Figure 7.12. Looking northwest at overhanging ledges to north of Easy Gully. Source area for rock fall.

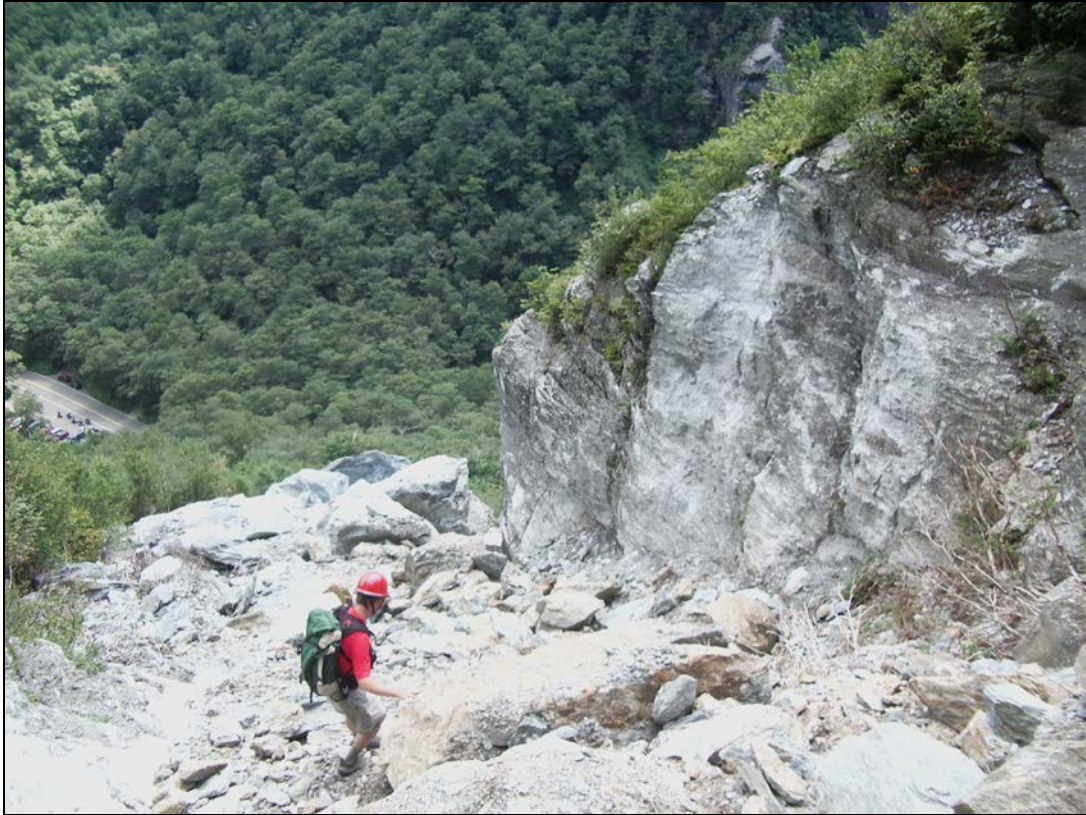
Figure 7.13. Easy Gully, August 18, 2006. White powdered rock on south wall of Easy Gully where falling rock impacted before coming to rest in background (above head of climber.)

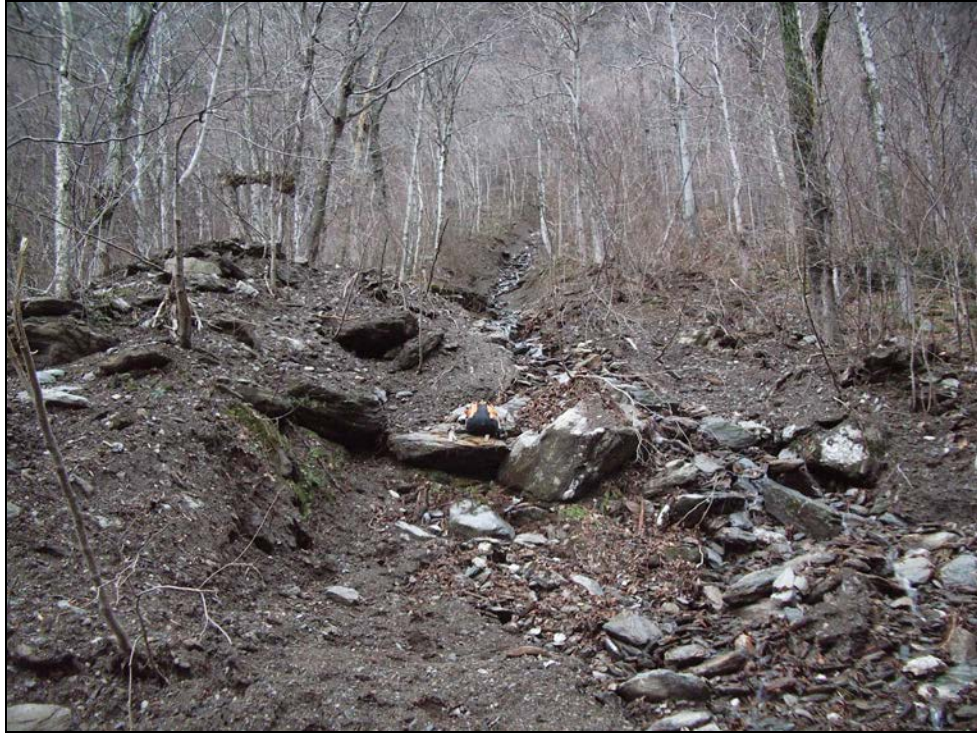
Figure 7.14. Looking up the track of the November, 2006 debris flow described above. Orange and black pack for scale. Photo taken from the terminal lobe of the deposit shown in Figure 7.16.

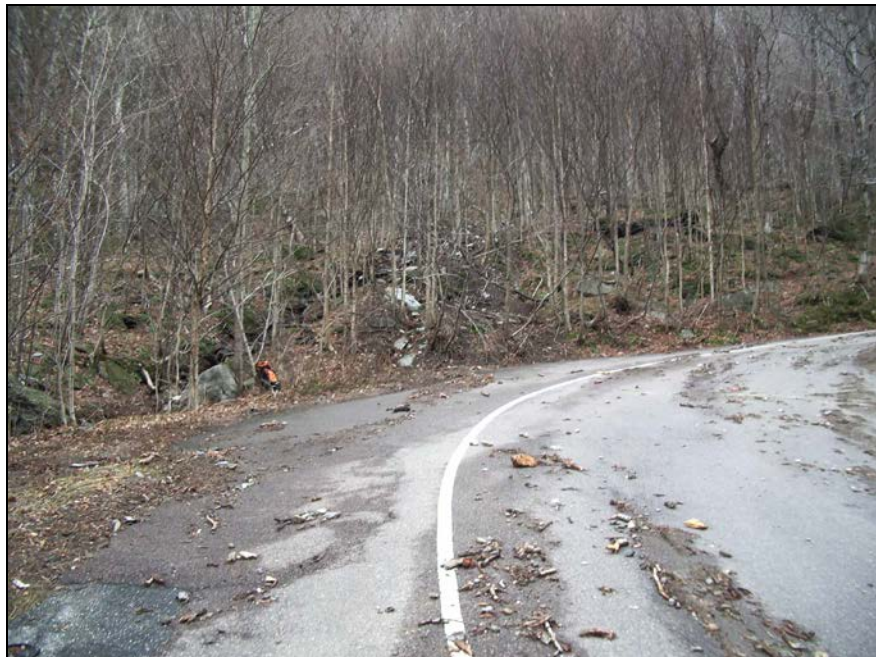
Figure 7.15. Debris flow that reached Vermont Rt. 108 at “S” turns. This slope failure occurred during a rain and snowmelt event of November 14 or 15, 2006. Snout of debris flow in center background.

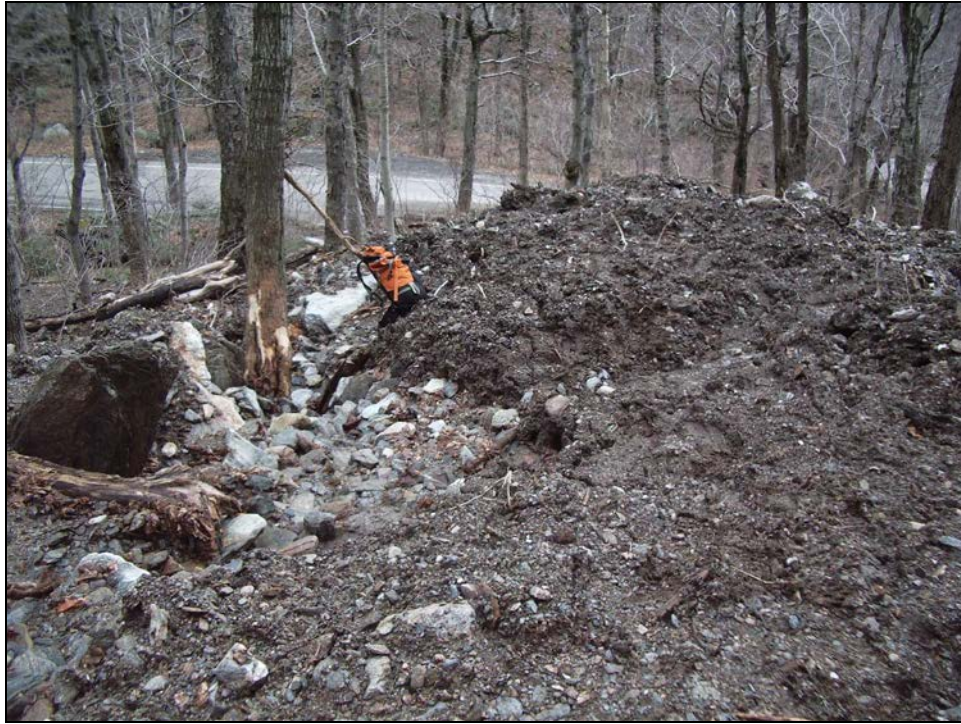
Figure 7.16. Looking downhill at the terminal lobe or snout of the November, 2006 debris flow. Orange and black pack for scale. Note scour on tree at left and Vermont Rt. 108 in background.

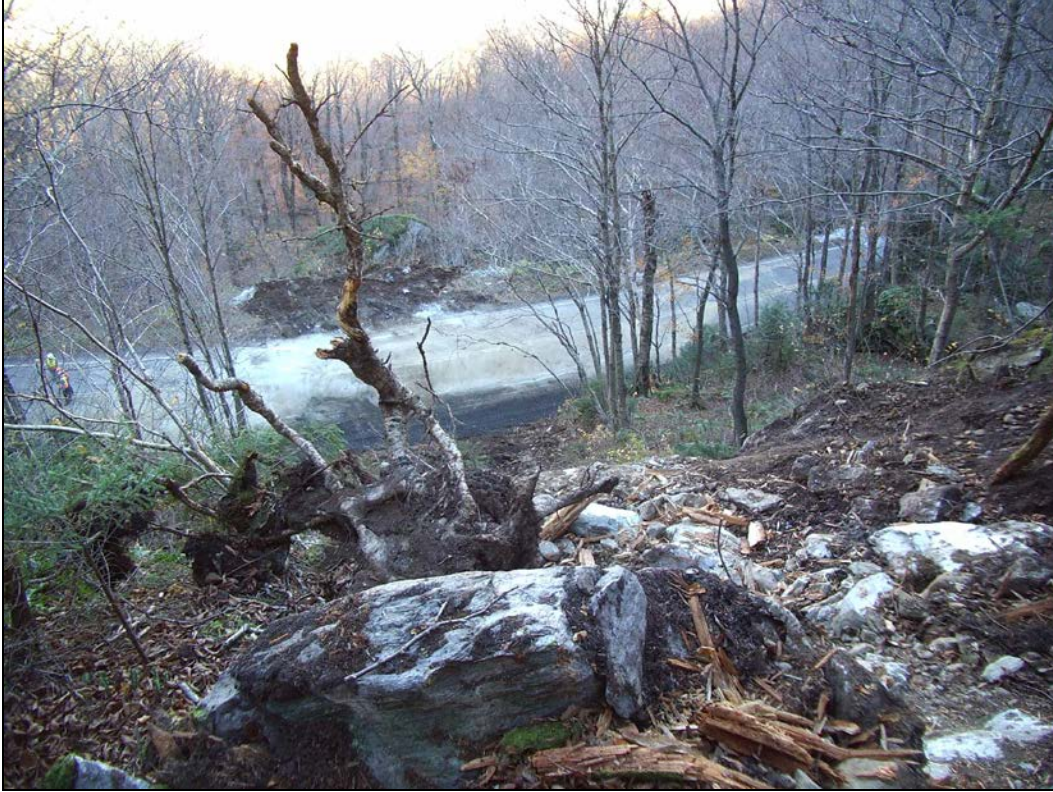
Figure. 7.18. Looking down the path of the October 21, 2007 rock slide. Although much of the fallen material was trucked away, some was pushed over the far side of the road.

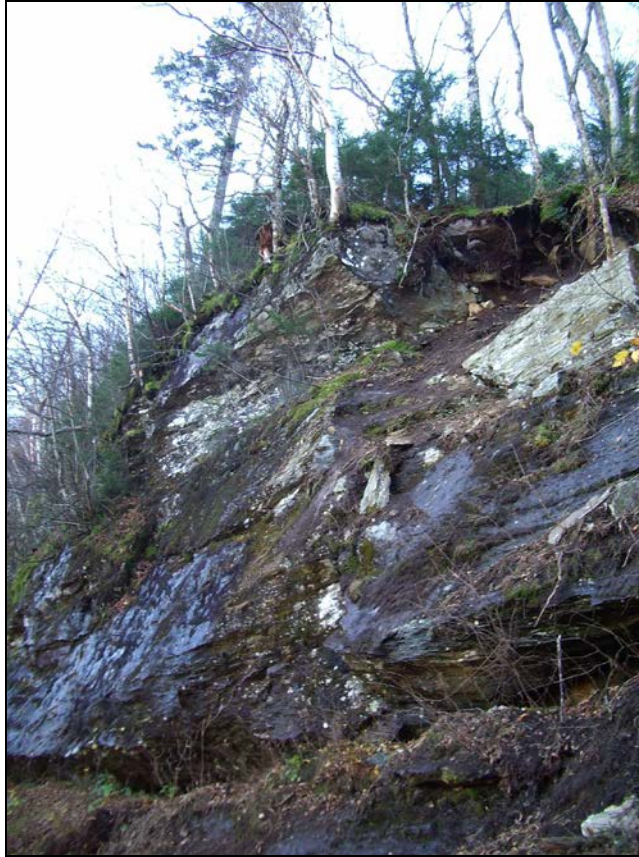
Figure 7.19. Source area for October 21, 2007 rock slide. This is part of a long set of ledges containing abundant loose material. Future falls and slides from this area onto Vt. Rt. 108 are to be anticipated.

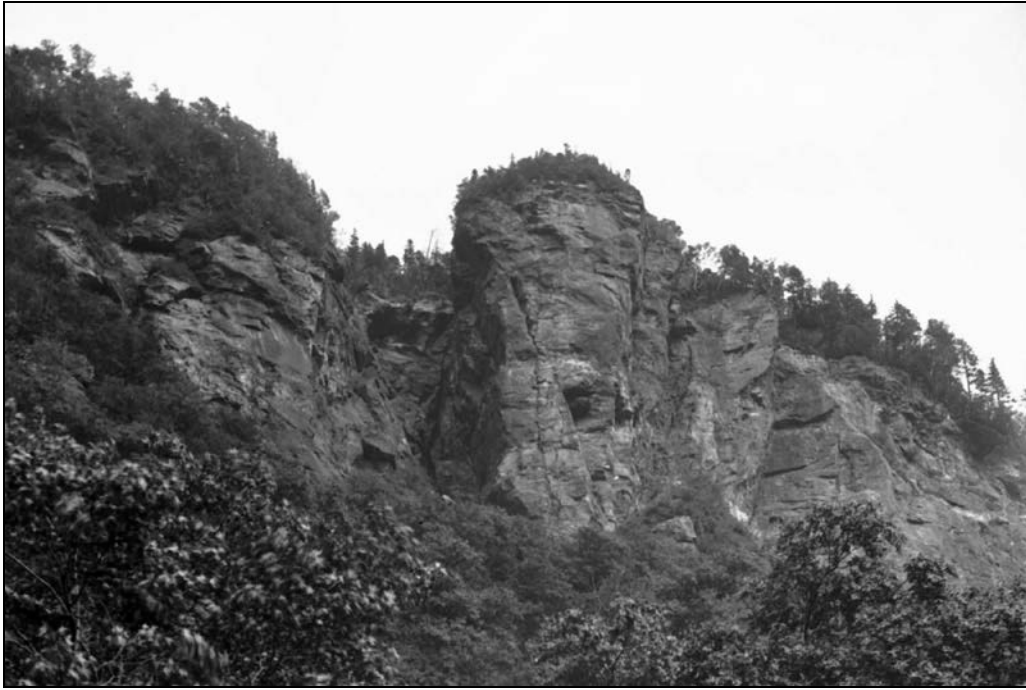
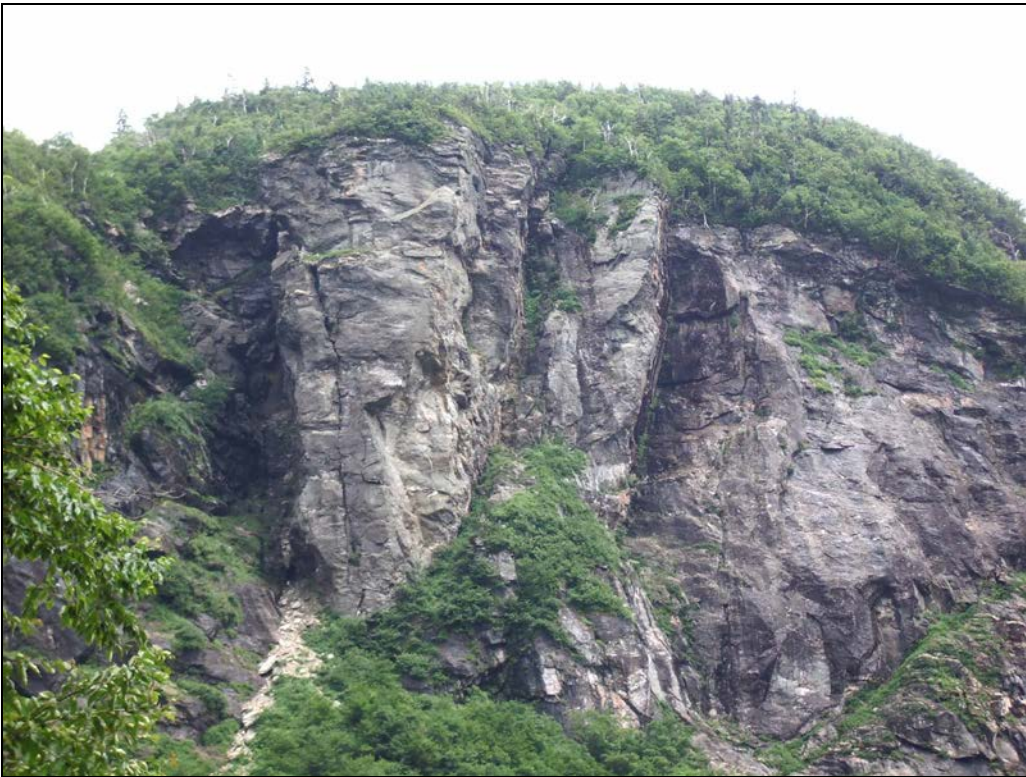
Figure 7.20. Elephant's Head in 1921 and in 2007. A.) 1921. Landscape Change Program Image LS06988. Courtesy of the Vermont State Archives. B.) July, 2007.

As part of this study, historic photos were compared to modern ones taken from similar locations. As an example, Figure 7.20 compares a photo taken in 1921 with one taken in 2007. The only substantial change that is visible is on the lower right-hand side of the Elephant's Head buttress, where a block fell in the spring of 1964 (Table 7.1.) Additional comparisons should be undertaken with some of the other historic photos, such as Figure 7.21, which provides a good view of the west cliffs.

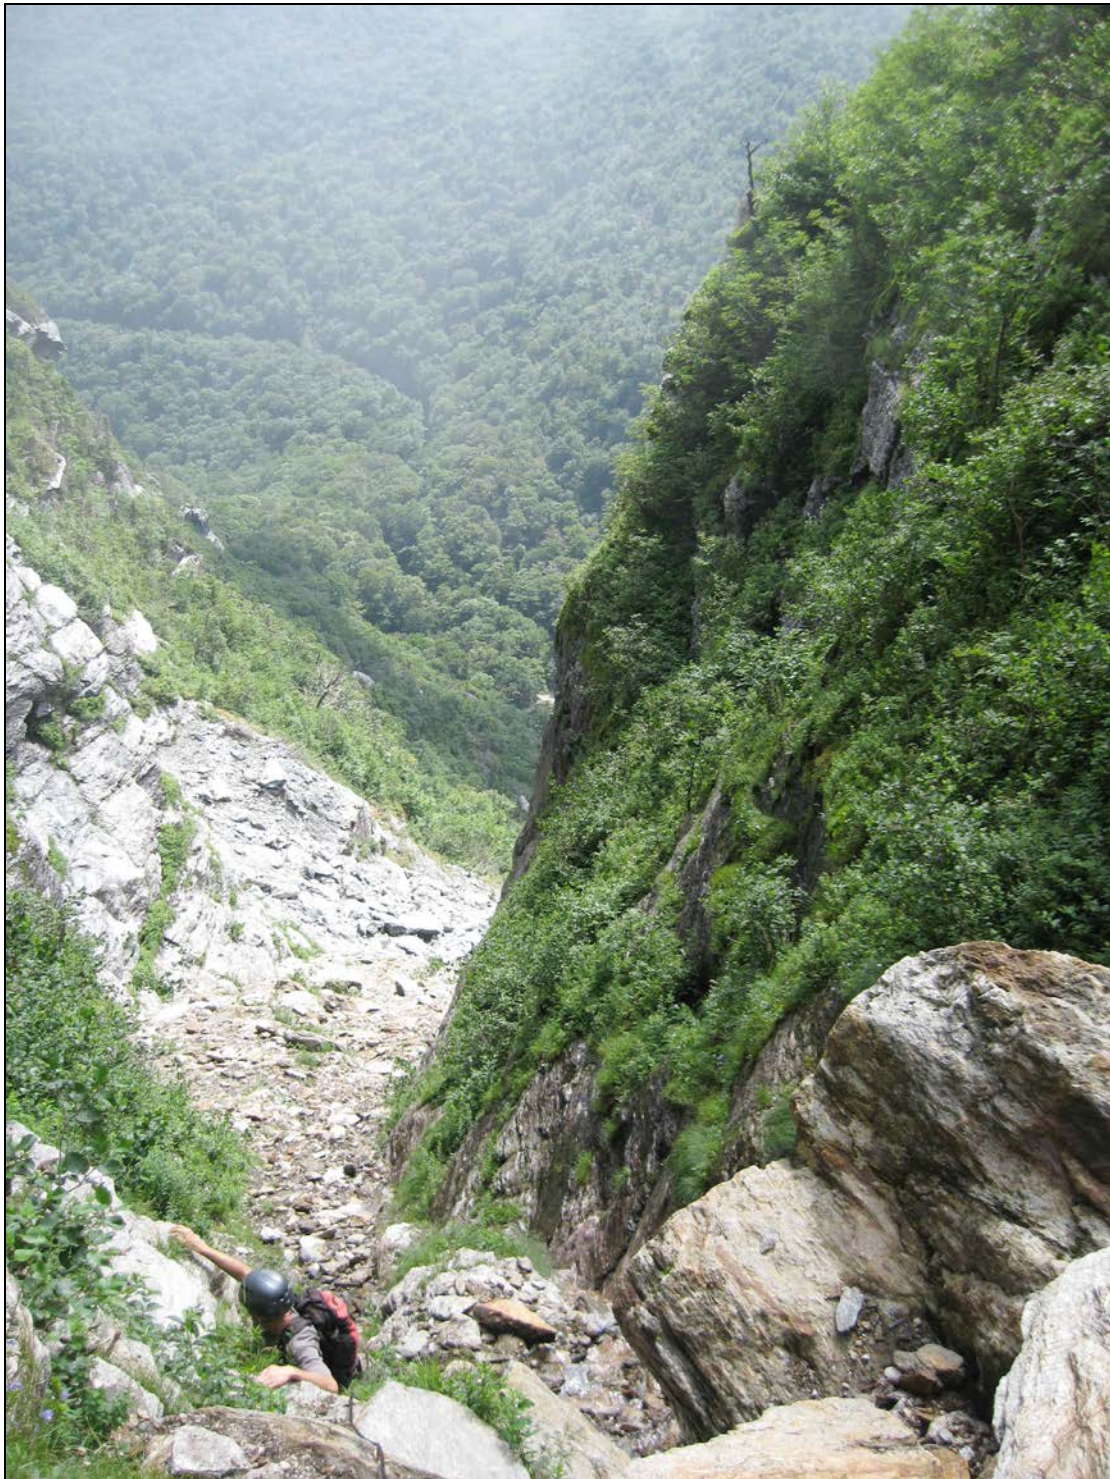
Figure 9.11. Looking down Easy Gully in July, 2007. Note abundant debris in center of gully and heavy vegetation on cliffs. This material ultimately feeds down onto the Easy Gully debris flow cone. Photo by Marc Couper, Stowe Mountain Rescue Service.
