Referral of a Petroleum Site

RE: St. Albans Exxon Facility, Piping Replacement Inspection, St. Albans, Vermont.

On November 14, 2001, I conducted a piping replacement inspection at the above-stated facility. On this date product piping associated with three gasoline underground storage tanks (USTs) and one diesel UST were disconnected from their respective USTs and removed from the excavation for proper disposal. No USTs were removed from the excavation. Enclosed are site photographs, the completed State of Vermont inspection forms, and a site location map.

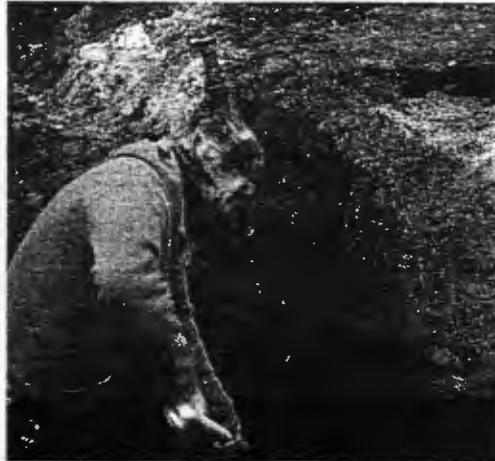
Stained soils were observed at the base of the former location of the diesel dispenser. The screened soil sample at this location had a VOC concentration of over 100 ppm as measured with the PID. Significant levels were also observed at the base of the former gasoline dispensers.

Figure 3. This photograph shows the location of the diesel dispenser. Grey, contaminated soils were observed from surface grade to the base of the excavation.

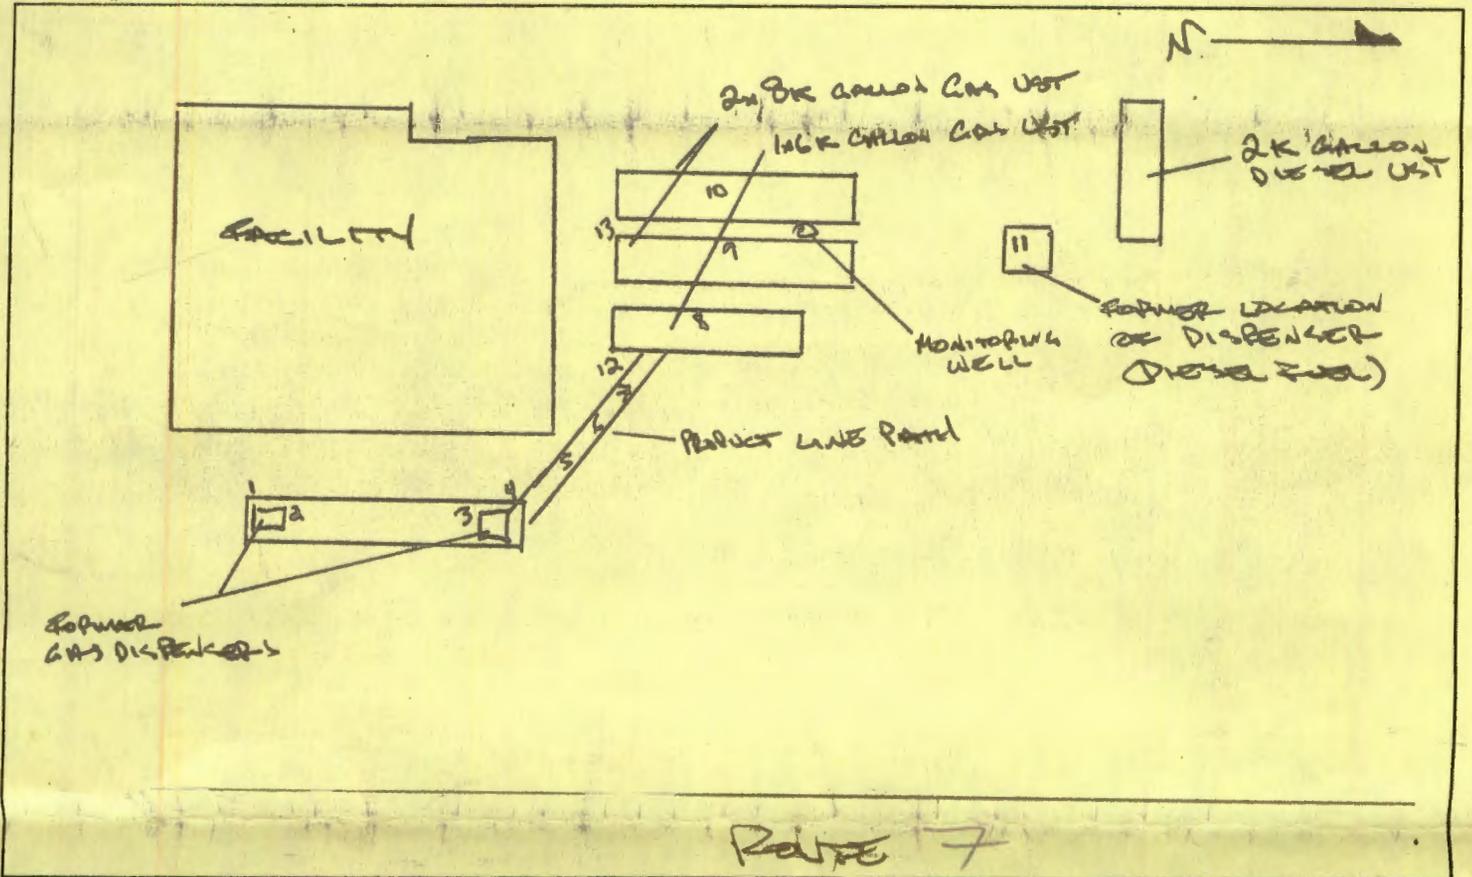
Site diagram

A total of thirteen soil samples were collected from the piping excavation with the use of a backhoe and shovel. Samples were screened for volatile organic carbons (VOCs) with an H-Nu model PI-101 photoionization device (PID). An average reading of 45.9 ppm was recorded for all thirteen of the samples screened. All soil samples were collected and screened in accordance with Griffin soil sampling protocols, which comply with state and industry standards. The PID was properly calibrated in accordance with Griffin and manufacture protocols prior to use. The location, depth, and VOC concentration for each sample are tabulated below (See Site Diagram).

Sample #	Depth (ft)	Location	P.I.D. (ppm)
1	1.0	S. Dispenser	158
2	1.0	S. Dispenser	6.8
3	1.0	N. Dispenser	170
4	1.0	N. Dispenser	128
5	3.0	Product Lines	2.2
6	3.0	Product Lines	3.0
7	3.0	Product Lines	0.7
8	1.0	Above UST/P.L.	5.2
9	1.0	Above UST/P.L.	0.1
10	1.0	Above UST/P.L.	0.0
11	6.0	Beneath Dies. Disp.	122
12	3.0	Product Lines	0.9
13	3.0	Product Lines	0.3
