RE: *Initial Site Investigation*  
*Ten Acres Lodge, Stowe, Vermont - (SMS site # 2004-3263)*

**Initial Site Investigation Report**

**Ten Acres Lodge  
14 Barrows Road  
Stowe, Vermont 05672**

**SMS Site #: 2004-3263**

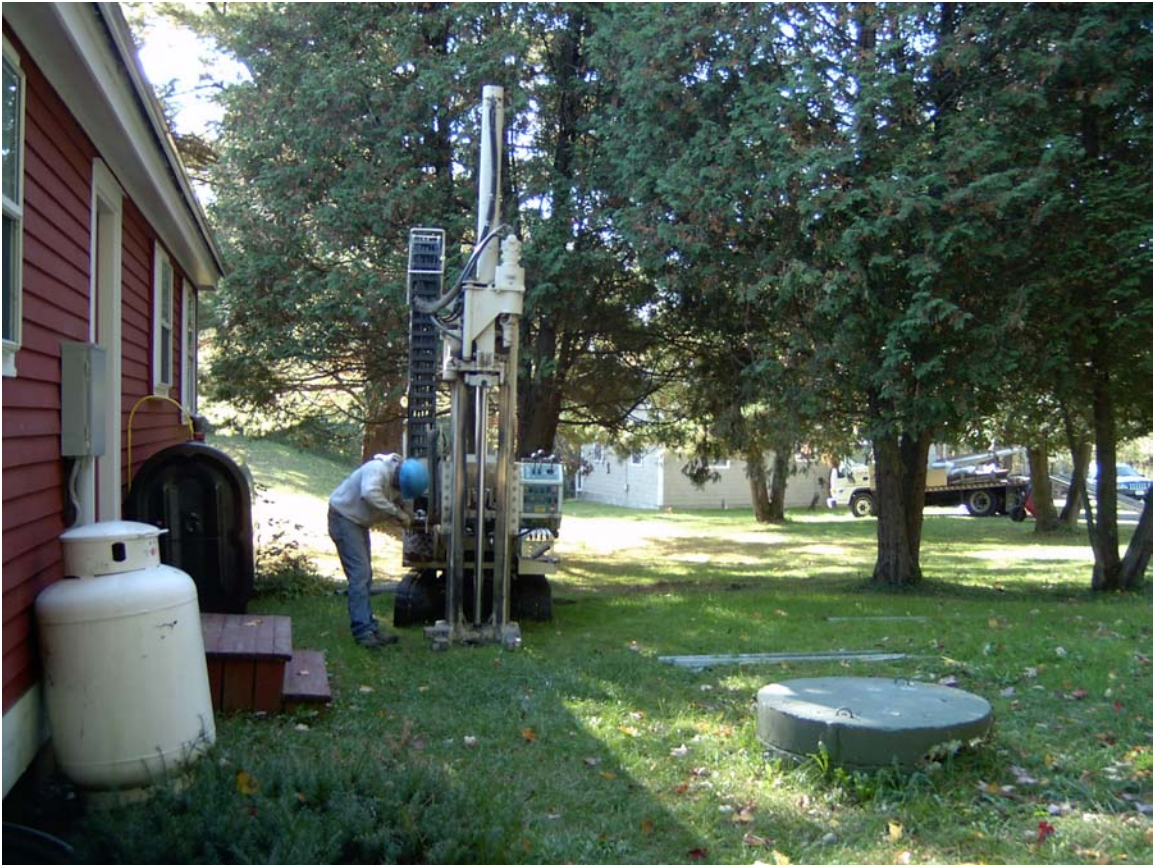
TEN ACRES LODGE – STOWE, VERMONT  
(Installation of MW-1 and Location of MW-2, and MW-3 – View Toward East)

On 7 October 2004, **R.E.A.** provided oversight during the installation of three monitoring wells; MW-1 was installed in the former UST excavation, and MW-2 and MW-3 were installed in the presumed downgradient direction from the former UST system. Based on the site setting and field observations during soil boring, **R.E.A.**'s geologist determined that three monitoring wells were sufficient for the initial site characterization. The soils at the site consisted primarily of fine sand and clay. The soil borings for the monitoring wells were extended to at least eight feet below the water table, which was encountered between approximately 6 and 9 feet bgs at the time of drilling.

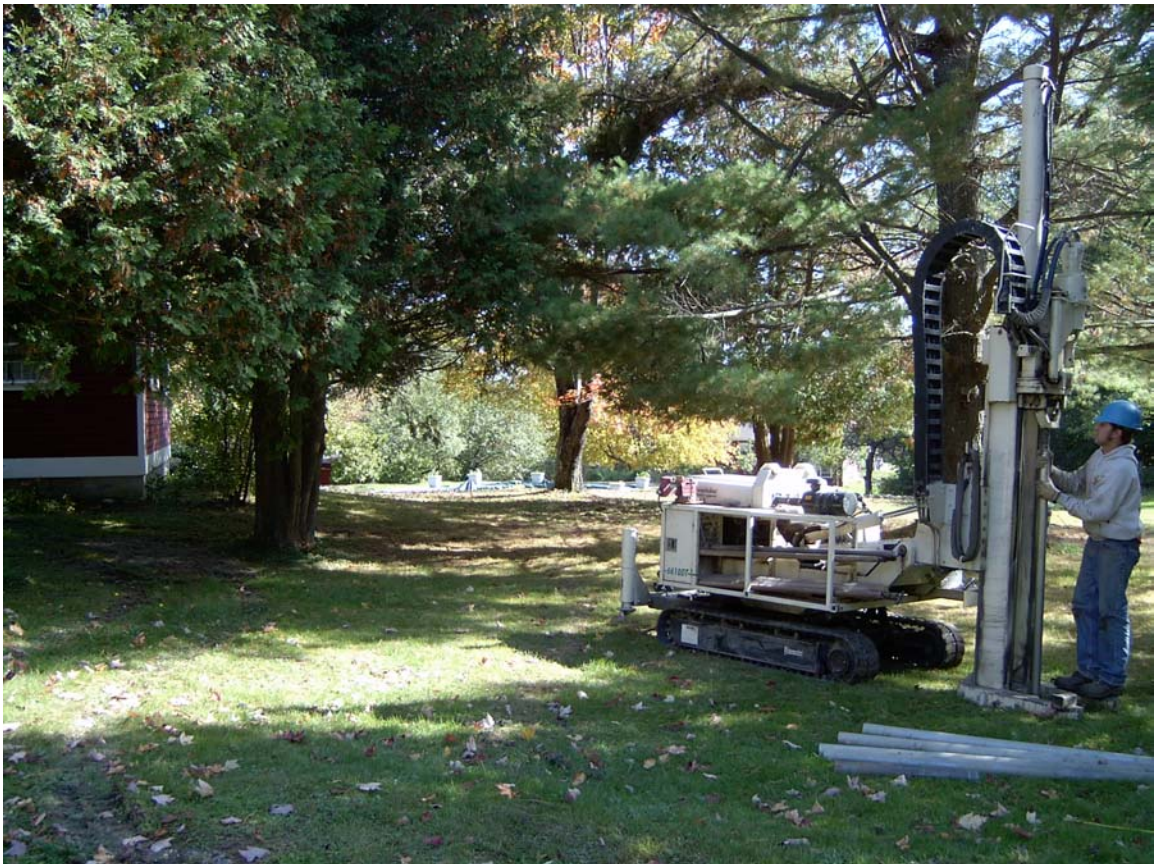
TEN ACRES LODGE – STOWE, VERMONT  
(Installation of MW-2 – View Toward North)

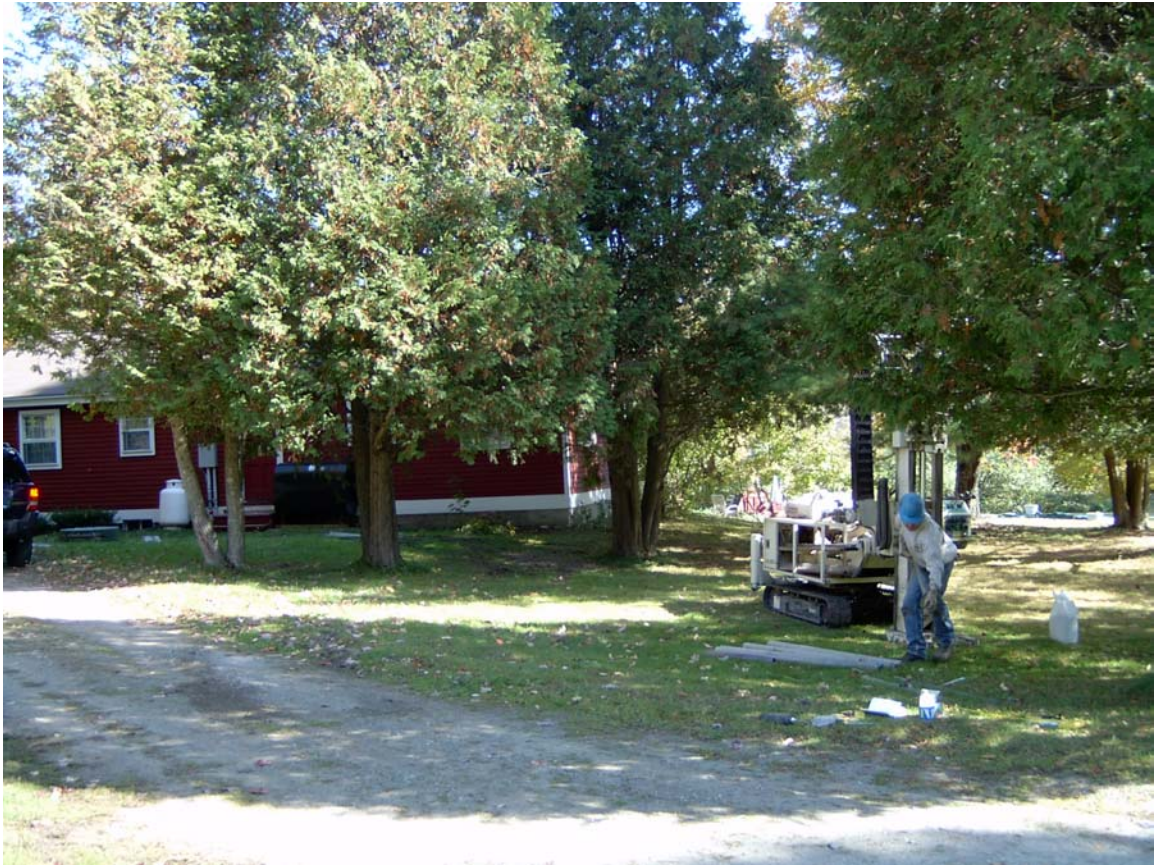
TEN ACRES LODGE – STOWE, VERMONT  
(Installation of MW-3 – View Toward North)
