Re: Well Decommissioning
Energizer Facility
Bennington, Vermont
Parratt-Wolff Project No. 25106A

Parratt-Wolff, Inc. recently completed well decommissioning activities at the Energizer Facility located at 401 Gage Street in Bennington, Vermont (the “Site”). The Site is identified under Number 2006-3509 by the Vermont Department of Environmental Conservation (VTDEC). Work was completed under the direction of Environmental Resources Management, Inc. (“ERM”). ERM submitted a Well Abandonment Work Plan on behalf of Energizer Holdings, Inc. (“Energizer”) to VTDEC on April 18, 2025.

Energizer Well Abandonment

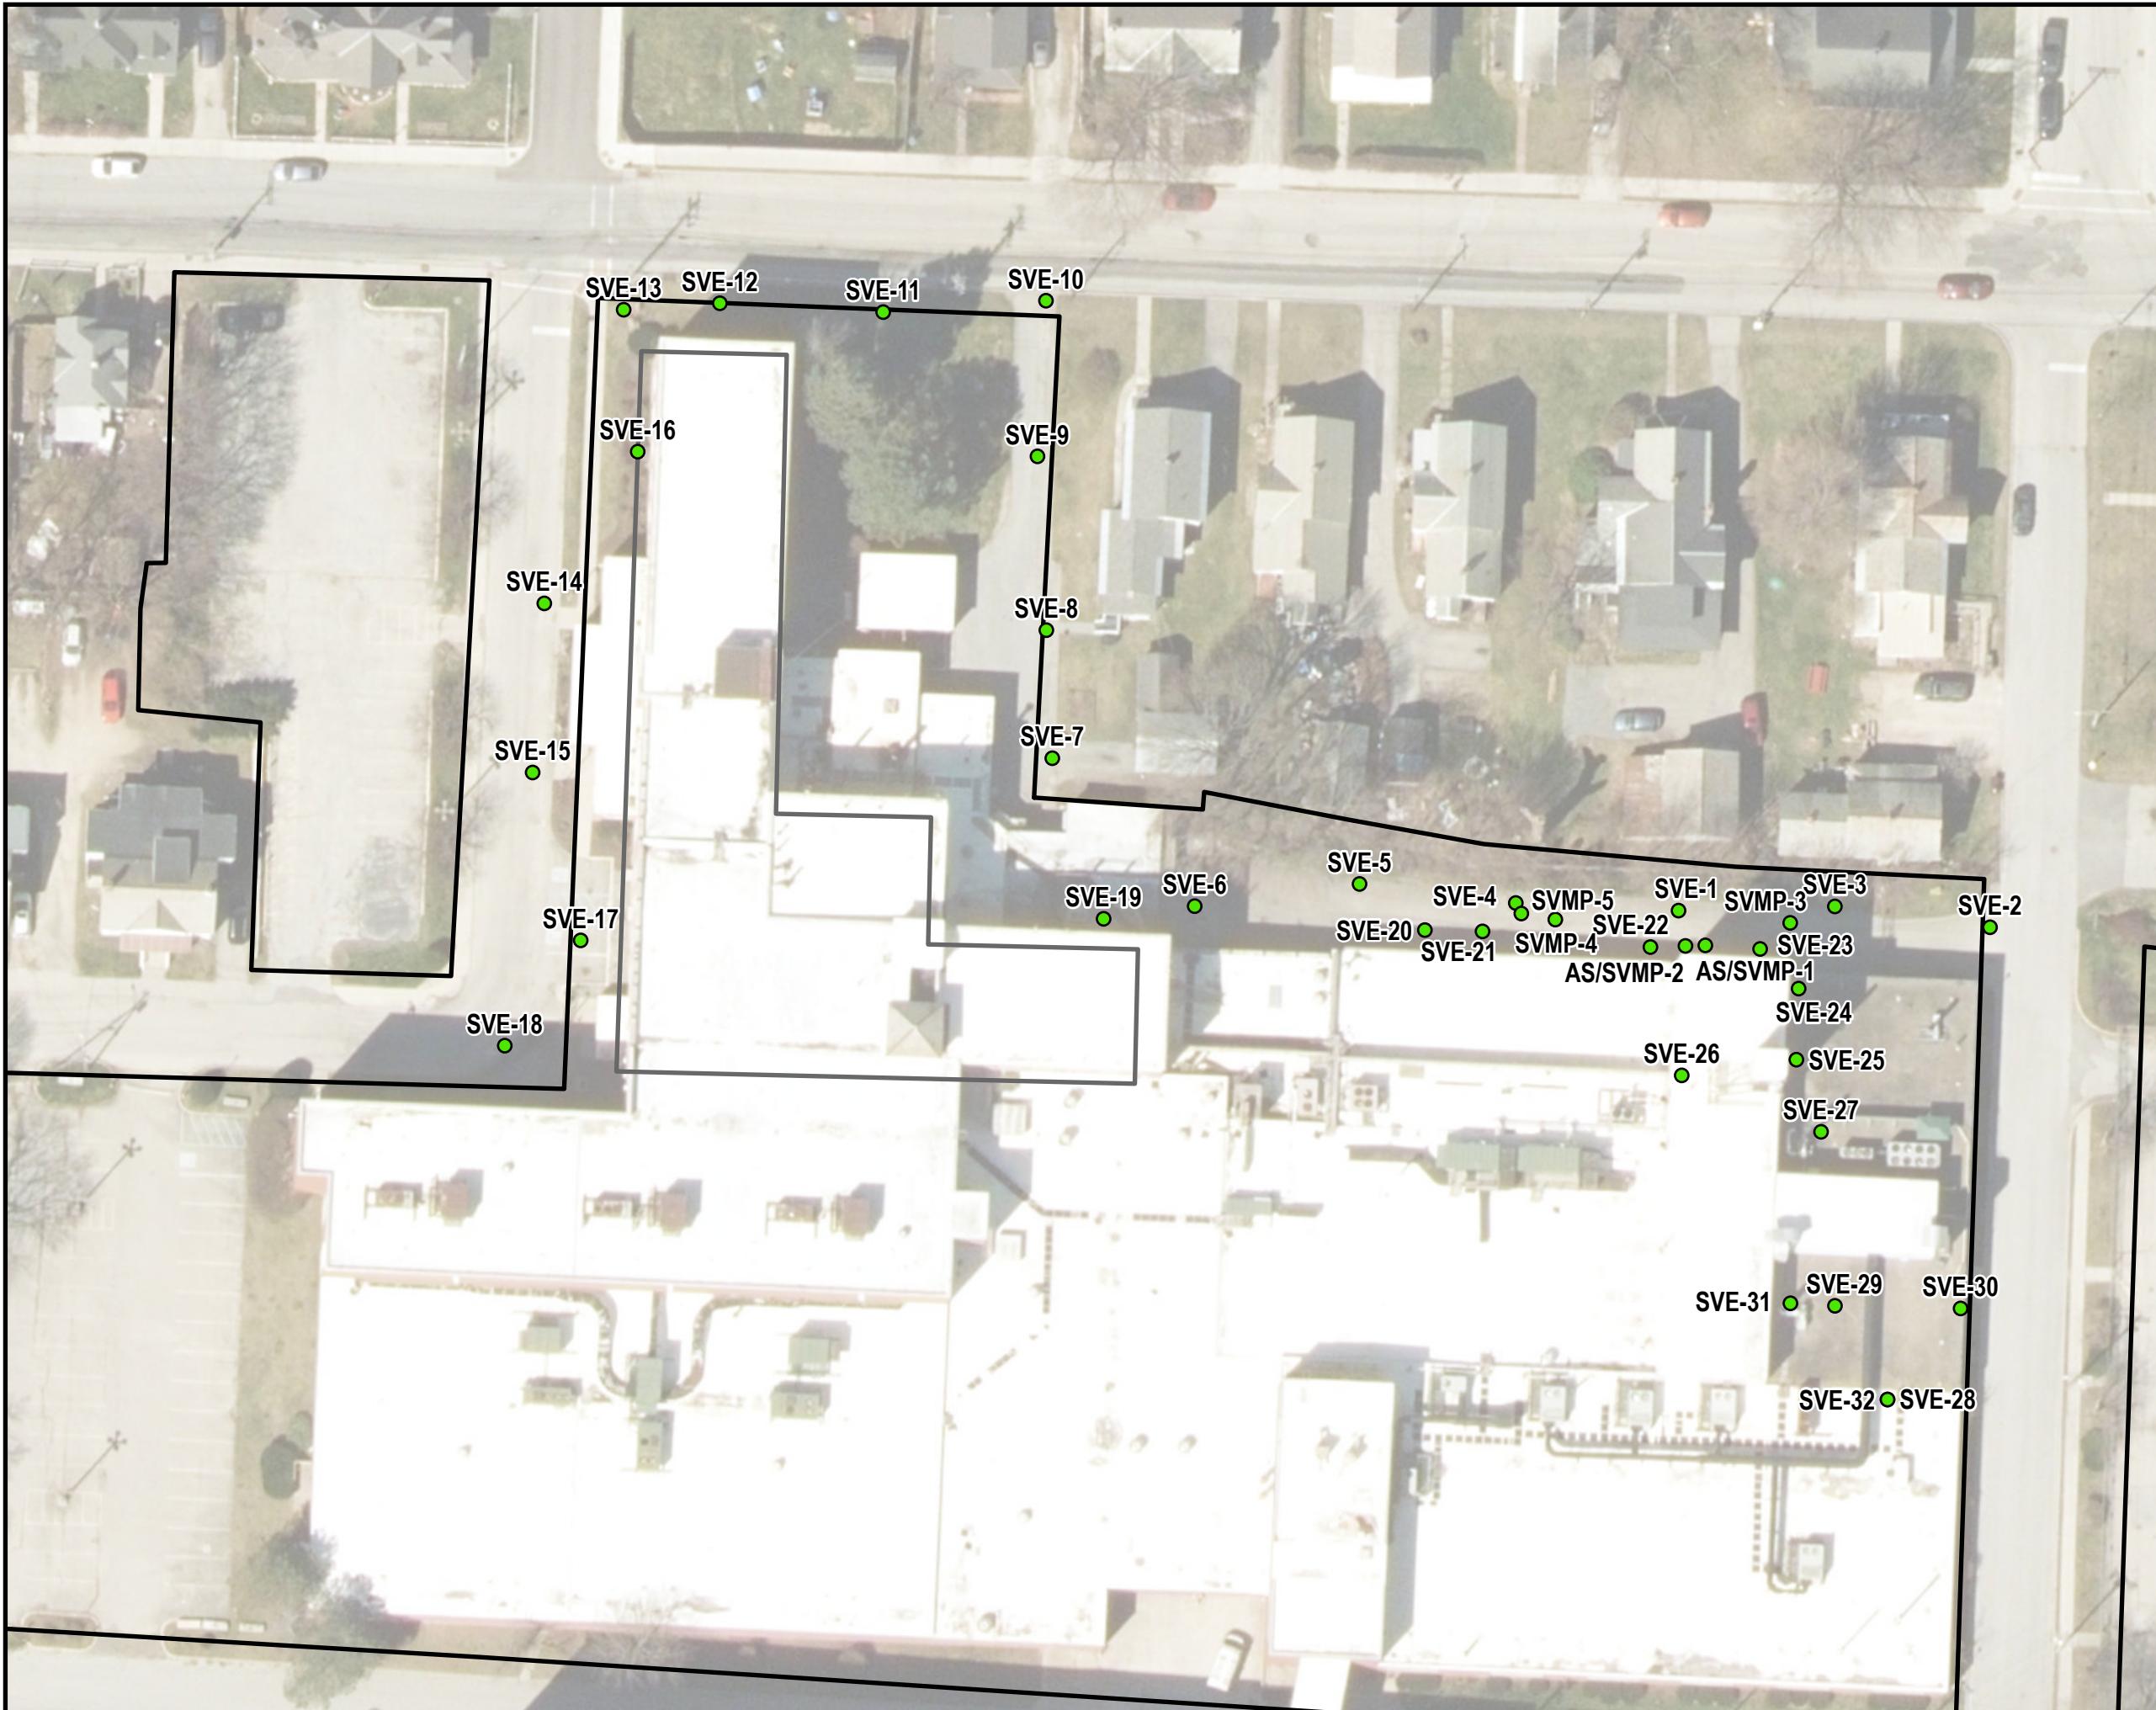
Figure 1c:
Proposed Plugging Locations
Energizer Holding, Inc.
Bennington, Vermont

- Soil Vapor Extract Location
- Approximate Basement
- Site Property Boundary

1. 36 physical locations
2. 38 individual boreholes
3. Aerial Imagery: ESRI World Imagery

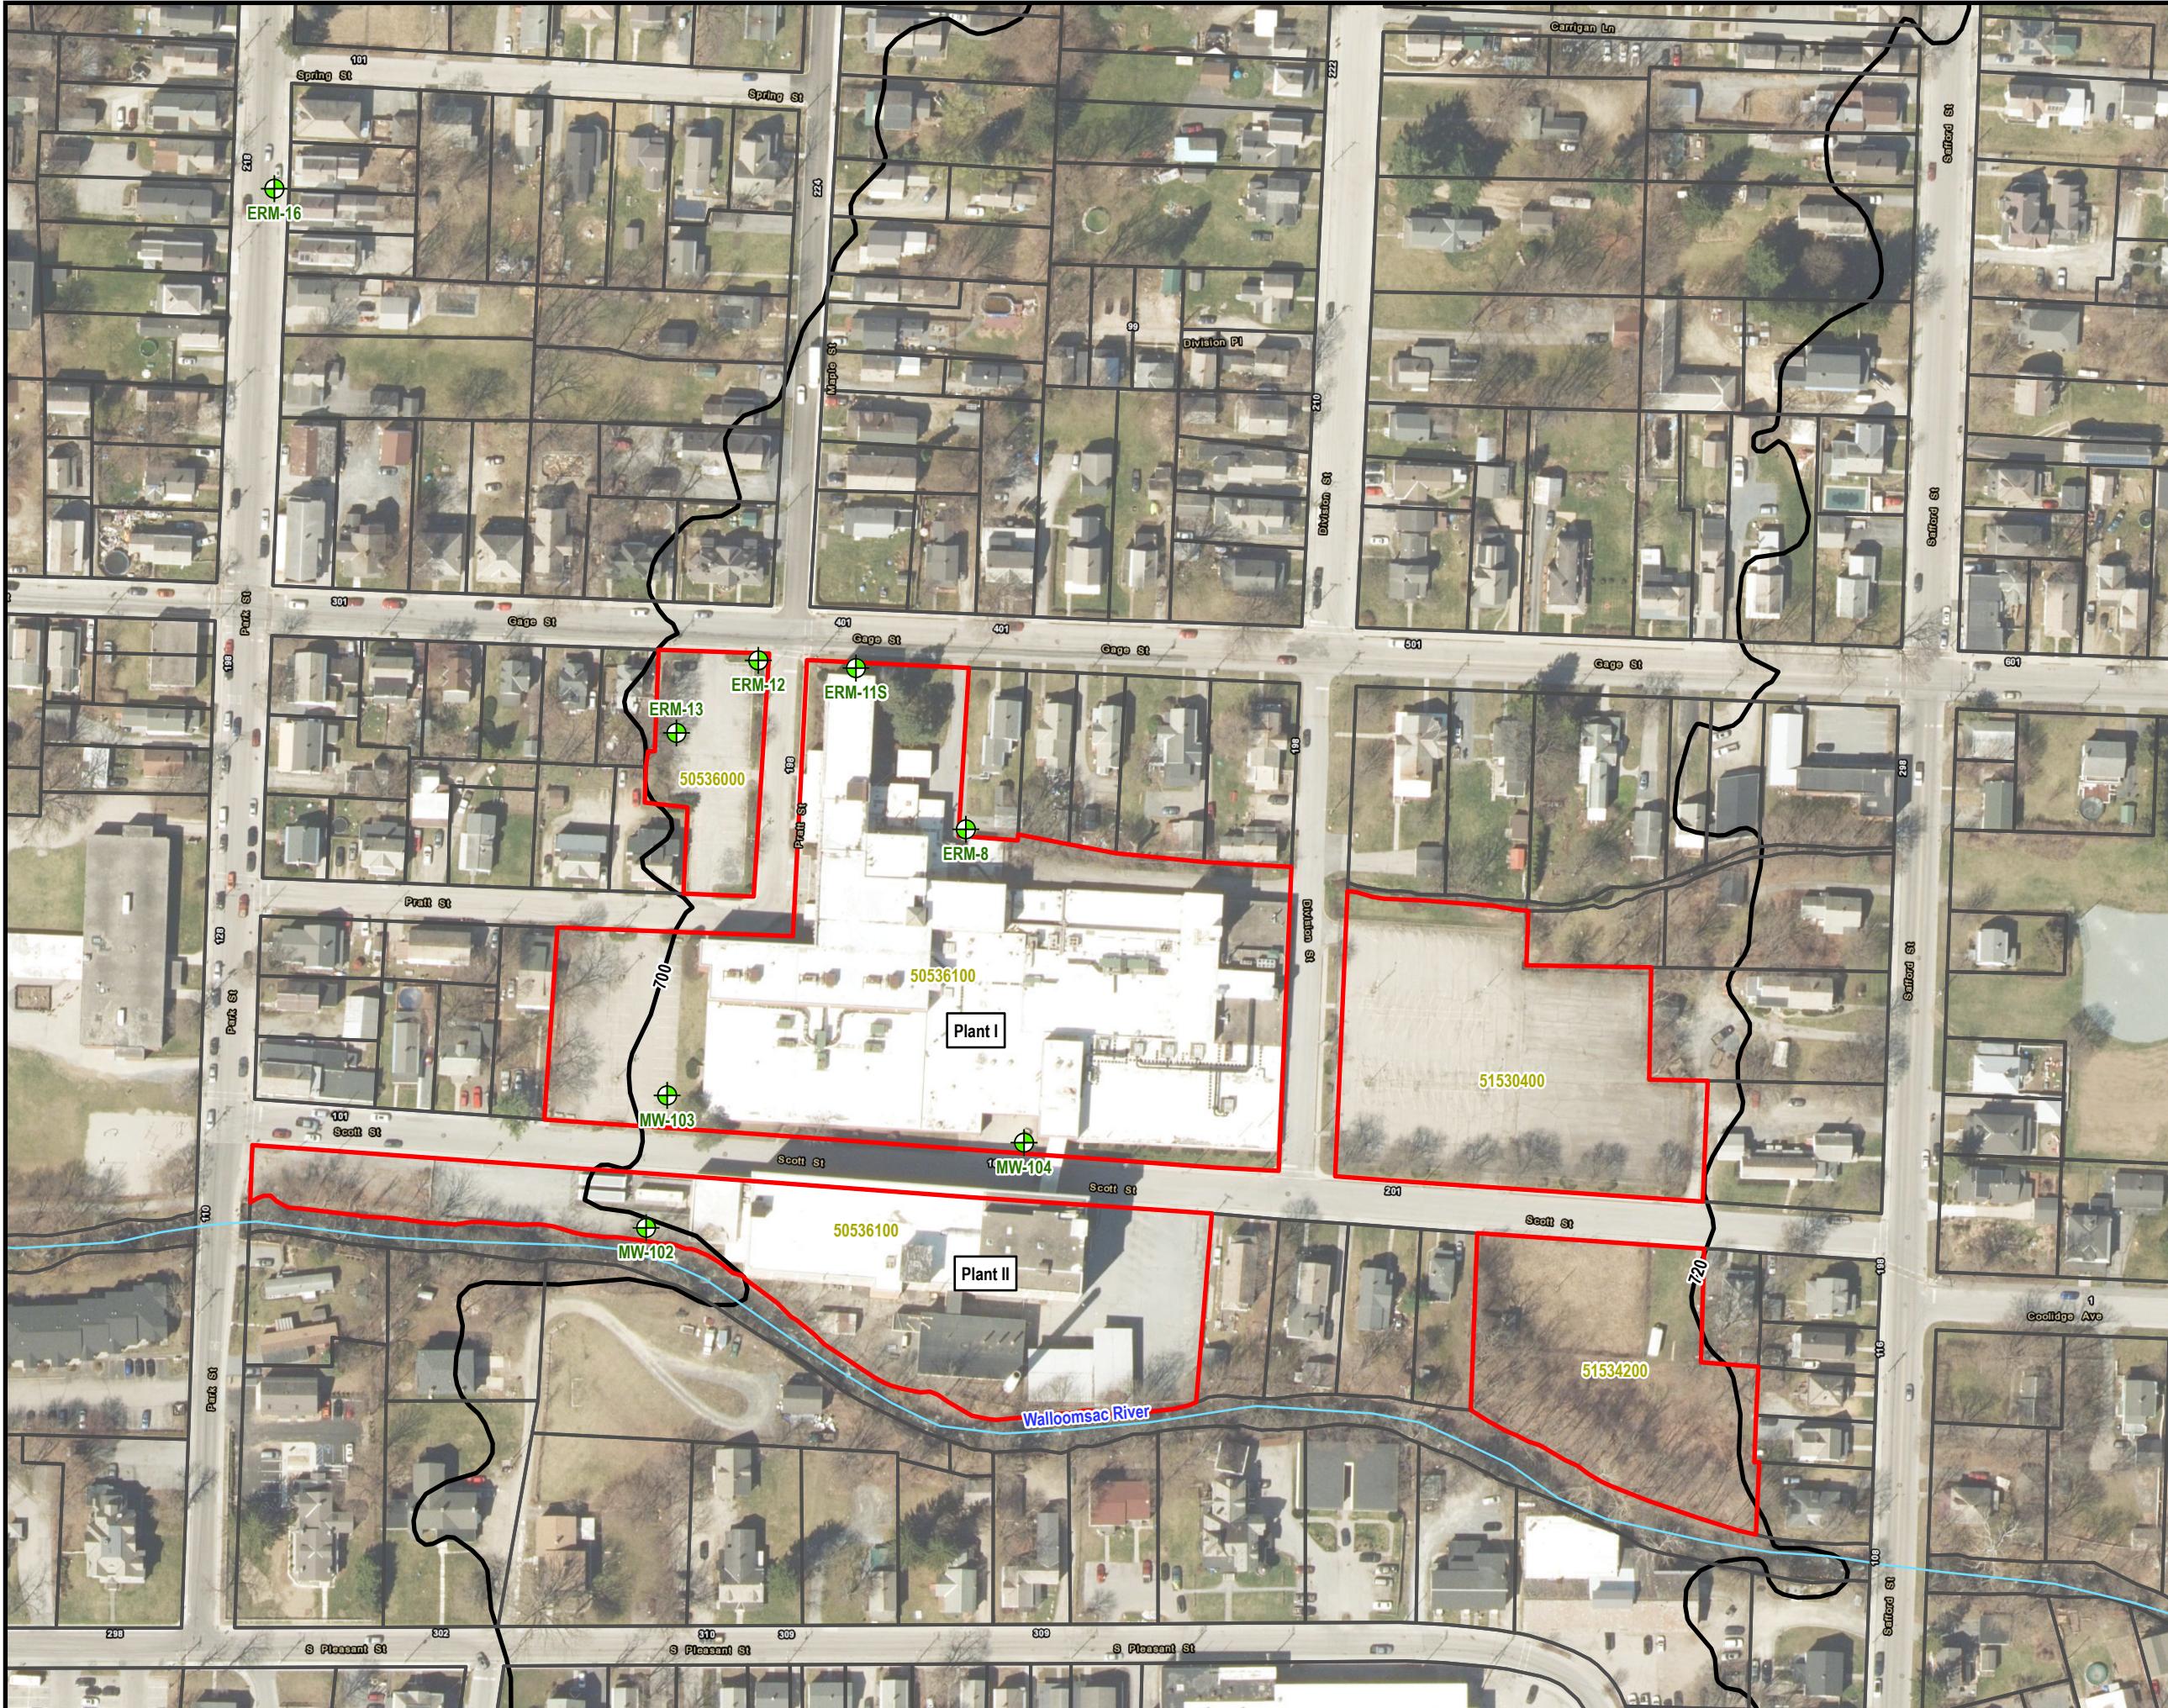
Figure 2: Long-Term Monitoring Well Locations
Energizer Holding, Inc.
Bennington, Vermont

- Existing Well Proposed for Long-Term Monitoring
- Elevation Contours
- Site Property Boundaries
- Tax Parcels
- 50536100 Tax Parcel ID

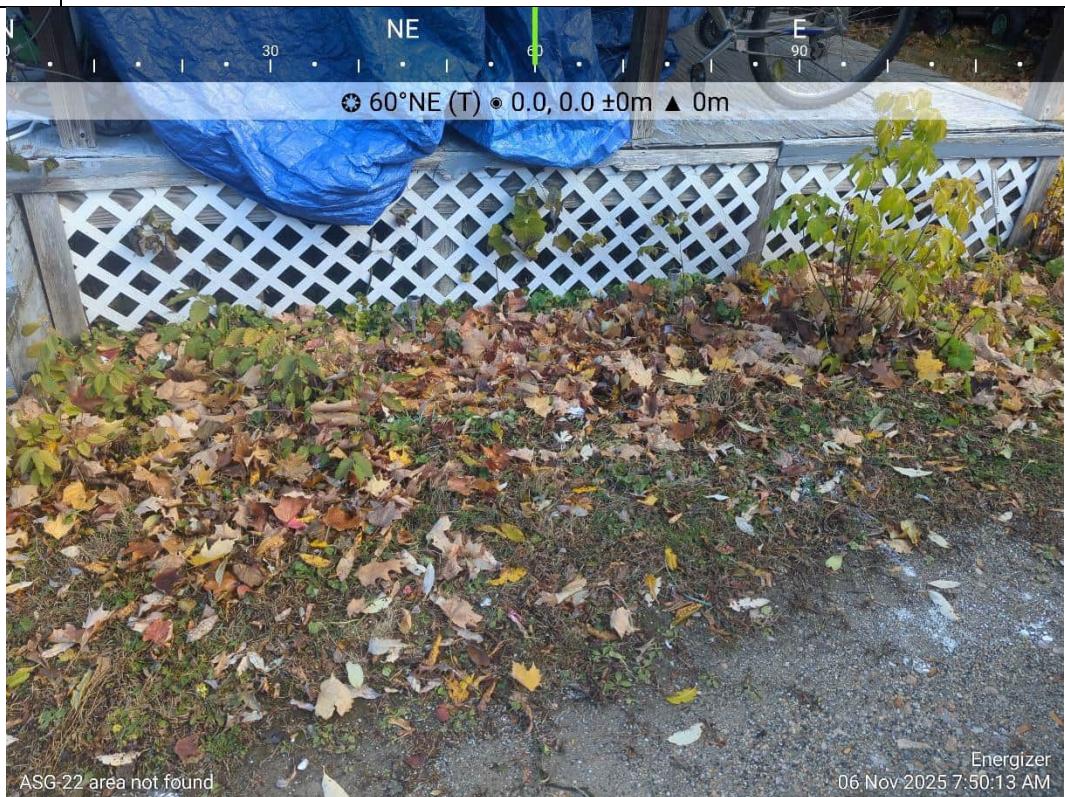
Photo 114

*Note: not found

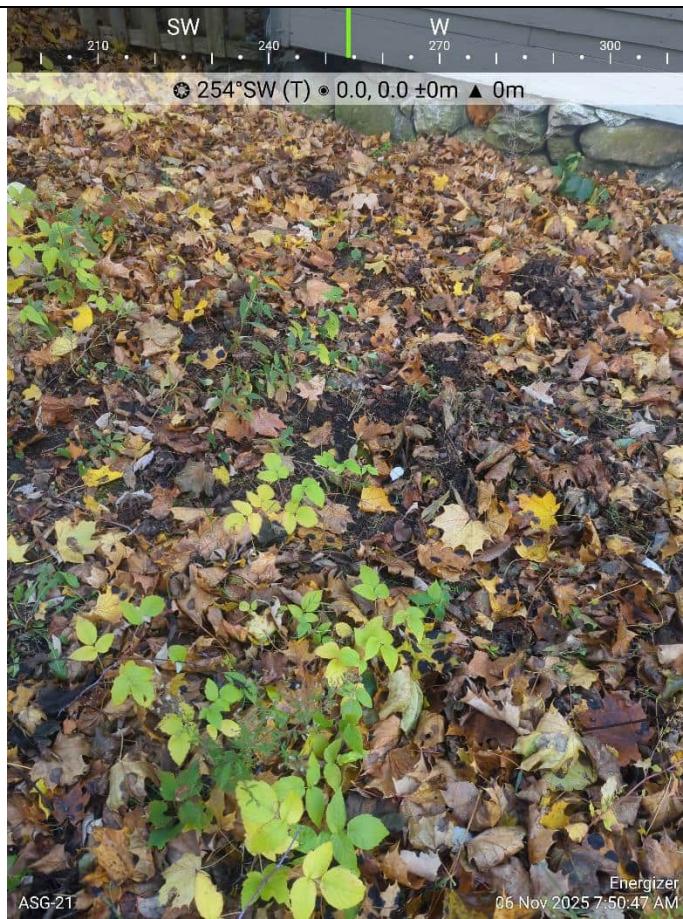
Photo 115

*Closed
