Re: Site Investigation Report – Herber Residence
6826 Monument Hill Road, Castleton, Vermont

Herber Residence Site Investigation Report SMS Site #2006-3511

Deanna Herber
6826 Monument Hill Road
Castleton, VT 05735-9635
(802) 273-2301

July 10, 2006

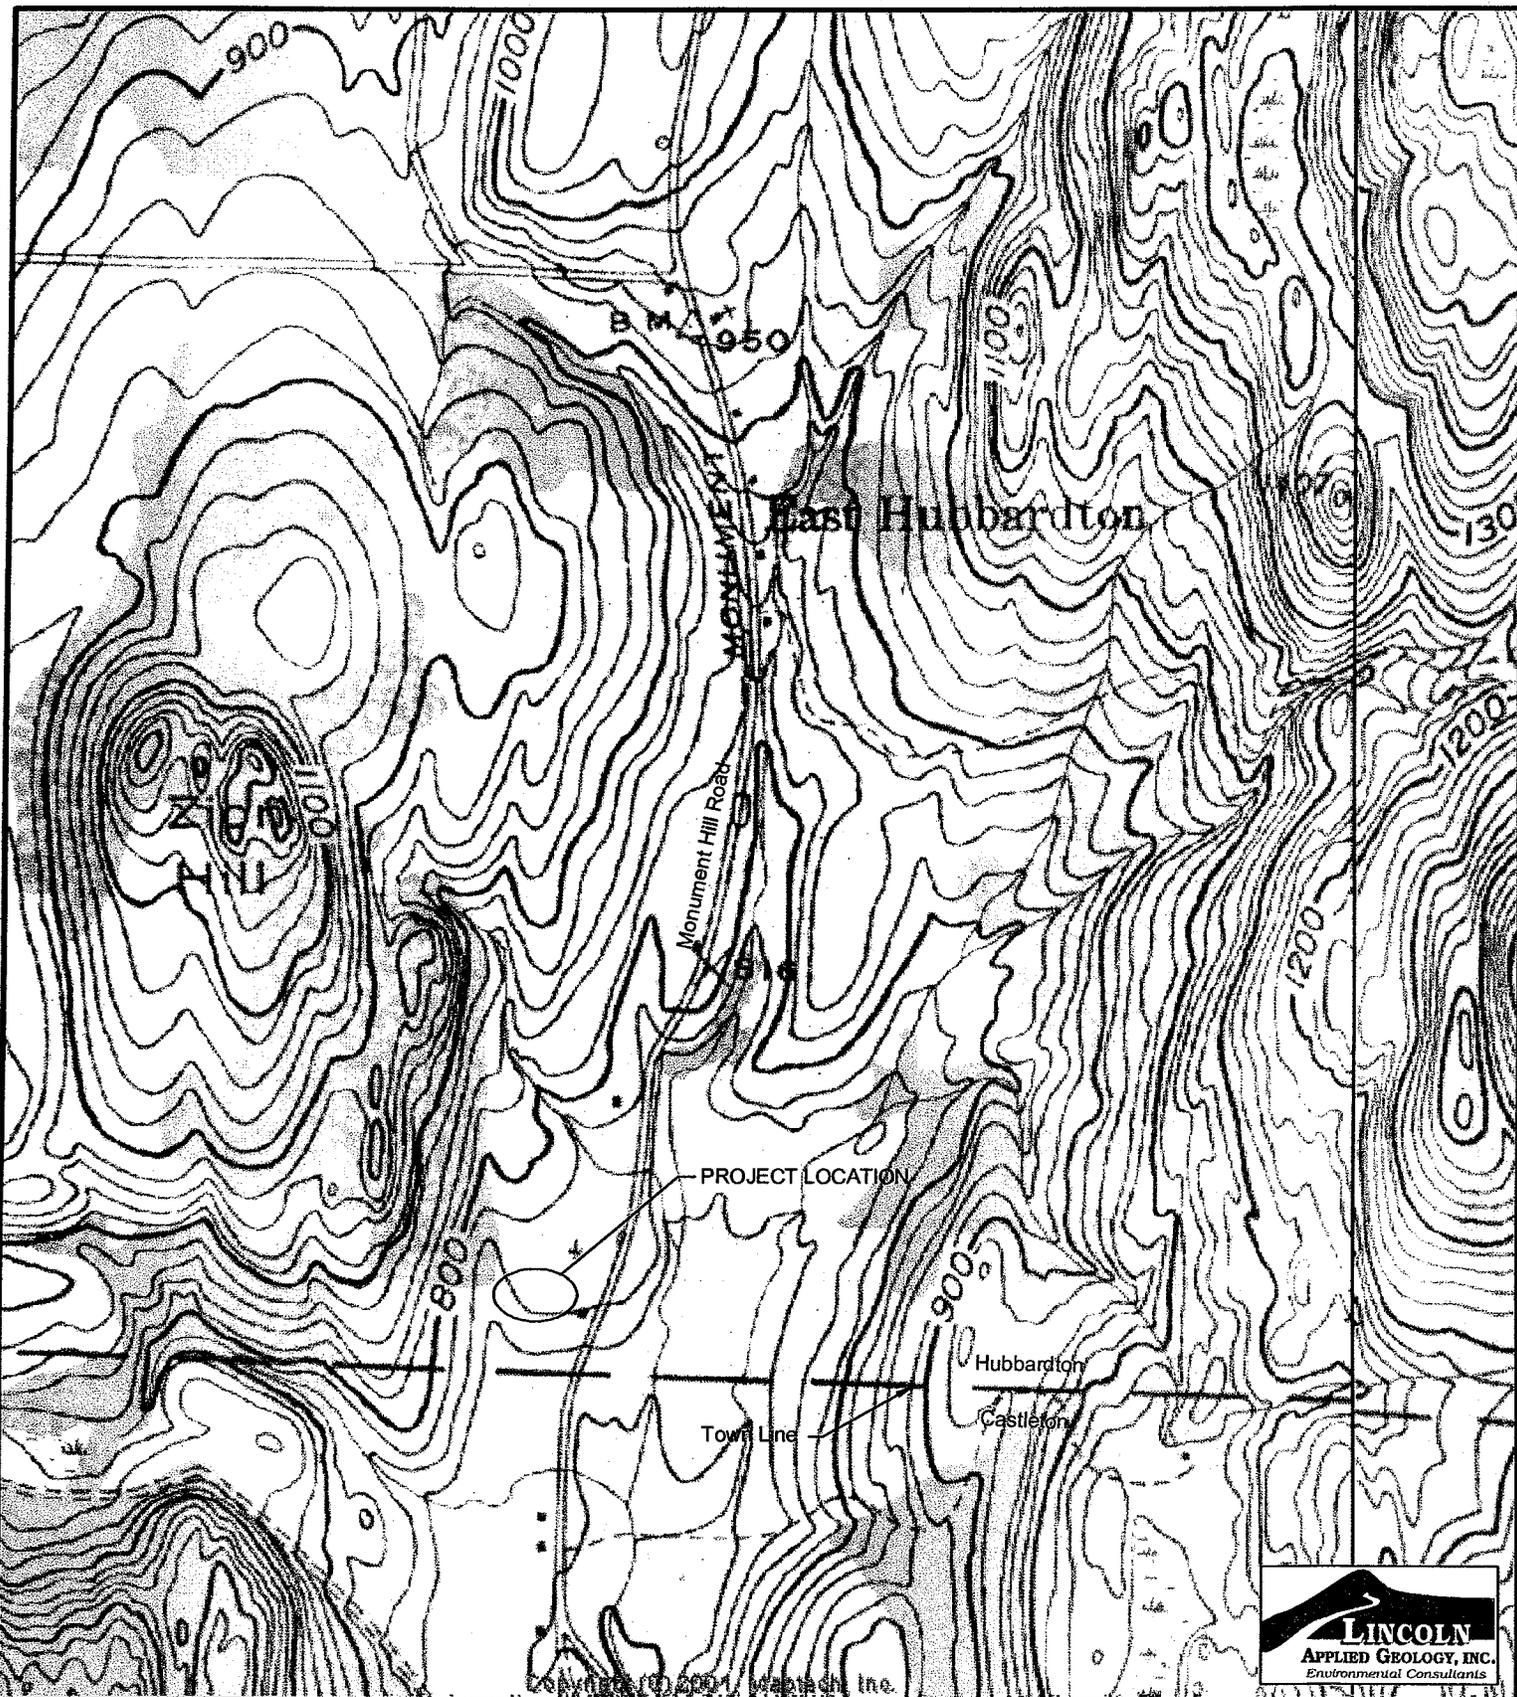
Figure 1

The Herber Residence (Site) is located at 6826 Monument Hill Road in Castleton, Vermont as shown on **Figures 1, 2, and 3** as a USGS Topographic, an Area Map, and a Detailed Site Map, respectively. **Figure 2** provides details regarding locations of adjacent and nearby landowners and their water supply sources. **Figure 3** provides Site-specific information and pertinent features. The 5 acre Site is currently used as a residential property. The residence is constructed on a slab-on-grade foundation. The Site is served by a drilled bedrock drinking water source, as are all adjoining and nearby residences. The property is bounded to the north and west by undeveloped land, to the east by the Whitehurst Residence, and to the south by the Loso Residence. The Site has been a residential property since it's creation in the early 1990's. The current property owner is Deanna Herber.

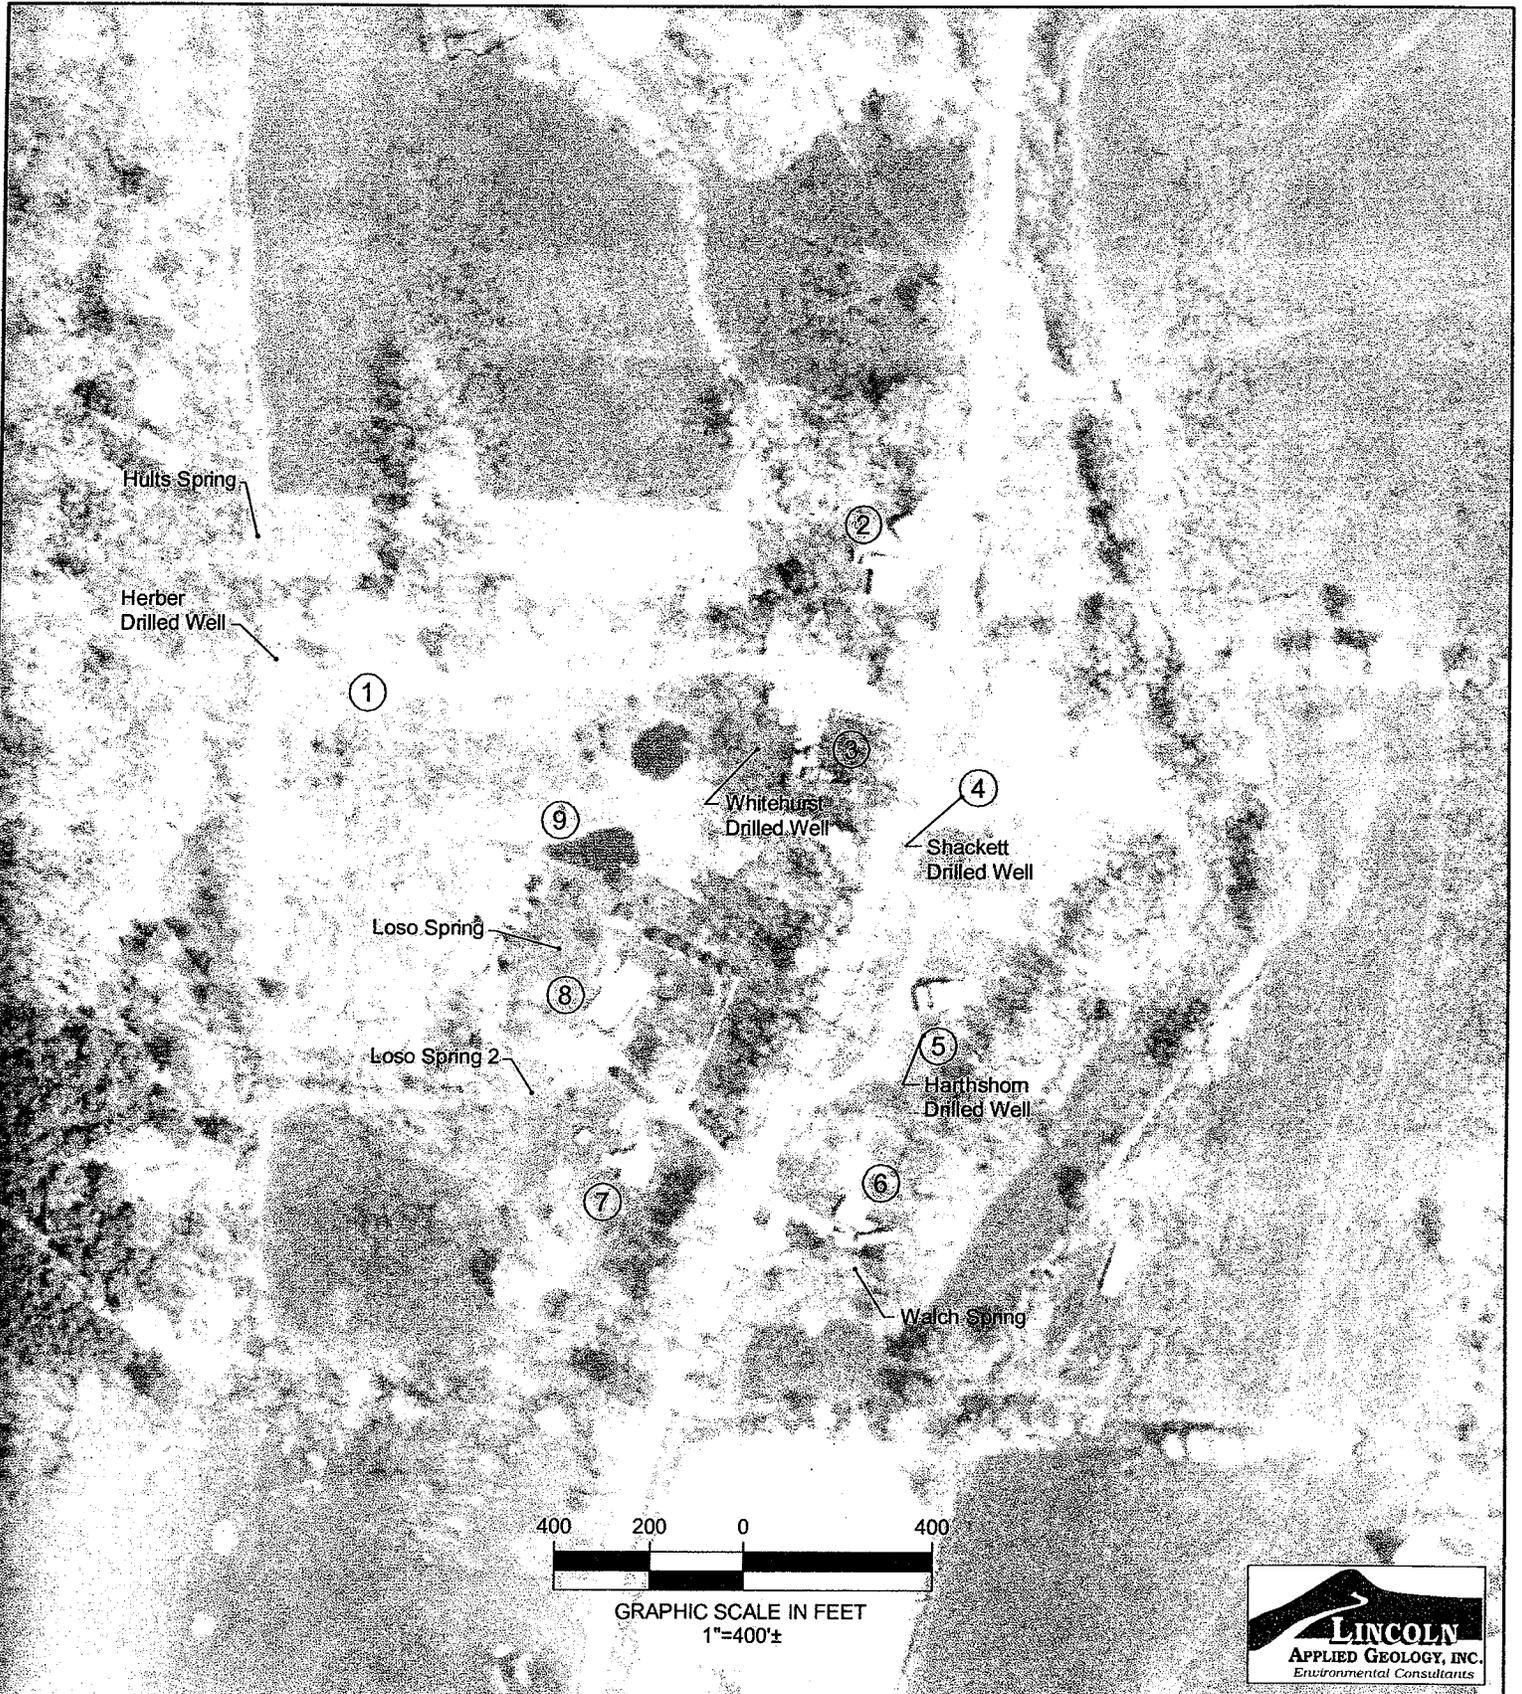
- ① Herber Residence
- ② Hults Residence
- ③ Whitehurst Residence
- ④ Shackett Residence
- ⑤ Harthshorn Residence
- ⑥ Walch Residence
- ⑦ Baird Residence
- ⑧ Loso Residence
- ⑨ Loso Pond

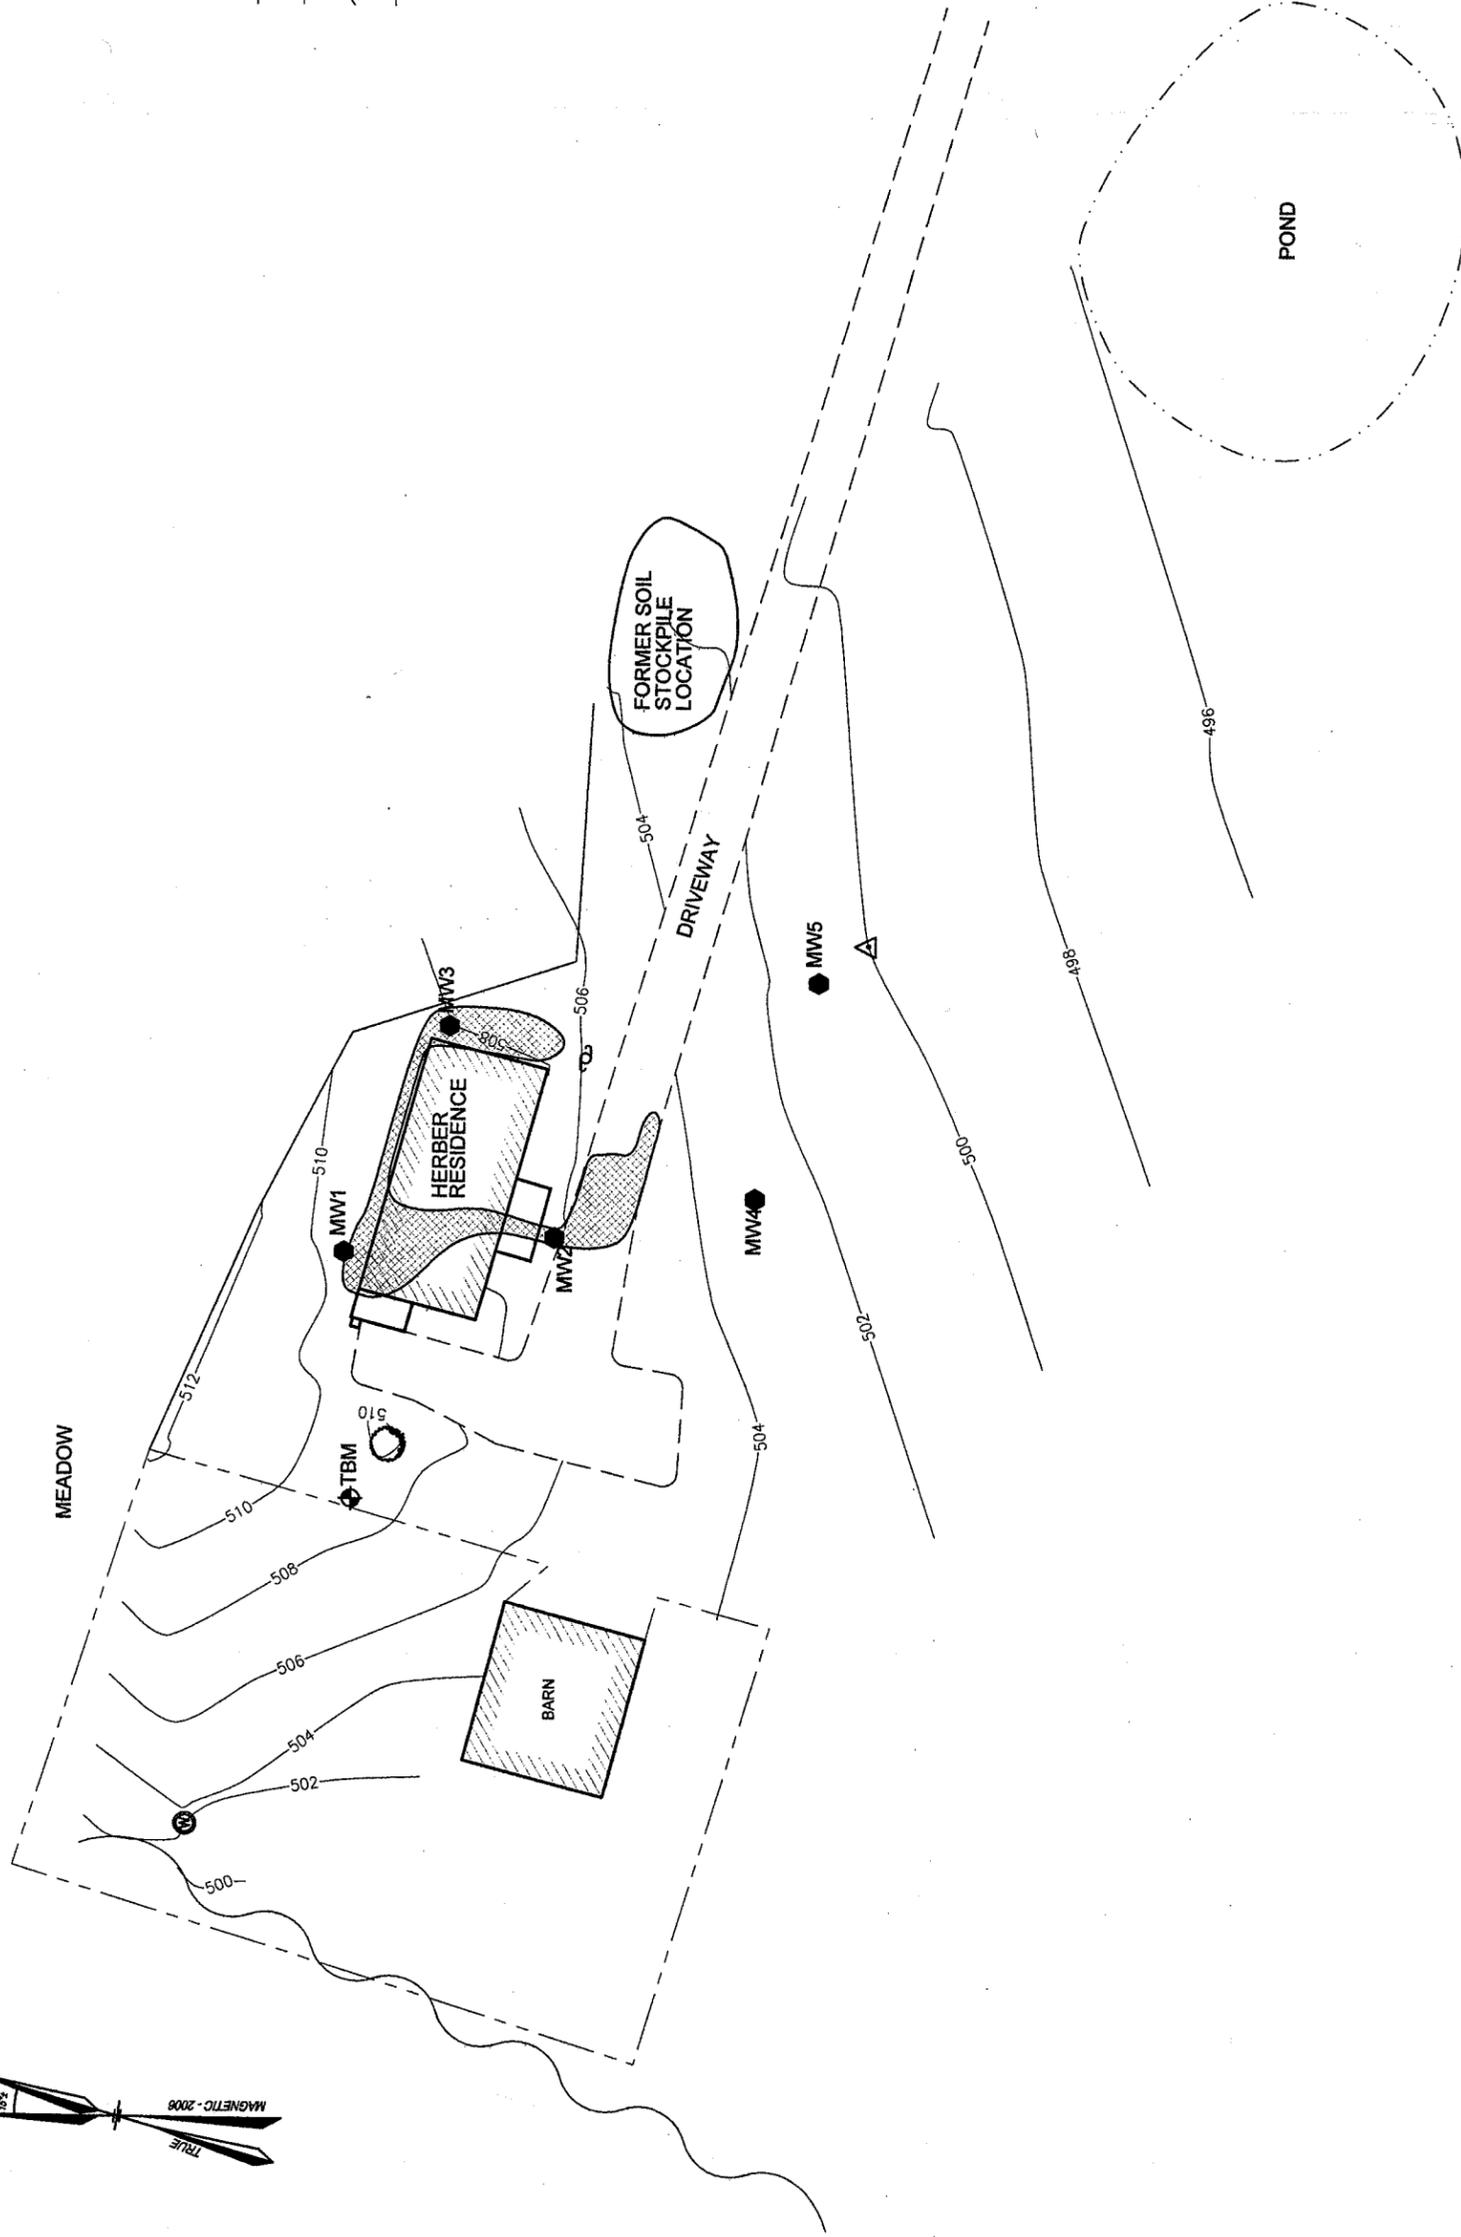
Approximately 80 cubic yards of soil were excavated and temporarily stockpiled and encapsulated with polyethylene sheeting during the initial spill response in April 2006. The stockpile location is noted on **Figure 3**. The soil stockpile was covered with two layers of plastic sheeting, and constructed in accordance with the VDEC regulations for stockpiling petroleum contaminated soil and debris.

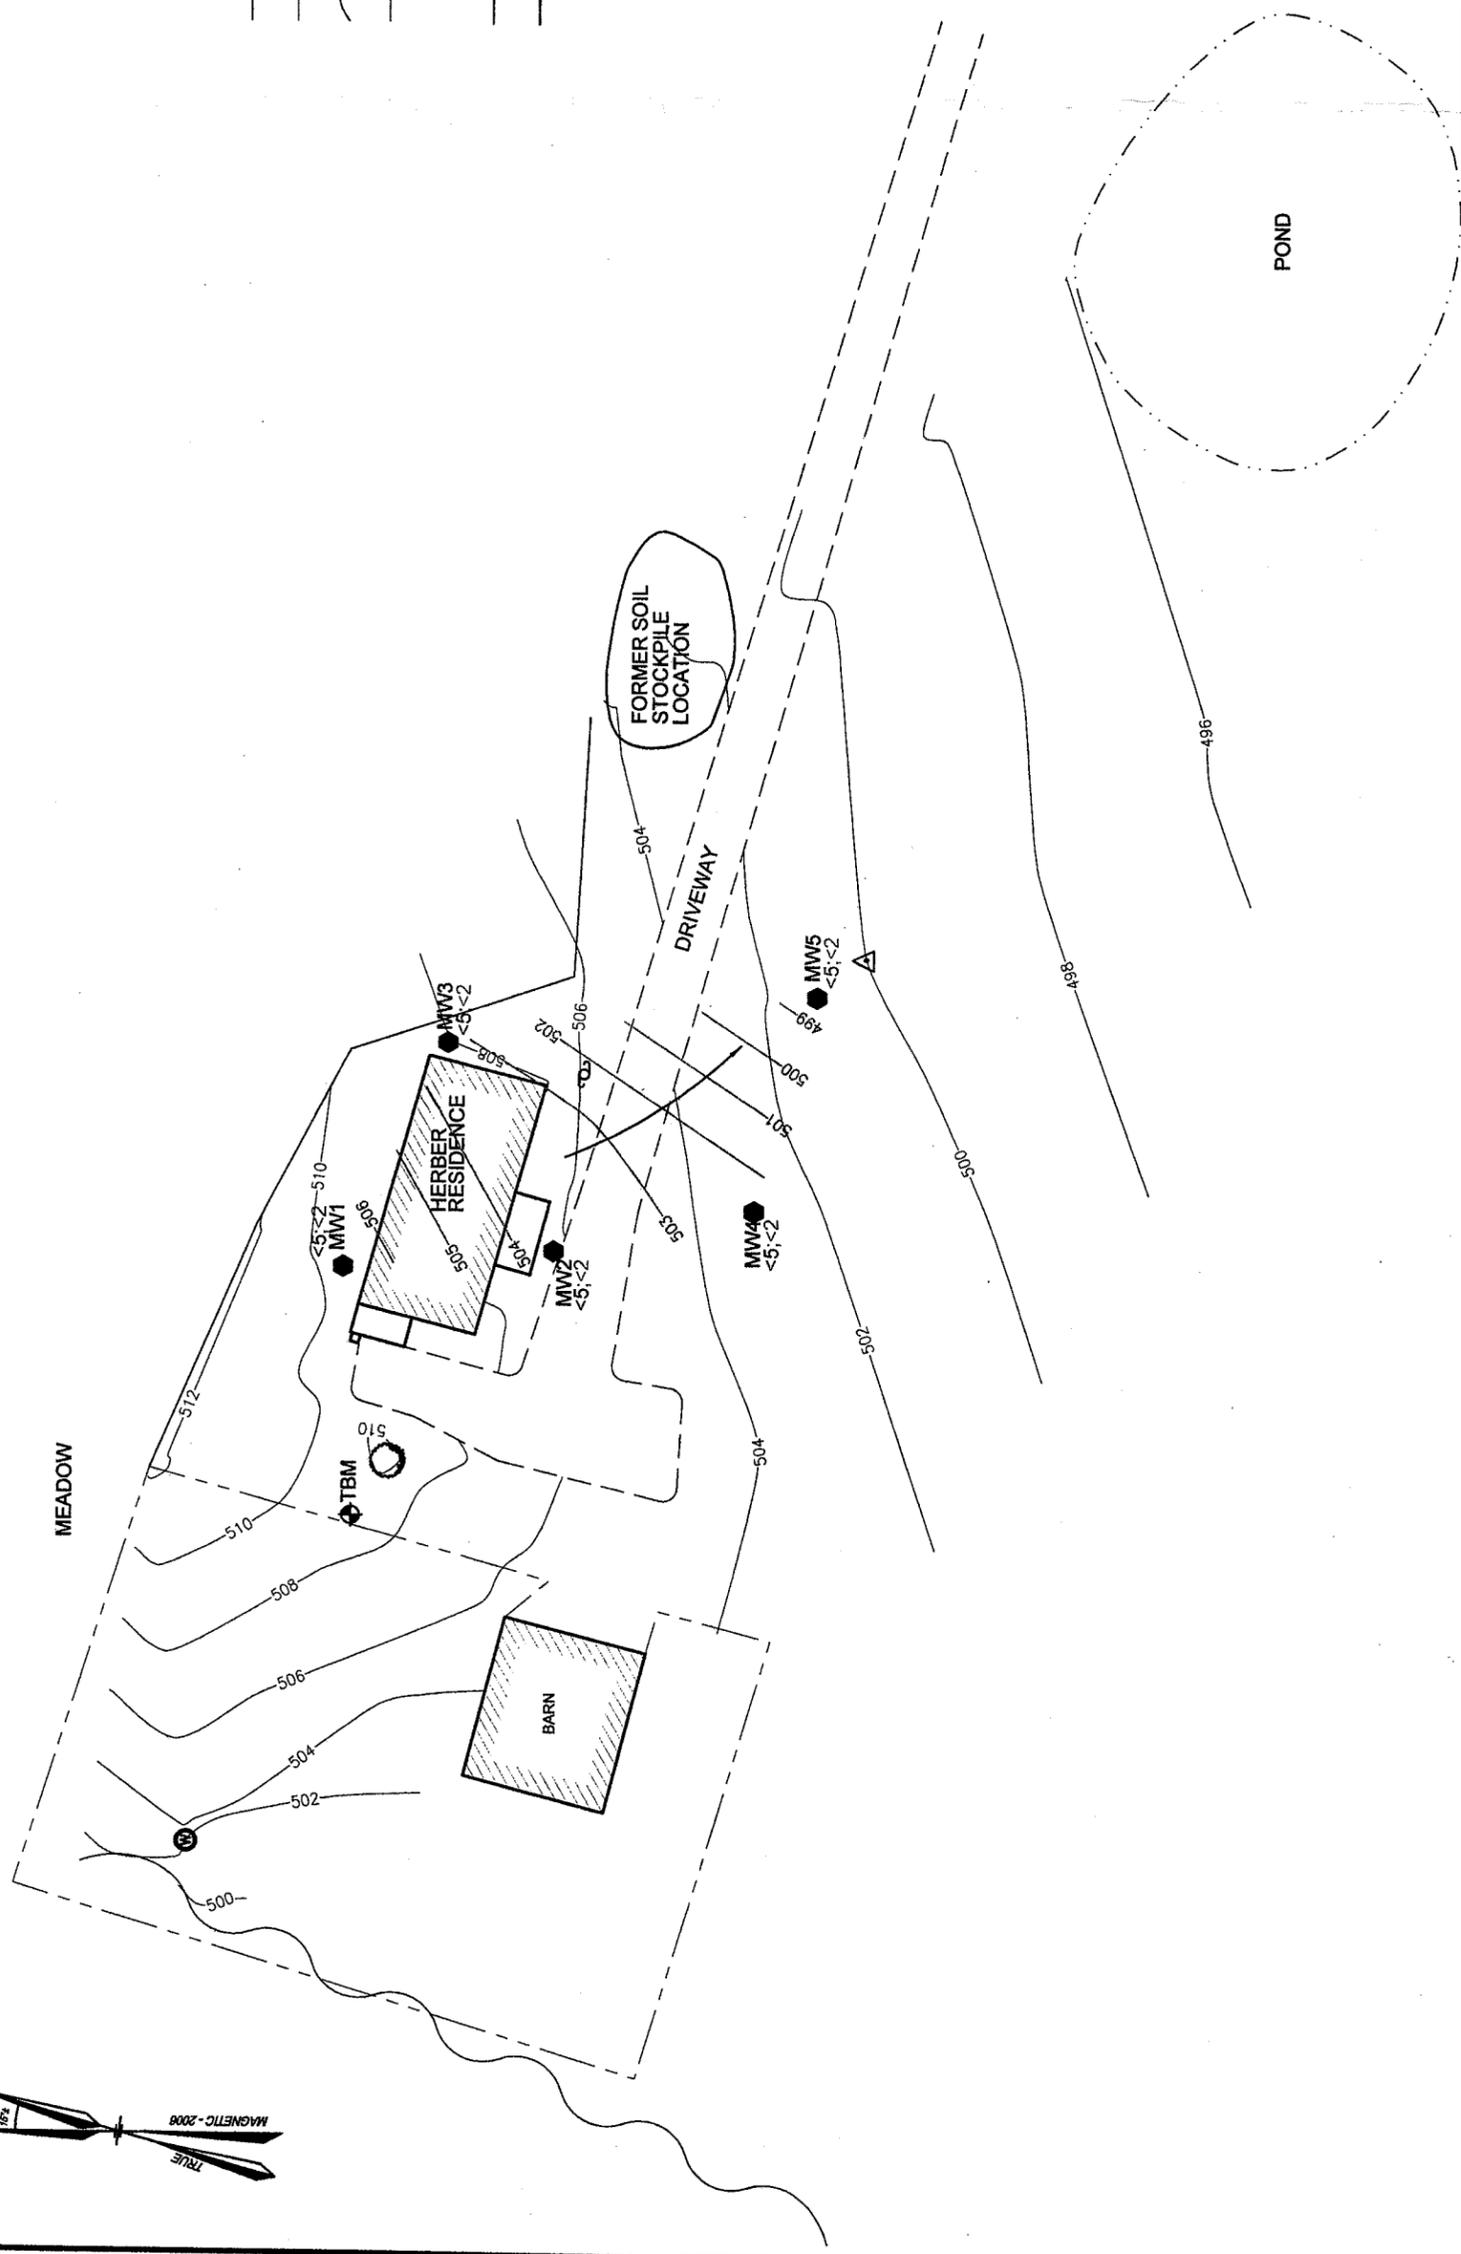
Figure 4	
Herber Residence 6826 Monument Hill Road Hubbardton, Vermont	
Ground Water Contour and Water Quality Summary Map for May 18, 2006	
LAG PROJECT # 06040	LAG PROJECT TYPE Site Contamination

Laboratory analysis of the collected ground water samples indicates no impact of dissolved phase petroleum contaminants above the Groundwater Quality Enforcement Standard (GQES) exist beneath the Site. It appears that the large amount of soil excavated during the initial cleanup activities has helped to prevent penetration of contaminants to the saturated zone, and mitigate dissolution of petroleum VOCs into the underlying shallow aquifer. LAG recommends a confirmatory water quality sampling round in August 2006 to assess the threat to sensitive receptors in the area during lower water table conditions.

- LAG recommends a confirmatory sampling round to be conducted in August 2006 to coincide with a lower water table. The ground water monitoring round will consist of monitoring well headspace screening, ground water level gauging, ground water quality sample collection and laboratory analysis; surface water sampling from the Herber and Loso ponds; water quality sampling of the Herber supply, Whitehurst supply, and Loso Spring, and a summary report on the findings. Samples will be analyzed for petroleum related VOCs per EPA Method 8021B.

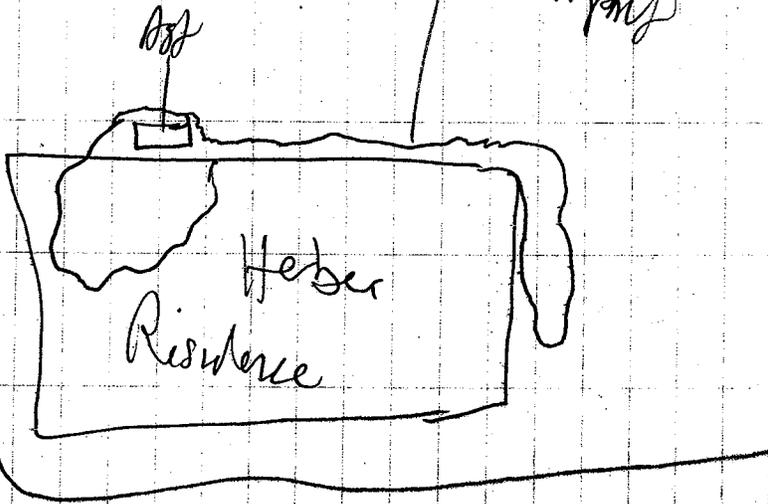
Site Sketch

Product found down curtain drain
around north side of the trailer to
the east of ground on the east side
of the trailer. Product appeared to
roll on the east side of the residence
w/ contamination down at least 2'.
No impact appears to be below 6" along
the curtain drain as the ground is still
frozen in that area.

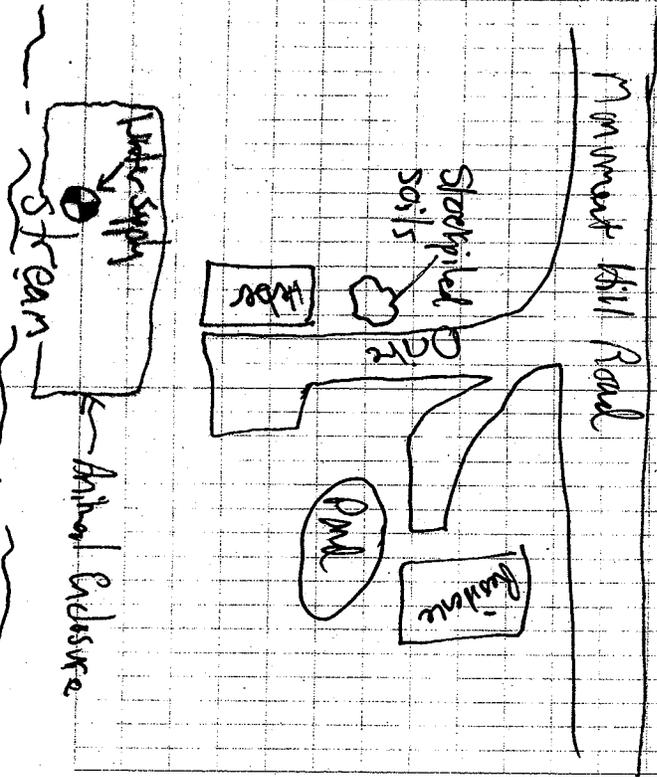
#66811 4/7/06 Huber Residence

- Noticed a stained area originating from underneath the front steps that traveled out onto the driveway & to the east. did not travel across to the lawn to the south. Appears to have moved across the top of the slab during high water. The right the spill occurred. Potentially may have discharged from underneath the pad?
- The staining was not visible on 4/6/06.
- Installed fencing around open excavation holes.
- Collected water supply samples @ B:TB on 4/7/06

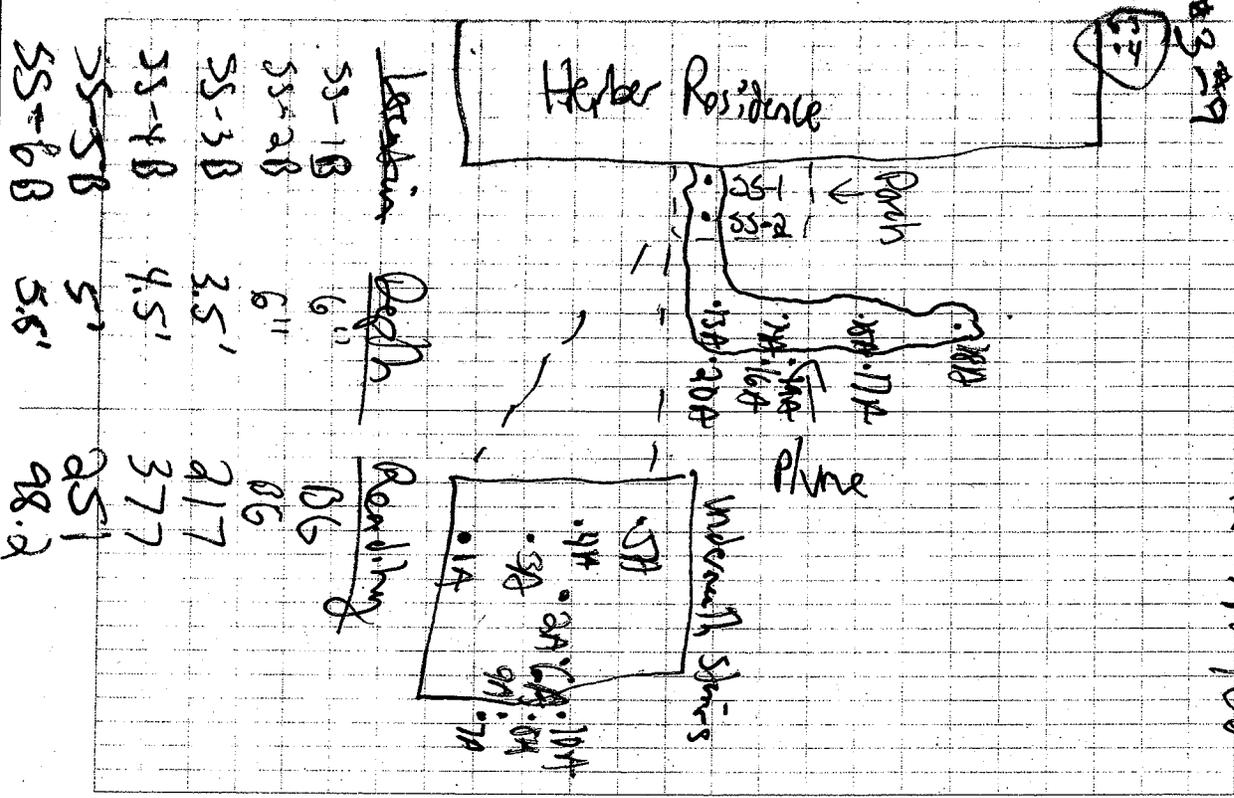
Z-N Herber Residence 4/12/06

Encountered wet soils @ 4.5' of groundwater @ 5' w/ product of slum on the surface. P&D reading above clean @ 6.5' below grade.

Location	Depth	Reading	4/12/02
SS-7B	6'	B6	
SS-8B	6.5'	B6	
SS-9B	6.5'	B6	
SS-1A	6"	45	
SS-2A	6"	42	
SS-3A	6"	212	
SS-4A	10"	23.5	
SS-5A	1'	1.2	
SS-6A	1'	420	
SS-7A	1.5'	65	
SS-8A	1.5'	117	
SS-9A	2'	40	
SS-10A	2.5'	B6	
SS-11A	3.5'	110	
SS-12A	4'	141
