**FUEL OIL SPILL
 MOULTON RESIDENCE
 95 WHITESHILL ROAD
 EAST DOVER, VT
 VT DEC SMS #2006-3523**

Prepared for:

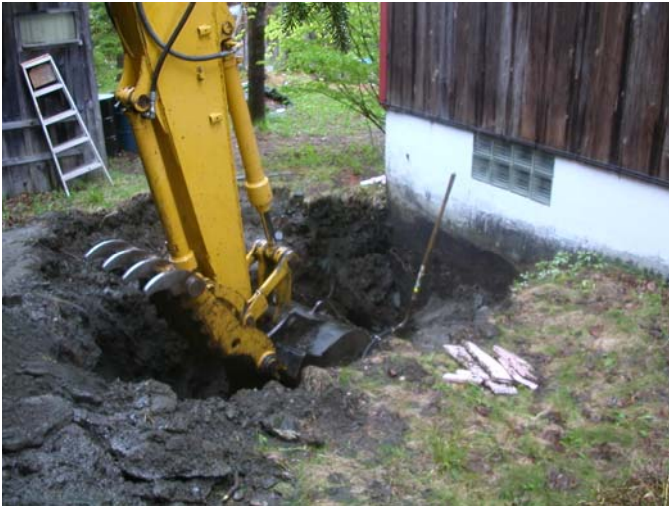
Excavation was determined to be deepest at house foundation. Bedrock was present immediately beneath house foundation and to the north, west and south of excavation grave.

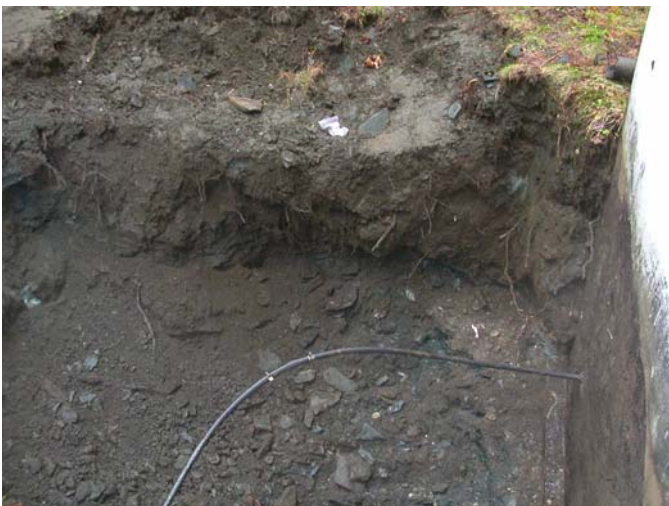
Second water line from pressure tank in basement extending south of site building. Site owner thought this line delivered water to an undetermined location, south of house. The water line from the well enters house of the north side of house, approximately 1-2 feet north of excavation pit.

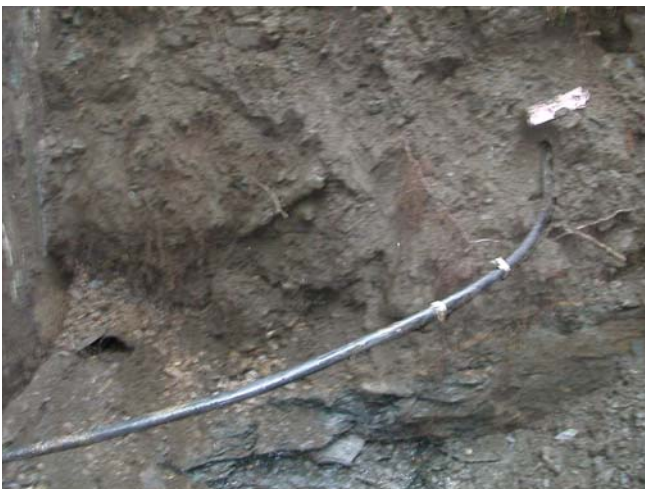
Secondary water line extending to the south from house (left). Note curtain drain along west side of house foundation. Drain was mostly filled with gravel and not considered to be a pathway for free phase oil. Note ledge immediately beneath curtain drain and house foundation.

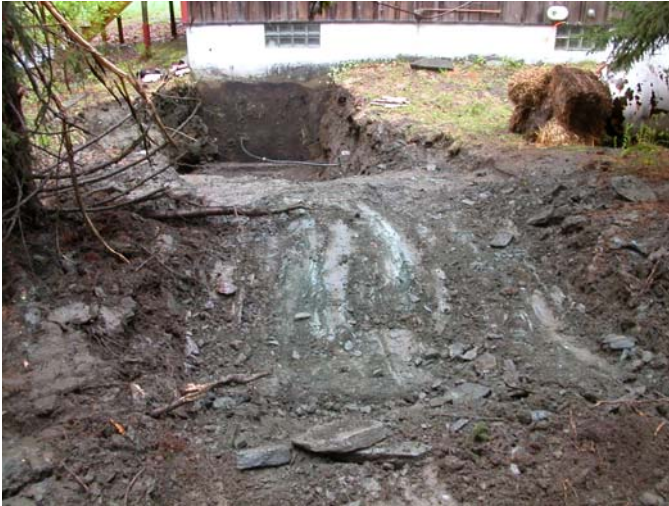
Polyencapsulated soil pile west of
excavation area.
