RE: *Emergency Response and Receptor Survey – Gasoline AST Fuel Release
Fred's Plumbing and Heating Bulk Storage Facility – Derby, Vermont*

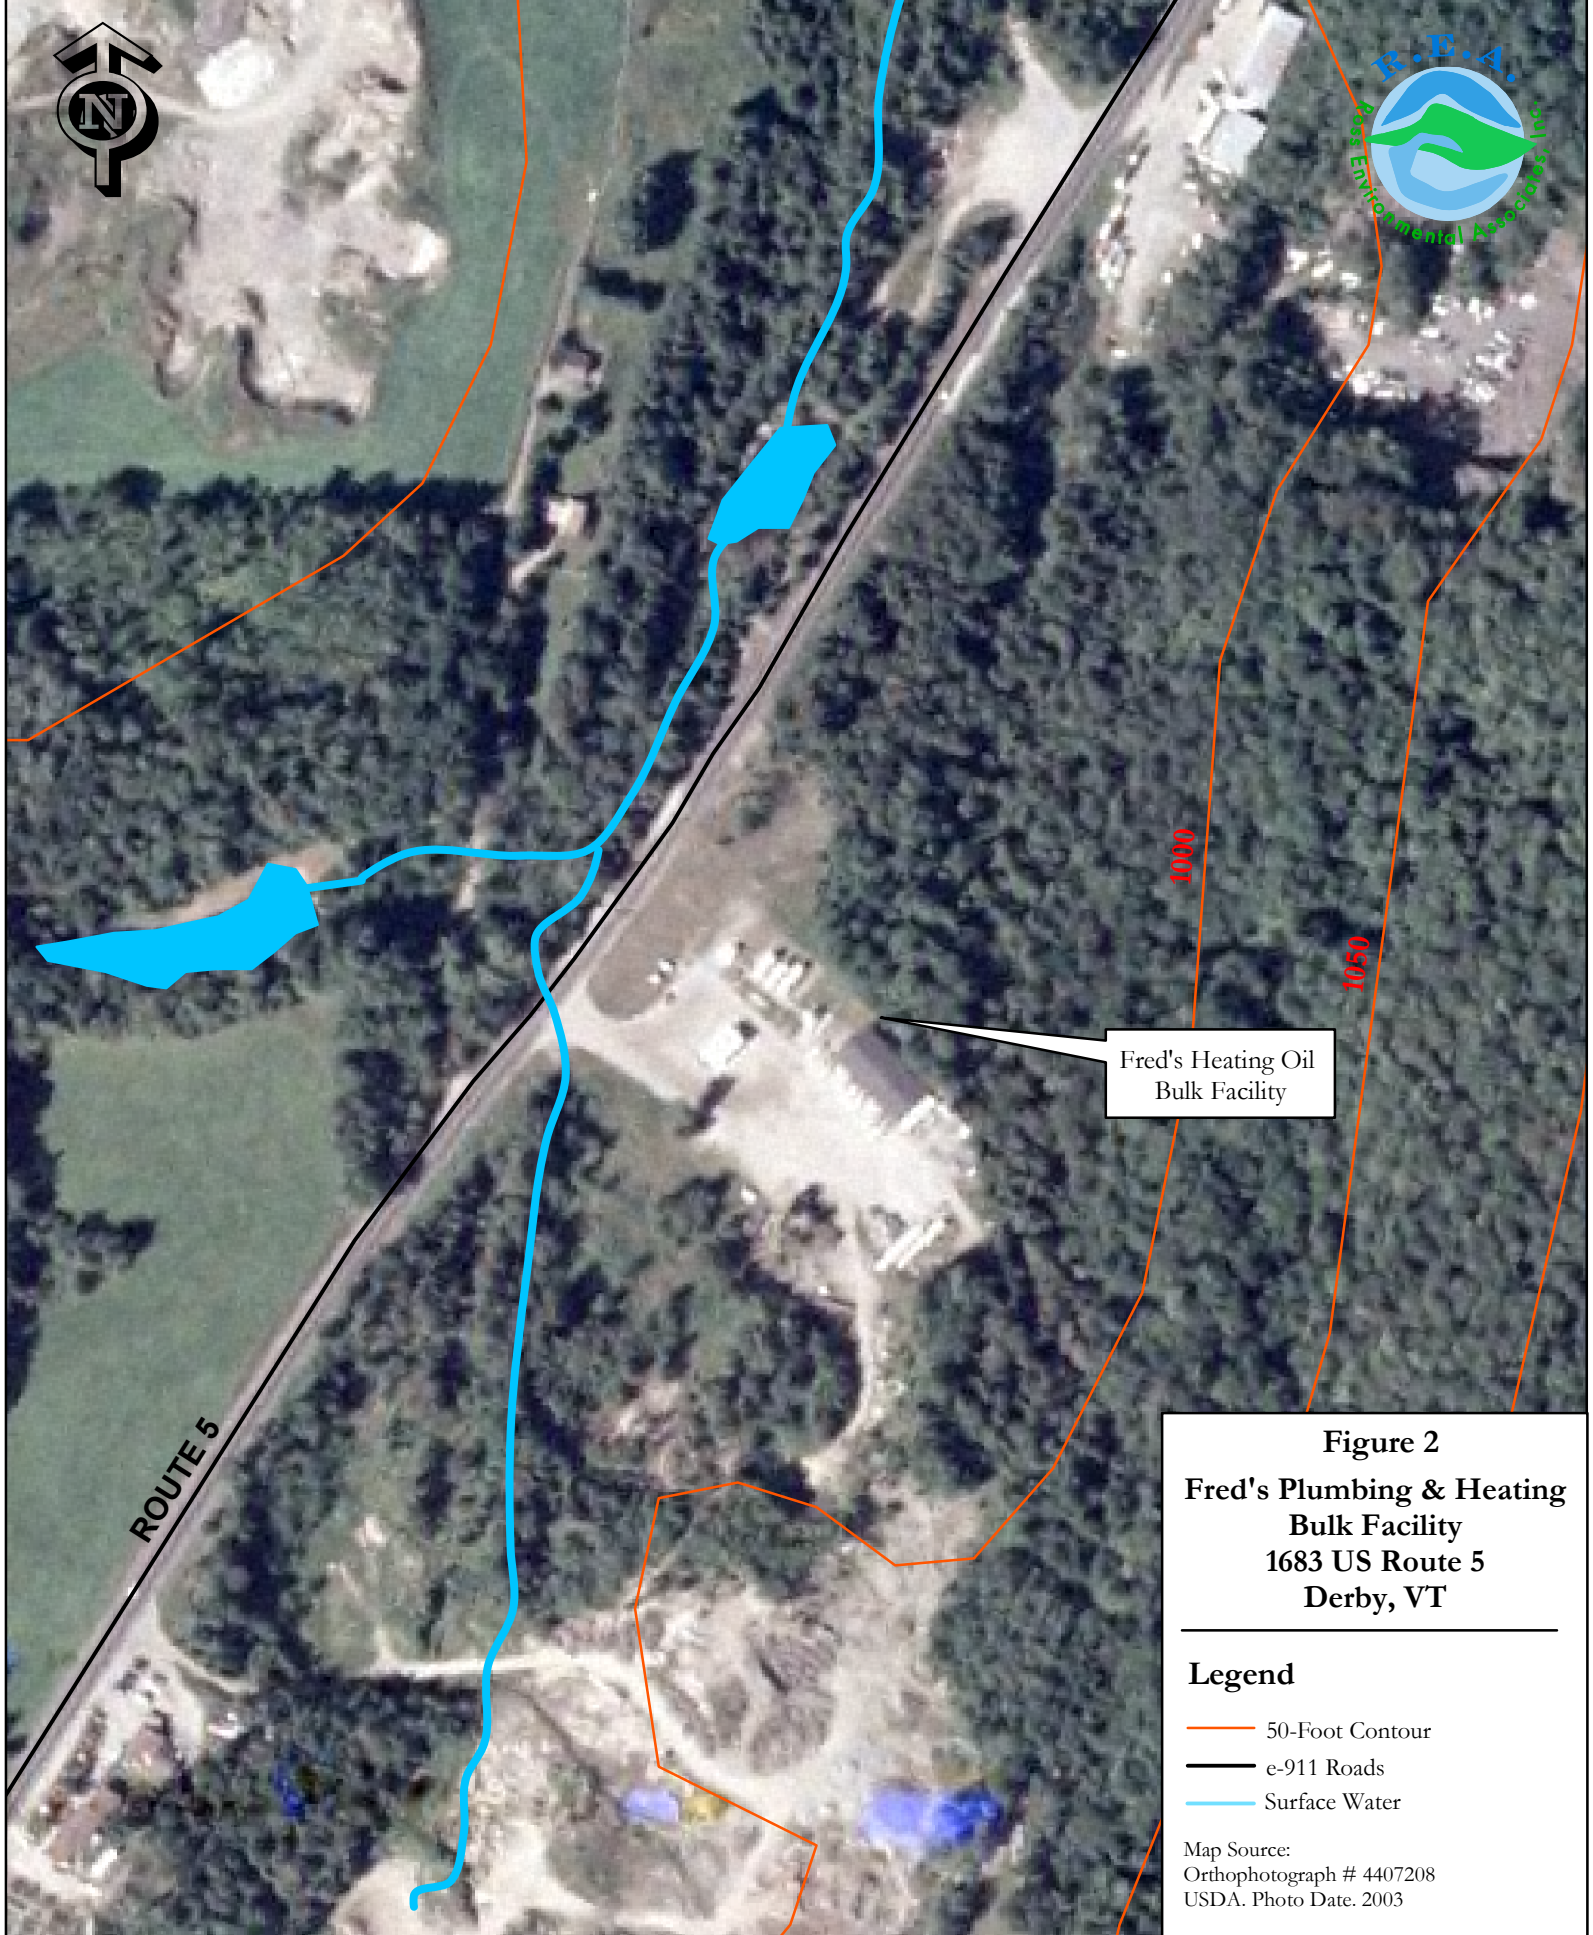
Figure 2
Fred's Plumbing & Heating Bulk Facility
1683 US Route 5
Derby, VT

The spill occurred at the bulk storage facility operated by Fred's Plumbing and Heating located at 1683 US Route 5 in Derby, Vermont. The coordinates for the spill area are 44° 58' 24.5"N and 72° 07' 2.0"W. The secondary containment area is located on the northwest corner of the property. Six above ground storage tanks are located within the clay-lined containment area; Tank 1A (12,000-gallon #2 fuel oil), Tank 1B (12,000-gallon diesel), Tank 2A (12,000-gallon #2 fuel oil), Tank 2B (12,000-gallon kerosene), Tank 3A (10,000-gallon high-octane gasoline) and Tank 3B (15,000-gallon unleaded gasoline). An unnamed tributary to the Johns River is located approximately 200 feet northwest of the spill area. During the initial response, four drinking water supply wells were identified within 1,500 feet of the spill area; three off-site wells and one on-site well. The on-site drinking water supply is a shallow spring that is located approximately 200 feet upgradient to the southeast of the spill area. The nearest downgradient supply well is located approximately 550 feet to the north-northwest. No other receptors were identified within close proximity to the spill. Potential receptors and significant site features are shown on **Figure 2** in Attachment A.

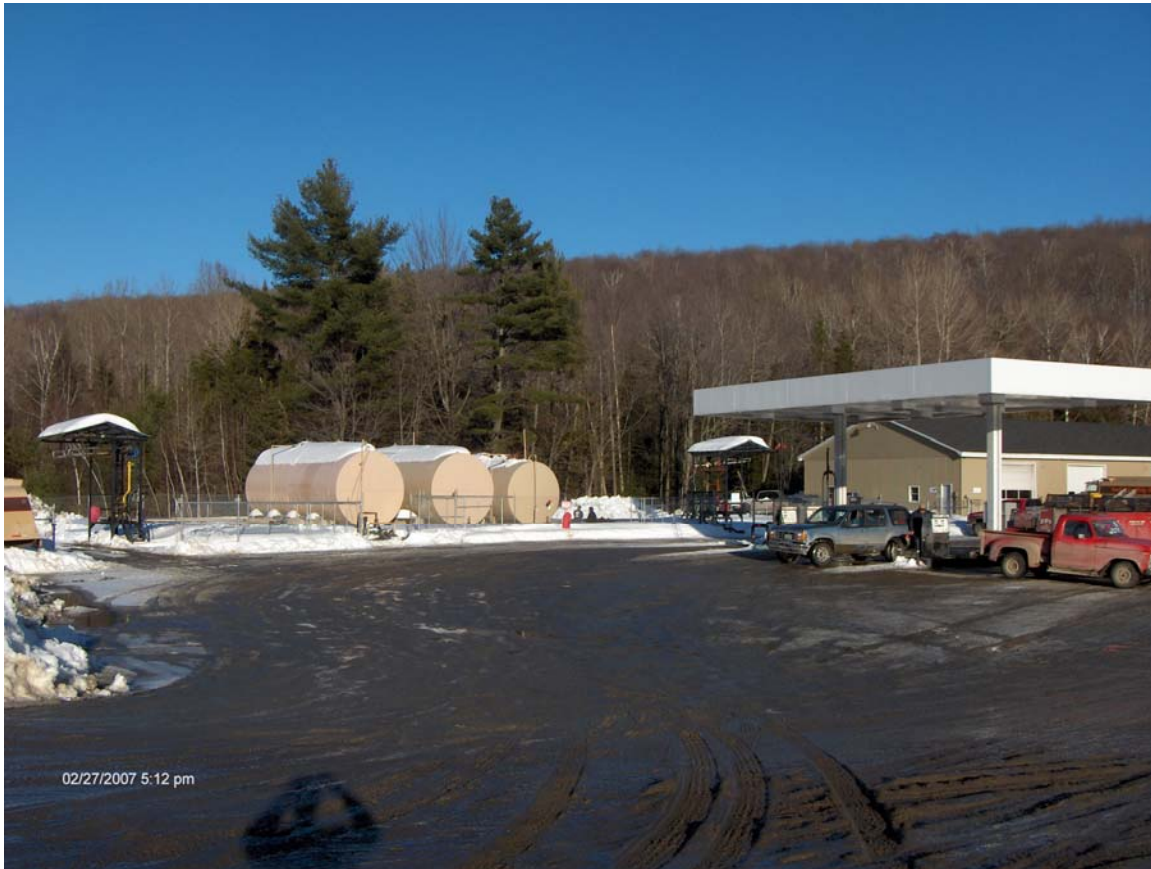
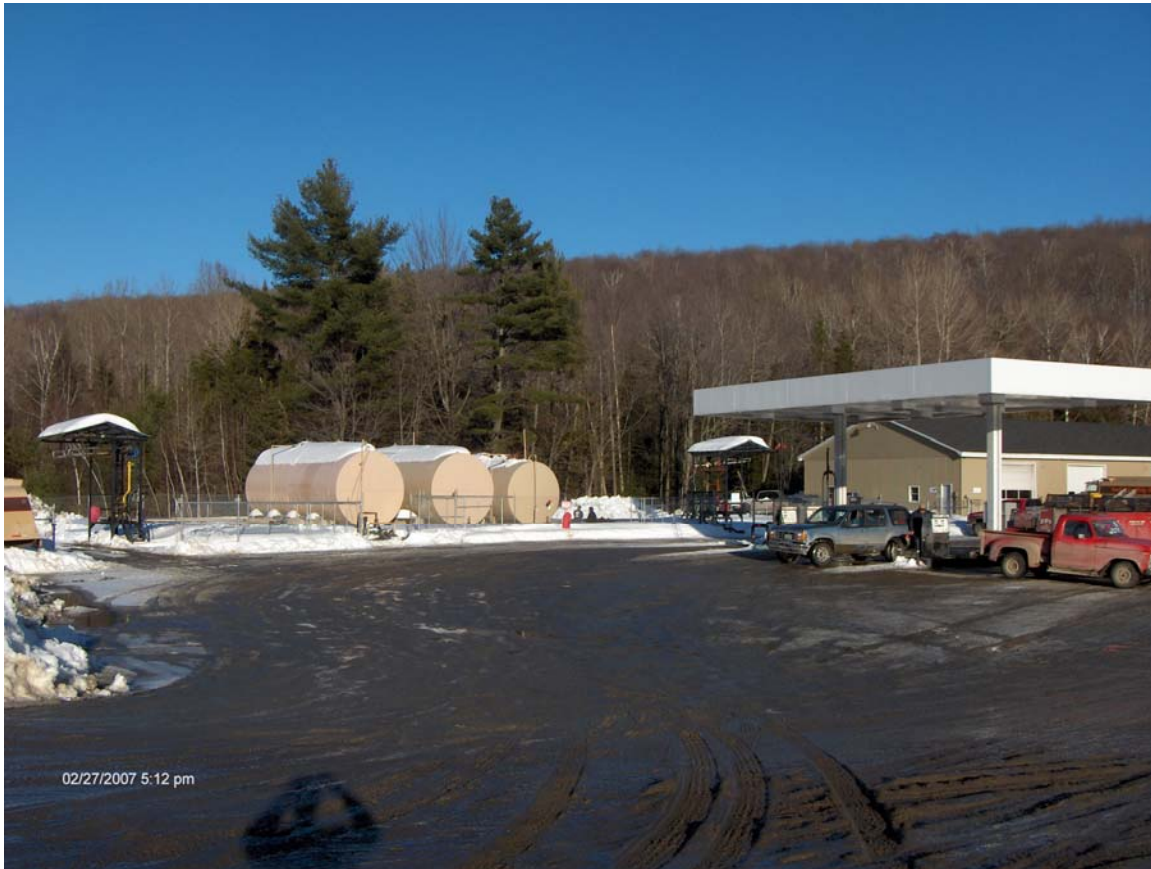
FP&H BULK STORAGE FACILITY – DERBY, VERMONT
(Site Overview – View Toward North-Northeast)

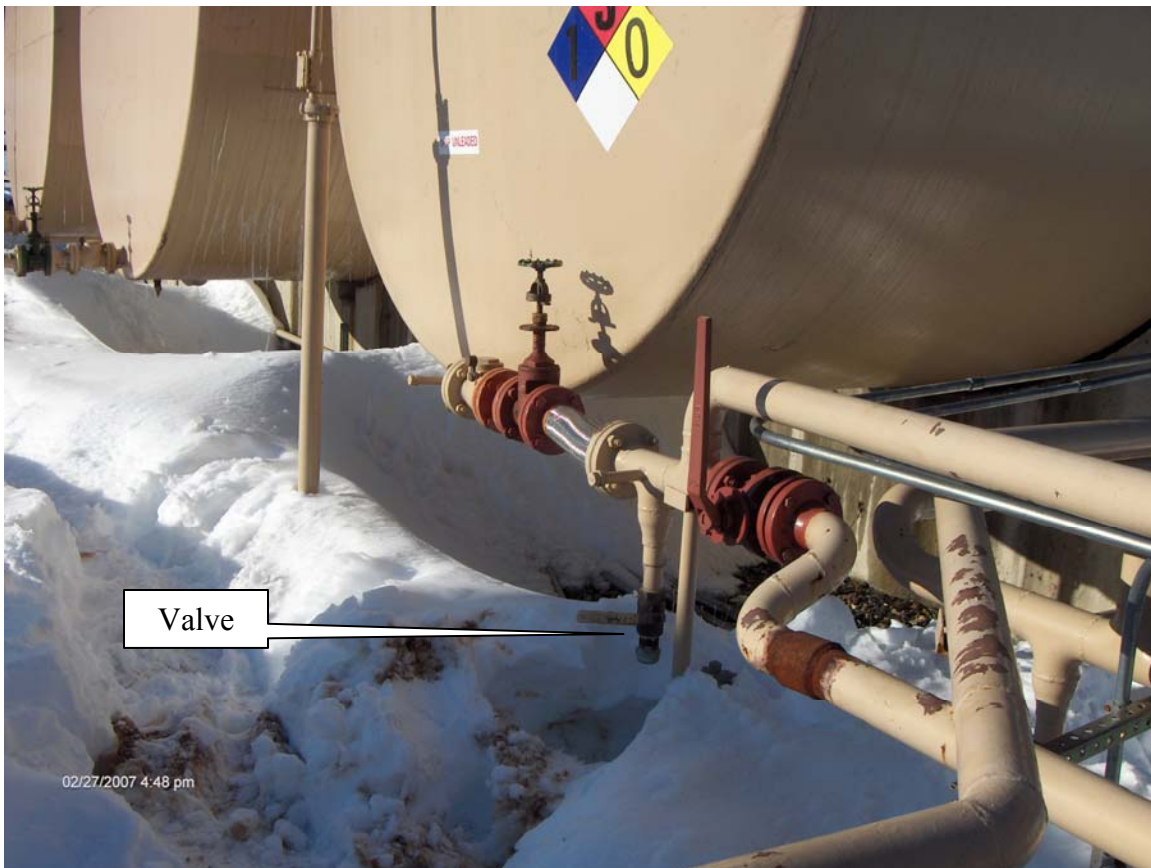
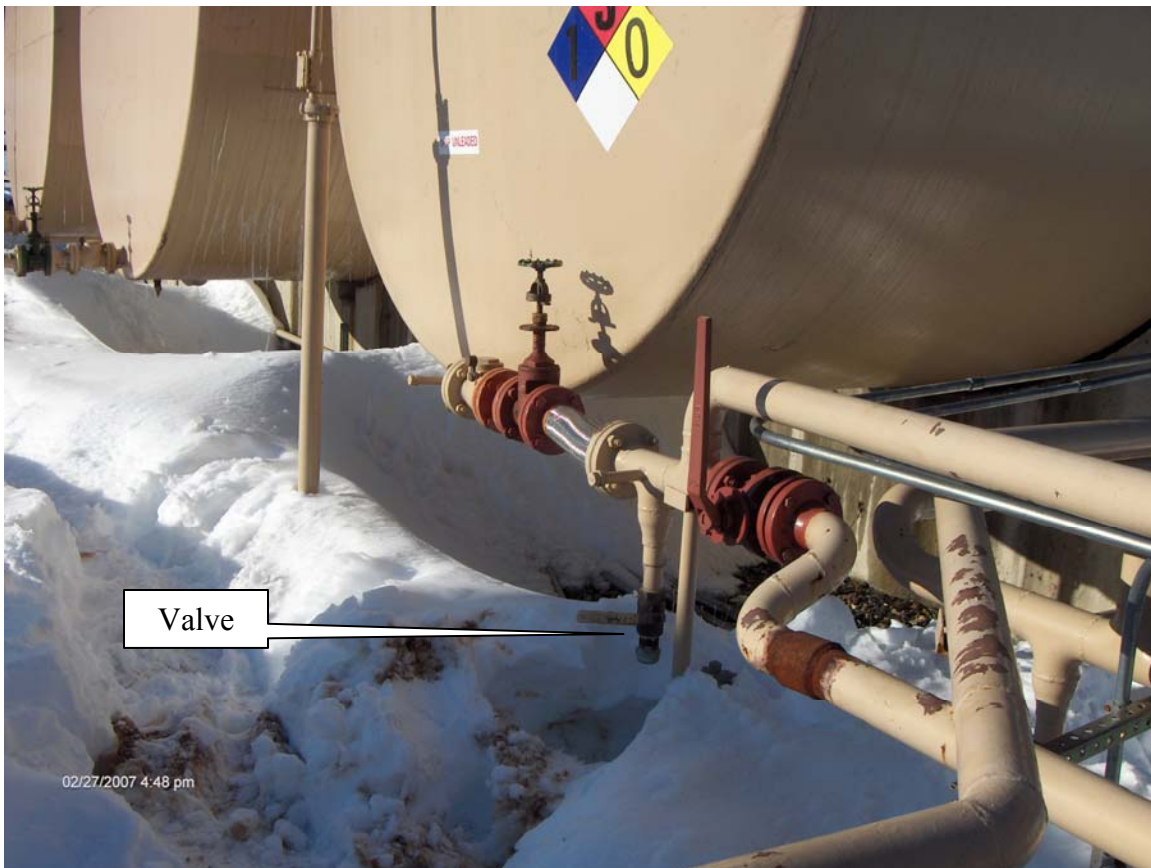
- The spill was the result of snow falling off the top of the AST, which partially opened a gate-type valve located at the base of the tank.
- Approximately 5,000 gallons of gasoline were released into the clay-lined secondary containment area and surrounding soils.
- The secondary containment area consisted of an approximately six-inch thick clay liner with a two foot high berm encompassing approximately 4,000 square feet. According to Mr. Scott Oeschger, the clay was resurfaced a few years ago.
- The drain for the secondary containment area, which is located in the northeast corner of the containment area, is connected to a 1,000-gallon oil-water separator. The oil-

FP&H BULK STORAGE FACILITY – DERBY, VERMONT
(Point of Release (Valve) – View Toward Northwest)

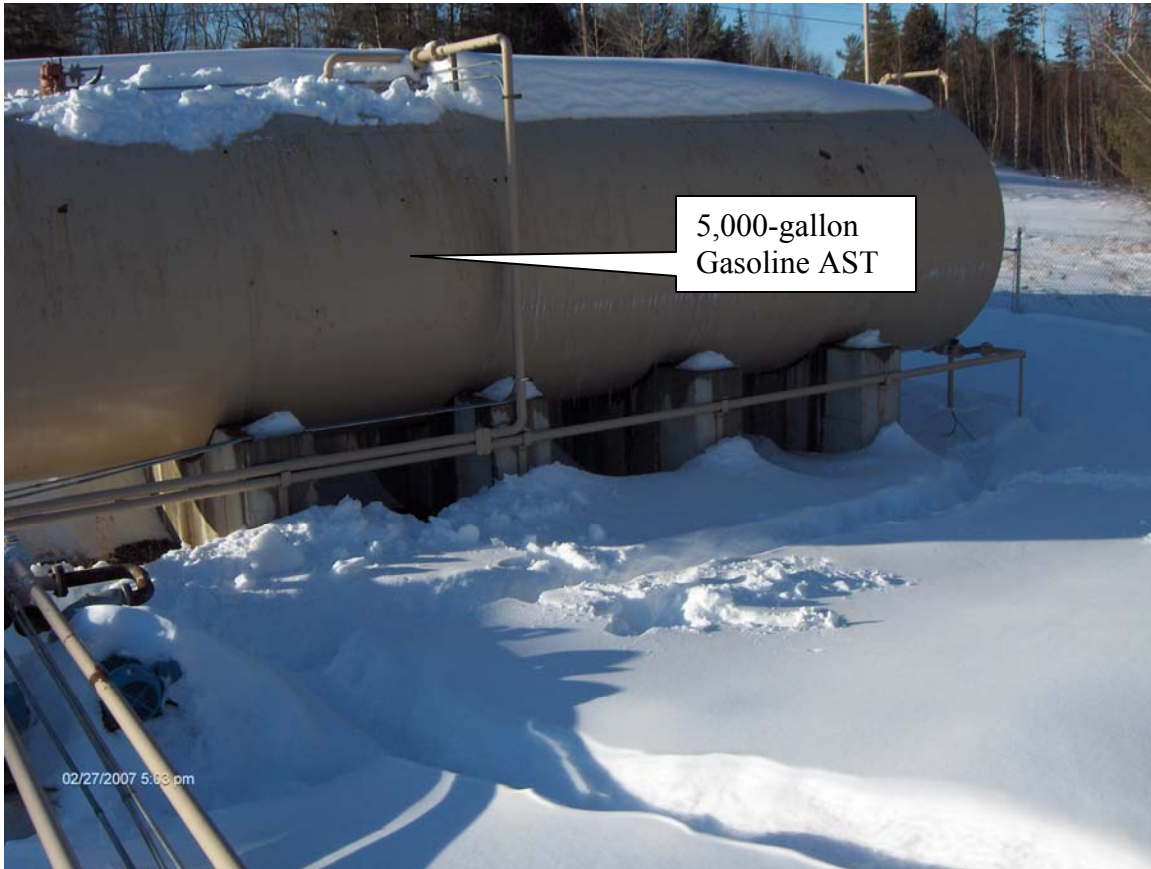
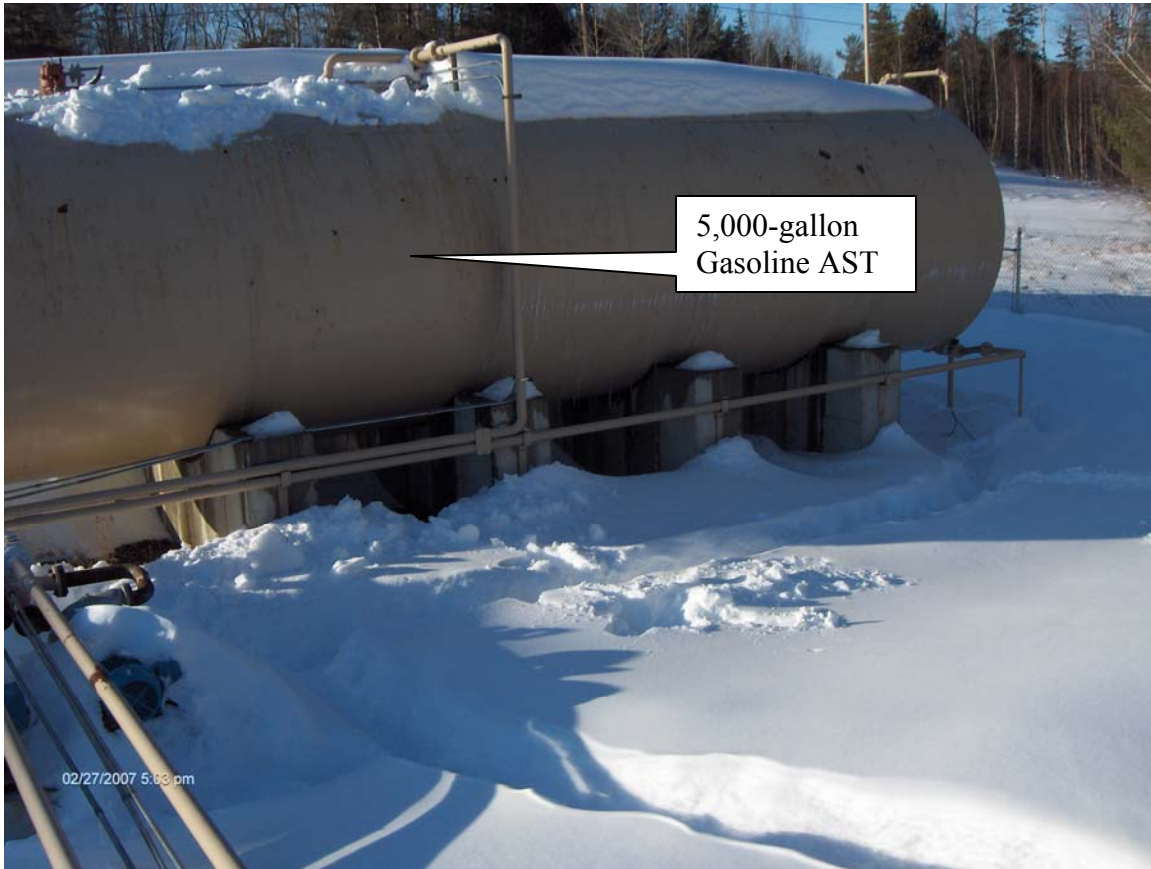
FP&H BULK STORAGE FACILITY – DERBY, VERMONT
(Containment Berm covered with Gas contaminated snow – View toward North)

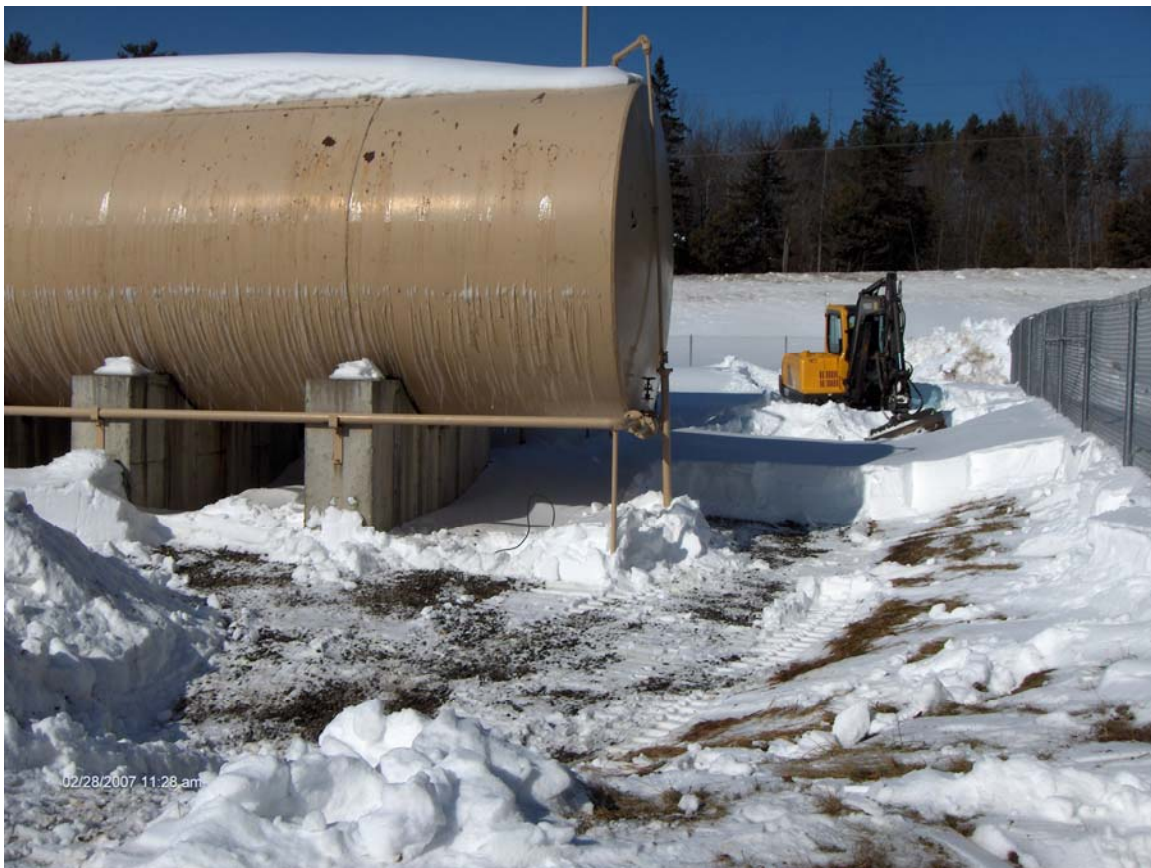
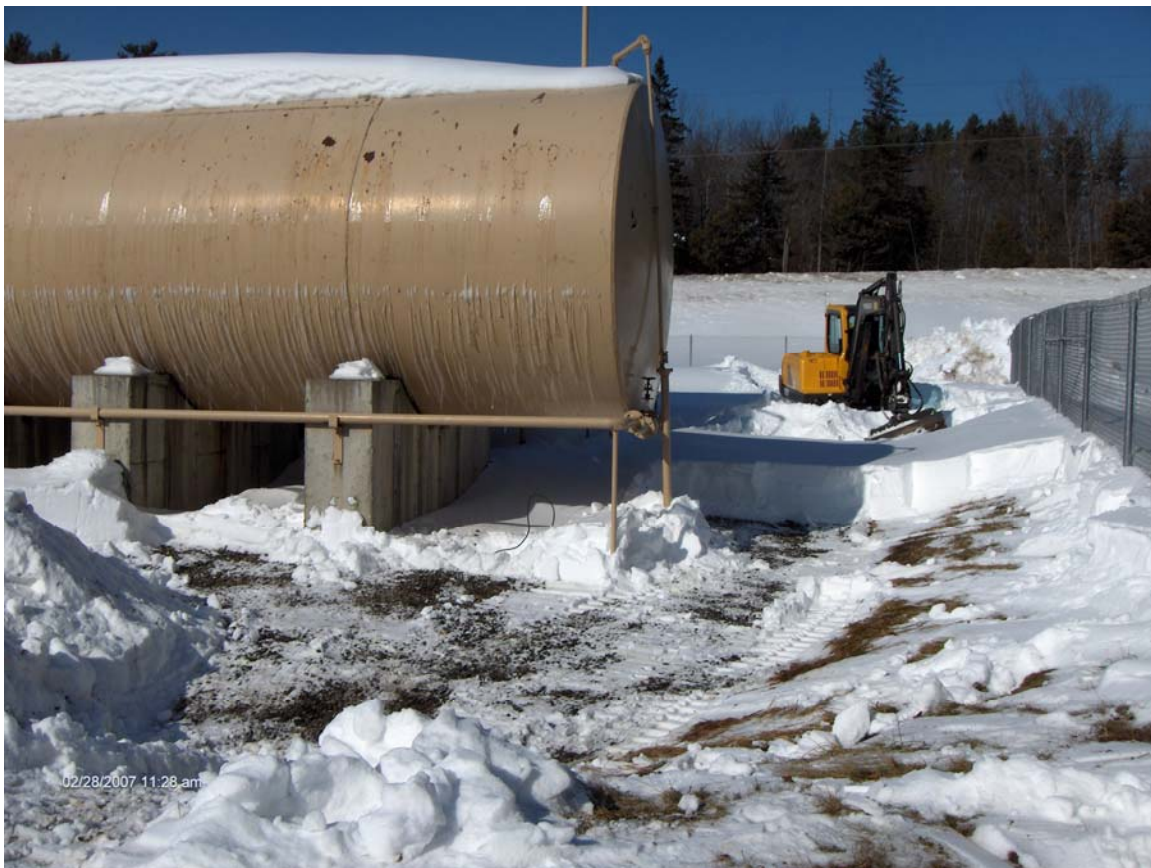
FP&H BULK STORAGE FACILITY – DERBY, VERMONT
(Removal of Gas contaminated snow – View Toward West)

- Approximately 30 cubic yards of gasoline contaminated snow were removed from the secondary containment area and placed into two 20 cubic yard roll-off dumpsters, lined with polyethylene.

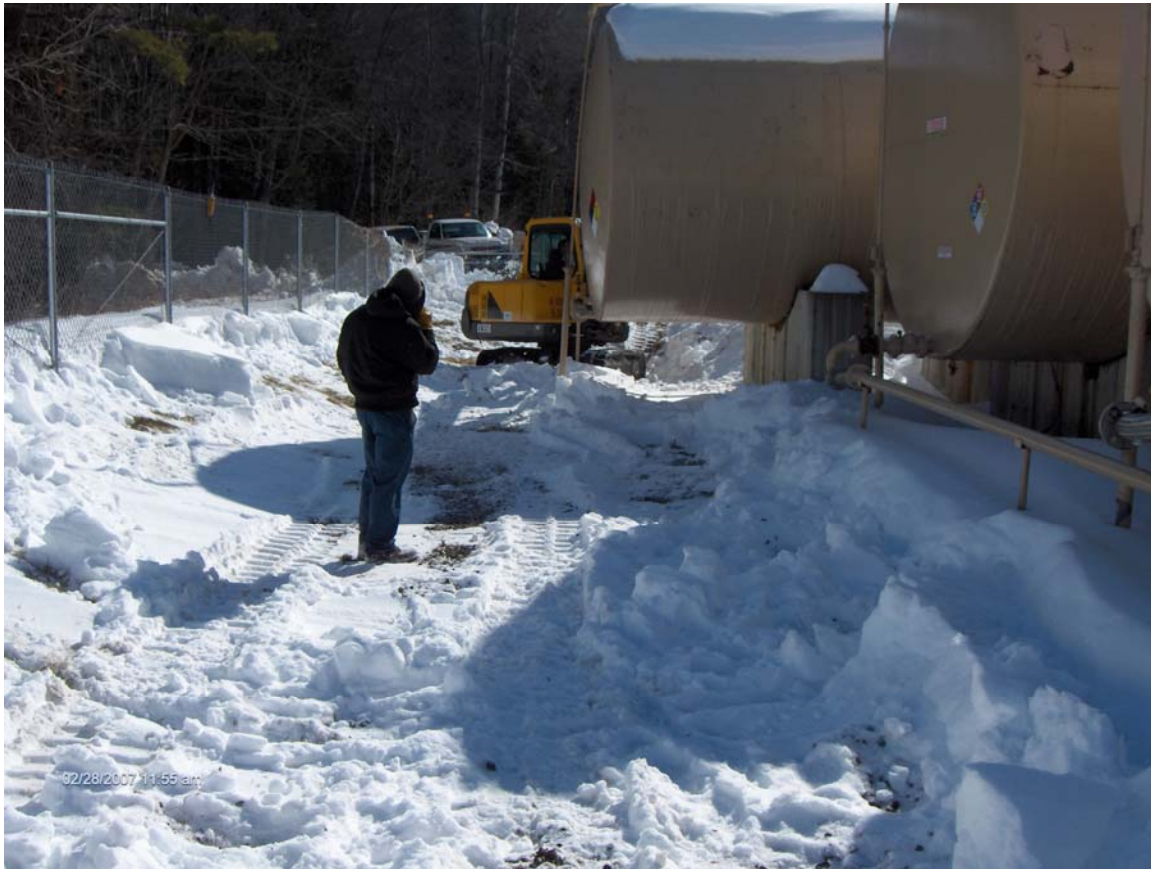
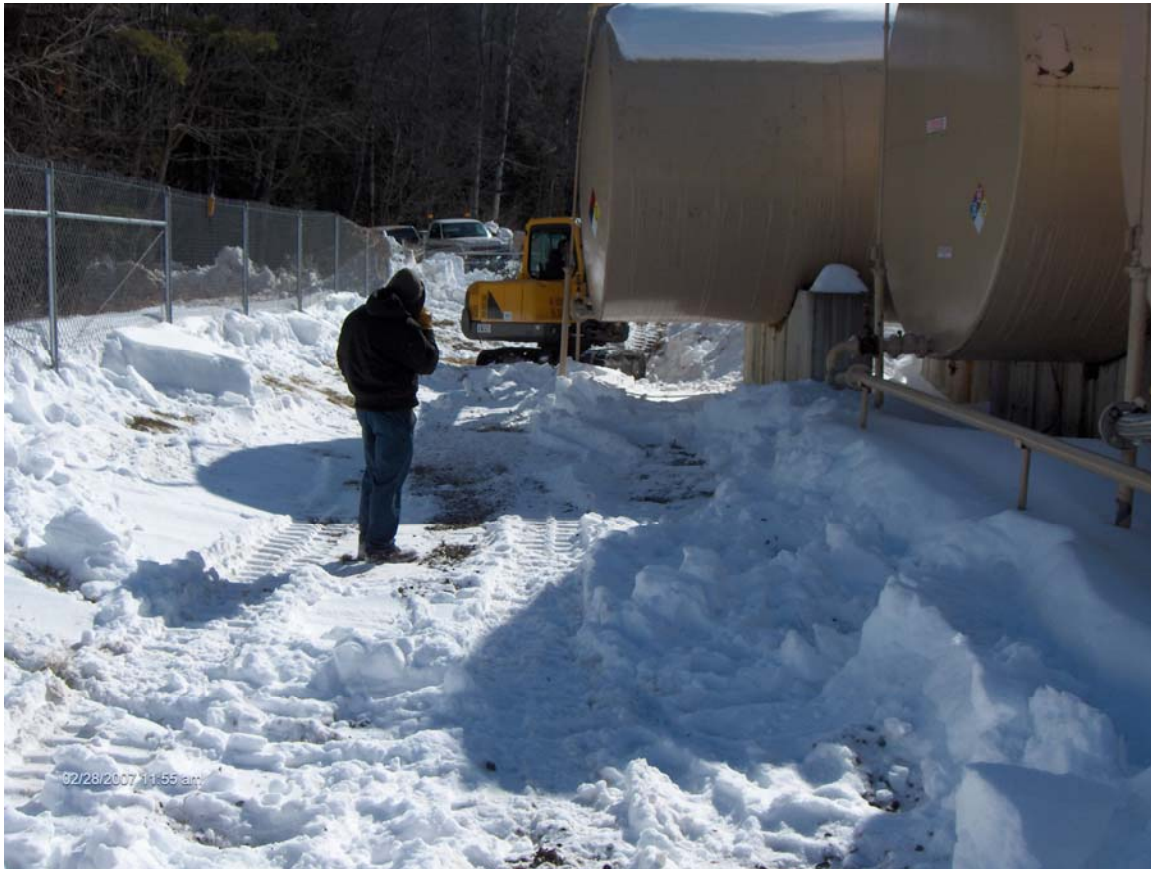
FP&H BULK STORAGE FACILITY – DERBY, VERMONT
(Removal of Gas contaminated snow – View toward East)

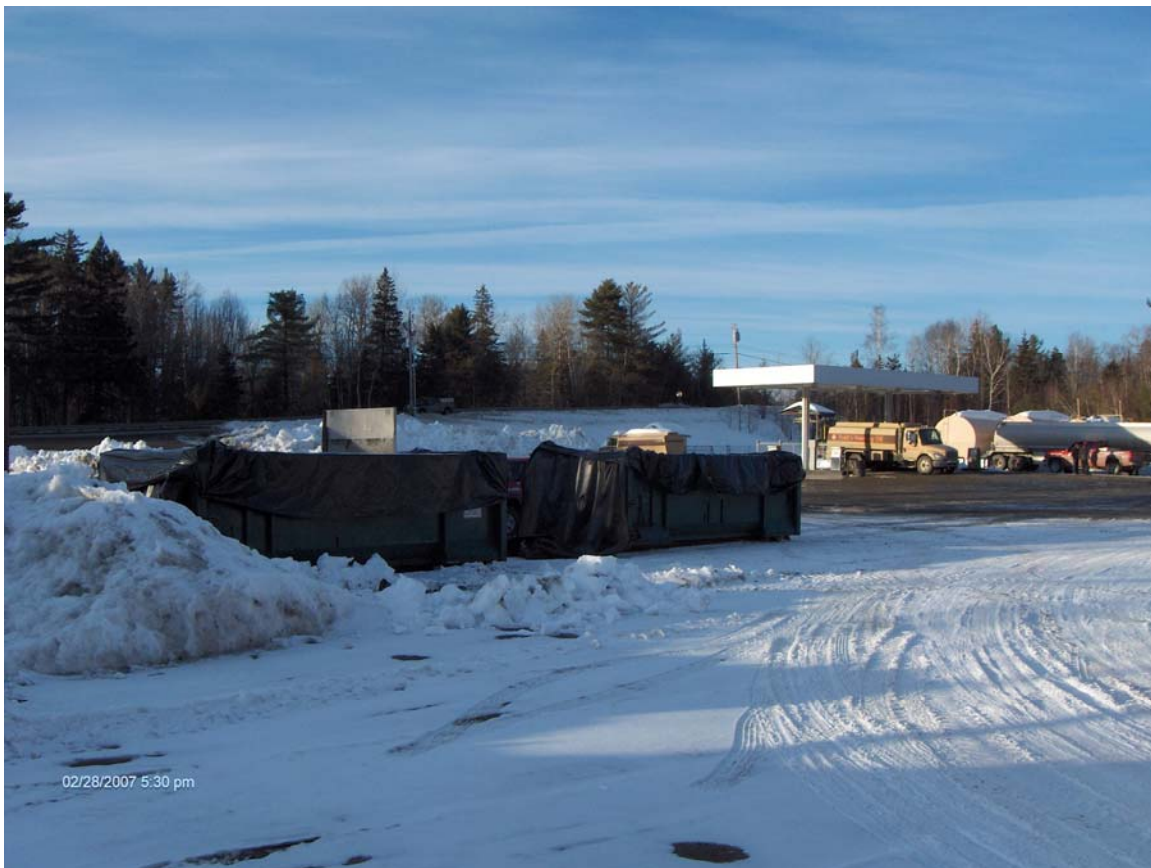
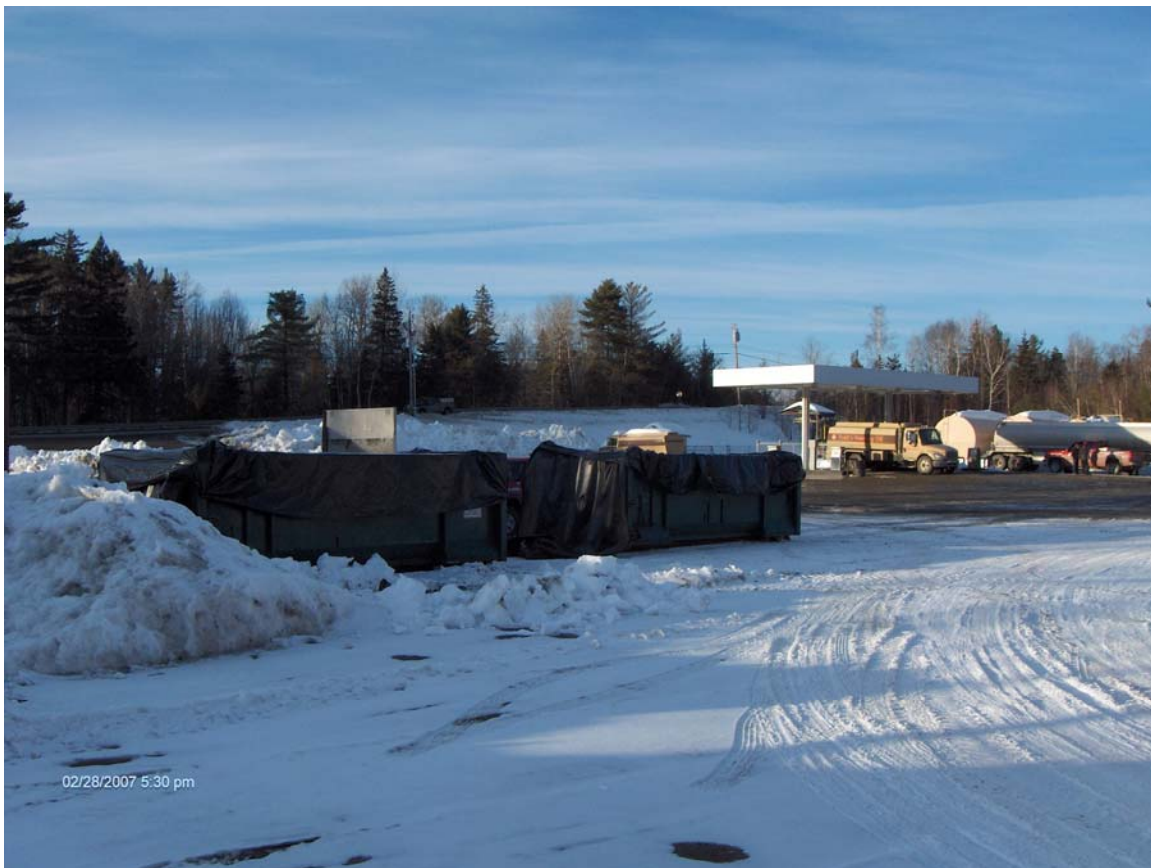
FP&H BULK STORAGE FACILITY – DERBY, VERMONT
(Poly-lined dumpsters to contain contaminated snow – View Toward North)

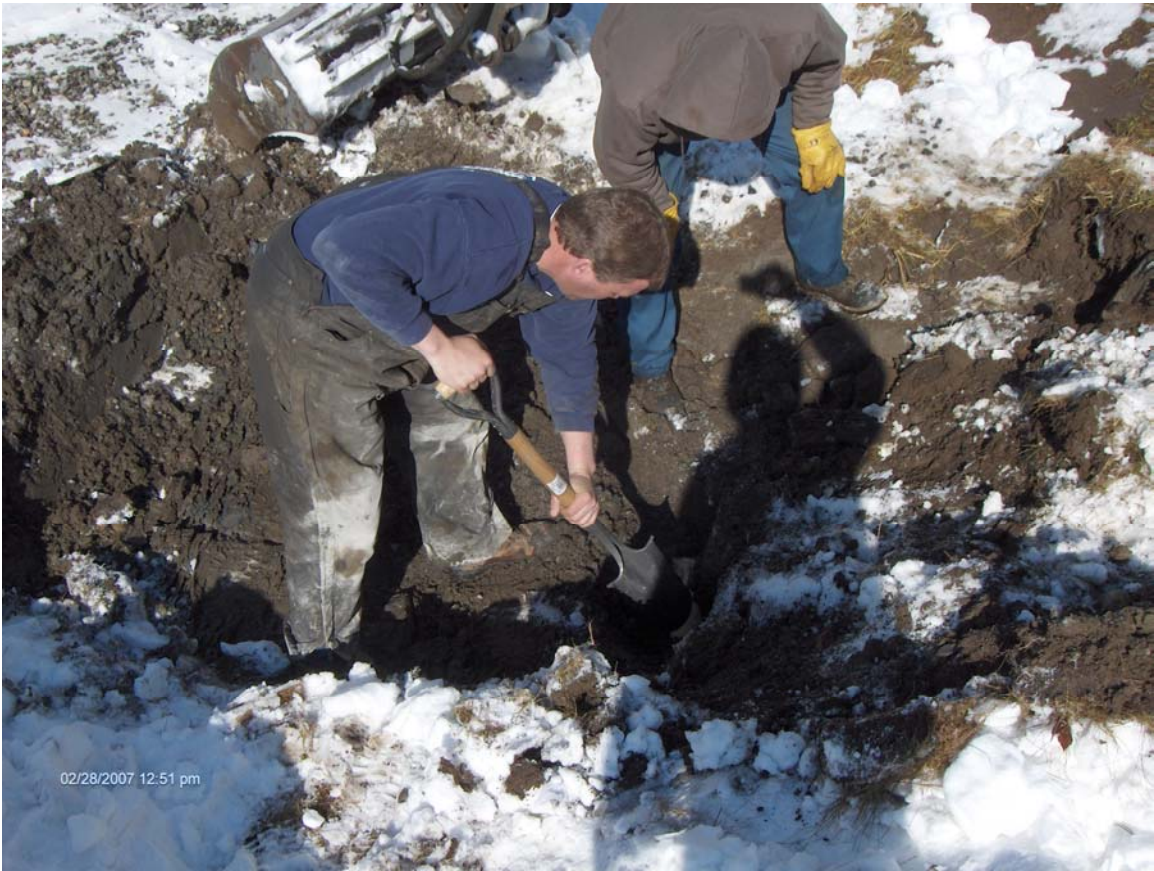
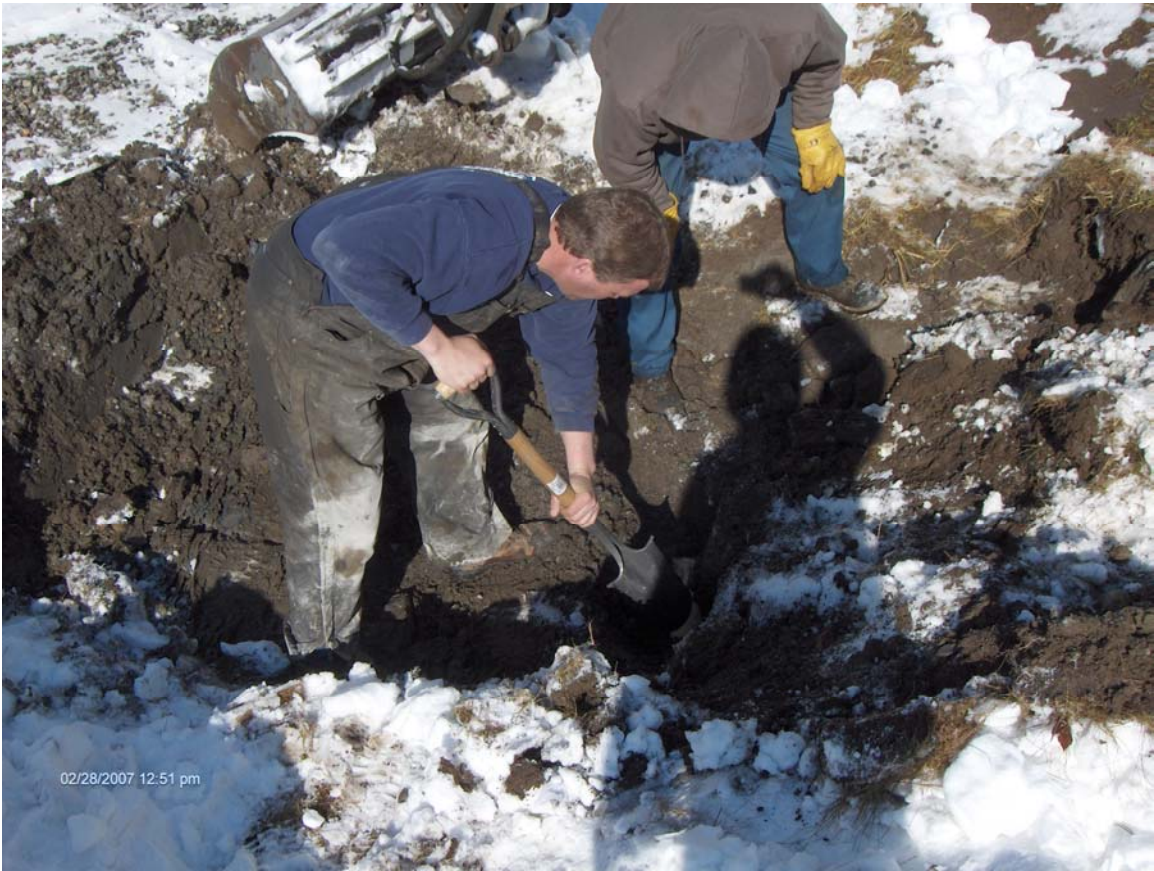
water separator was found to be full of water with approximately an eighth inch of product on top. The outlet for the oil-water separator is controlled by a valve that was found to be closed.

FP&H BULK STORAGE FACILITY – DERBY, VERMONT
(Location of Berm drain pipe in NE corner of Berm)

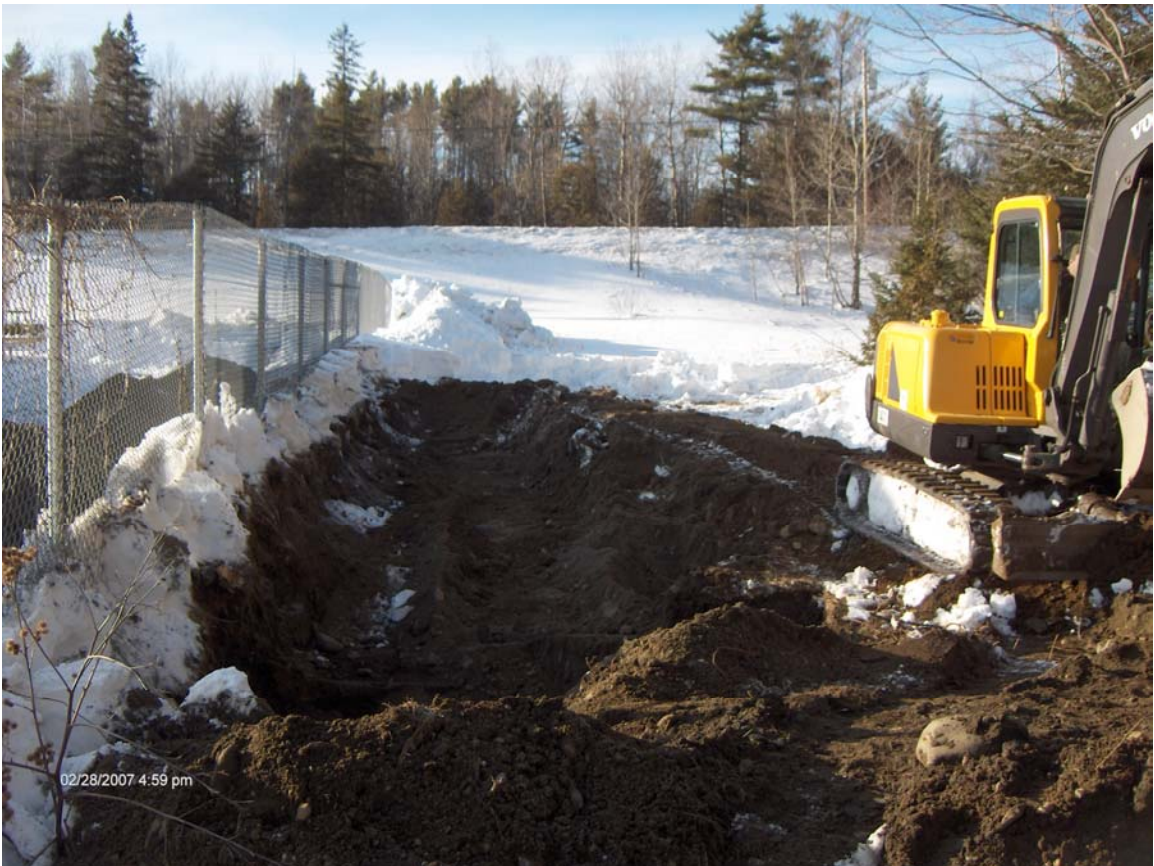
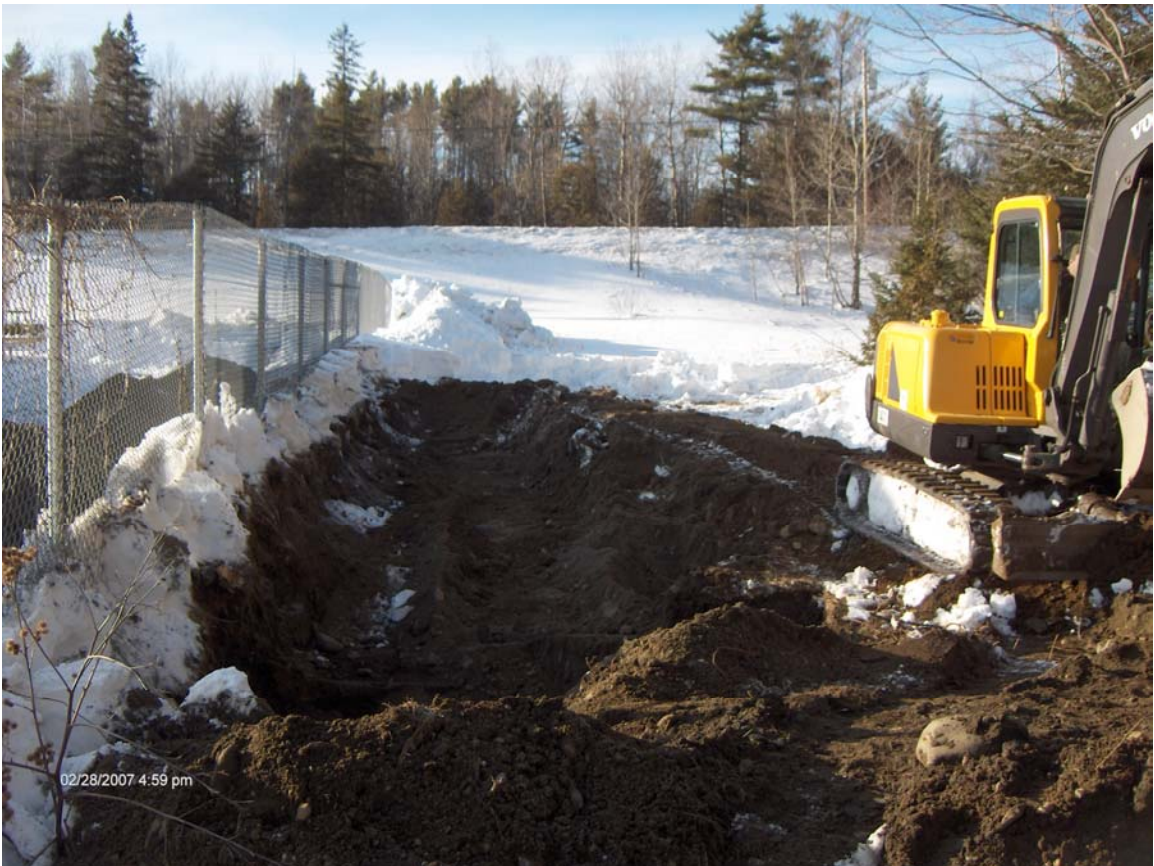
- The vertical and horizontal extent of contamination was not determined during the initial excavation activities.

FP&H BULK STORAGE FACILITY – DERBY, VERMONT
(Soil excavation to determine extent of contamination– View Toward West-Northwest)

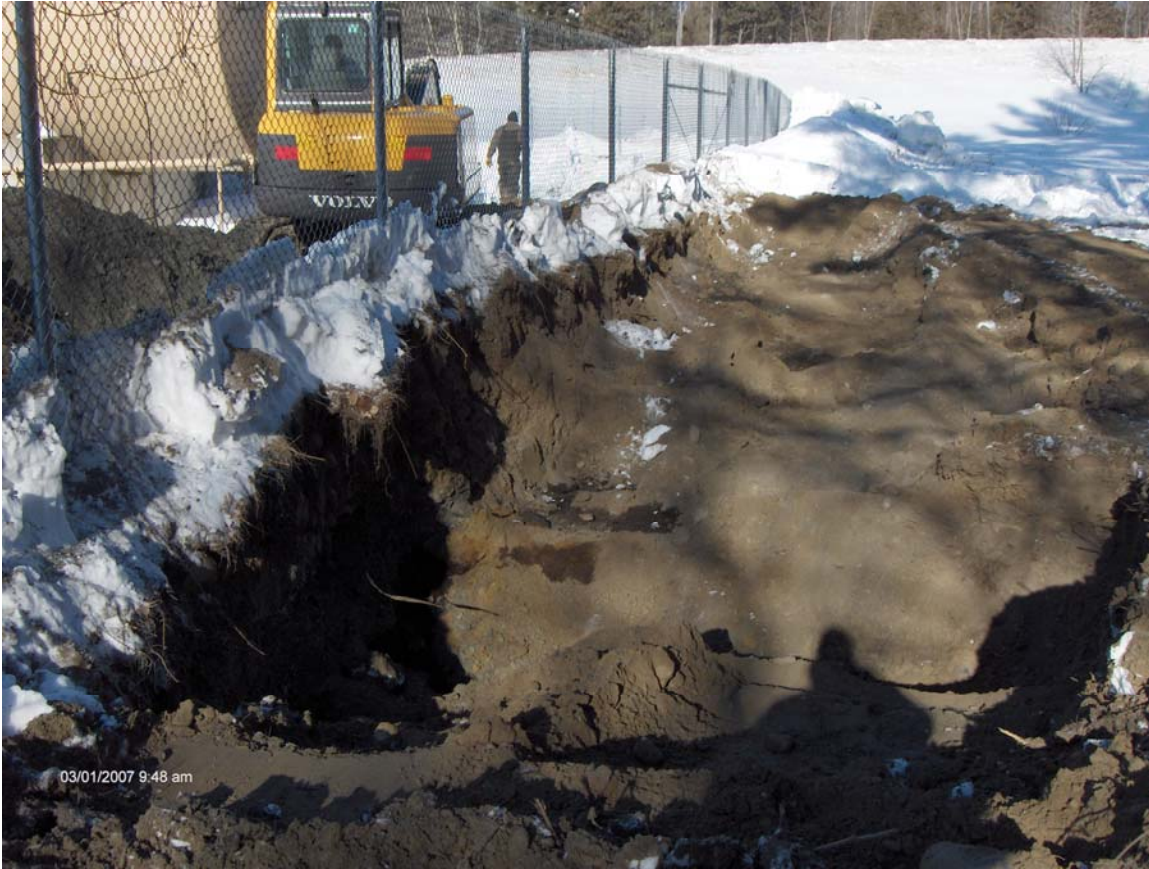
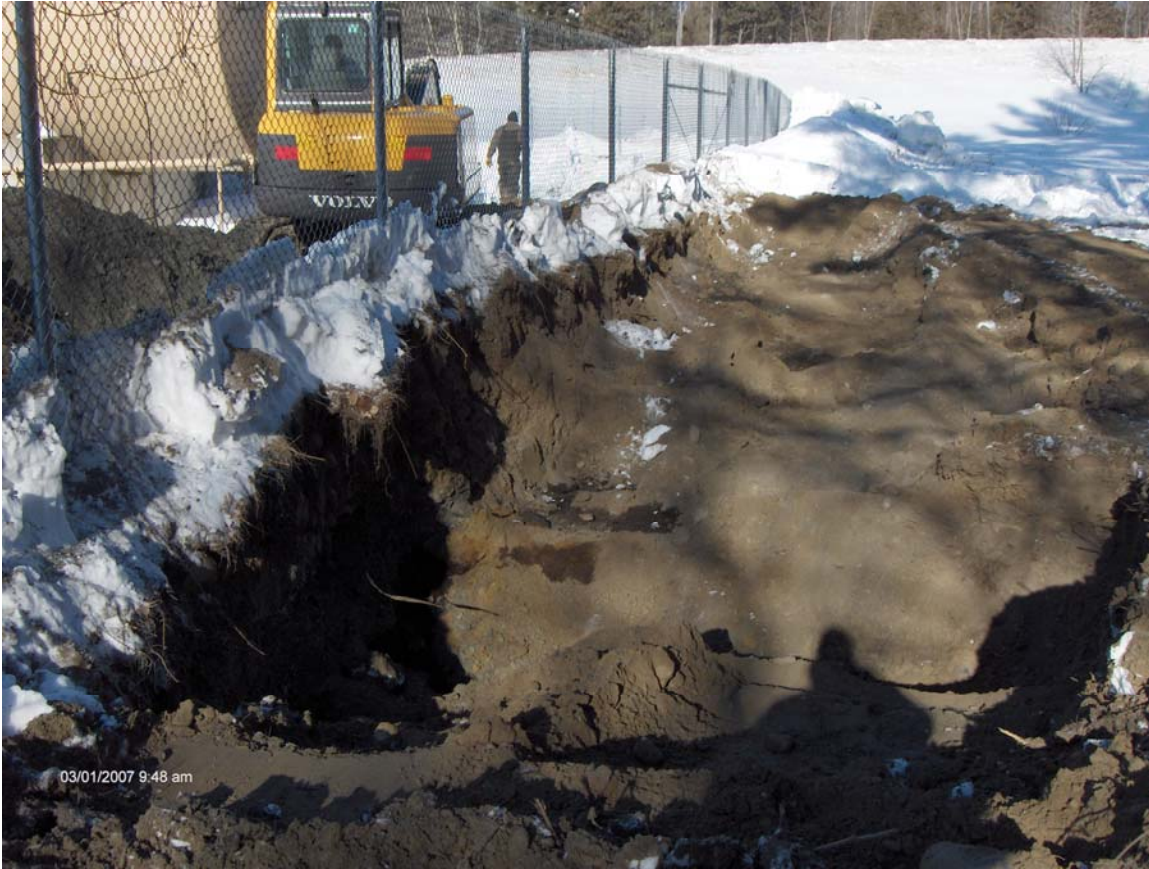
FP&H BULK STORAGE FACILITY – DERBY, VERMONT
(Seepage of product during night of 28 Feb. – View Toward West-Northwest)
