RE: *Emergency Response and Receptor Survey – Gasoline AST Fuel Release
Fred's Plumbing and Heating Bulk Storage Facility – Derby, Vermont*

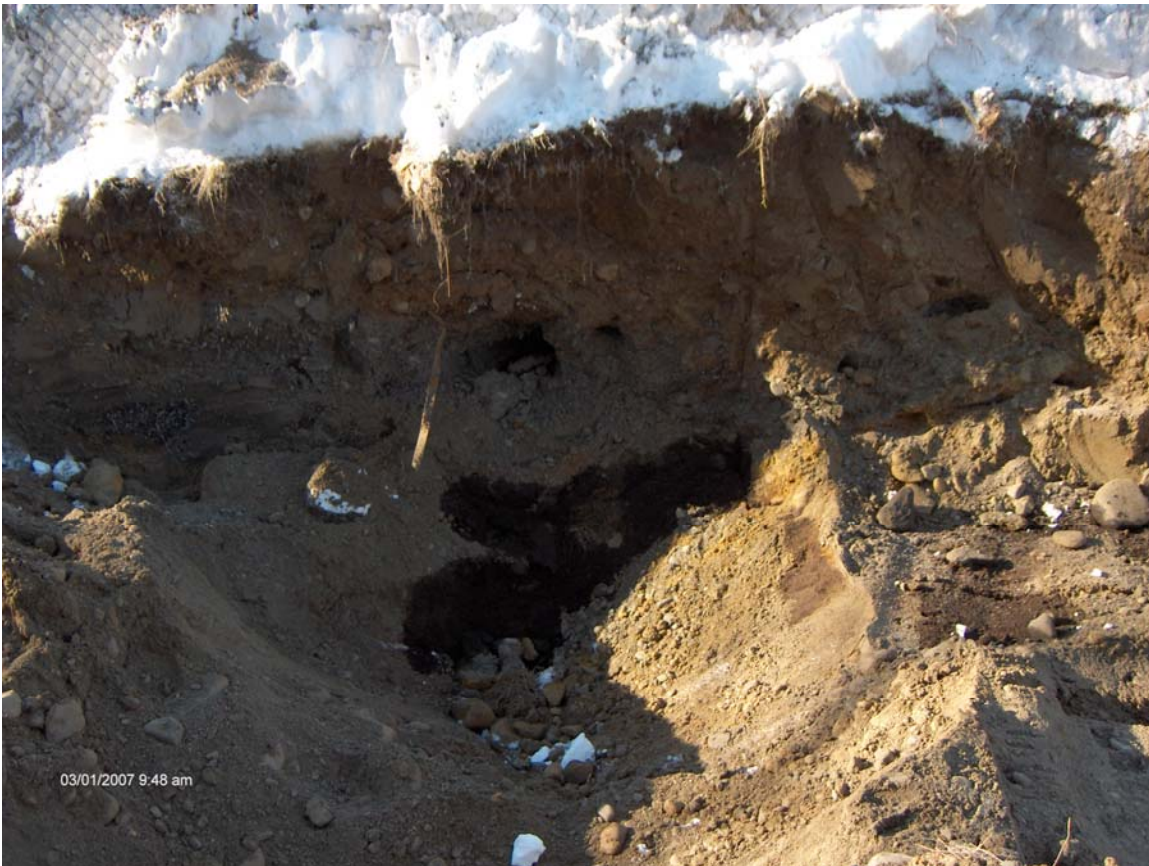
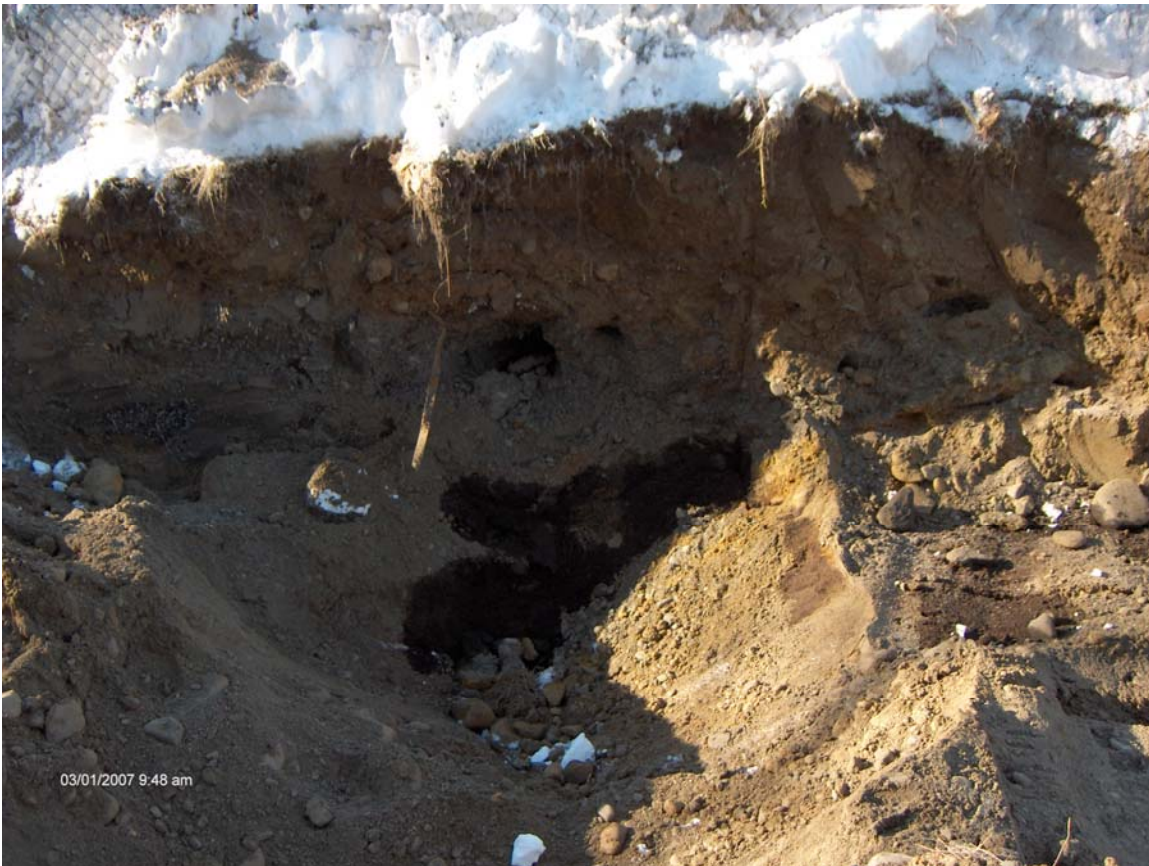
FP&H BULK STORAGE FACILITY – DERBY, VERMONT
(Seepage of product during night of 28 Feb.)

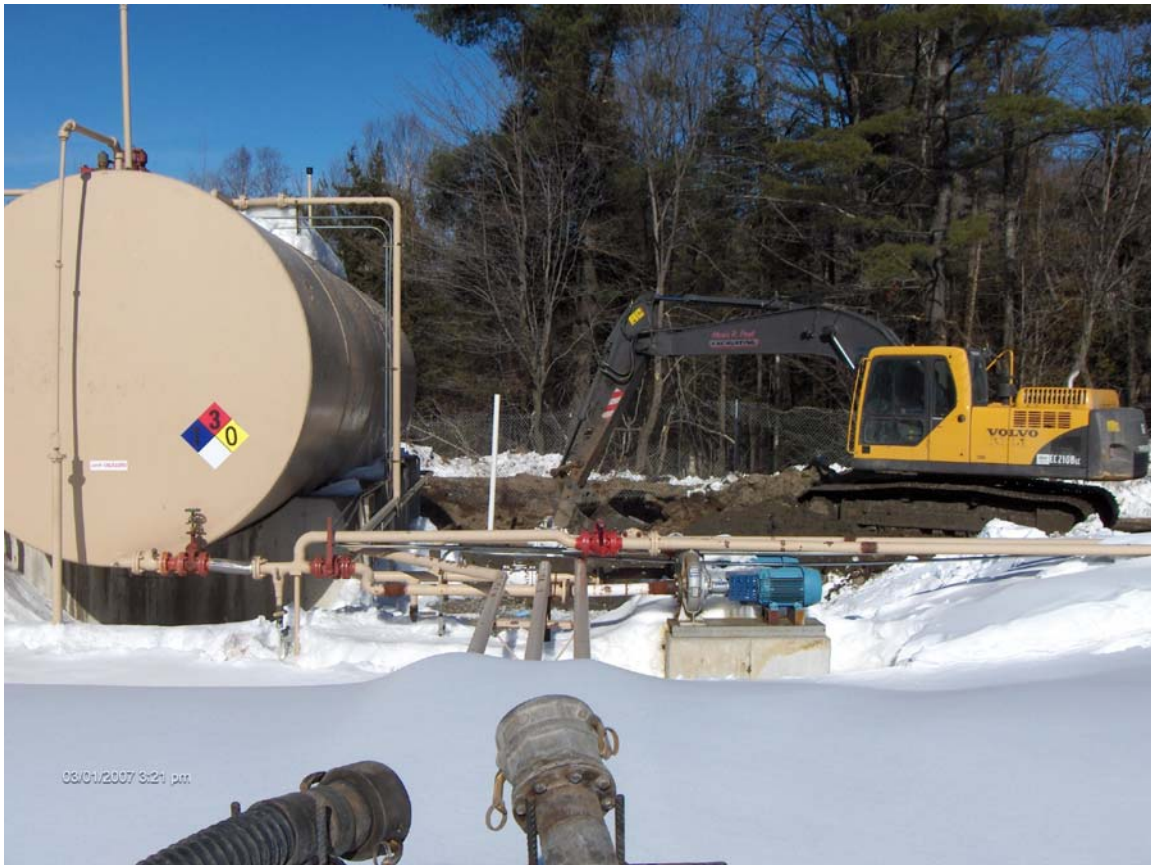
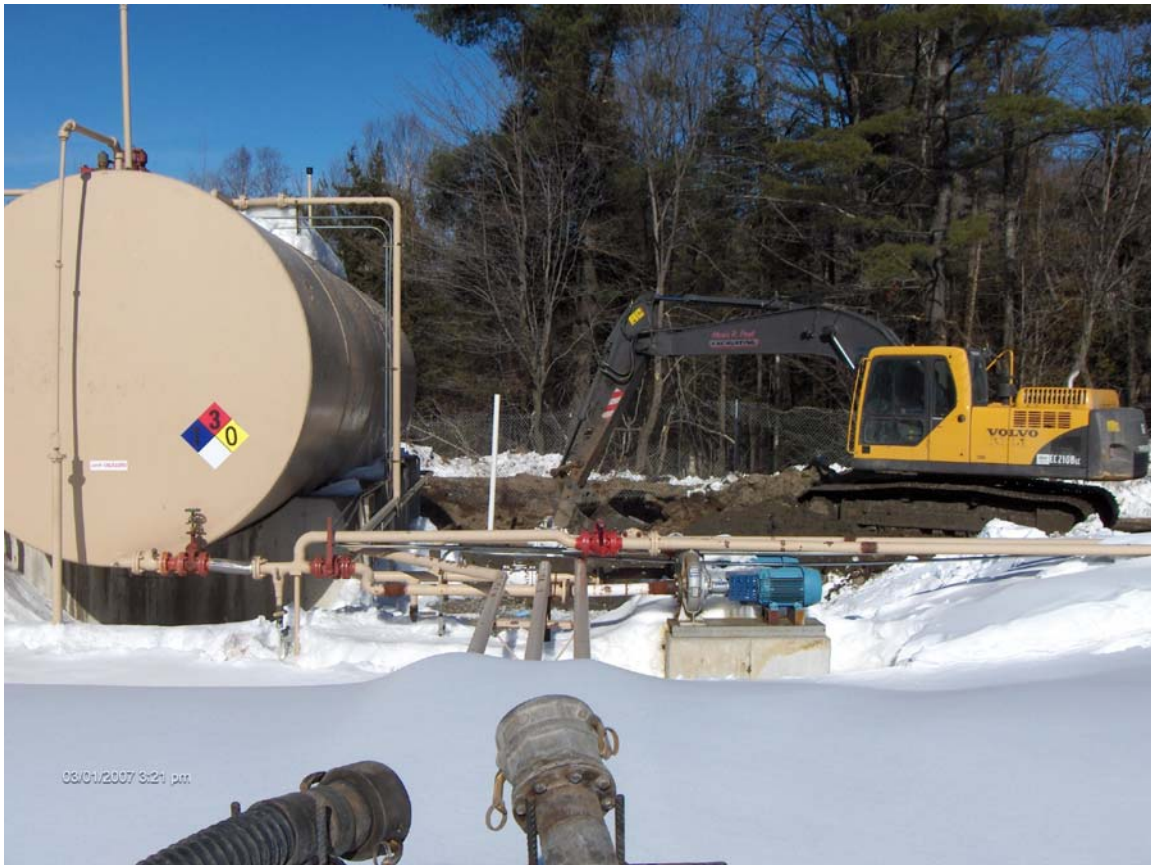
- The bermed containment area consisted of one foot of gravel overlying approximately six inches of clay. The native soil beneath and adjacent to the clay liner consisted of brown medium sand, silt and gravel to a depth of approximately 12 feet bgs. Medium sand extended from approximately 12 feet bgs to 14 feet bgs marking the bottom of the excavation.

The secondary containment area consisted of a six-inch thick clay liner with two foot high berm encompassing approximately 4,000 square feet. During excavation, the construction of the secondary containment area was found to contain inconsistent thicknesses of clay horizontally and almost no clay extending up the berm walls. According to Mr. Scott Oeschger, the concrete saddles that hold the six ASTs extend through the clay layer to a sub-clay concrete footer.

FP&H BULK STORAGE FACILITY – DERBY, VERMONT
(Excavating contaminated soil in berm area – View toward North)

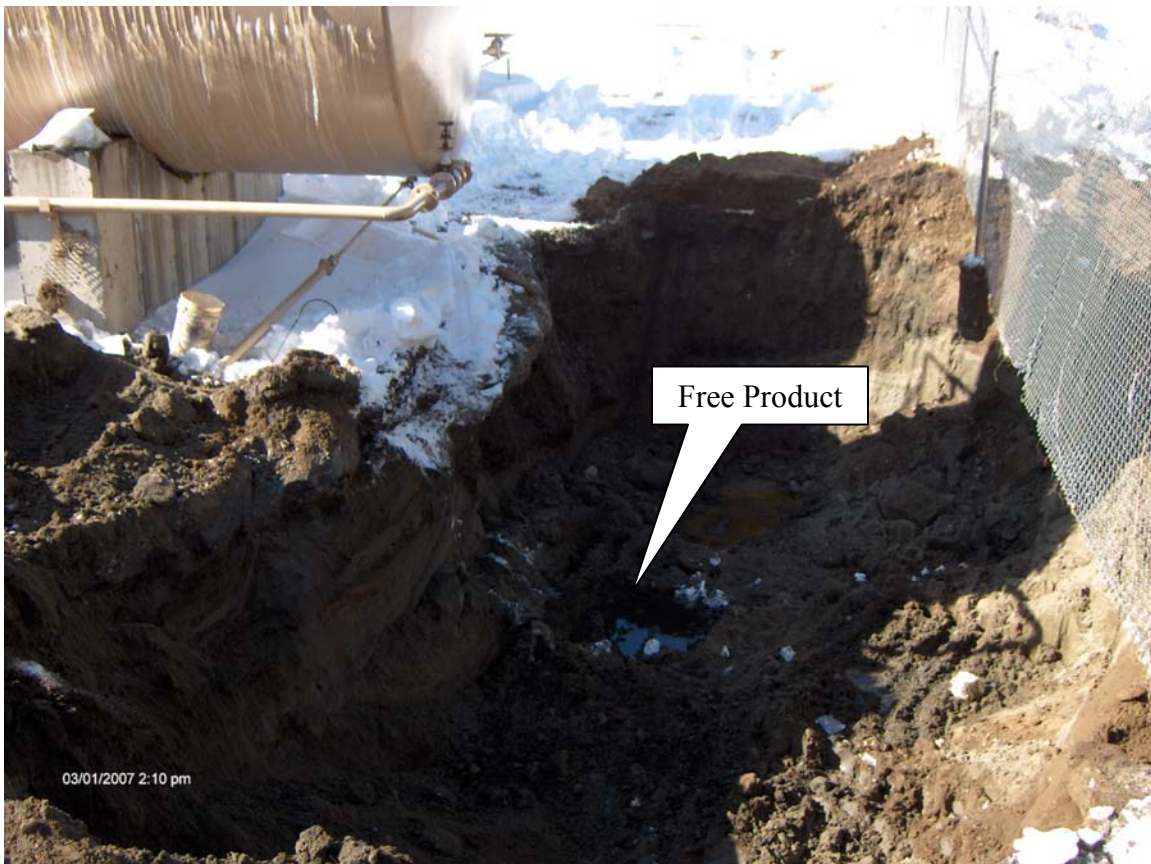
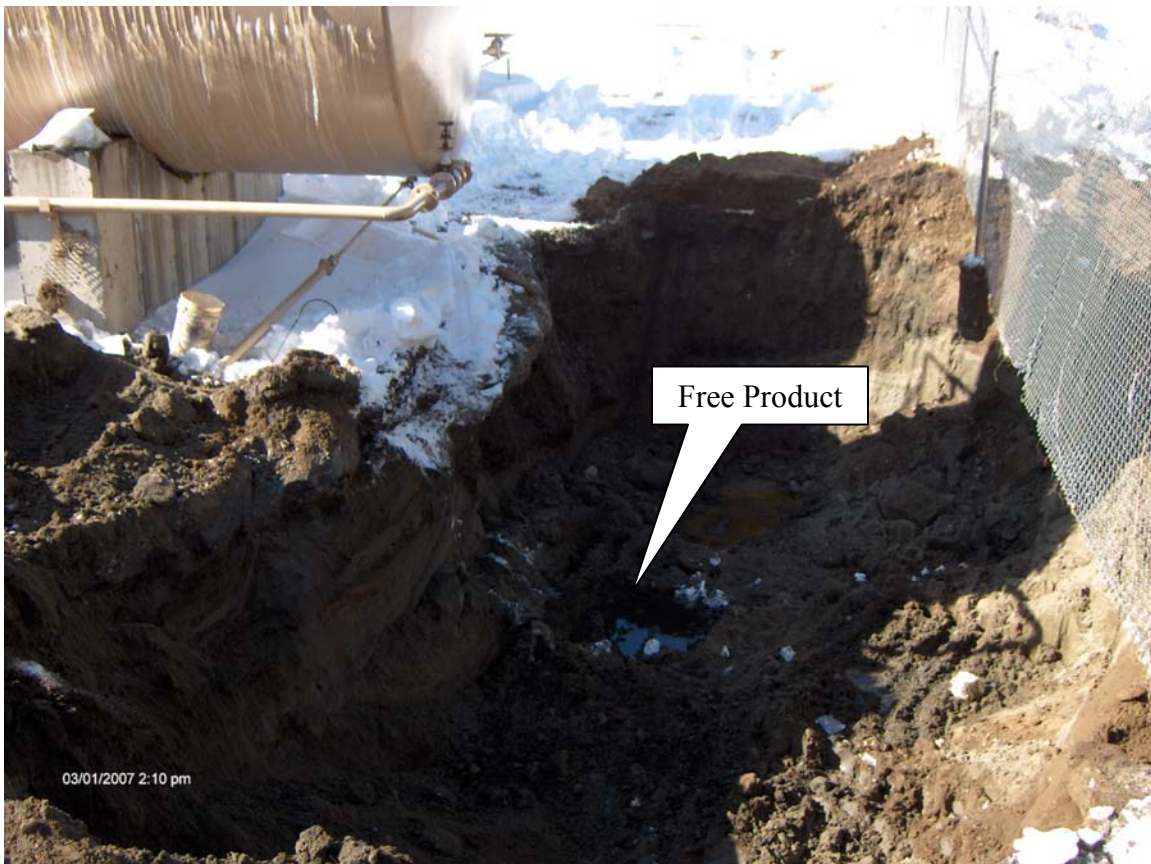
- Free phase gasoline was observed on the soil beneath the spill area at depths ranging between two and twelve 12 feet bgs.
- Groundwater was encountered during excavation at approximately 10 feet bgs. Free product was observed in direct contact with groundwater.

FP&H BULK STORAGE FACILITY – DERBY, VERMONT
(Free product observed at 10' bgs in Berm area – View Toward West)

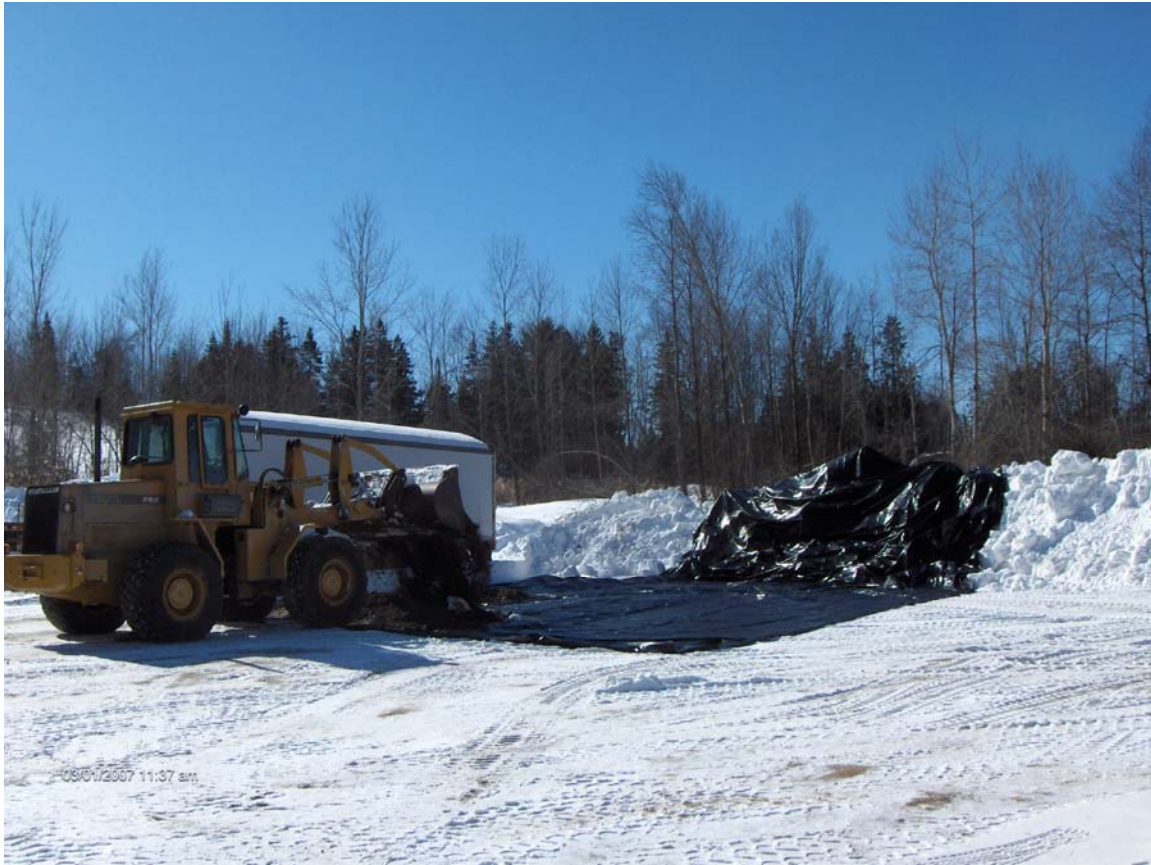
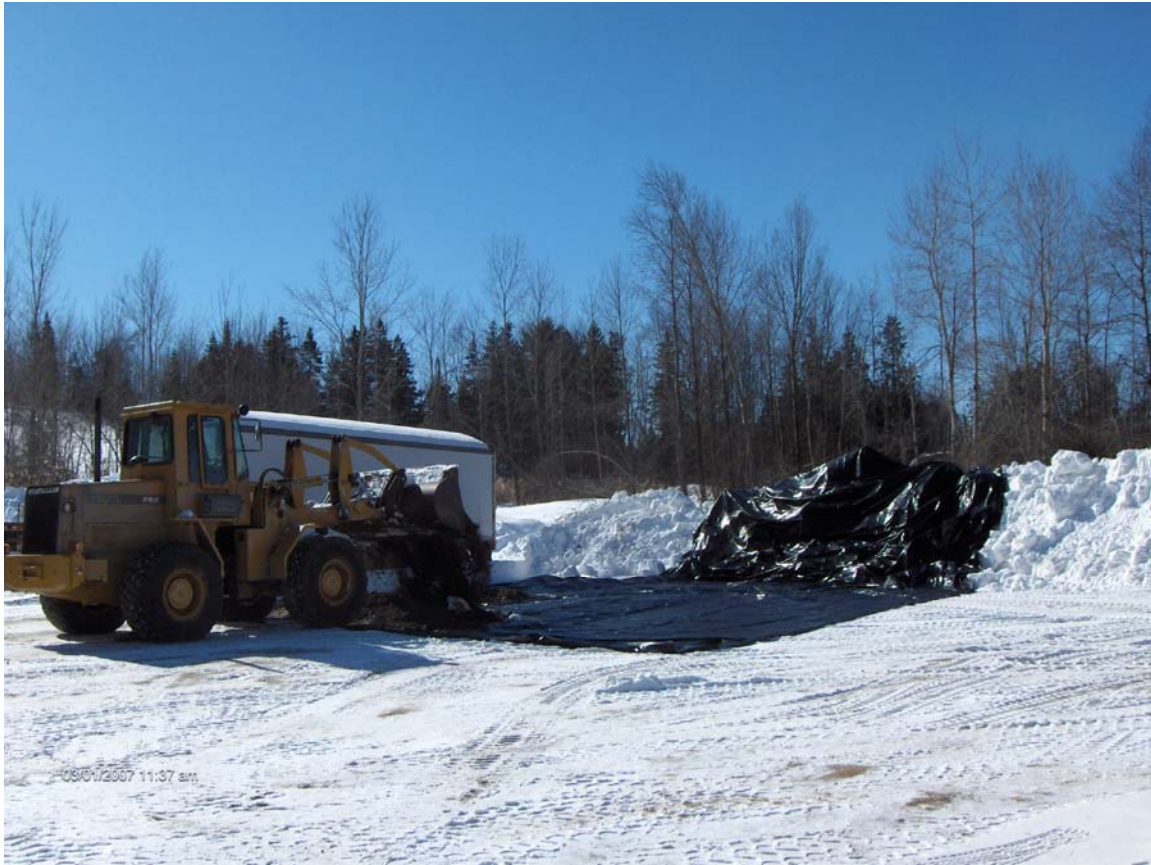
FP&H BULK STORAGE FACILITY – DERBY, VERMONT
(Area of temporary Soil containment – View toward Southeast)

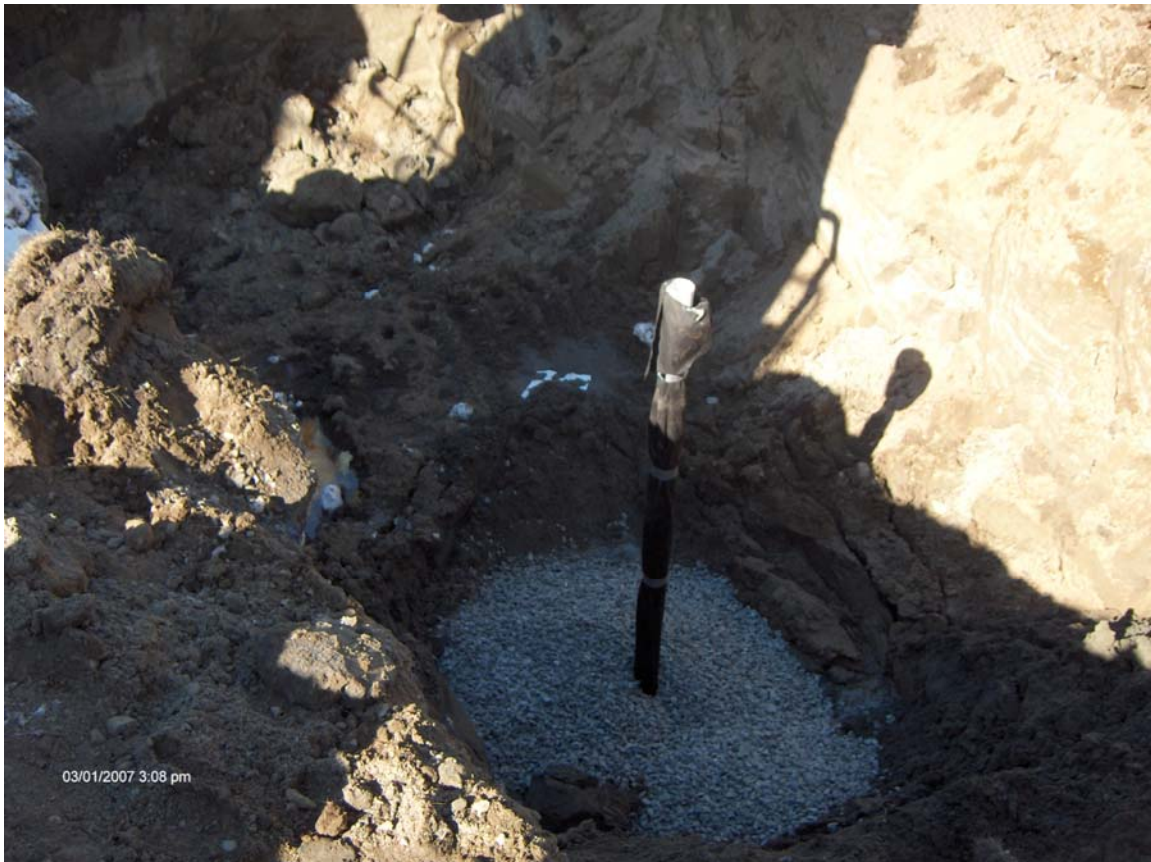
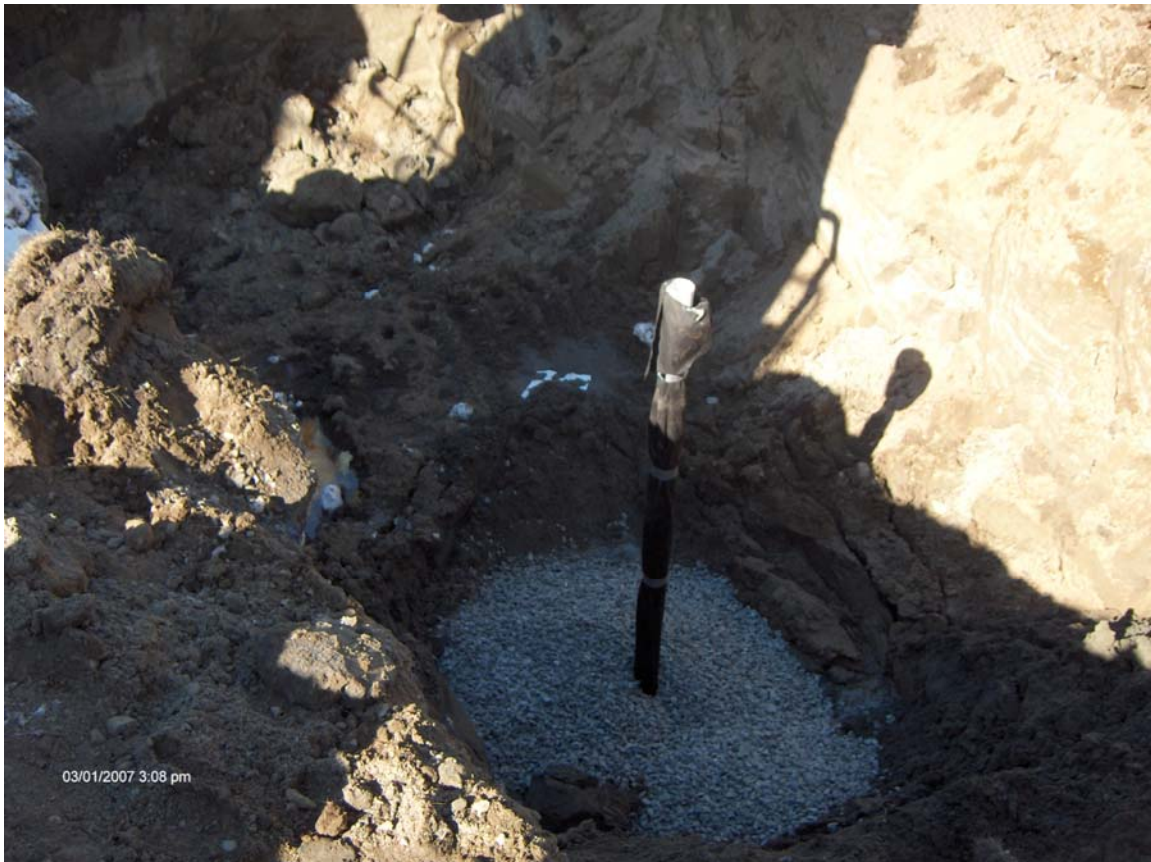
FP&H BULK STORAGE FACILITY – DERBY, VERMONT
(Installation of “Excavation” Well in Berm area)

- A free product recovery well was installed at a depth 14 feet bgs within the excavation area.
- To date, approximately 1,000 gallons of gasoline have been recovered from the well using a vacuum truck. Free-product continues to be recovered daily using a vacuum trailer.

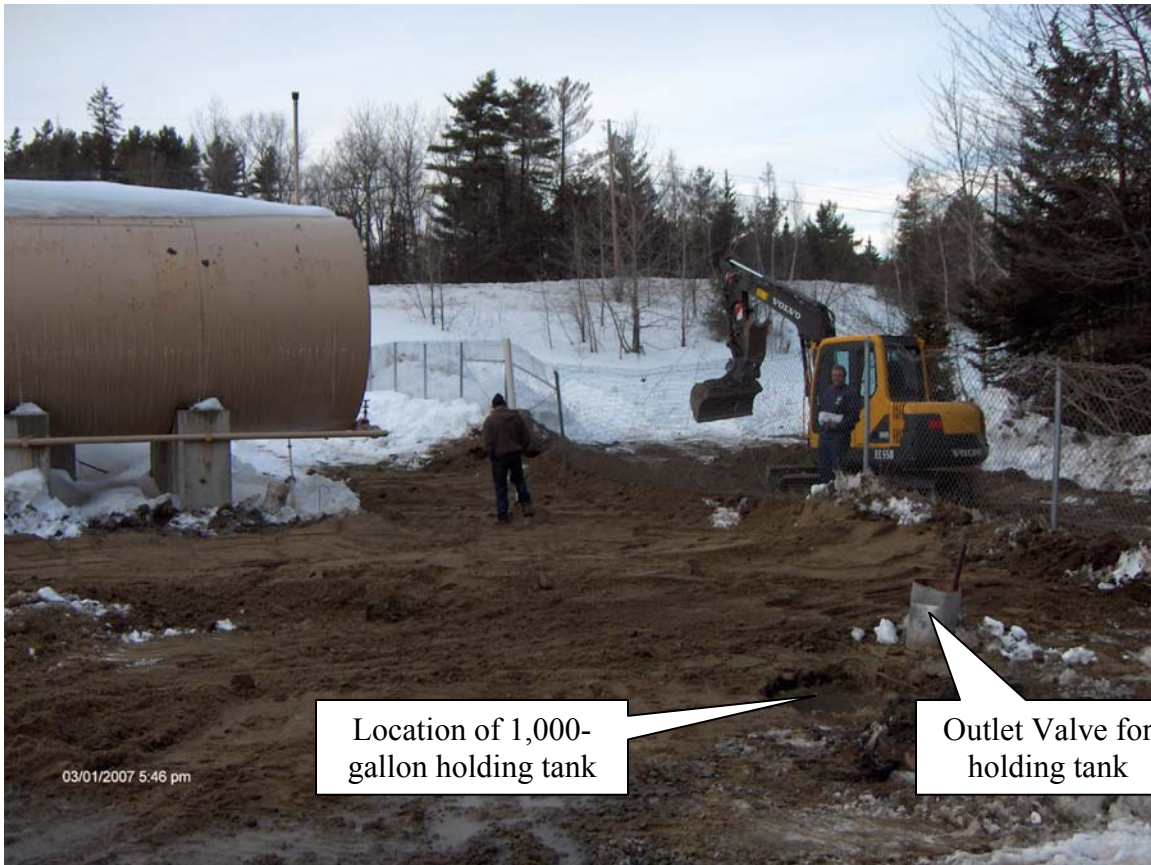
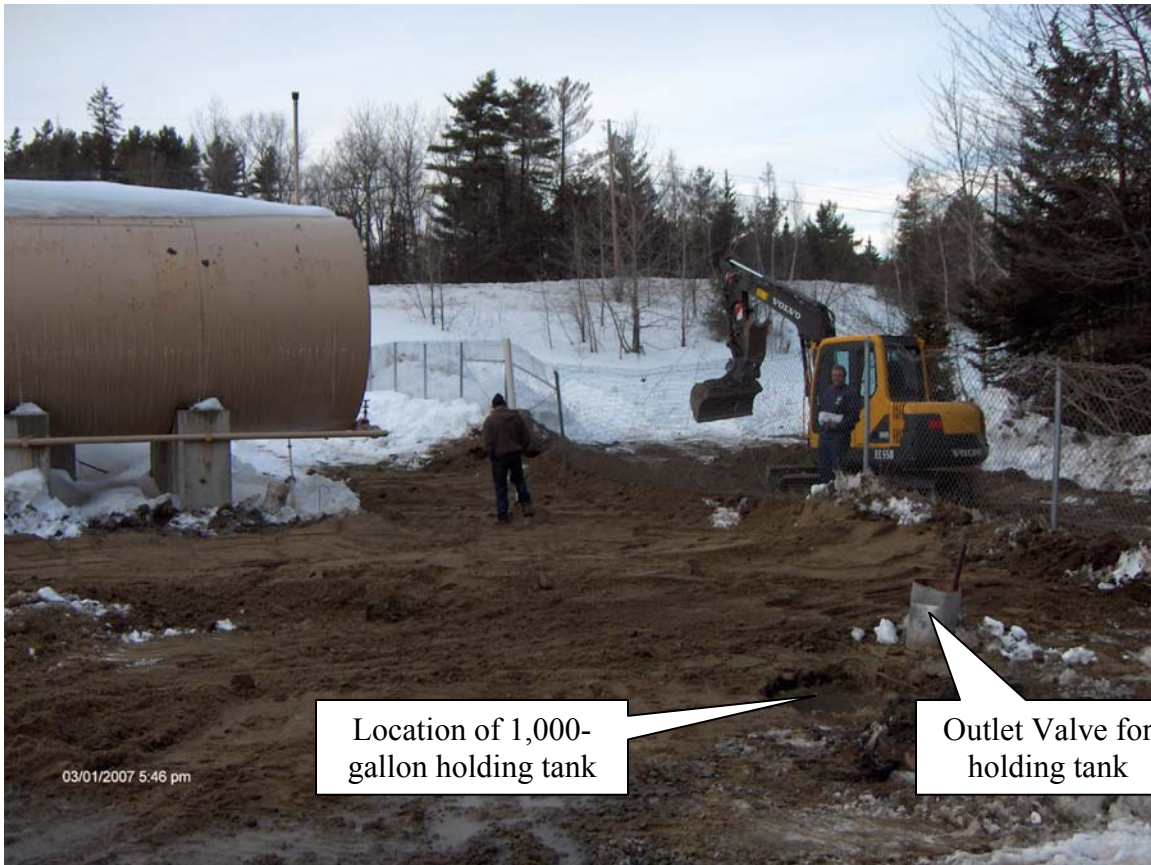
FP&H BULK STORAGE FACILITY – DERBY, VERMONT
(Berm area up to grade with clean fill – View toward Northwest)

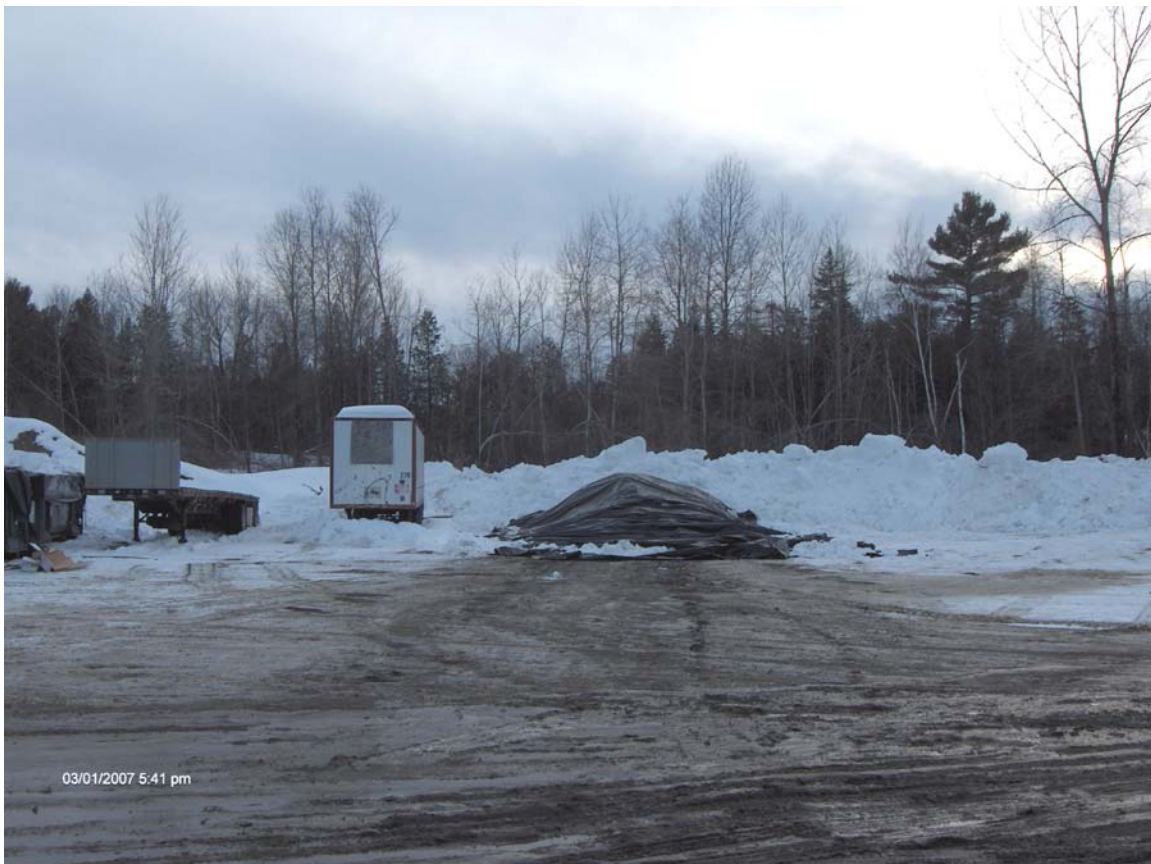
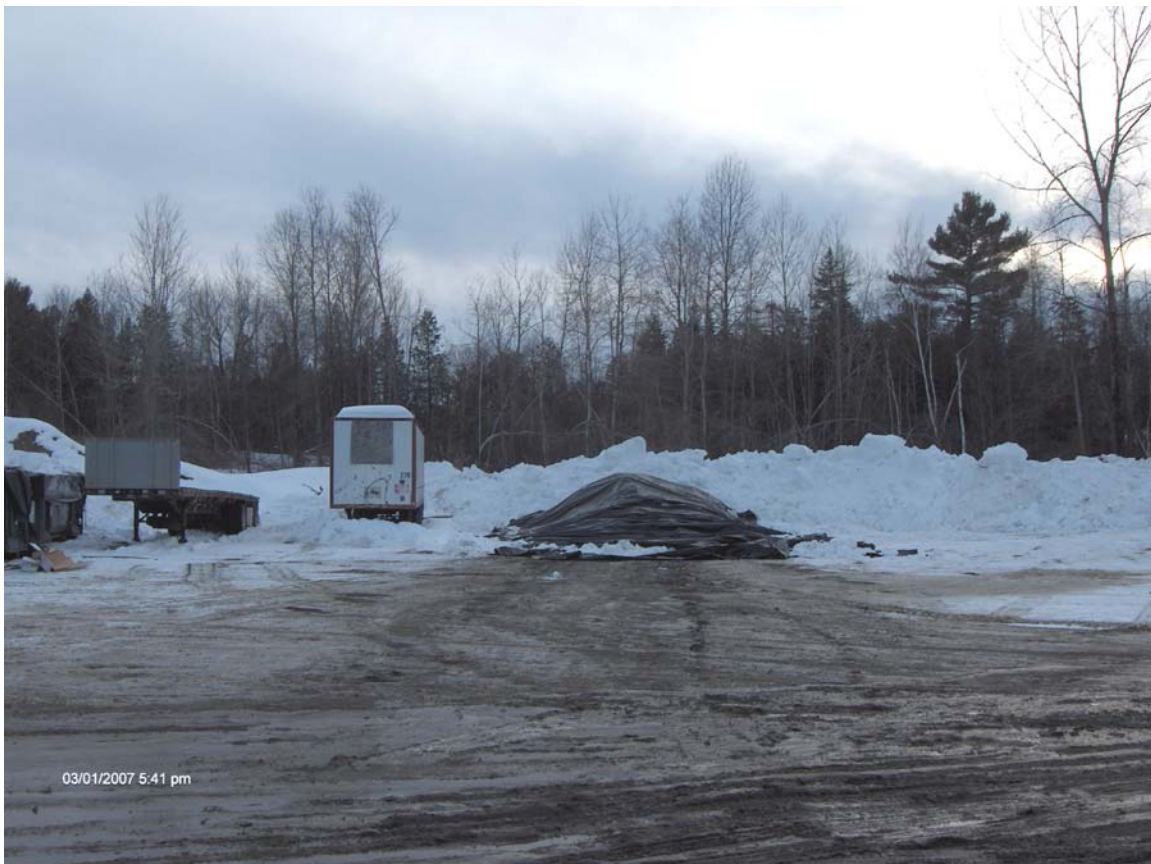
- Approximately 140 cubic yards of gasoline contaminated soil were excavated from the area of the spill and poly-encapsulated on site.
- Approximately 500 gallons of free product is estimated to have been collected during the initial snow and soil removal

FP&H BULK STORAGE FACILITY – DERBY, VERMONT
(Poly-encapsulated Soil Stockpile – View Toward South)

Approximately 30 cubic yards of gasoline contaminated snow were excavated and placed in two poly-lined roll-off dumpsters and 1,000 gallons of contaminated water were pumped from the 1,000-gallon oil-water separation UST into a temporary holding tank. Once weather permits, the gasoline contaminated melt-water and contaminated water from the oil-water separator will be treated or disposed of in accordance with VT DEC guidelines. Approximately 144 cubic yards of petroleum contaminated soil (PCS) were excavated from the spill area and poly-encapsulated onsite. The excavation was backfilled with clean soil. Free phase gasoline was observed on soils and groundwater within the excavation, which was encountered at approximately 10 feet bgs. A free product recovery well was installed in the excavation and approximately 1,000 gallons of gasoline have been recovered using a vacuum trailer to date. A summary of the PID readings and approximate sample locations are shown on **Table 1** of Attachment A, and photographs of the polyencapsulated soil are included in Attachment B.
