Remedial Action Report
Estate of Harriet Clark/Former Moxley Auto Body
172 Stage Road, South Pomfret, VT
(VT DEC SMS Site #2009-3994)

Prepared By:
Harper Environmental Associates, Inc.
1811 Hale Hollow Road, Bridgewater Corners, VT 05035
(802) 672-6112 fax (802) 672-6227
Cliff Harper, CPG, Principal

November 12, 2014

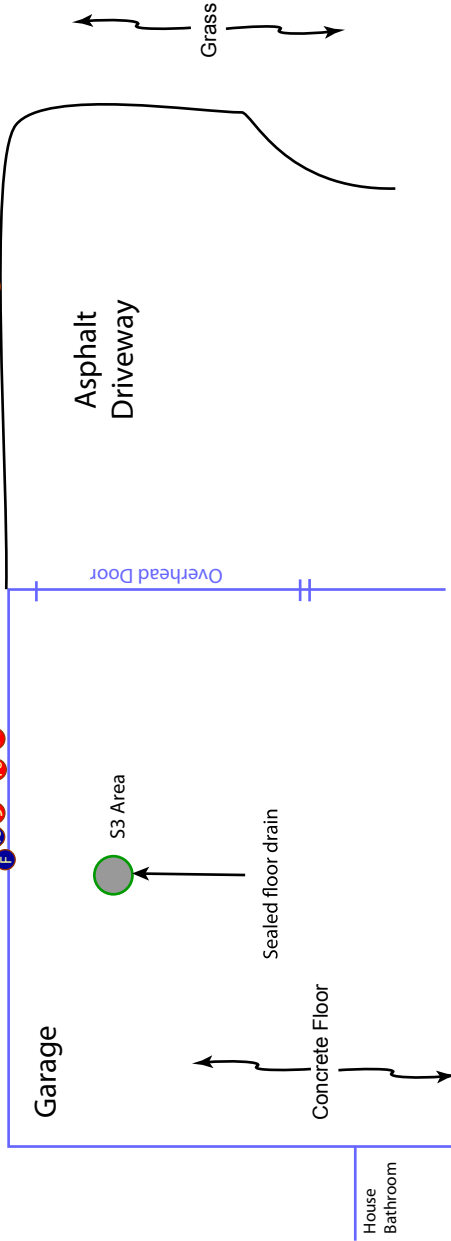
FIGURE **5**

Soil excavation: Former tank pit.
 Soil will be excavated between 0 and 4 fbg. Area of tank pit soil excavation: approximately 840 sq. ft.
 Volume = approx **31 yds.**

The approved plan specified that soils from the former UST tank pit area, which exhibited PCB contamination at concentrations in excess of applicable standards, would be excavated to a depth of up to ~10 feet below grade (fbg), transported and disposed at a licensed treatment and disposal facility (Figures 5 and 6). Similarly, the vehicle drying area

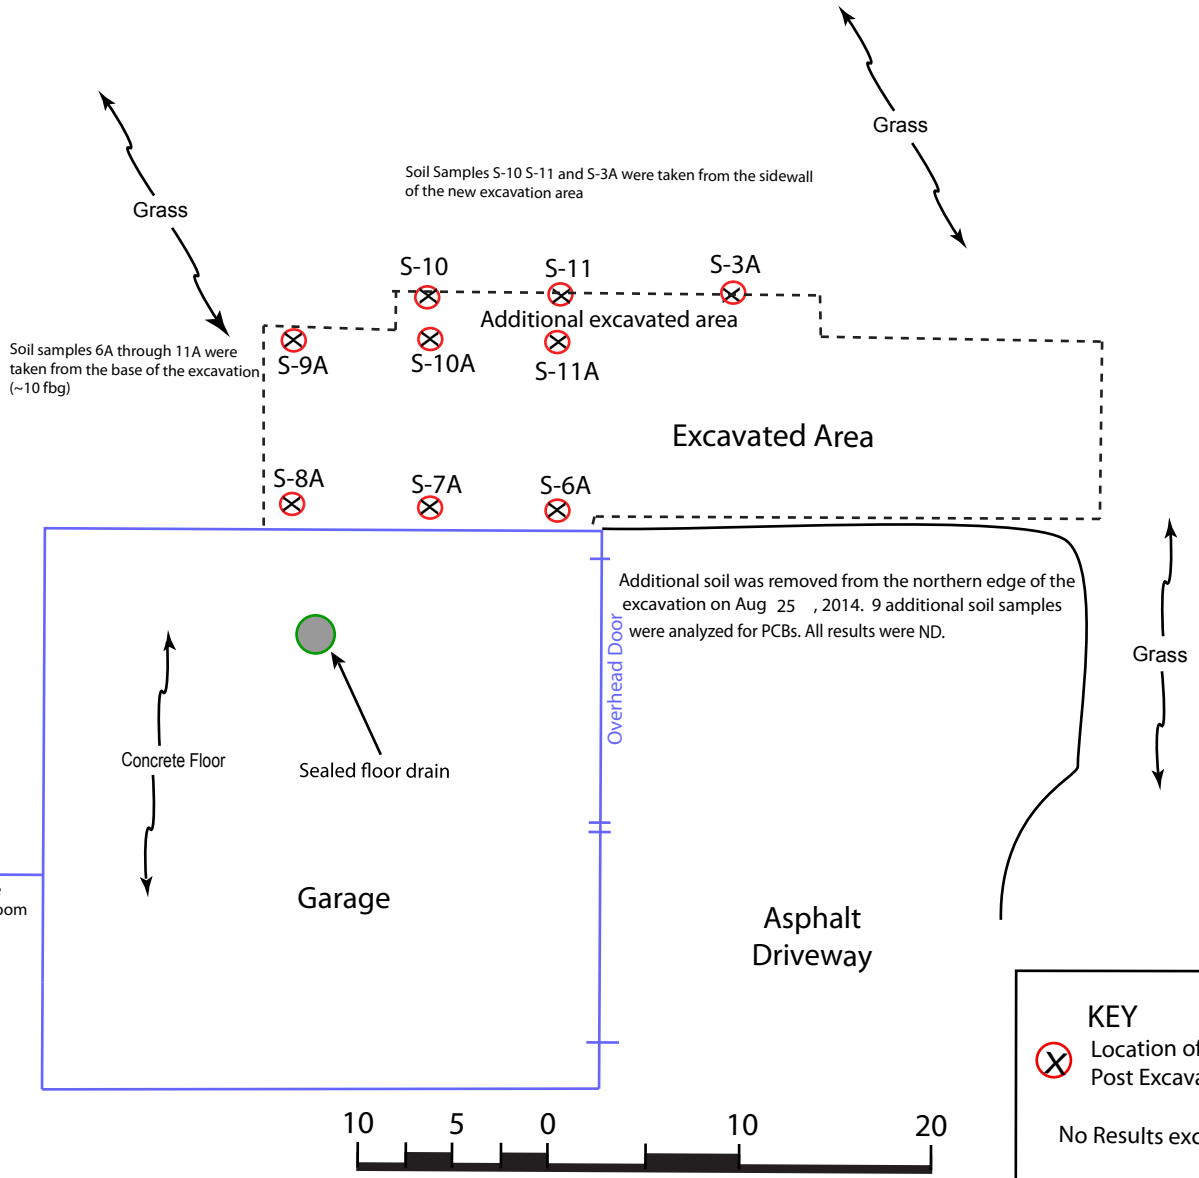
Second Post Excavation Soil Sample Map
 Clark Pomfret
 172 Stage Road
 So. Pomfret, Vermont

After further soil removal along the northern edge of the excavation, additional post-cleanup verification sampling of the soil was conducted on September 4, 2014. Nine additional soil samples were taken from the areas of the excavation. Sample numbers S-3A, S-6A, S-7A, S-8A, S-9A, S-10A, S-11A, S-10 'shallow' and S-11 'shallow' were sent to Phoenix Environmental Laboratories for PCB analysis. Table 2 shows the results of the second, post-excavation sampling. Soil samples 6A through 11A were taken from the floor of the excavation (below the corresponding number in Figure 9.) For example, S-6A was sampled in the same location as S-6 but from the floor of the excavation.

Sidewall samples S-3A, S-10 and S-11 were taken from the sidewall of the northern edge of the excavation generally corresponding to their former sample locations (Figures 9 & 10).

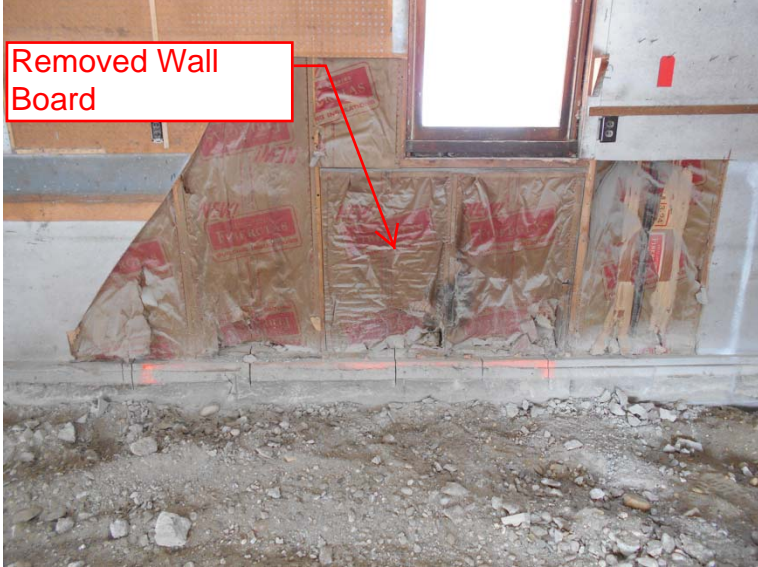
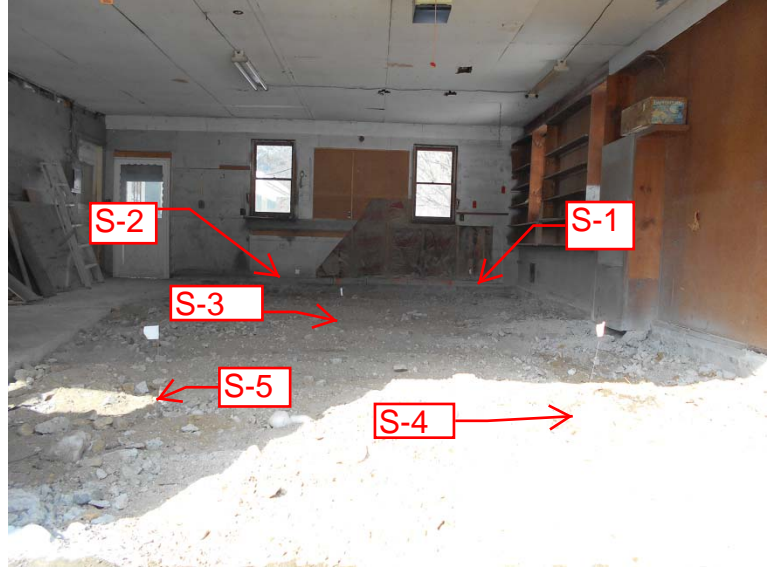
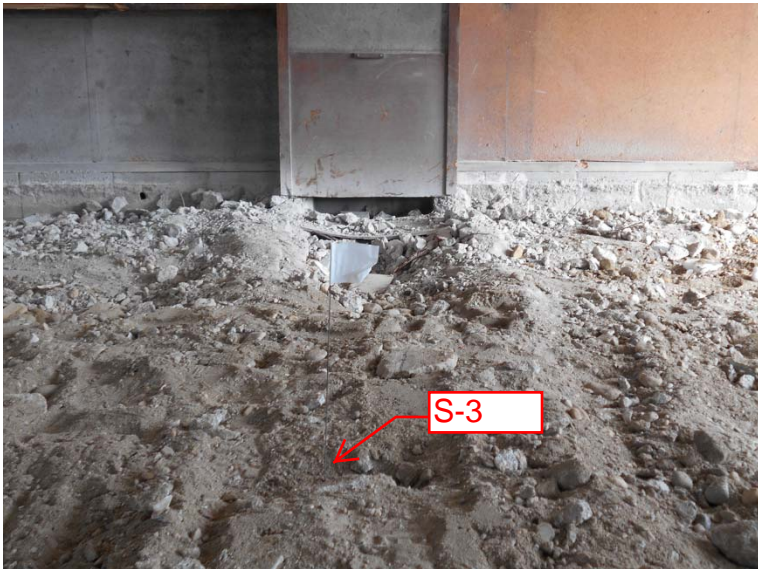
Clark Pomfret Garage Floor Removal
Sampling Points S-1 thru S-5

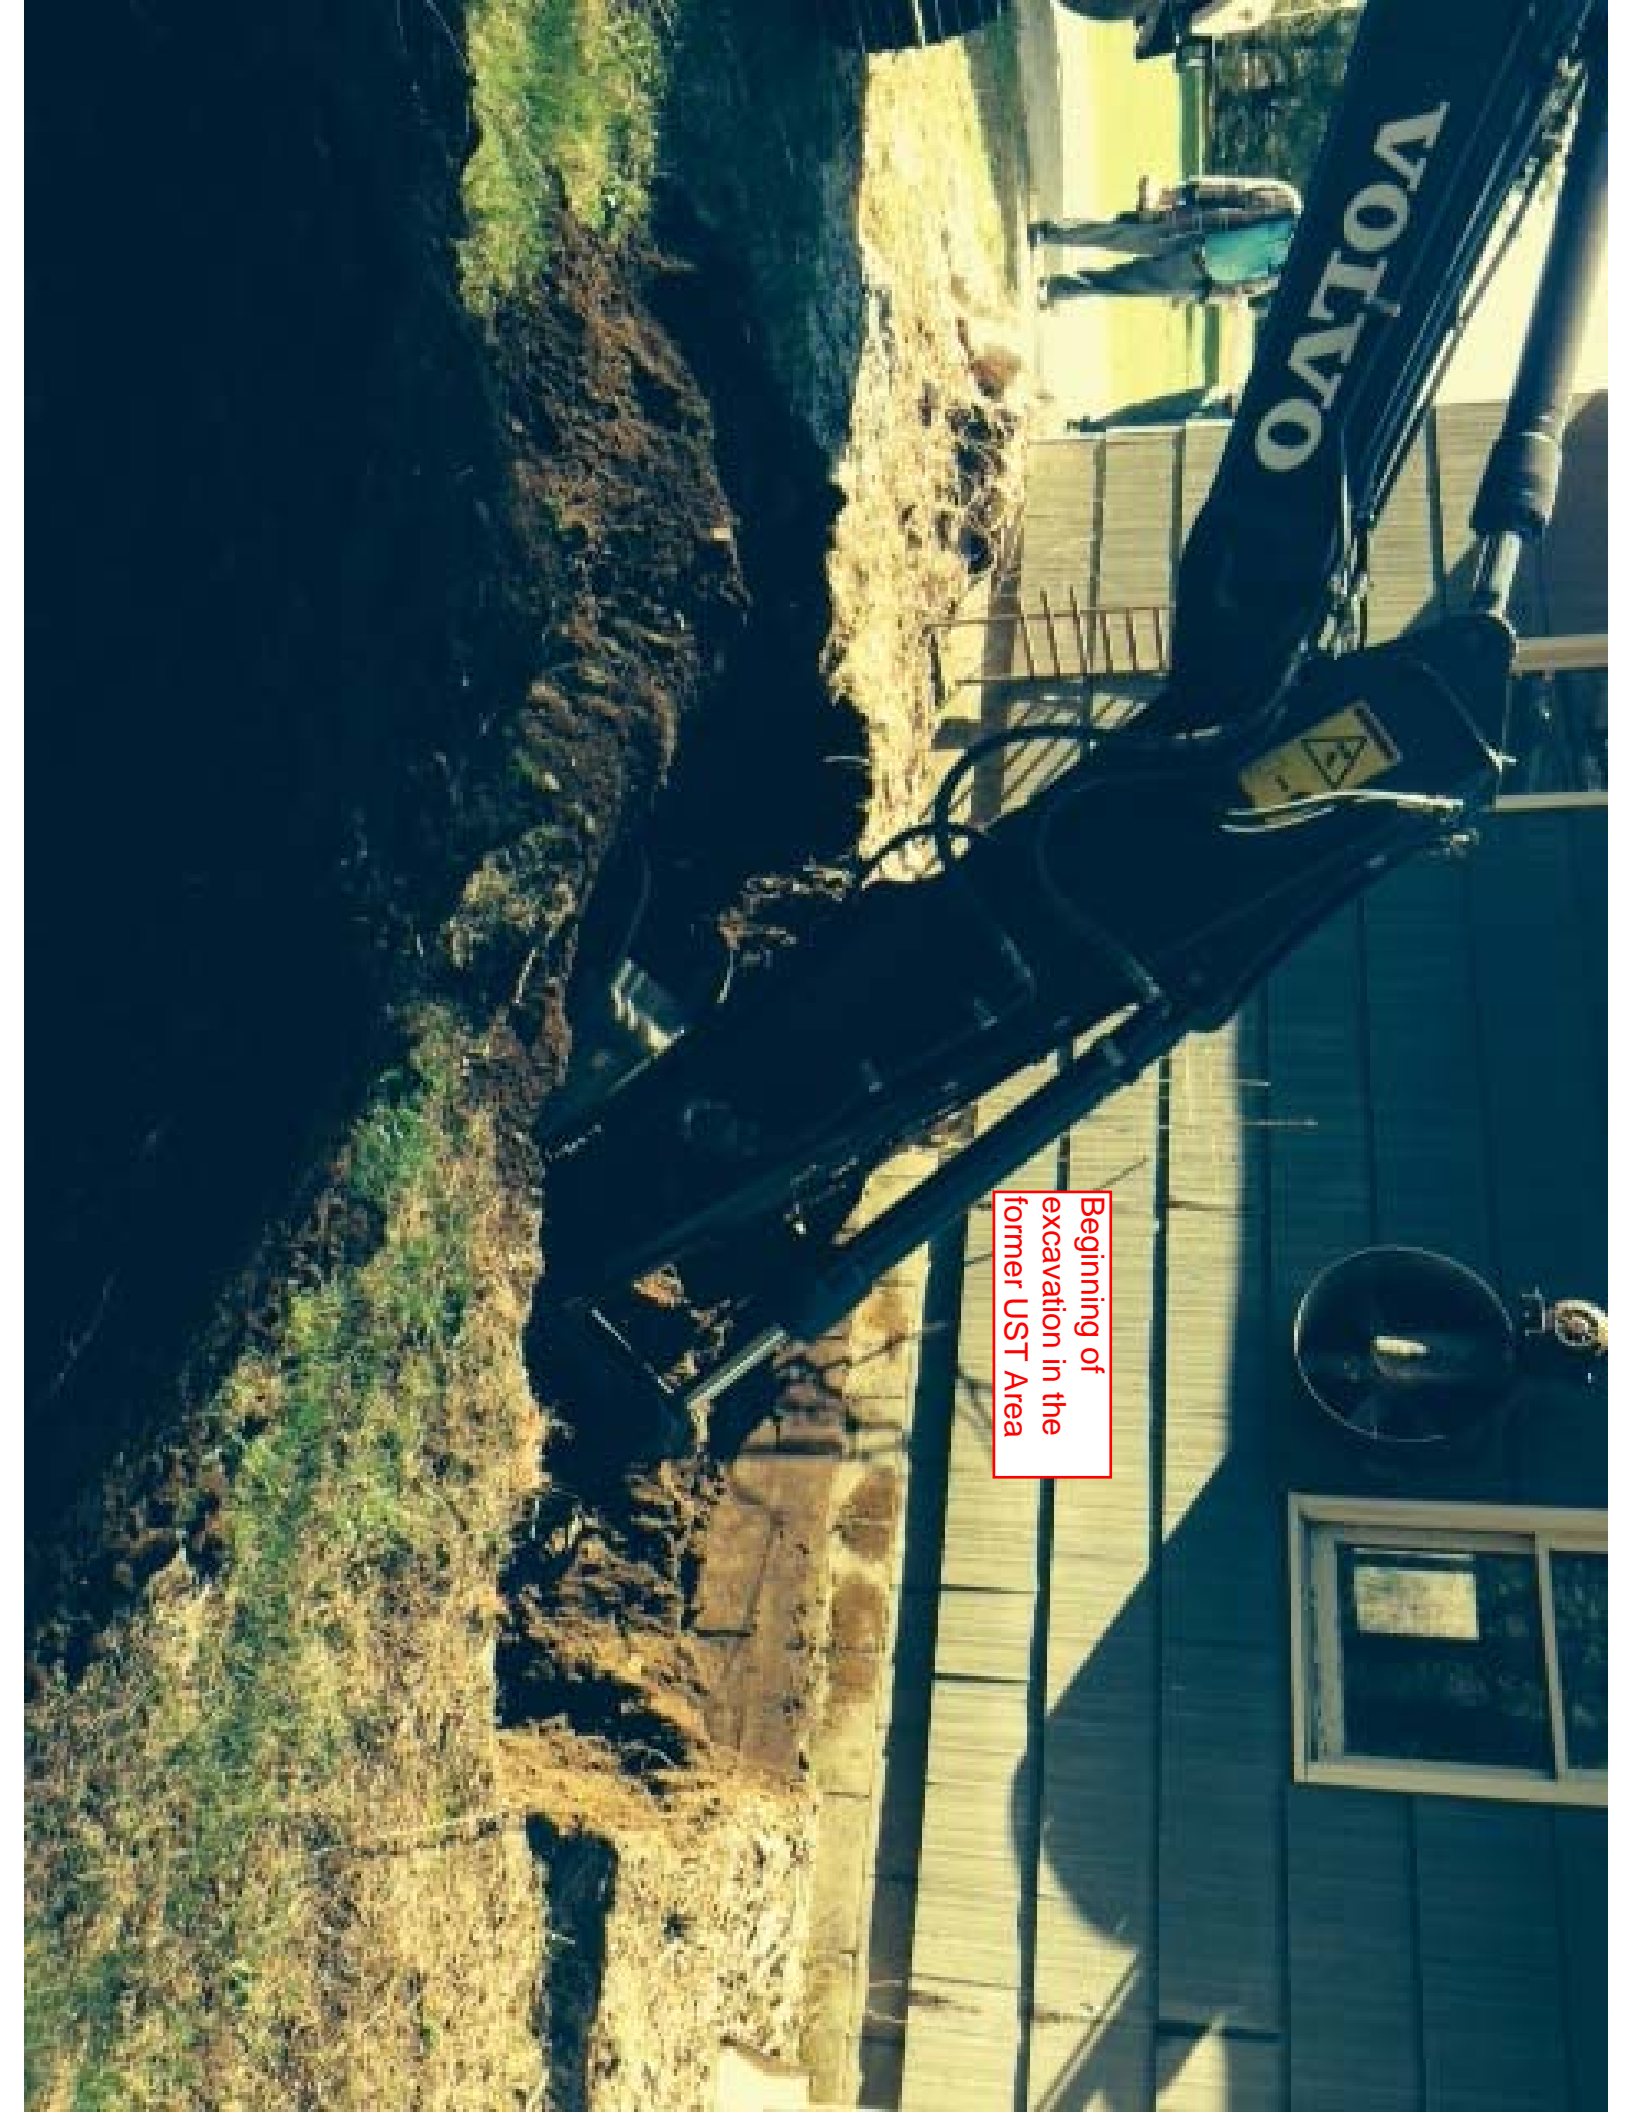
Beginning of excavation in the former UST Area

Soil Excavation in the Former UST Area

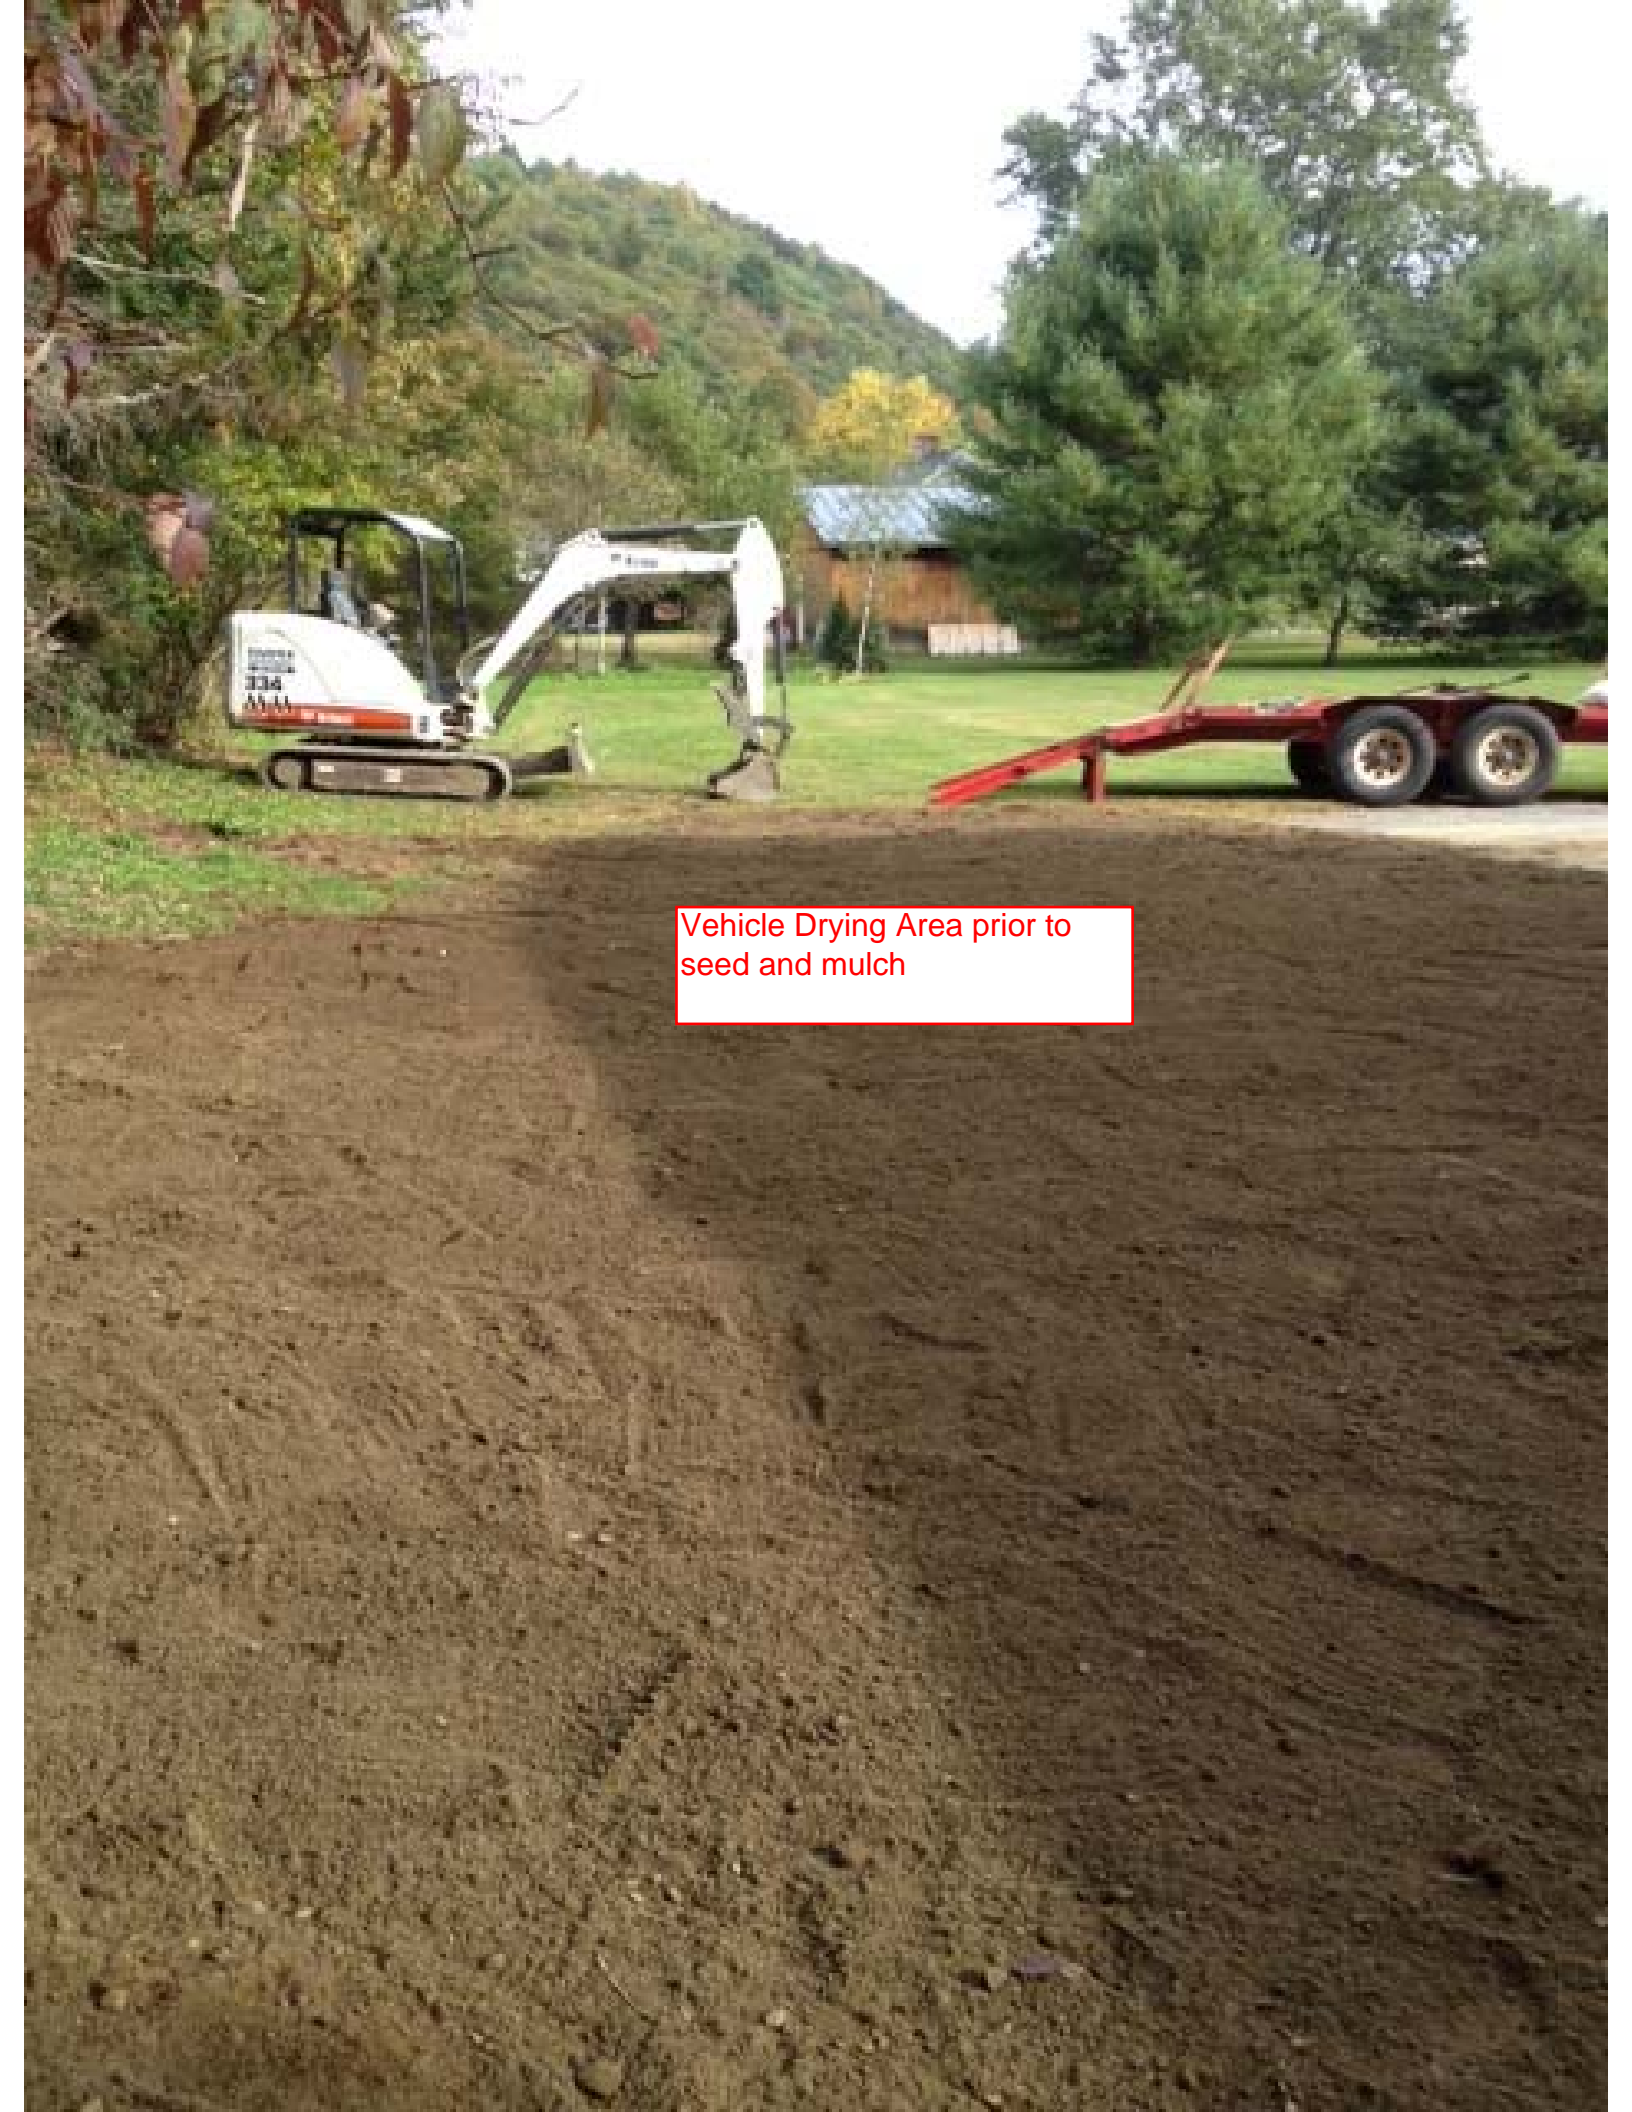
Vehicle Drying Area prior to seed and mulch
