# Corrective Action Plan

## Morrisville, VT

Gristmill-Creamery

VTDEC SMS: 20114207  
WSE: 2120063 A

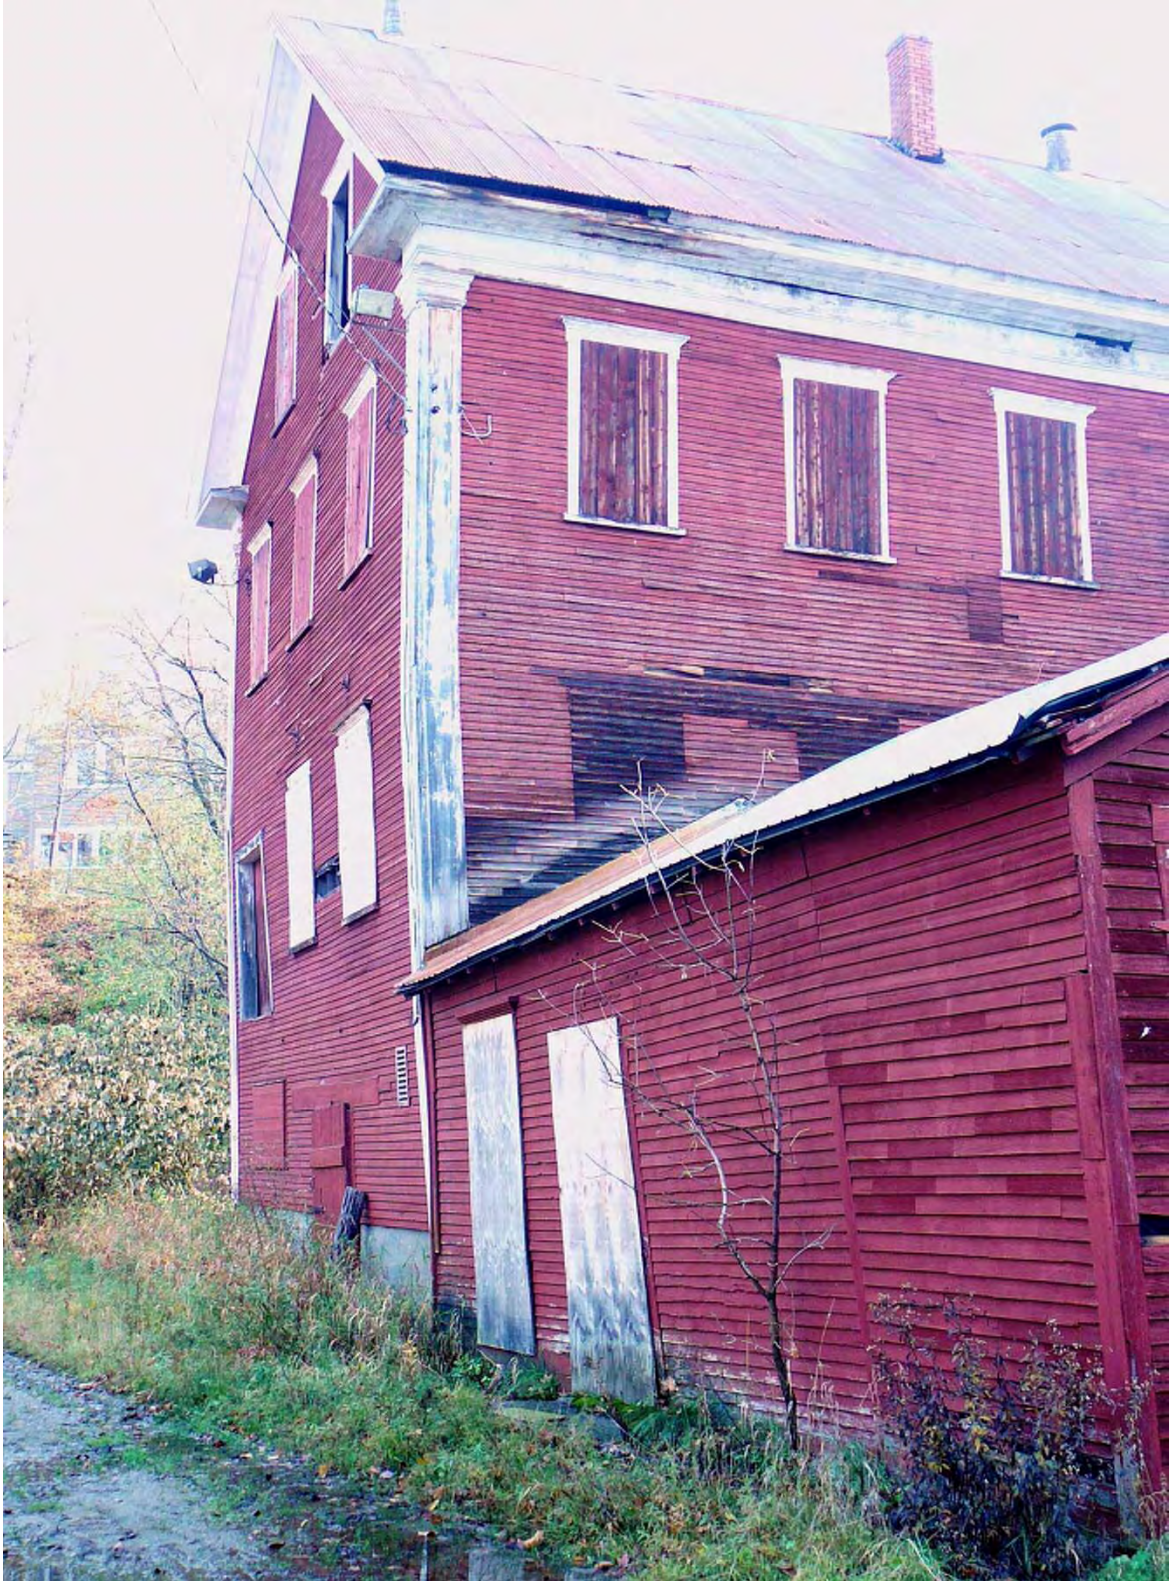
Figure 9. View northeast of rear façade of creamery, Morrisville, Vermont.

The creamery is constructed in the Greek Revival style and exhibits a period box cornice, corner pilasters, gable returns, and symmetrical 6/6 sash with molded heads. It has a metal roof, field stone foundation and painted clapboard sheathing. The main entry door facing A Street is a plank door with a simple door surround with a molded head. Along A Street, the front façade of the building stands 1 ½ stories tall, while the rear of the building is 3 ½ stories tall, making the street level at the front façade the third floor of the building. A freight door is in place at the rear of the building on the second story. The National Register Nomination reports that a platform elevator inside the building allowed flour, lumber and other finished goods to be raised easily to the top of the bluff, avoiding the steep ascent of the road. A single story ell, which first appears on the 1922 Sanborn map, is attached to the west side of the building.

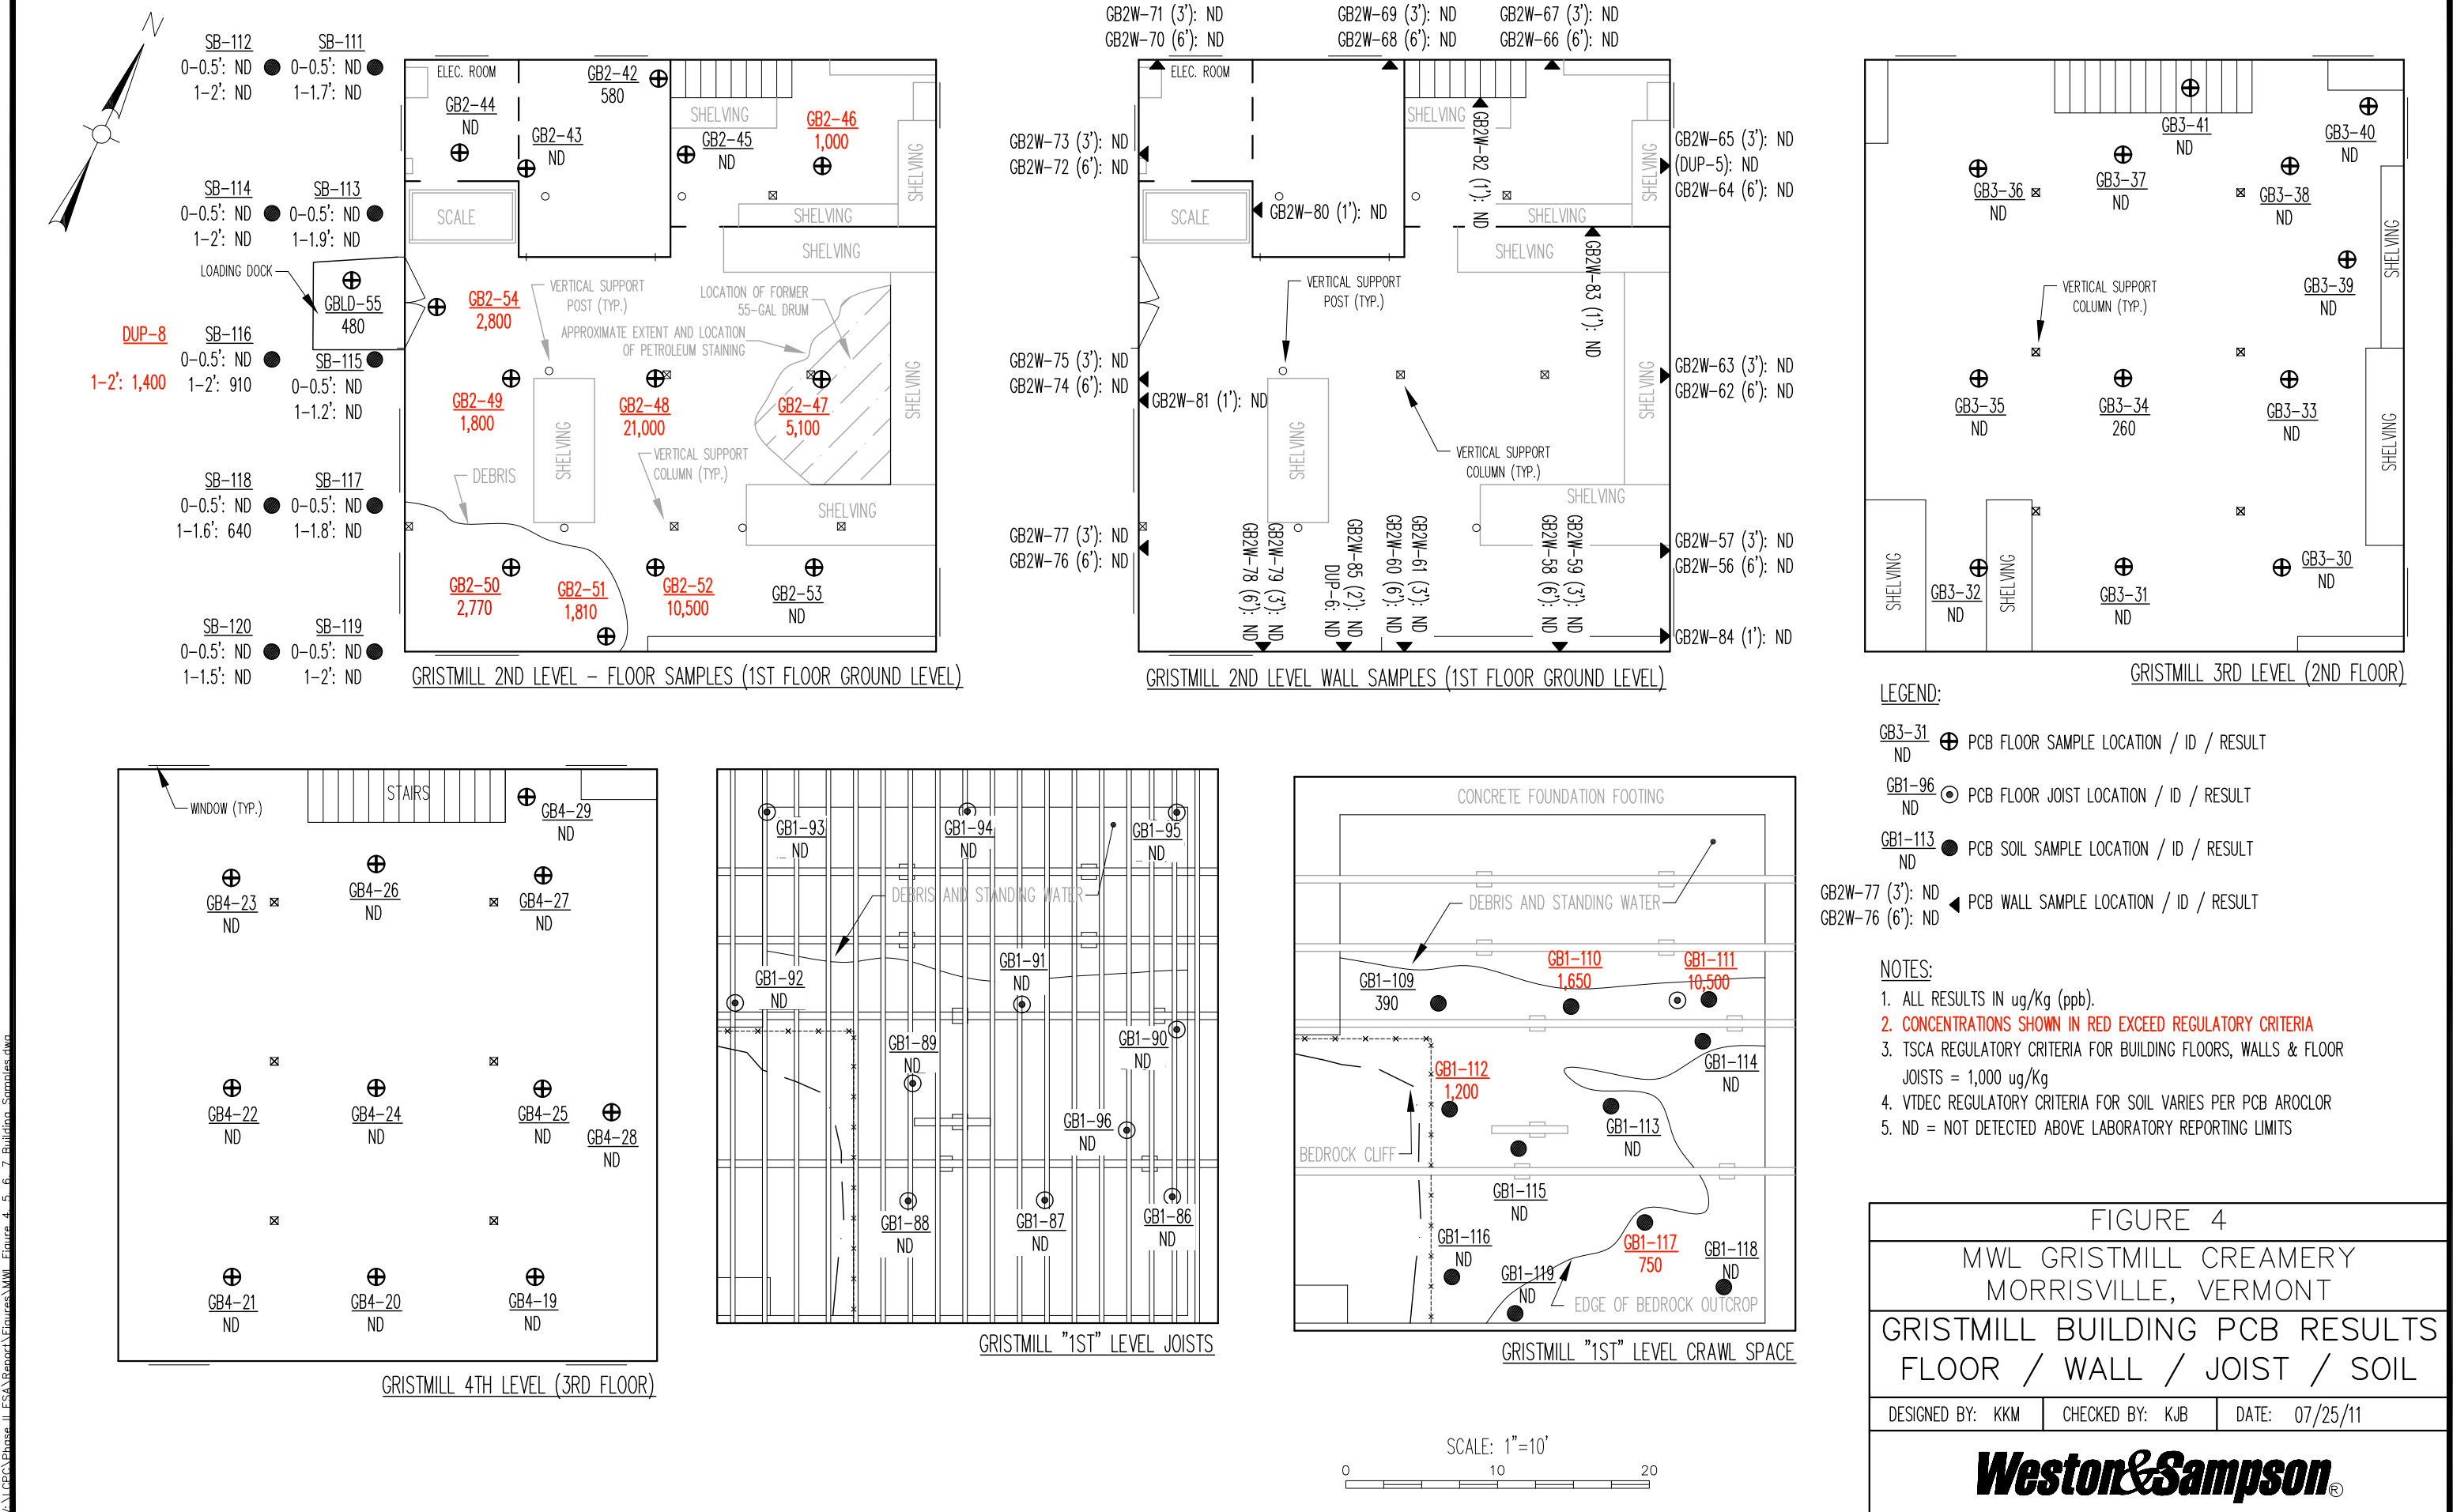
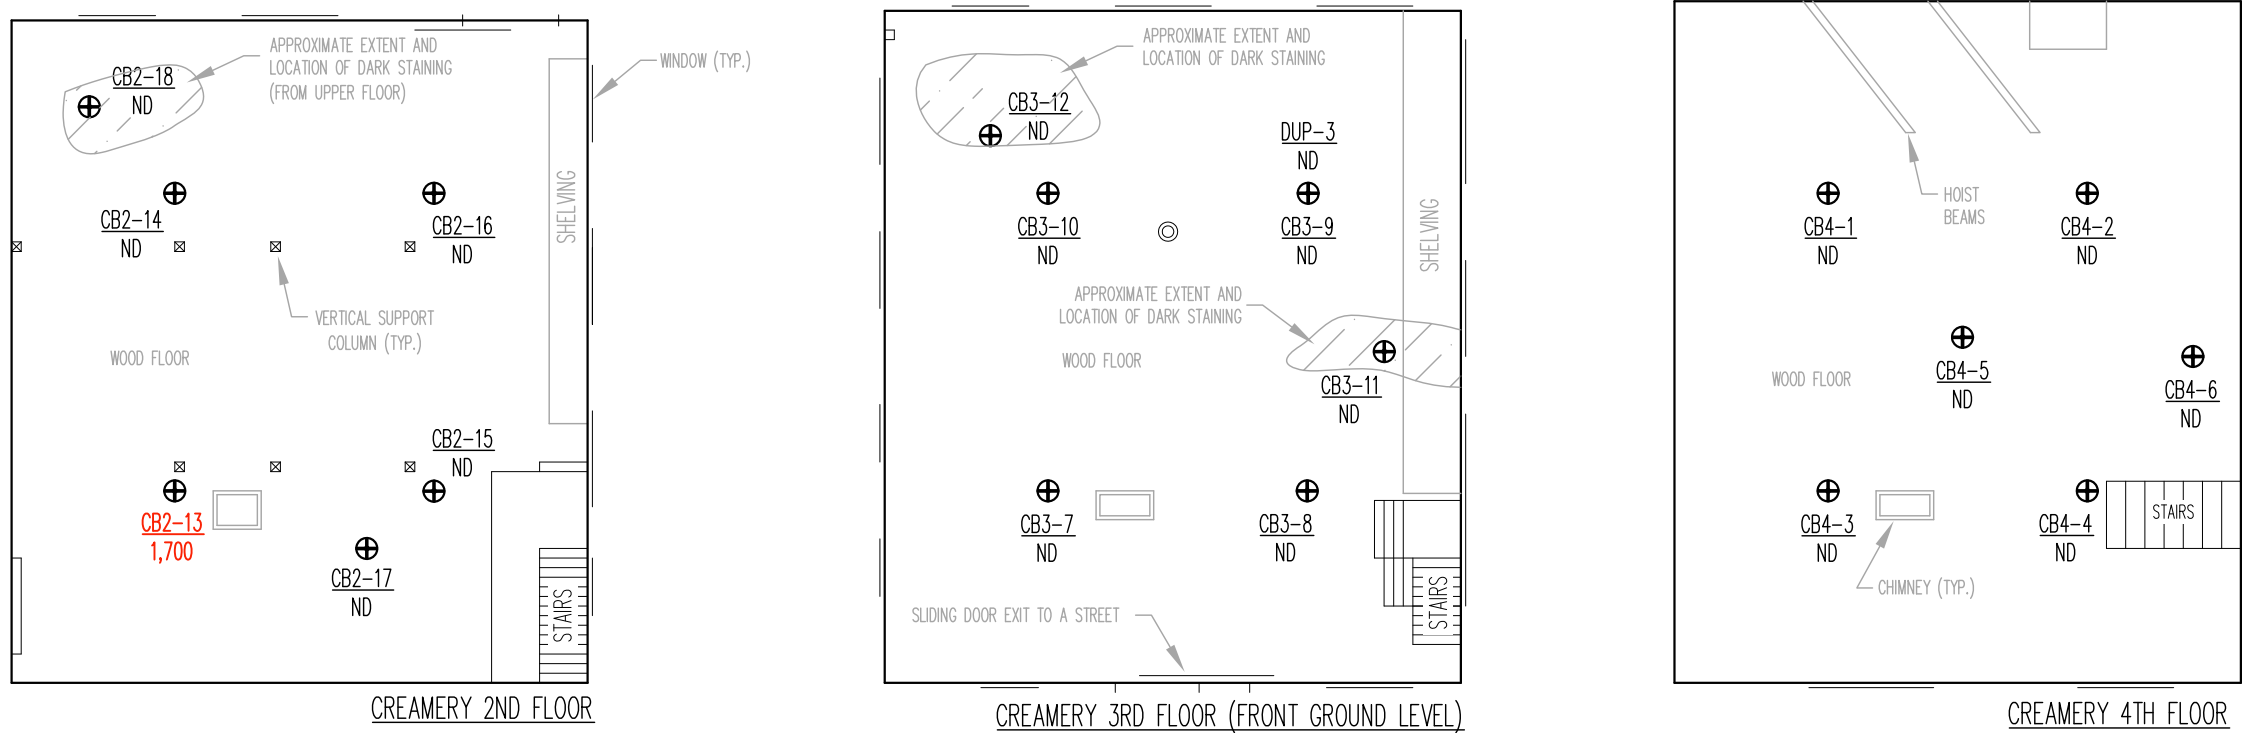
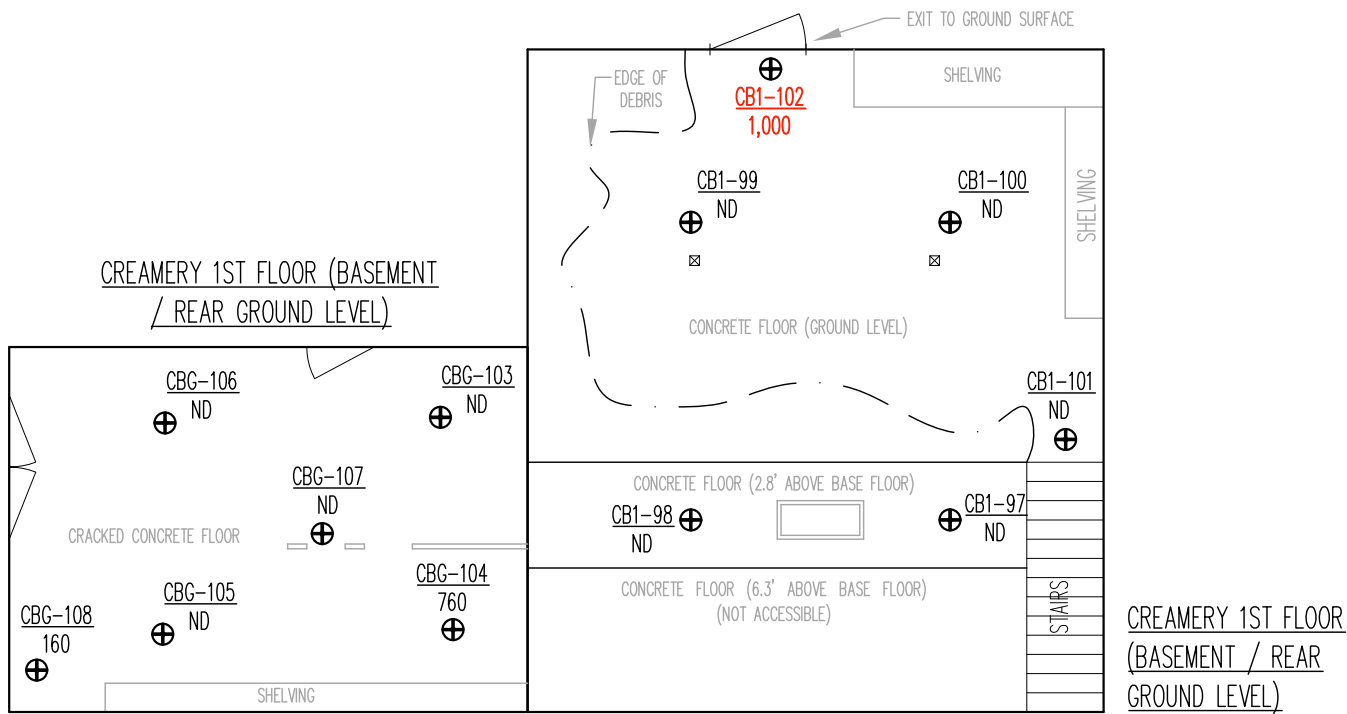
| FIGURE 5 | | |

- GB3-31 ND ⊕ PCB FLOOR SAMPLE LOCATION / ID / RESULT
- GB1-96 ND ⊙ PCB FLOOR JOIST LOCATION / ID / RESULT

- ALL RESULTS IN ug/Kg (ppb).
- CONCENTRATIONS SHOWN IN RED EXCEED REGULATORY CRITERIA
- TSCA REGULATORY CRITERIA FOR BUILDING FLOORS, WALLS & FLOOR  
JOISTS = 1,000 ug/Kg
- ND = NOT DETECTED ABOVE LABORATORY REPORTING LIMITS

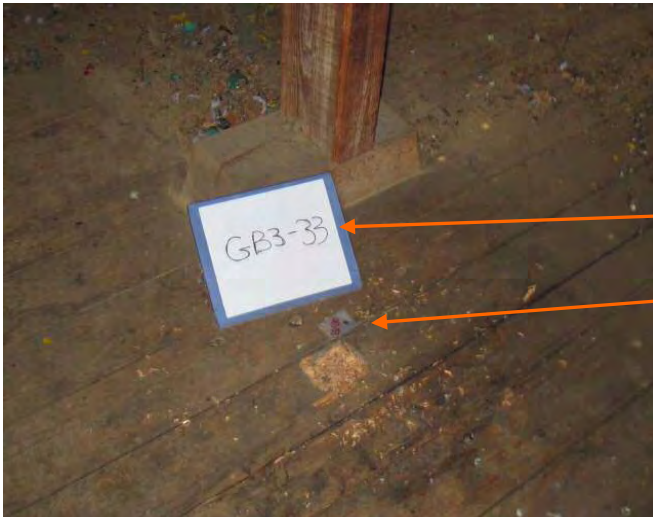
Photo #14

Photo Documentation of PCB  
Floor Sample Location  
Tag Identifier

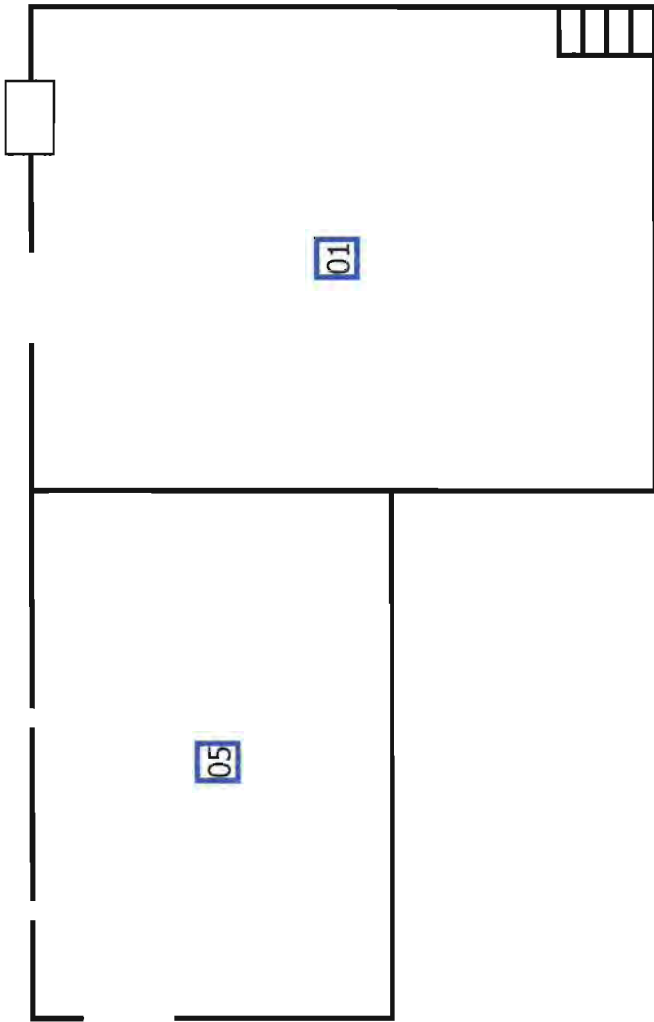
First Level

| Clay Point Associates, Inc.<br>Project #11595<br>May 23, 2011 | Former Creamery Building<br>36 A Street<br>Morrisville, Vermont | Asbestos Inspection<br>Not to Scale<br>Drawn by: Heather Bromberg |

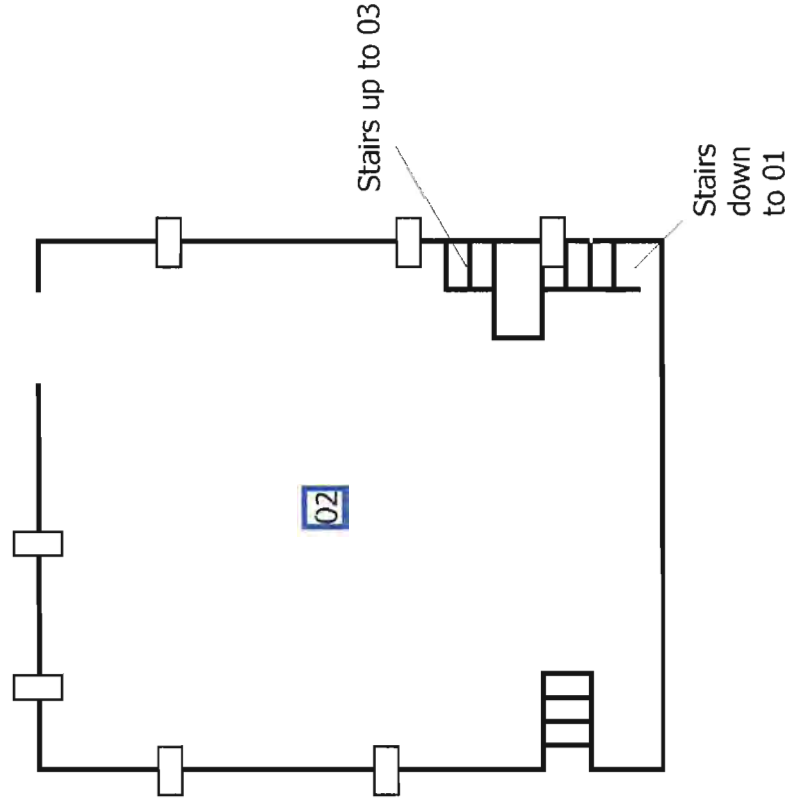
Second Level

| Clay Point Associates, Inc.<br>Project #11595<br>May 23, 2011 | Former Creamery Building<br>36 A Street<br>Morrisville, Vermont | Asbestos Inspection<br>Not to Scale<br>Drawn by: Heather Bromberg |
